DOE/RL-99-11  
Draft A

# 200-BP-1 Prototype Barrier Treatability Test Report

June 1999

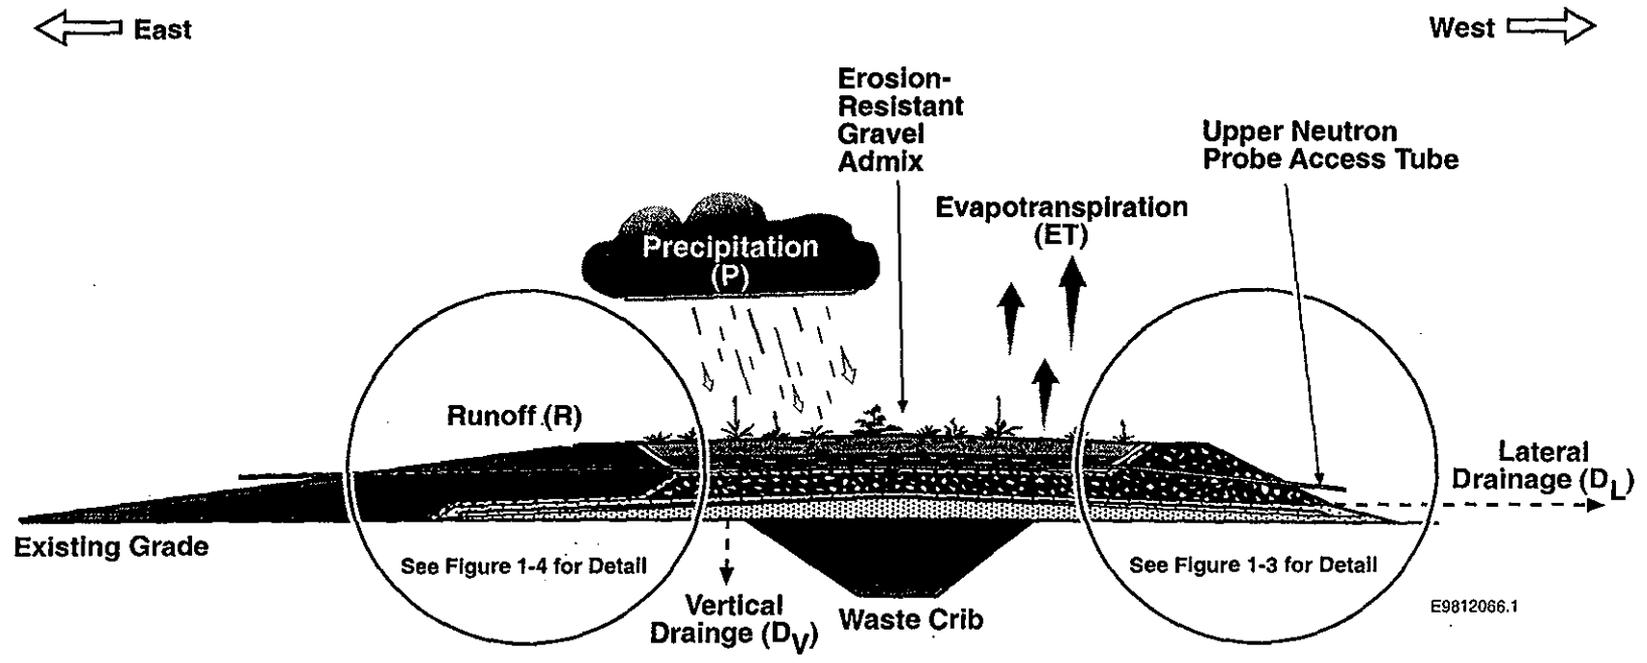
Figure 1-2. Hanford Prototype Surface Barrier Cross Section.

The barrier design consists of a fine soil (silt-loam) layer overlying other, coarser materials such as sands, gravels, and basalt riprap (Figure 1-3 and Appendix A). Each layer serves a distinct purpose. The silt-loam layer acts as a medium in which moisture is stored until the processes of evaporation and transpiration recycle any excess water back to the atmosphere. The design storage capacity, the total amount of water that can be stored in the silt-loam layer before drainage occurs, is 600 mm based on an assumed available water storage capacity of 0.3 volume water/volume soil estimated from field lysimeter results ( $0.3\% \times 2,000 \text{ mm silt loam} = 600 \text{ mm storage capacity}$ ). The silt loam is designed to store more than three times the long-term average (LTA) annual precipitation at the Hanford Site. The silt loam also provides a medium for establishing plants, which are necessary for transpiration to take place. In addition, the top 1 m of silt loam had been amended with pea gravel to minimize wind erosion. Coarser materials (sand overlying gravel) placed directly below the silt-loam layer create a capillary break that inhibits the downward percolation of water through the silt (similar to a sponge holding water) and prevent fine soil from filtering downward into the coarse layer. The coarser materials (i.e., basalt riprap) also help deter root penetration, animal burrowing, and inadvertent human intruders (biointrusion) through the barrier profile. An asphalt layer is placed at the bottom of the barrier to provide a low-permeability (hydraulic barrier) and redundant biointrusion layer.

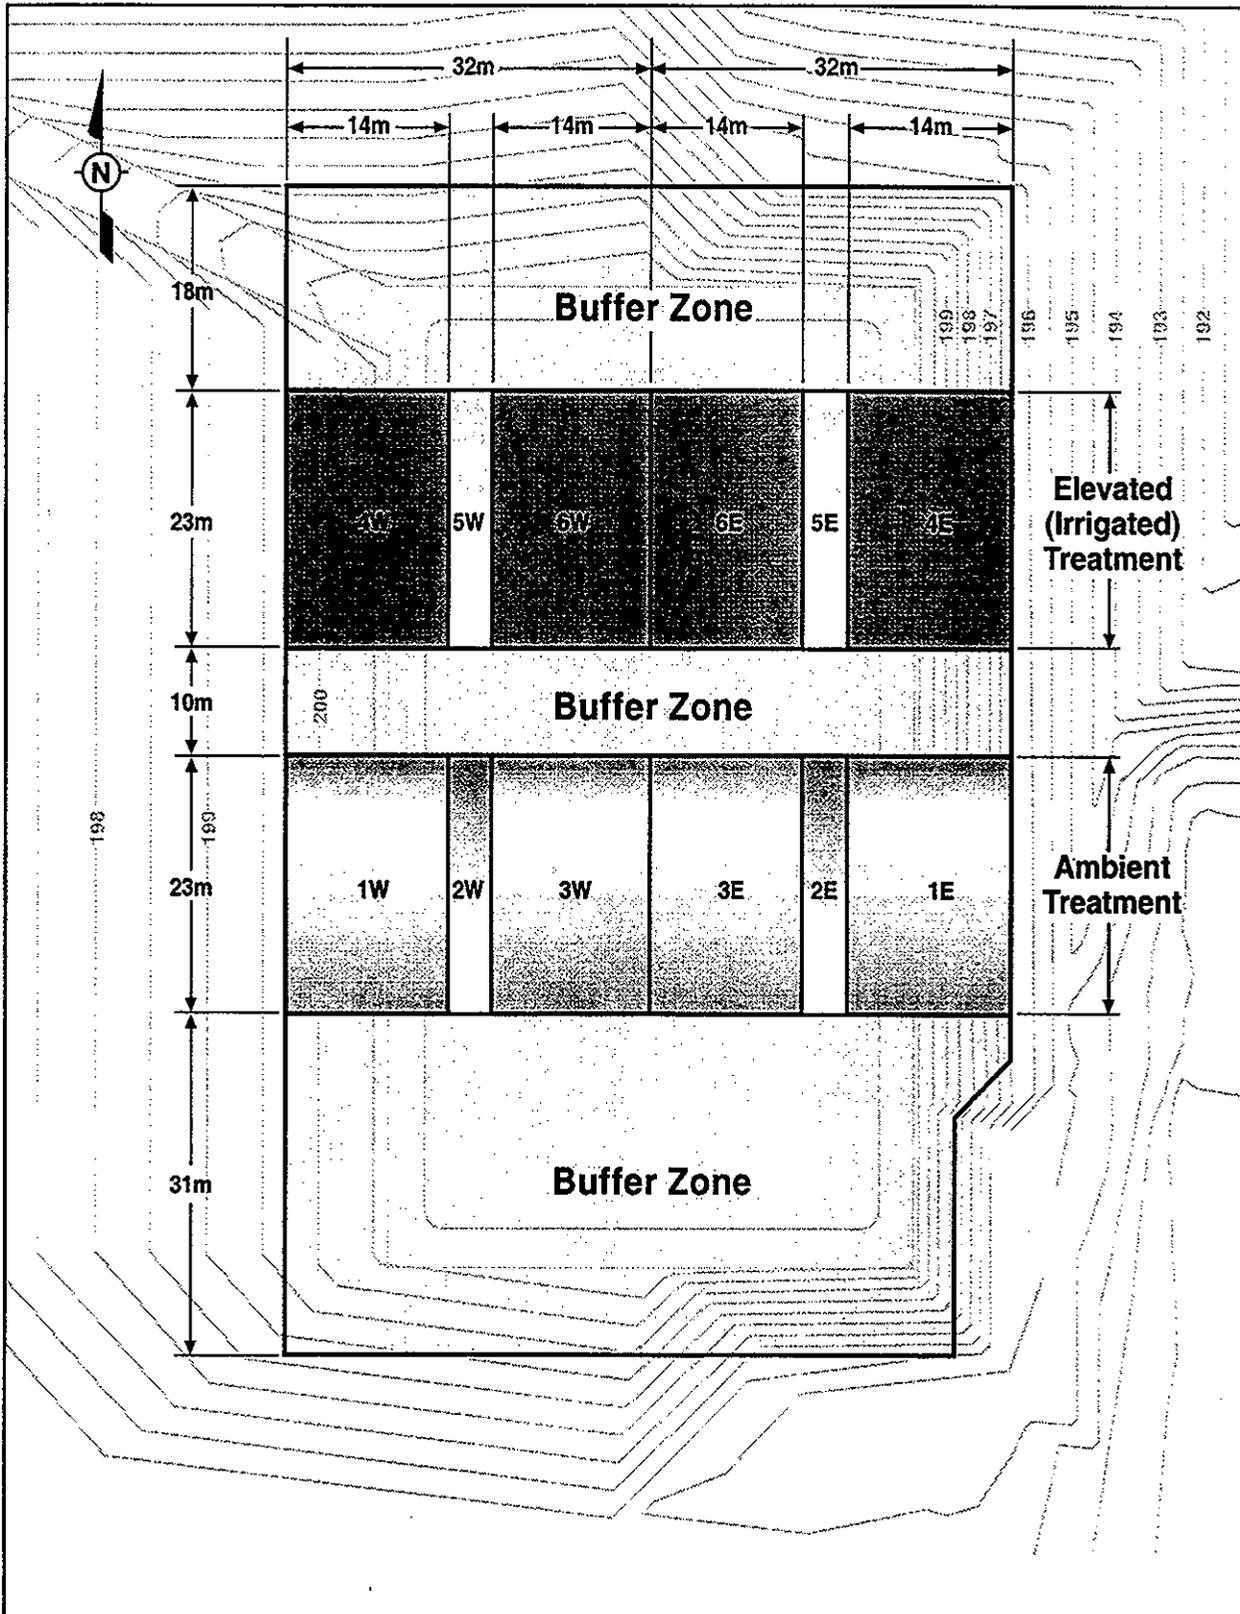
**Figure 2-1. Plan View of the Prototype Hanford Barrier Showing Layout of the 2 Precipitation Treatments, the 3 Buffer Zones, and the 12 Surface Soil Plots (1W-6W and 1E-6E).**

**2.2.2.1 Experimental Design.** For monitoring purposes, the surface of the barrier is divided into two treatments or sections (elevated and ambient), one to the north and the other to the south. The north section was designated to receive an elevated amount of precipitation (natural precipitation plus supplemental irrigation) to simulate extreme climatic conditions (three times the long-term annual precipitation), while the south section received only natural (i.e., ambient) precipitation. To minimize edge effects and interaction between the precipitation treatments, the two sections are separated from each other and from the north and south edges of the barrier by buffer zones. The north section is separated from the south by a 10-m buffer zone. To minimize the impact that the edges could have on monitored processes, the north section is separated from the northern edge by an 18-m buffer zone, whereas a 31-m zone separates the south section from the southern edge. Figure 2-1 is a plan view of the prototype Hanford Barrier showing the layout of the two precipitation treatments.

The low-permeability composite asphalt layer was built with a 2% slope to the east and west of the crown of the barrier, to facilitate lateral water movement. A series of curbs divide the surface of the asphalt into 12 water collection zones (Figure 2-1 and Appendix A). The entire surface of the asphalt pad is covered with a layer of gravel to facilitate lateral drainage toward the lower slope positions of each collection zone. The boundaries of the 12 water collection zones align vertically with each of the 12 surface plots shown in Figure 2-1 and Appendix A, and described in Table 2-1.

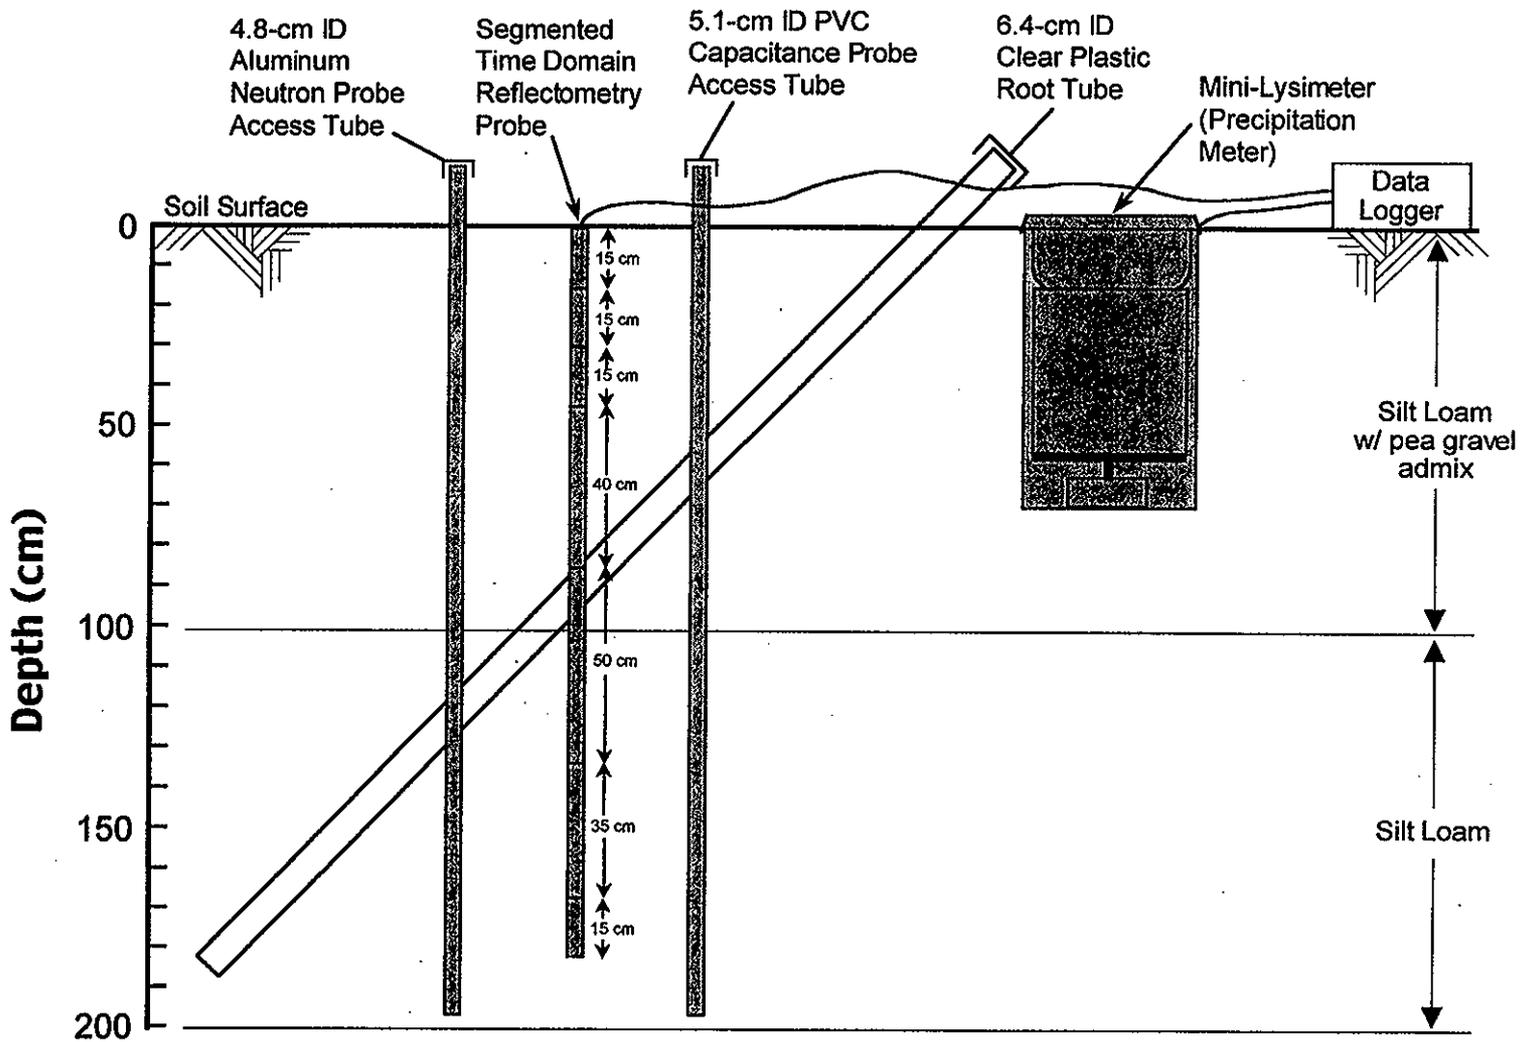
Figure 2-3. Cross Section of a Typical Water Balance Monitoring Station.

To measure water content profiles in the top 2-m-thick silt-loam layer, each monitoring station was fitted with a vertical aluminum access tube for measurements with a neutron probe, a polyvinyl chloride (PVC) access tube for capacitance probe, and a 1.85-m segmented time domain reflectometry (TDR) probe (Figure 2-3). Each surface plot is associated with a water collection system (with boundaries on the asphalt layer) to permit measurement of drainage out of the upper soil layers (Appendix A). Below each treatment, U-shaped horizontal neutron probe access tubes permit measurement of water content above and below the asphalt layer (Figure 2-2 and Appendix A). A pan lysimeter was also installed under the asphalt pad at the northeastern corner of the riprap slope (plot 4E) to permit evaluation of the performance of the asphalt layer (Appendix A).

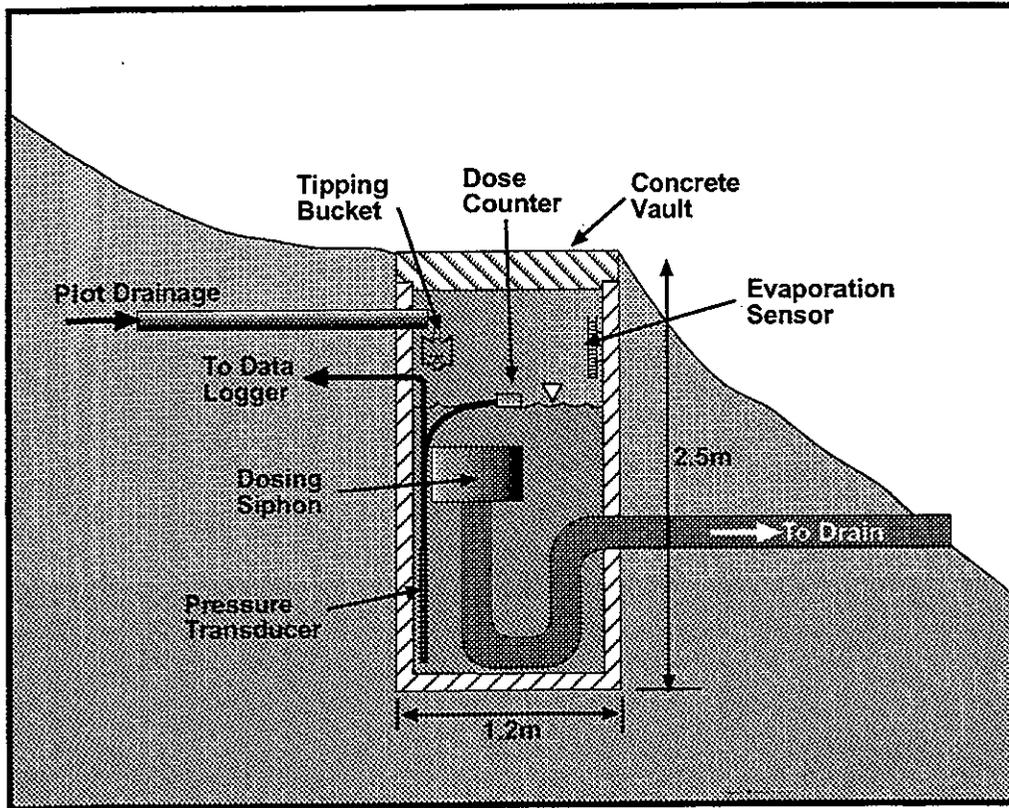
**Figure 2-5. Schematic of Drainage Monitoring System Showing the Siphon Vault and Associated Monitoring Instruments.**

The drainage monitoring system is composed of 12 concrete vaults (Figures 2-4 and 2-5 and Appendix A). The vaults were installed to the north and downgradient from the asphalt layer to allow the movement of water by gravity. Drainage water flows into each vault via a datalogger-controlled tipping-bucket rain gauge, which allows monitoring of low flows. Each vault is also fitted with a submersed Druck<sup>®</sup> pressure transducer that continuously monitors the intermediate to high flow rates by recording hydrostatic pressure, which is a function of water height. Measurements are made at intervals ranging from 10 minutes to 1 hour. Also included in each vault is an Orenco<sup>®</sup> dosing siphon, a passive device for monitoring large flows. The siphon is fitted with a dose counter connected to a datalogger to record dosing events. Each dose is equivalent to  $591 \pm 40 \text{ L}$  of water, or 1.8 mm from the full-sized plots and 6.4 mm from the transition plots. Each vault is also fitted with an evaporimeter to monitor the amount of water evaporating from the vault. The measurement precision of the instruments is presented in Table 2-2. Detailed instructions on the measuring procedure are provided in PNL-PSB-4.0.

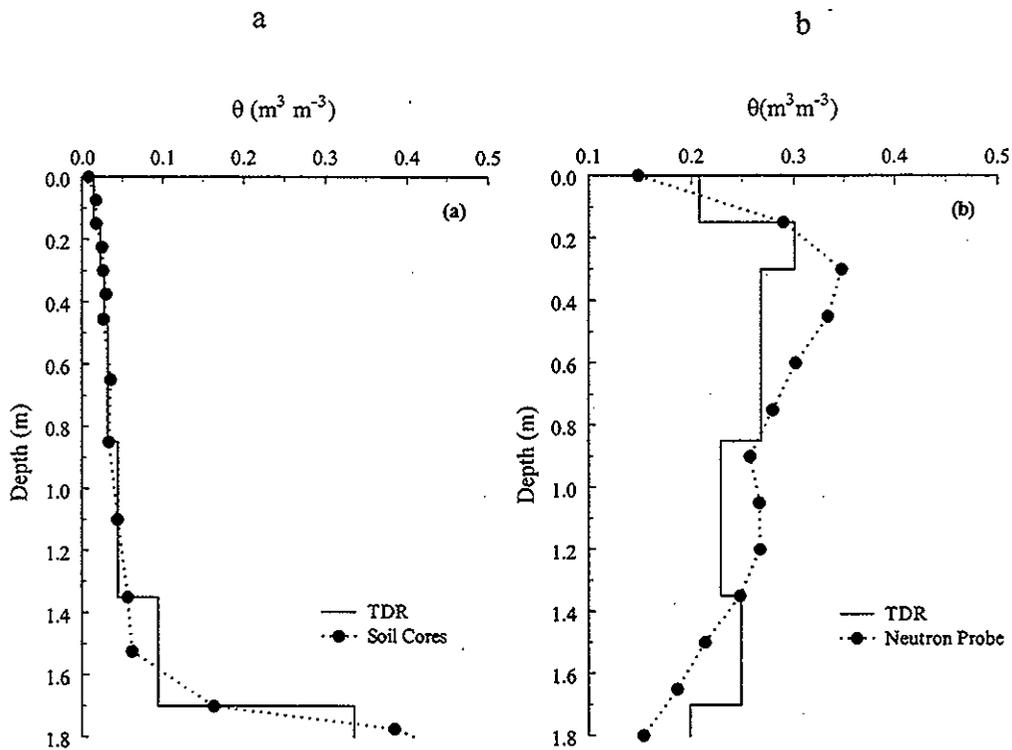
**Figure 3-3. Comparison of Water Content  $\theta(z)$  Measured with a Seven-Segment Remote Shorting TDR Probe with (a)  $\theta$  Determined by Gravimetry in a Draining Sand Column, and (b) Field Measurements of  $\theta$  (by Neutron Probe) in the Silt Loam.**

(After applying 70 mm of irrigation over 8 hours, the change in storage was 55 mm by TDR measurements compared to 69 mm by neutron probe.)

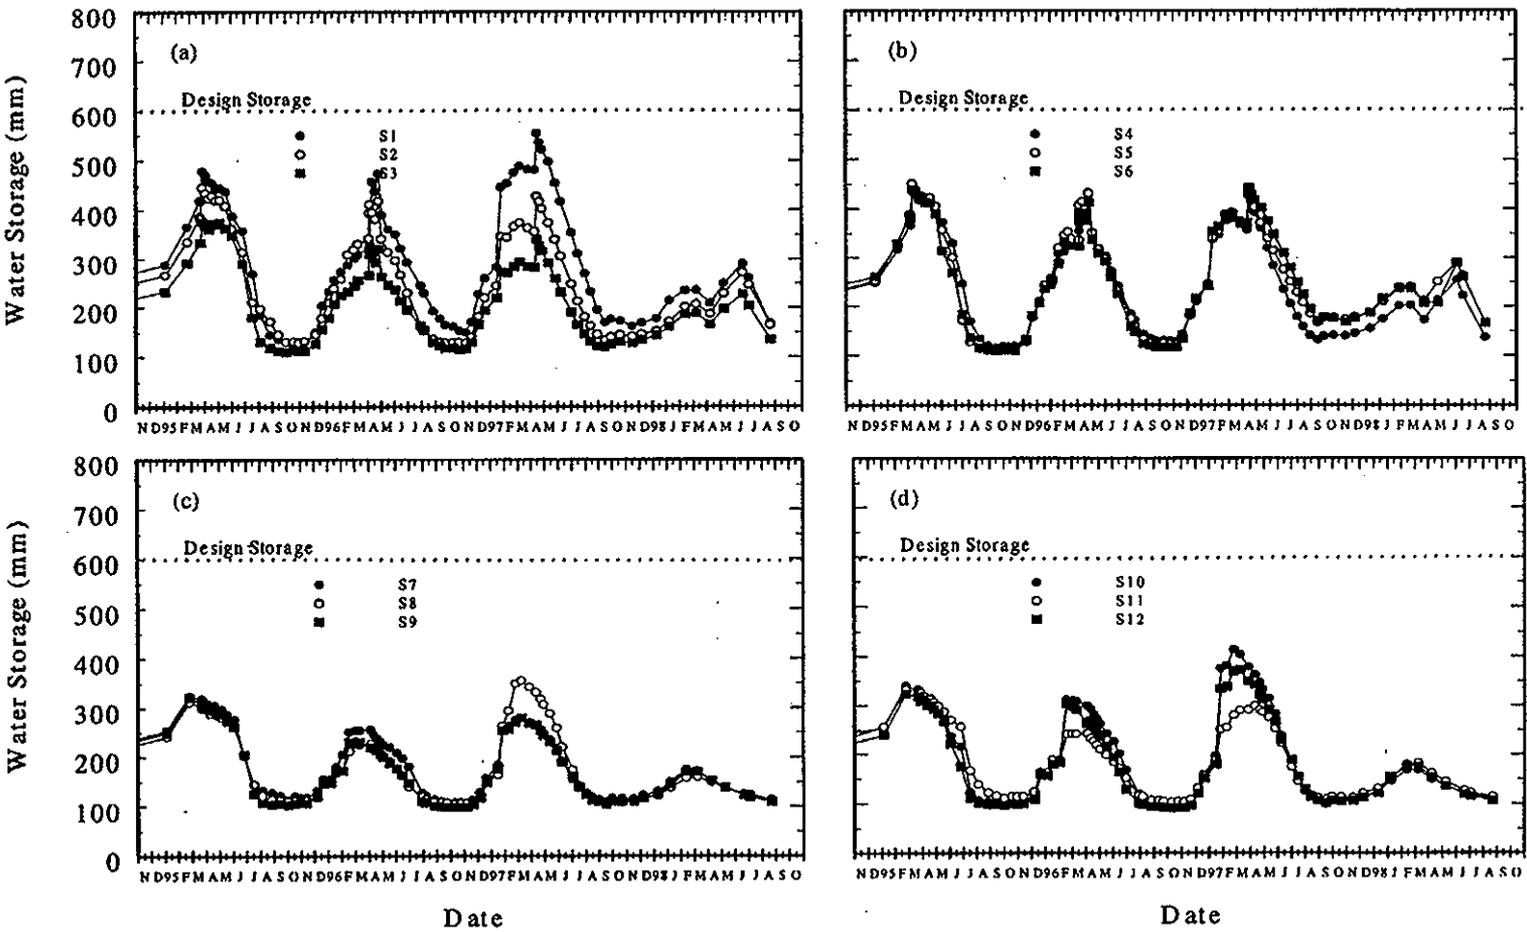
Figure 3-4. Temporal Variation in Soil Water Storage at the Barrier, for Each of the Silt-Loam Plots, from November 1, 1994 through September 30, 1998. [a] northwest, 6W; [b] northeast, 6E; [c] southwest, 3W; [d] southeast, 3E).

Figure 3-4 shows unusually small peaks in water storage in the winter of WY 1998. There are two explanations: (1) irrigation events were discontinued in September 1997 and briefly resumed in May 1998 to facilitate validation of water storage measurements, and (2) the winter of WY 1998 was unusually dry because of El Niño effects. Precipitation recorded at the barrier in the winter of WY 1998 was 69 mm, compared to 106 mm in WY 1995, 126 mm in WY 1996, and 140 mm in WY 1997. The winter LTA is 60 mm.

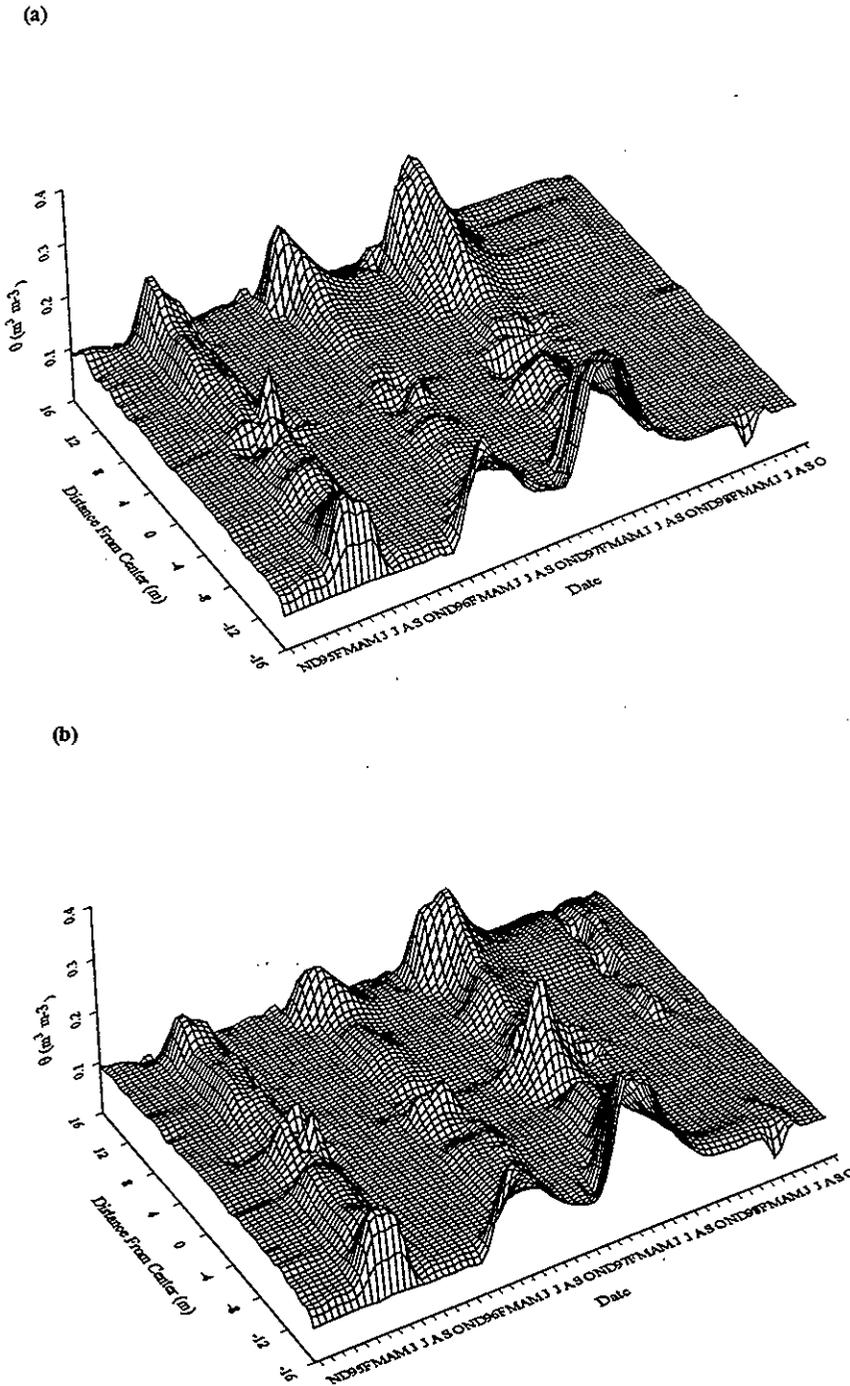
**Figure 3-5. Spatiotemporal Variations in Soil Water Content at the Bottom of the Silt-Loam Layer of the Irrigated Treatment of the Barrier.**  
((a) northern end of treatment, tube AA1 + AA5, and [b] southern end of treatment, tube AA2 + AA6).

In general, accumulation of water was greatest at the northwest and northeast edges of the irrigated plots (tubes AA1 and AA5) and usually peaked by early May. These data also show that the decline in  $\theta$  at the capillary break usually starts shortly after reaching its maximum value. There also appears to be a difference in the arrival time of the wetting front at tubes in the north and south ends of each plot, as well as a difference between the value of  $\theta$  on the western (Figure 3-7a) and eastern (Figure 3-7b) plots. These differences are most likely due to differences in the snow and water accumulation during the winter and spring.

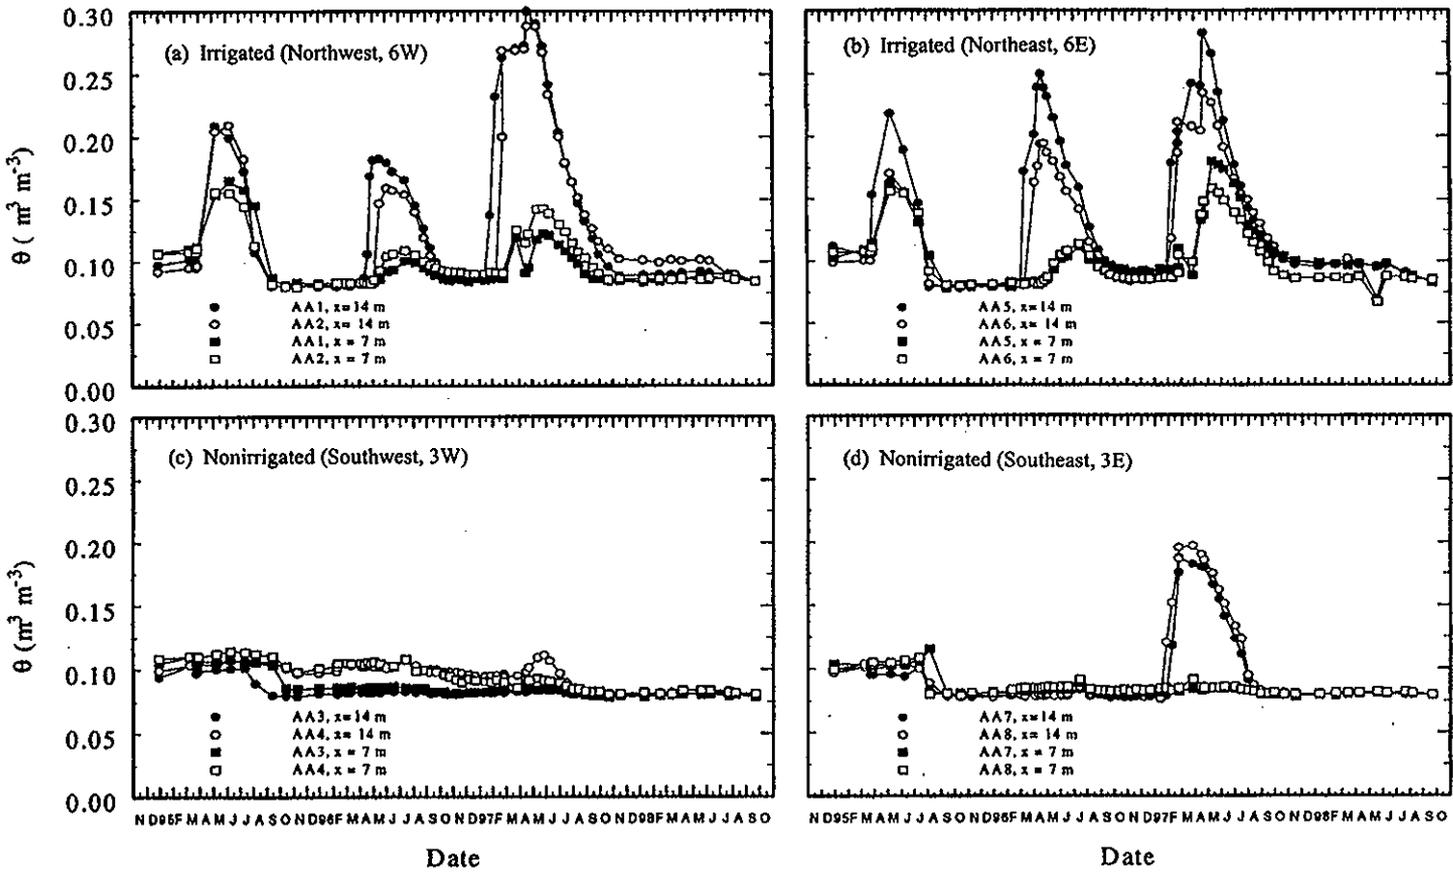
Figure 3-7. A Comparison of Temporal Variations in Soil Water Content Along Two Transects at the Bottom of Silt-Loam Layer of the Barrier. (Data represent water content  $\theta$  (t) at 7 m and 14 m from the center of each plot.)

A better visual perspective of the temporal change in  $\theta$  is obtained from two-dimensional plots of  $\theta(t)$  along a transect of interest. Figure 3-7 shows a plot of  $\theta(t)$  at 7 m (midpoint of the plot) and 14 m (outer edge of the plot) in each treatment. In November 1994, initial  $\theta$  on the four plots was relatively similar, with a mean of  $0.10 \text{ m}^3 \text{ m}^{-3}$  over all plots. Despite regular irrigations, no significant increase in  $\theta$  was observed at the capillary break until just after the first simulated 1,000-year storm on March 26, 1995.

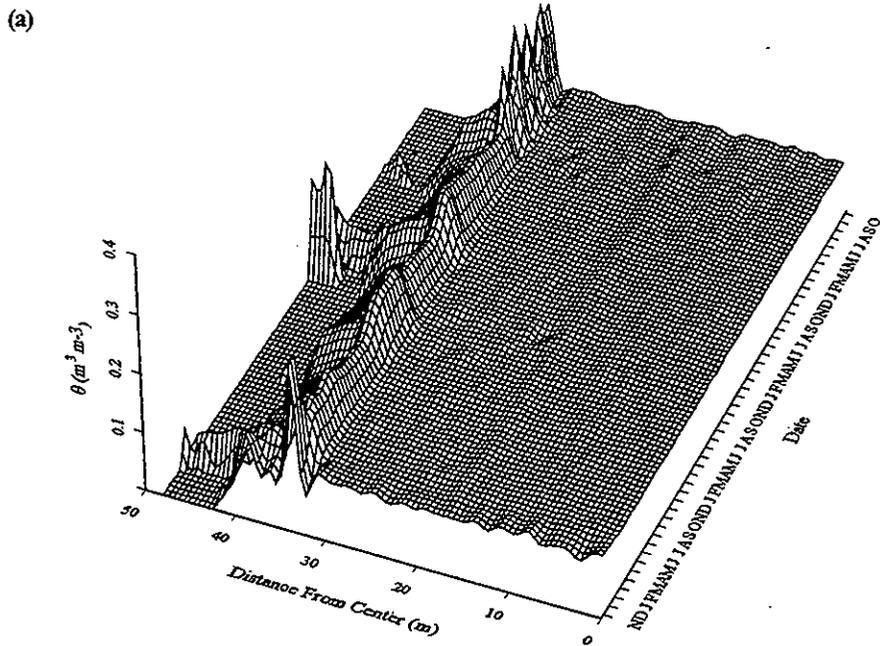
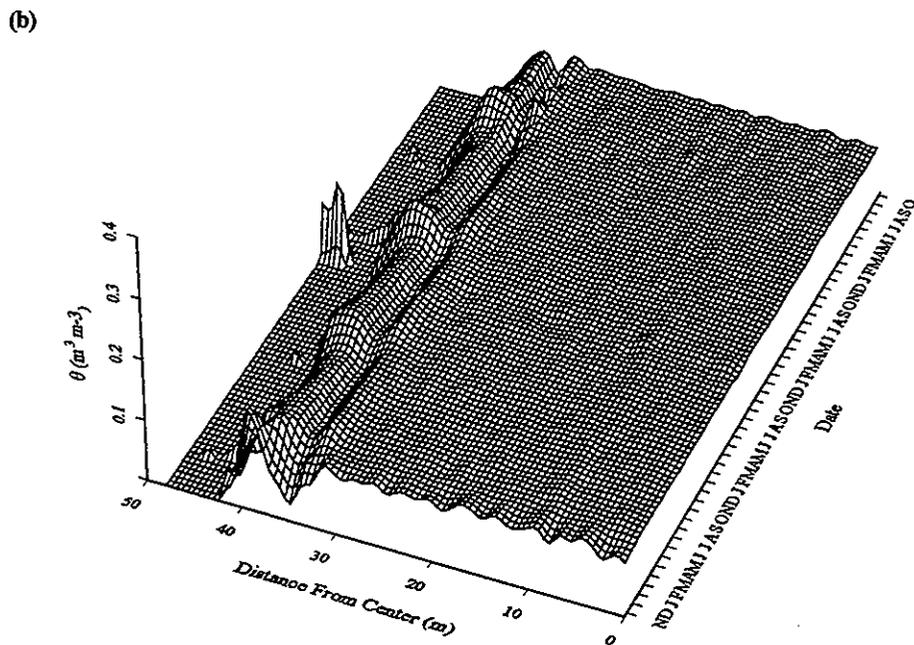
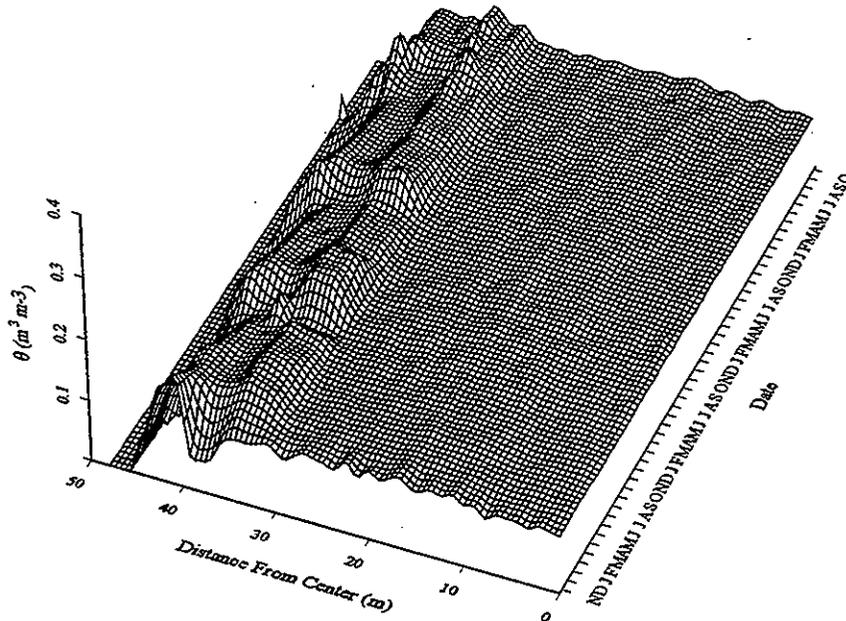
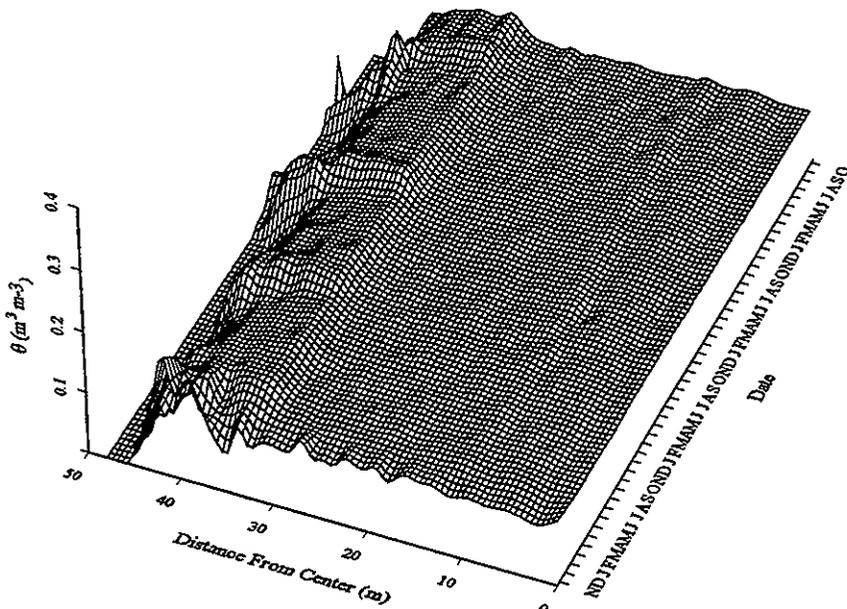
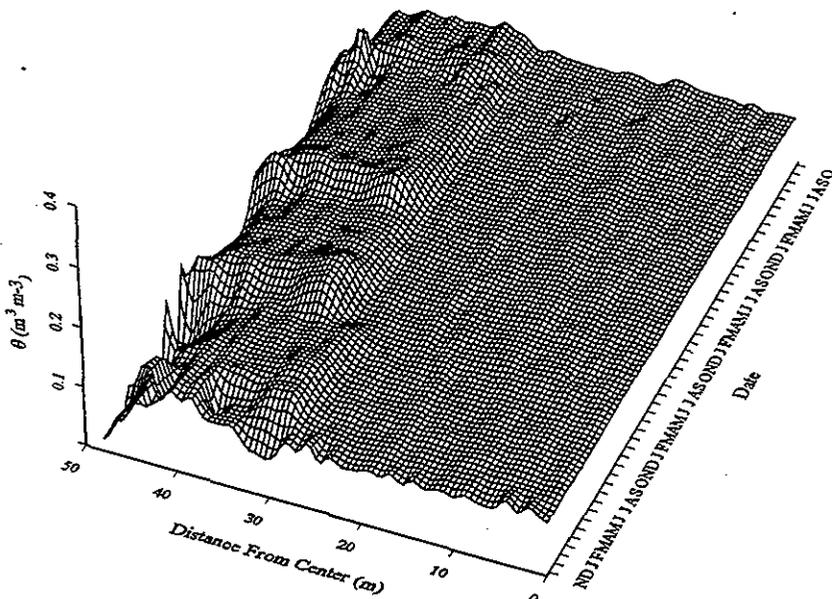
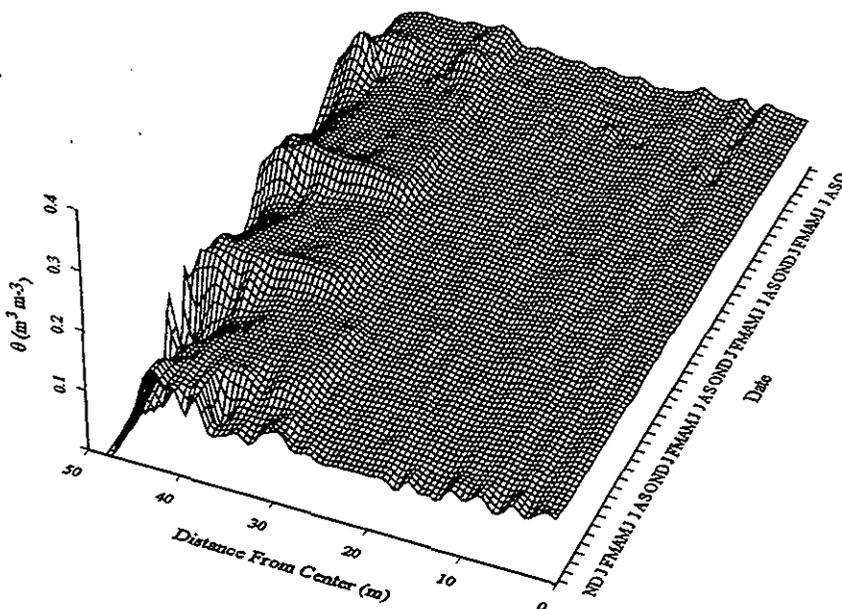
Figure 3-9. Spatiotemporal Variations in Soil Water Content Under the Asphalt Layer.

(Uncurbed asphalt tube [a] BA1 at 1 m and curbed asphalt tube [b] BA2 at 1 m.)

(Uncurbed asphalt tube [c] BA3 at 2 m and curbed asphalt tube [d] BA4 at 2 m.)

to the east where the water is shed, these changes have not extended very far under the asphalt. At all three depths, changes in  $\theta$  have not extended more than 2 m under the asphalt, and even then  $\theta$  has never increased beyond  $0.15 \text{ m}^3 \text{ m}^{-3}$ .

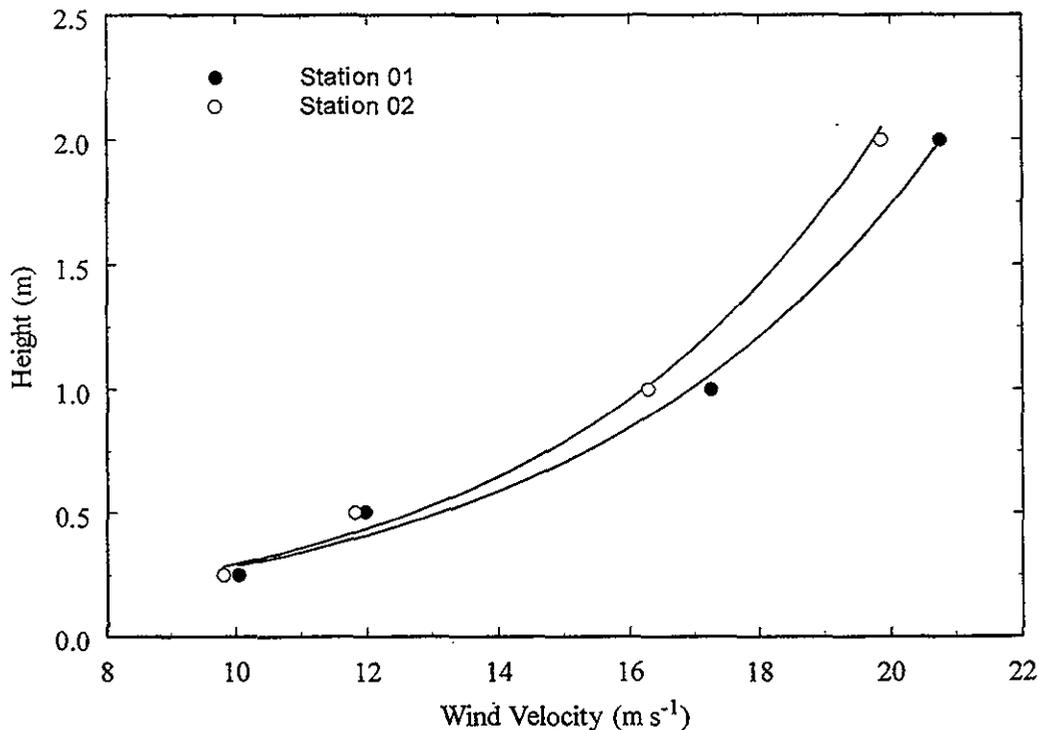
Figure 3-10. Peak Gust Wind Profiles Measured over the Elevated Surface of the Hanford Barrier on March 30, 1997.

Because  $z_0$  is controlled mainly by surface vegetation, comparison of field and laboratory measurements without plants, or with plants having dissimilar characteristics, can be misleading. Ward et al. (1997) estimated plant height from  $z_0$  and compared the results with measured values. Mean plant height estimated from  $z_0$  at Stations 01 and 02 was  $0.58 \pm 0.05$  m, compared to  $0.54 \pm 0.11$  m, obtained by averaging the height of *C. nauseosus* (gray rabbitbrush) and *A. tridentata* (big sagebrush) in the nonirrigated treatment.

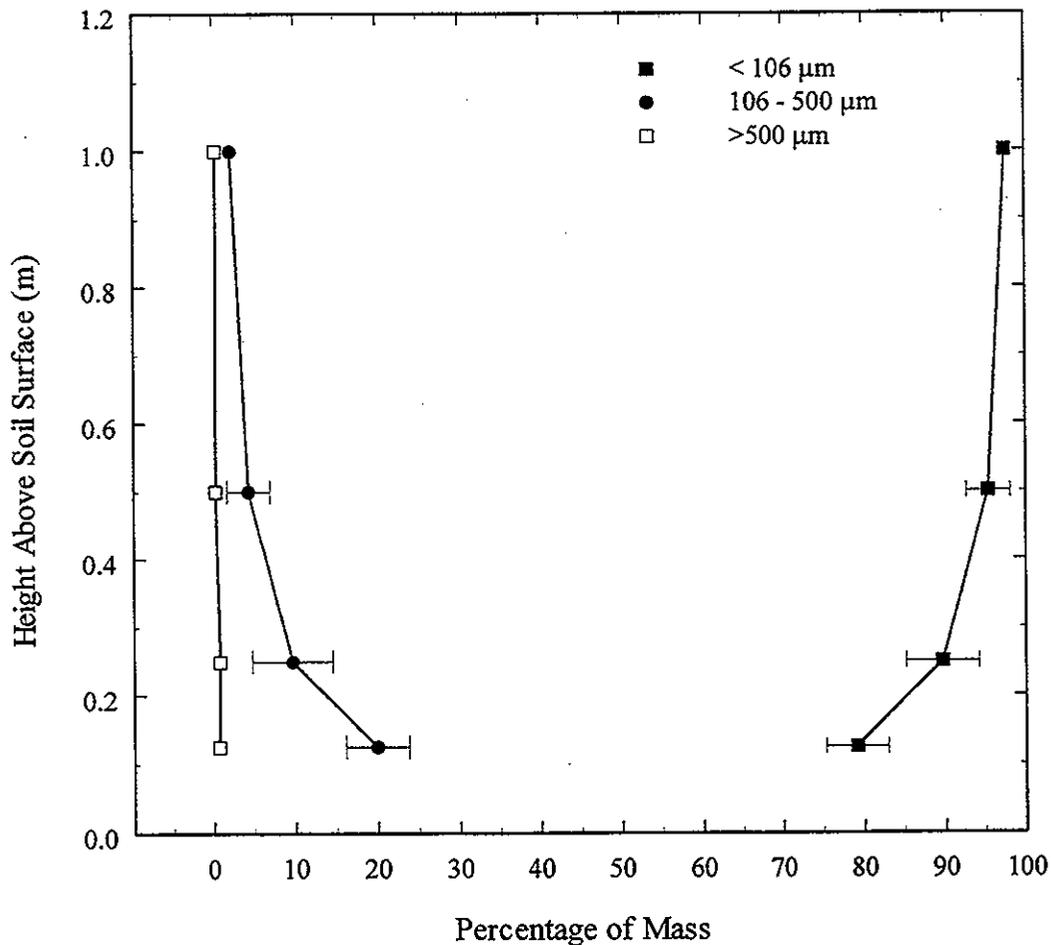
**Figure 3-12. Particle Size Distribution of Soil Material Collected in Dust Traps at the Barrier in WY 1995.**

Figure 3-12 shows that the composition of the material collected in the dust traps was dominated by very fine sand and silt particles with a mean diameter smaller than 106  $\mu\text{m}$ . Because of their small sizes, such particles have the greatest tendency to remain suspended once they are removed from the surface by wind. These particles pose little threat to causing further erosion. About 20% of the soil collected consisted of fine sand particles with diameters ranging from 106 to 500  $\mu\text{m}$ . The greatest quantities were found at a height of 0.5 m above the surface. This size of particle is most likely to be transported by wind in saltation, traveling short distances with low-angle terminal impacts causing smaller silt-sized particles to be ejected from the surface. Therefore, this size of particle poses the greatest threat for causing wind erosion. In contrast, very small quantities (<1%) of sand grains with diameters greater than 500  $\mu\text{m}$  were observed. This size of particle is generally transported by wind during creep sliding and rolling at or near the surface. Overall, the size distribution of the soil removed by wind was  $89 \pm 4\%$  with diameters less than 106  $\mu\text{m}$ ;  $10 \pm 4\%$  between 106 and 500  $\mu\text{m}$ ; and <1% greater than 500  $\mu\text{m}$ .

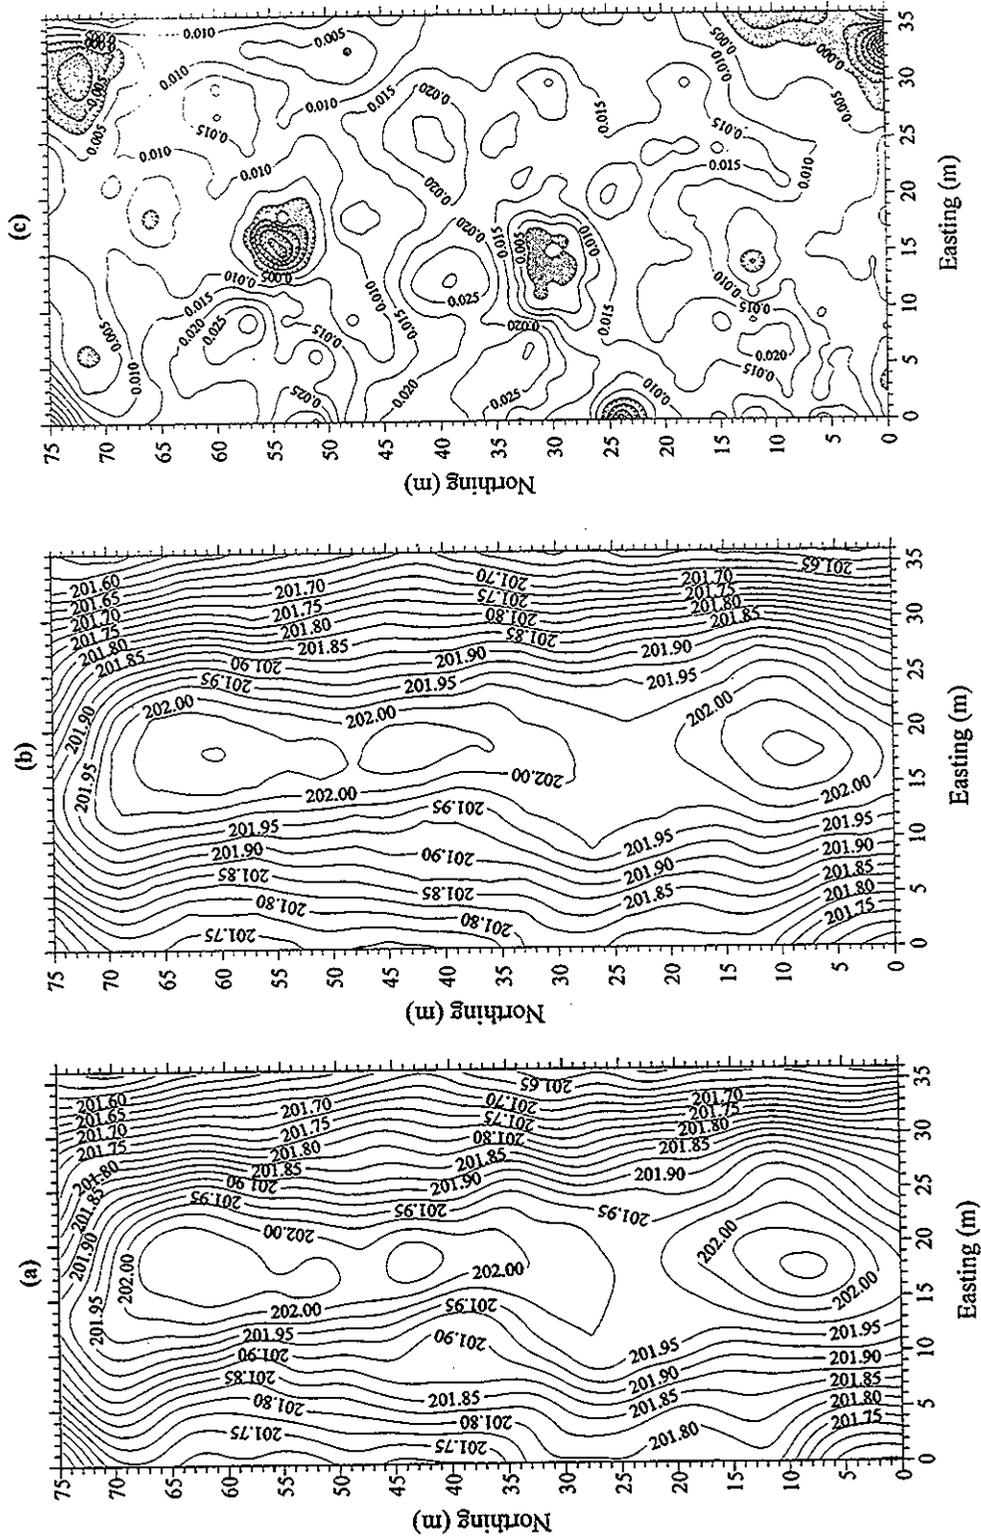
([a] surface elevation, in meters, measured on December 16, 1994; [b] surface elevation, in meters, measured on September 2, 1997; and [c] the change in elevation between December 1994 and September 1997. The contour interval is 0.025 m except for the difference map where it is 0.005 m.)

The largest amount of settlement occurred at the northeastern and southeastern corners of the silt-loam surface and has been ongoing since monitoring started (Gee et al. 1996). The observed settlement is difficult to explain without additional data. The creep gauge near these two locations shows no large-scale movement in the riprap side slope, and there are no other visible indicators that can explain this settlement. The smaller depression to the north is the location at which calibration of the neutron probe and other sensors took place in 1994. The calibration procedure involved the ponding of water on the surface and subsequent coring, activities that would have contributed to subsidence. The region near the 25-m coordinate north along the west edge is the original location of the runoff flume.

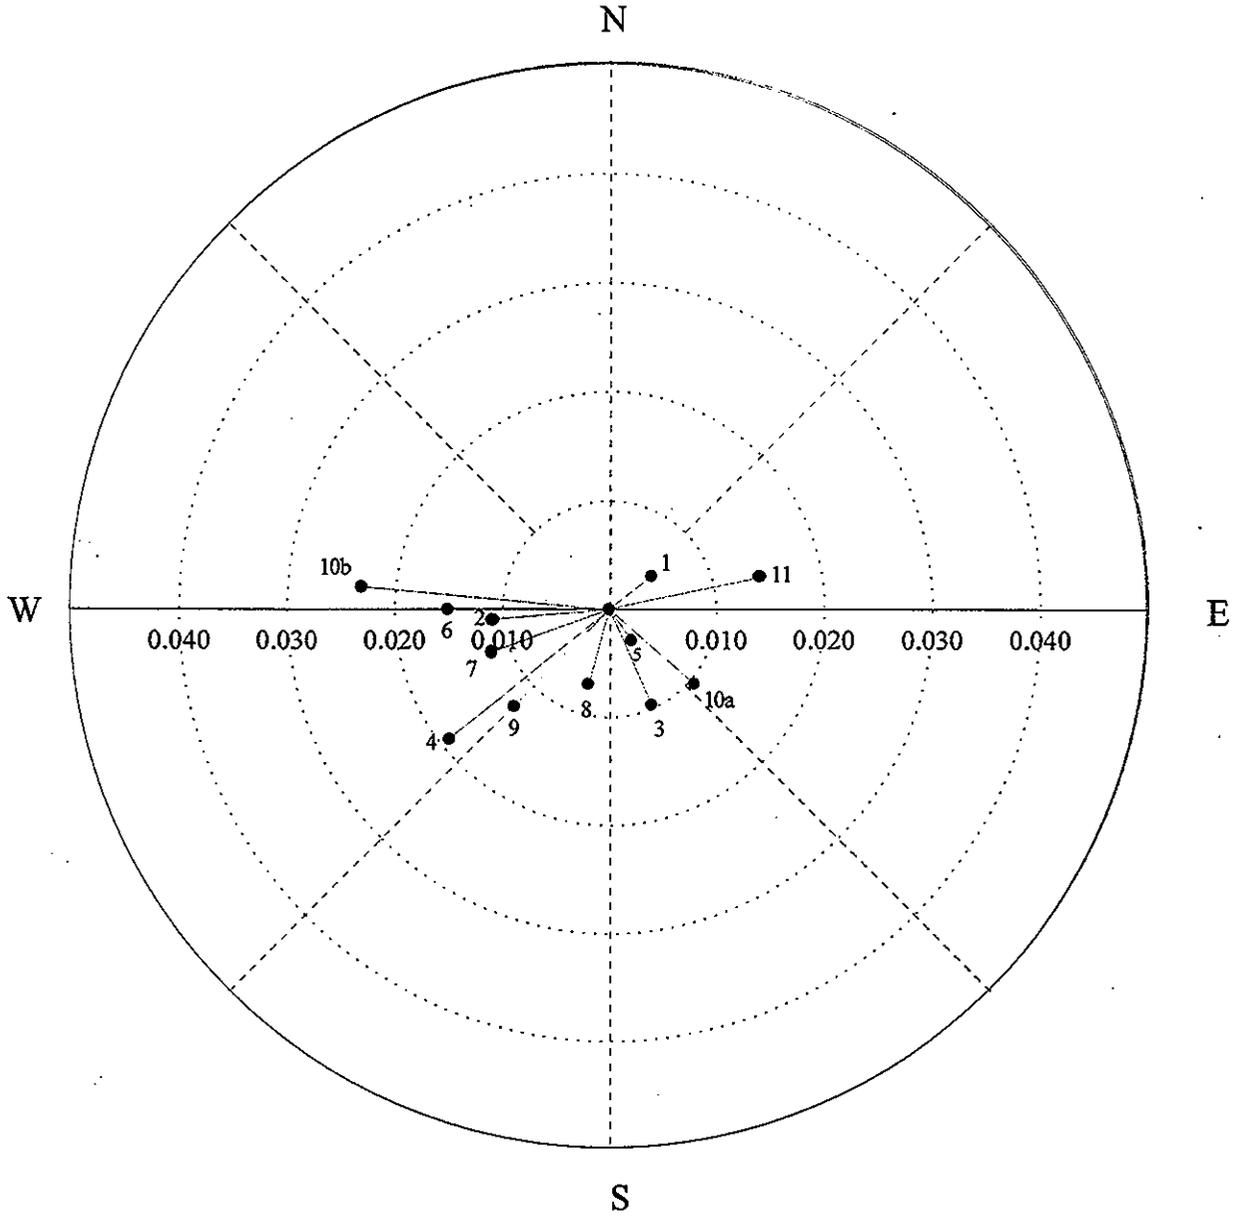
**Figure 3-15. Creep Gauge Movement Between December 1994 and September 1995.**  
(Elevation was measured by EDM; the resultant is in meters and the bearing is in radians).

An analysis of the time course of creep gauge movement over the last 3 years shows a decrease in both the resultant and bearing between the first and second surveys (Ward et al. 1997). After the initial decline, they both increased and remained relatively constant. The variance in the resultant data was also relatively high, suggesting some randomness to the movement. However, the decrease in variance of the bearing estimates between the first and last surveys suggest a preferred easterly movement. Movement in an easterly direction is consistent with an outward and downward movement of the rock slope. However, visual observation and the magnitude of the measured changes show no evidence of side-slope failure. Thus, the small amount of displacement observed between December 1994 and September 1997 is probably due to settlement of the side slope into a more stable and compact arrangement. As with the settlement gauges, additional monitoring would be required to confirm or eliminate slope failure.
