DOE/RL-99-11  
Draft A

# 200-BP-1 Prototype Barrier Treatability Test Report

June 1999

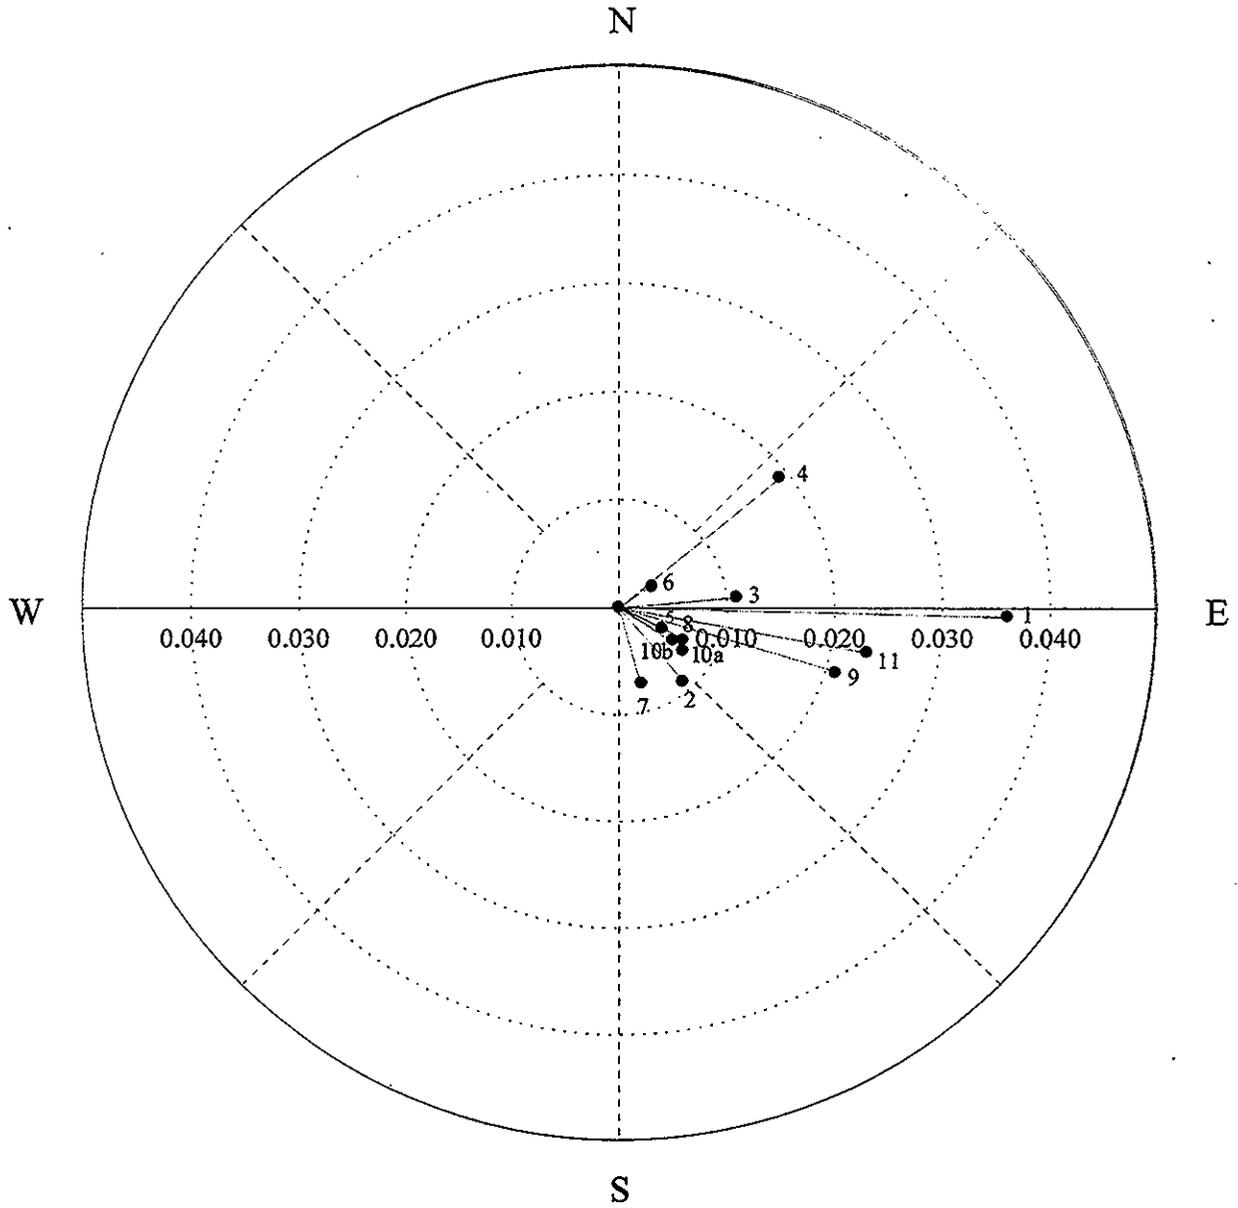
Figure 3-16. Creep Gauge Movement Between December 1994 and September 1997.  
(Elevation was measured by EDM; the resultant is in meters and the bearing is in radians).

An analysis of the time course of creep gauge movement over the last 3 years shows a decrease in both the resultant and bearing between the first and second surveys (Ward et al. 1997). After the initial decline, they both increased and remained relatively constant. The variance in the resultant data was also relatively high, suggesting some randomness to the movement. However, the decrease in variance of the bearing estimates between the first and last surveys suggest a preferred easterly movement. Movement in an easterly direction is consistent with an outward and downward movement of the rock slope. However, visual observation and the magnitude of the measured changes show no evidence of side-slope failure. Thus, the small amount of displacement observed between December 1994 and September 1997 is probably due to settlement of the side slope into a more stable and compact arrangement. As with the settlement gauges, additional monitoring would be required to confirm or eliminate slope failure.

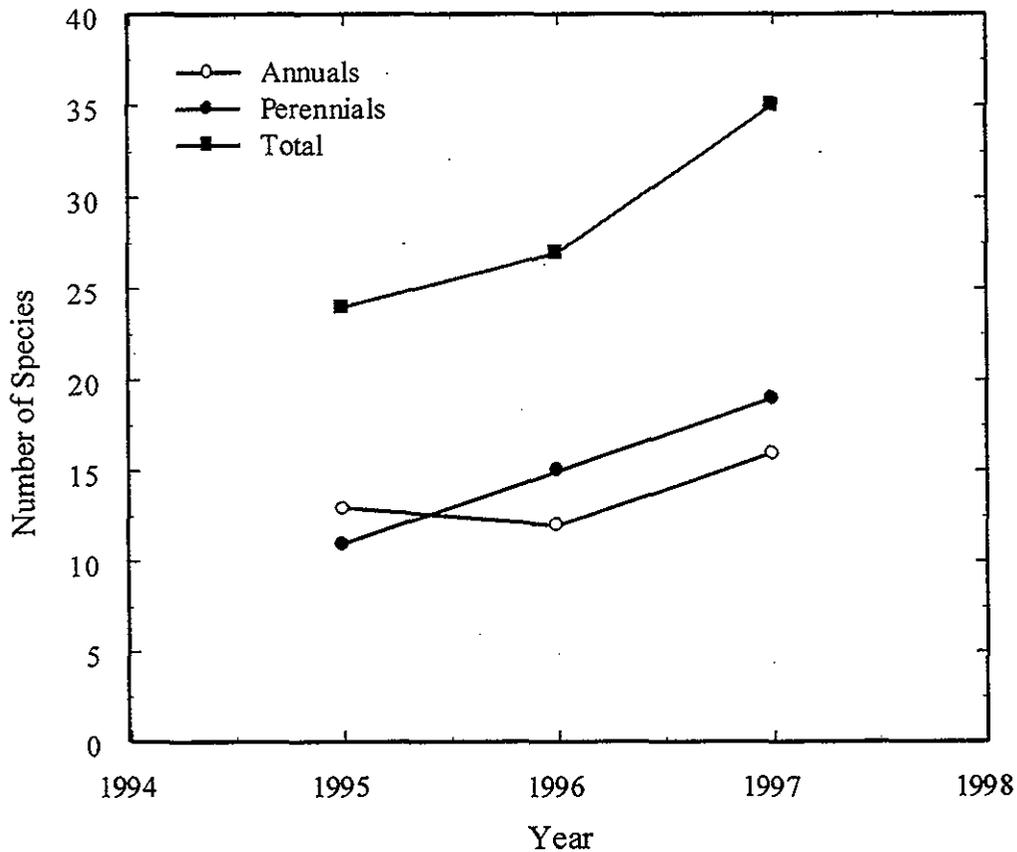
**Figure 3-17. Number of Annual and Perennial Species Including Total Species on the Barrier's Surface.**

The plant community currently on the barrier is considered mature and diverse. It is similar in many respects to that of nearby natural plant communities. Similar native plant communities extract essentially all the available water annually from the soil profile (Link et al. 1990b, 1994), as does the community on the prototype surface barrier. The capability of the plants to remove water from the surface may remain as long as an appropriate mix of perennial and annual plants exists on the surface. When soils at the Hanford Site are disturbed, invasive species generally dominate, as long as an invasive seed source is in proximity. If soils are not grossly disturbed, the native community is likely to remain the dominant vegetative cover.
