DOCUMENT RELEASE AND CHANGE FORM	1a. Doc No: RPP-RPT-55804 Rev. 01 1b. Project Number: <input checked="" type="checkbox"/> N/A
---	--

Common Factors Relating to Liner Failures in Single-Shell Tanks

Abstract: This report fulfills the requirement for target T04 for Hanford Federal Facility Agreement and Consent Order milestone M-045-91F. The goal of this report is to identify the common factors that may have contributed to liner failures in single-shell tanks. The tanks with probable liner failures are identified through the process identified in RPP-32681, Rev. 0, "Process to Assess Tank Farm Leaks in Support of Retrieval and Closure Planning."

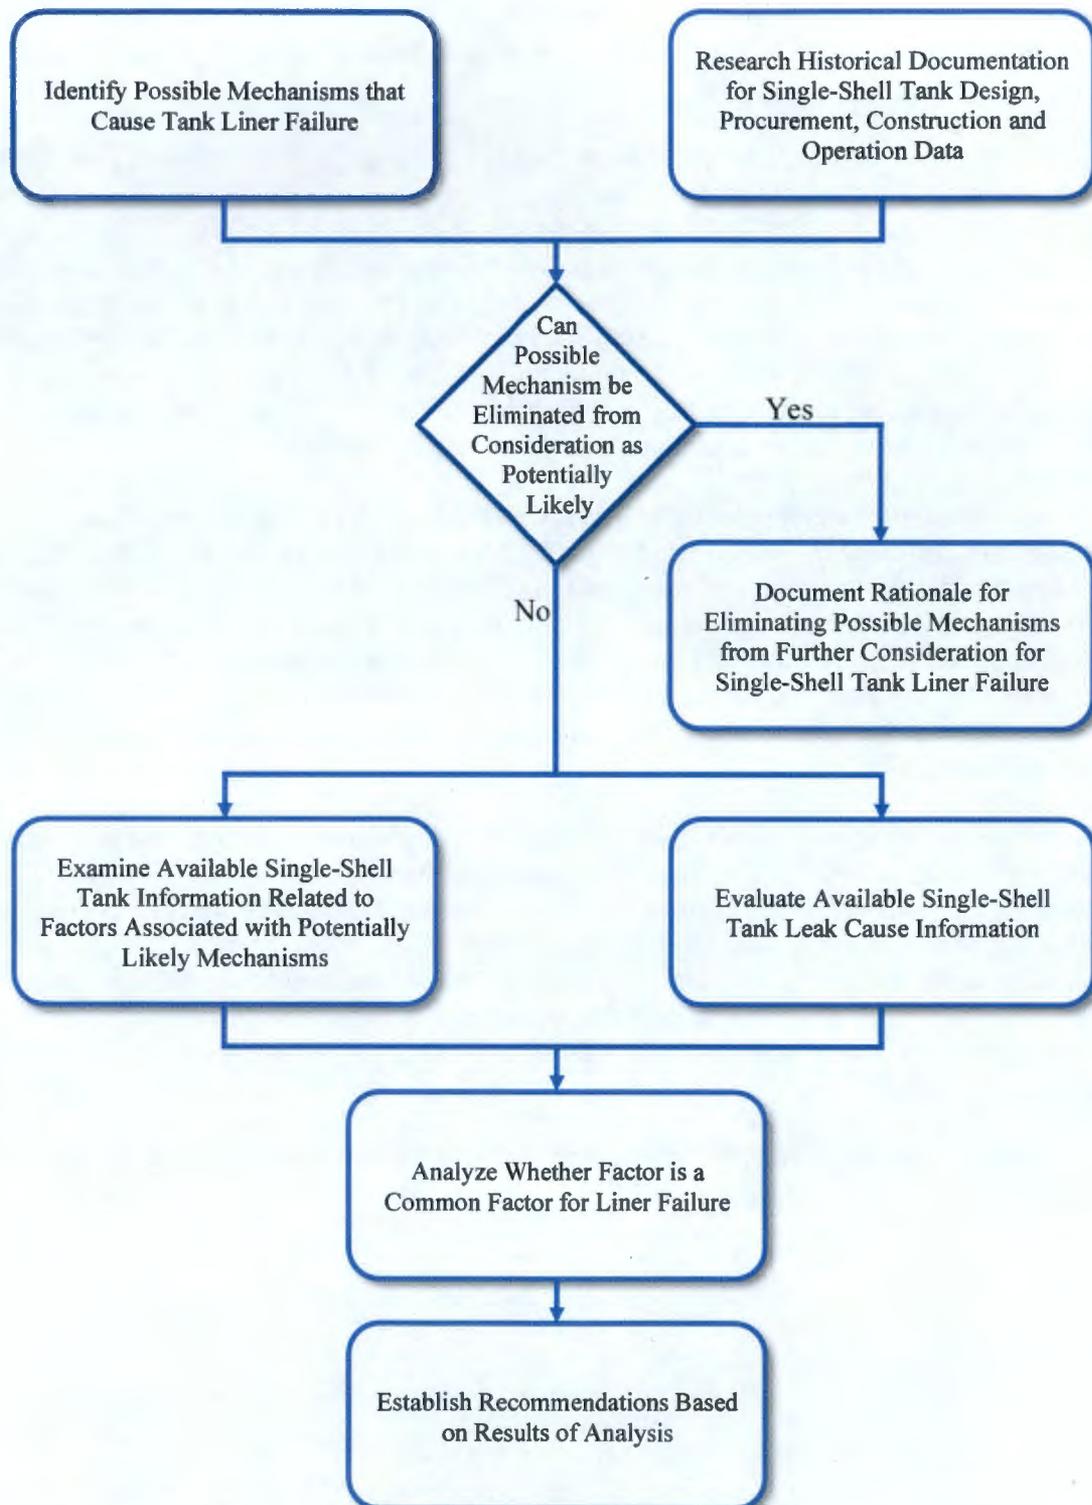
Figure 3-1. Methodology for Identifying Common Factors Contributing to Liner Failures

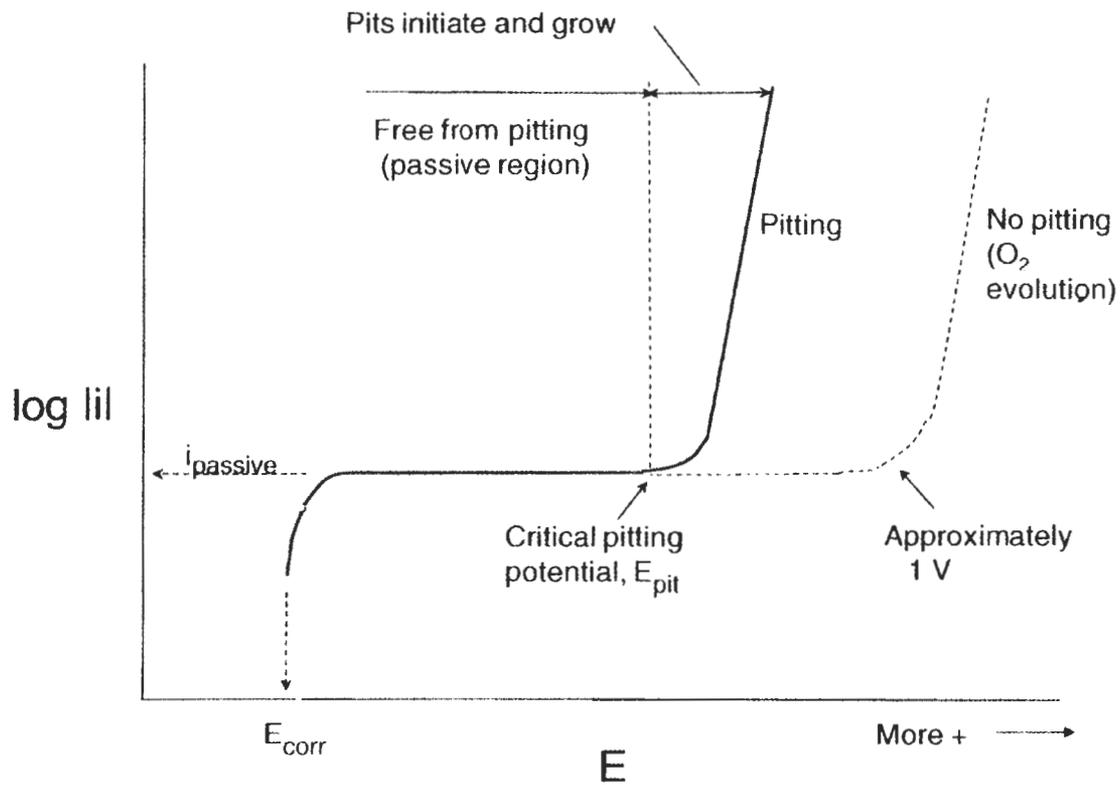
Figure 4-1. Schematic Illustration of Anodic Polarization Curve Showing Critical Pitting Potential (McCafferty 2010)

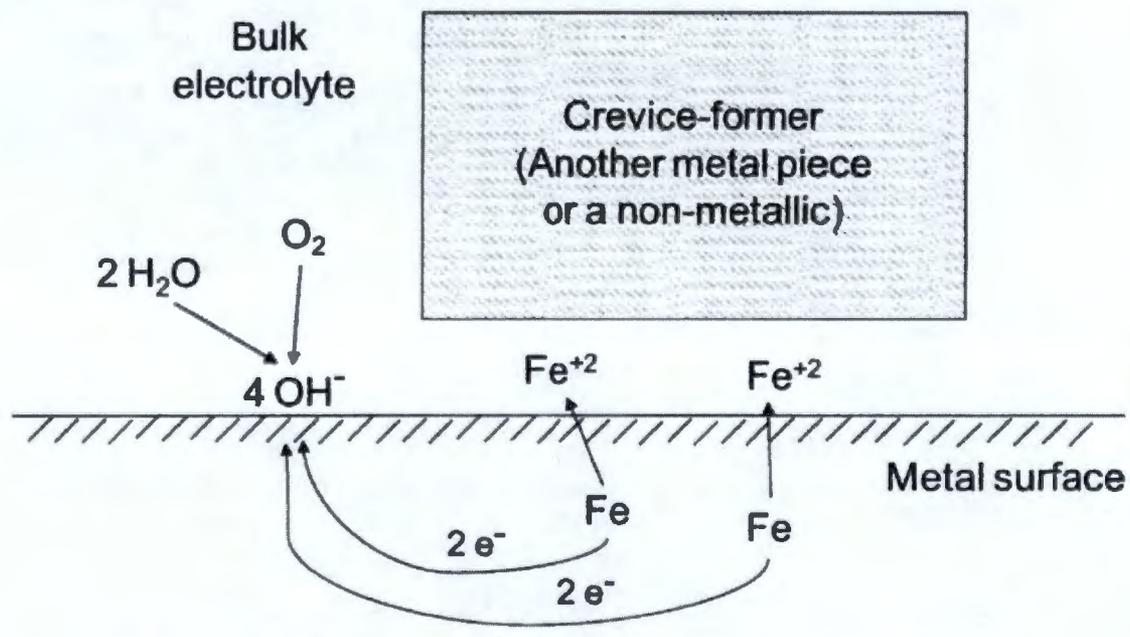
Crevice corrosion often starts as a differential oxygen cell, where corrosion processes consume the dissolved oxygen in the solution within the crevice and the potential of the metal in that region becomes more active than the surfaces outside the crevice. Oxygen reduction occurs both on the metal surface which is exposed to the bulk electrolyte and also on the portion of the metal surface which is contained within the crevice. However, when oxygen is consumed within the narrow clearance of the crevice, it is not easily replaced due to the narrow diffusion path formed by the crevice. This results in oxygen becoming depleted in the crevice. The metal in the crevice with the lower oxygen concentration has a more negative potential than the bulk metal and the limiting current density for oxygen reduction, which is proportional to oxygen concentration, within the crevice is decreased relative to the bulk solution. Figure 4-2 schematically illustrates the initiation of crevice corrosion. Once initiated, crevice corrosion proceeds by the same mechanism as pitting corrosion (RPP-RPT-33306, *IQRPE Integrity Assessment Report for the 242-A Evaporator Tank System*).

Figure 4-2. Schematic Illustration of Initiation of Crevice Corrosion (McCafferty 2010)

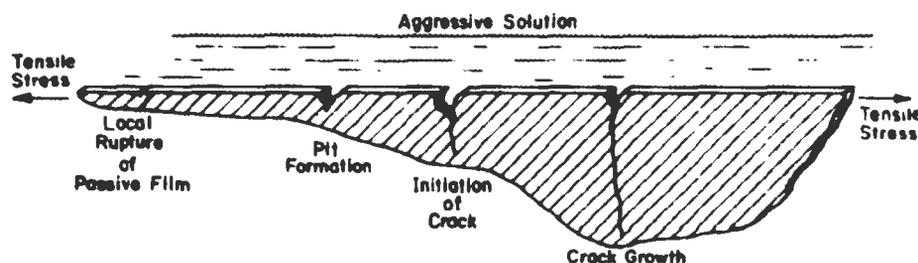
Stress corrosion cracking (SCC) requires a susceptible material with the simultaneous presence of a sustained tensile stress and an aggressive environment (BNL-52527). Figure 4-3 portrays the process involved in SCC.

Figure 4-3. Progression of Process that Causes Stress Corrosion Cracking (Reference DP-1476)

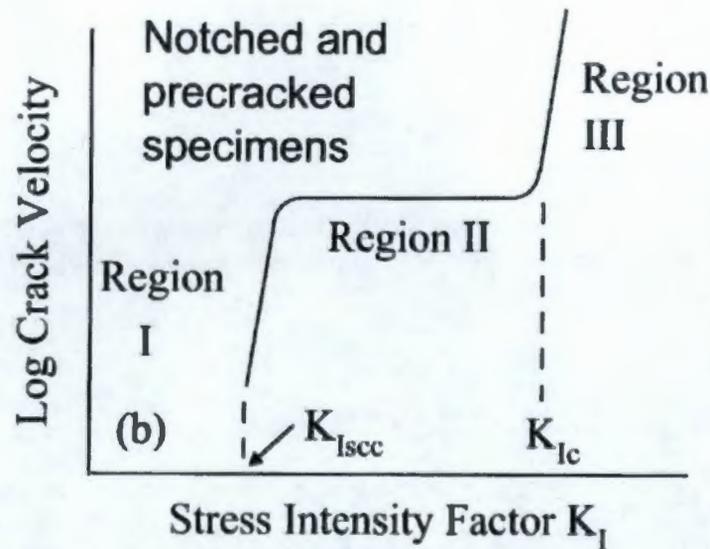
Figure 4-4. Stress Corrosion Cracking as a Function of Stress Intensity Factor (McCafferty 2010)

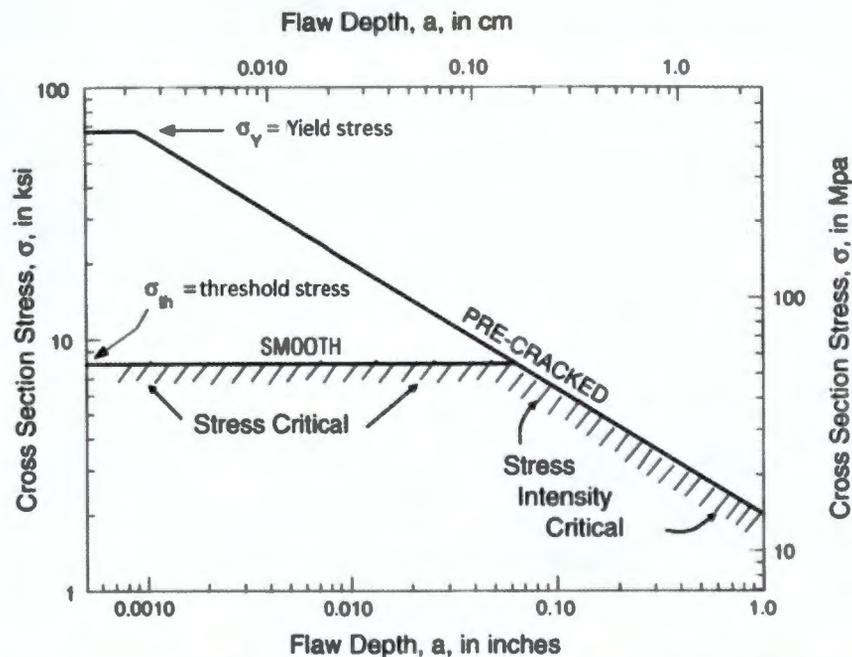
**Figure 4-5. Stress Corrosion Cracking Zone for Smooth and Pre-Cracked Material
(Adapted from McCafferty 2010)**

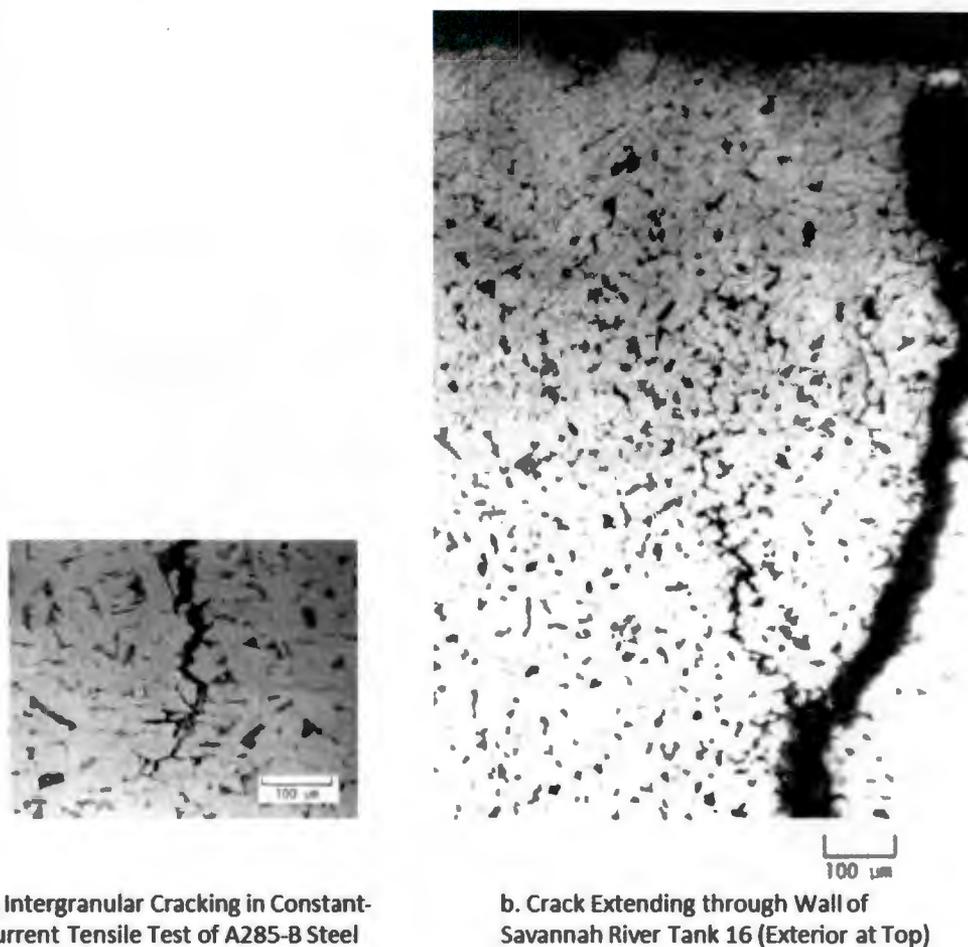
a. Intergranular Cracking in Constant-Current Tensile Test of A285-B Steel

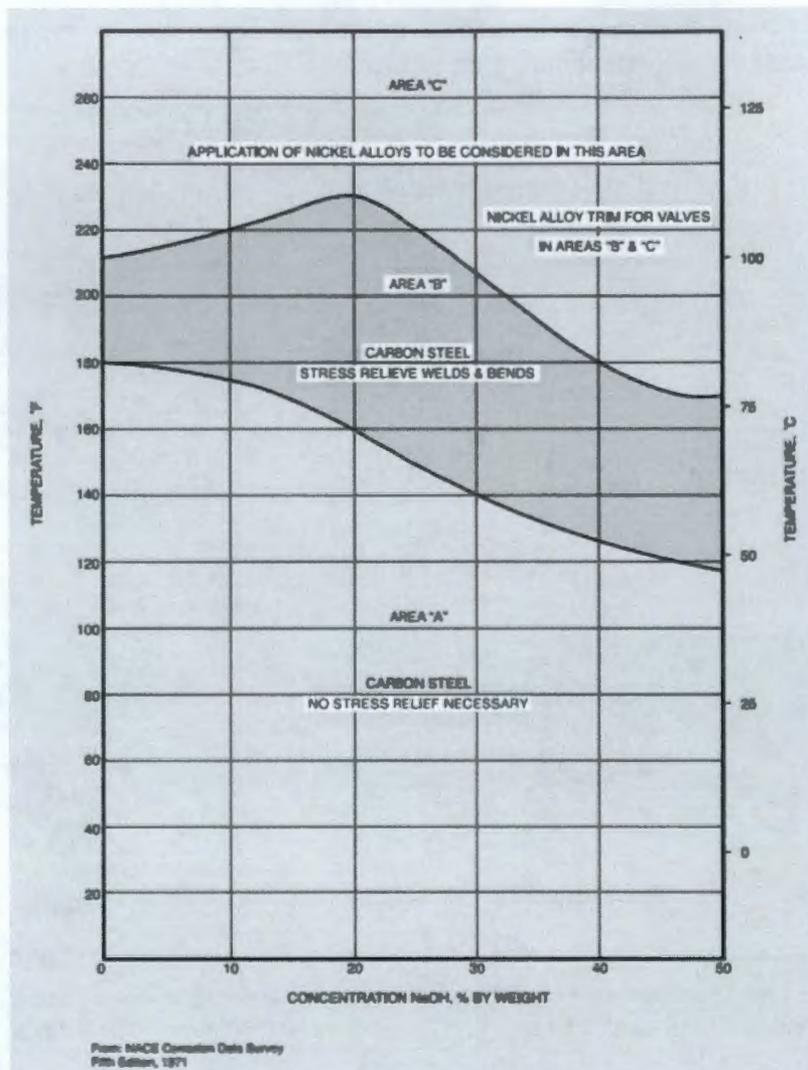
Figure 4-7. Caustic Soda Service Chart of Metallurgical Requirements

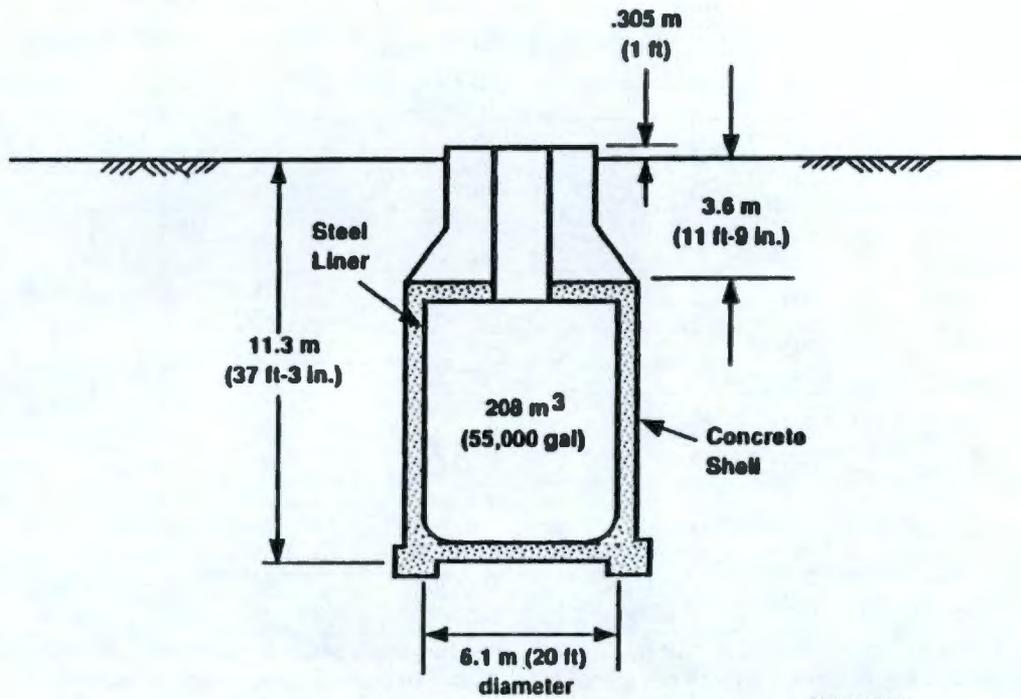
Figure 5-1. 200-Series, Type I, Twenty Foot Diameter, Single-Shell Tank

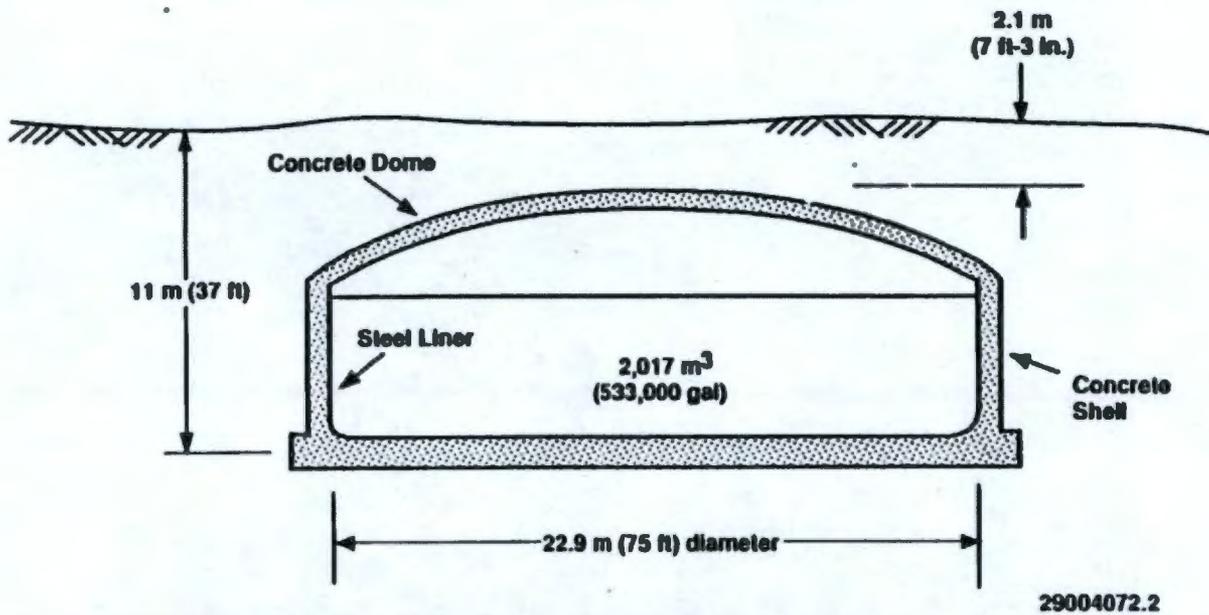
Figure 5-2. 100-Series, Type II, Seventy-Five Feet Diameter, Single-Shell Tank

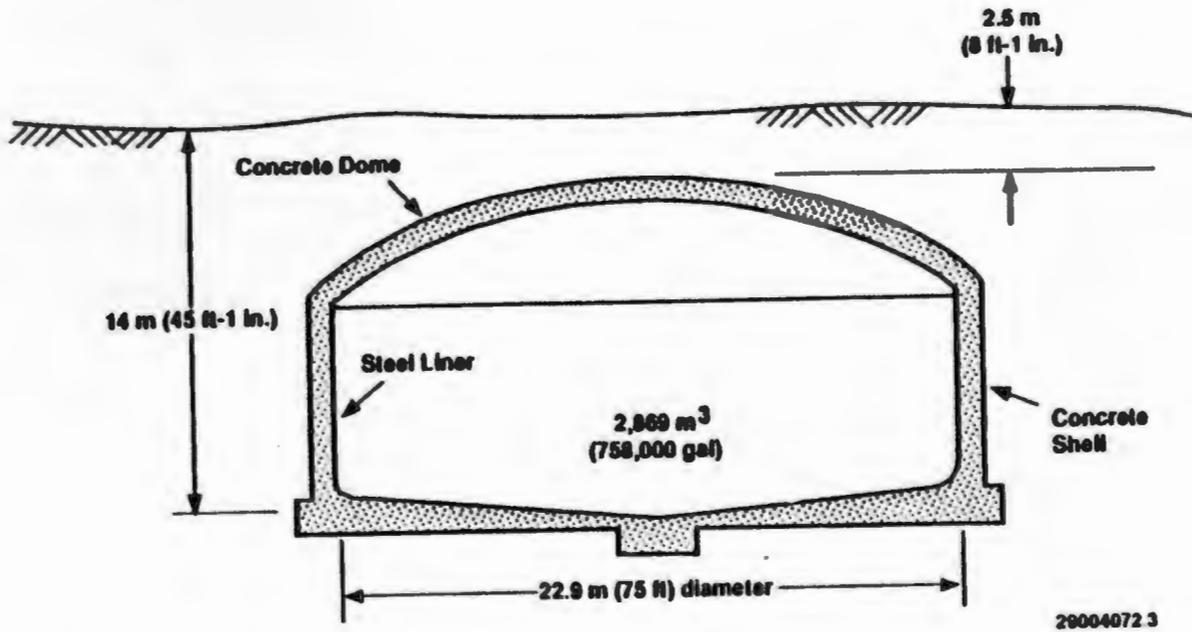
Figure 5-3. 100-Series, Type III, Seventy-Five Foot Diameter, Single-Shell Tank

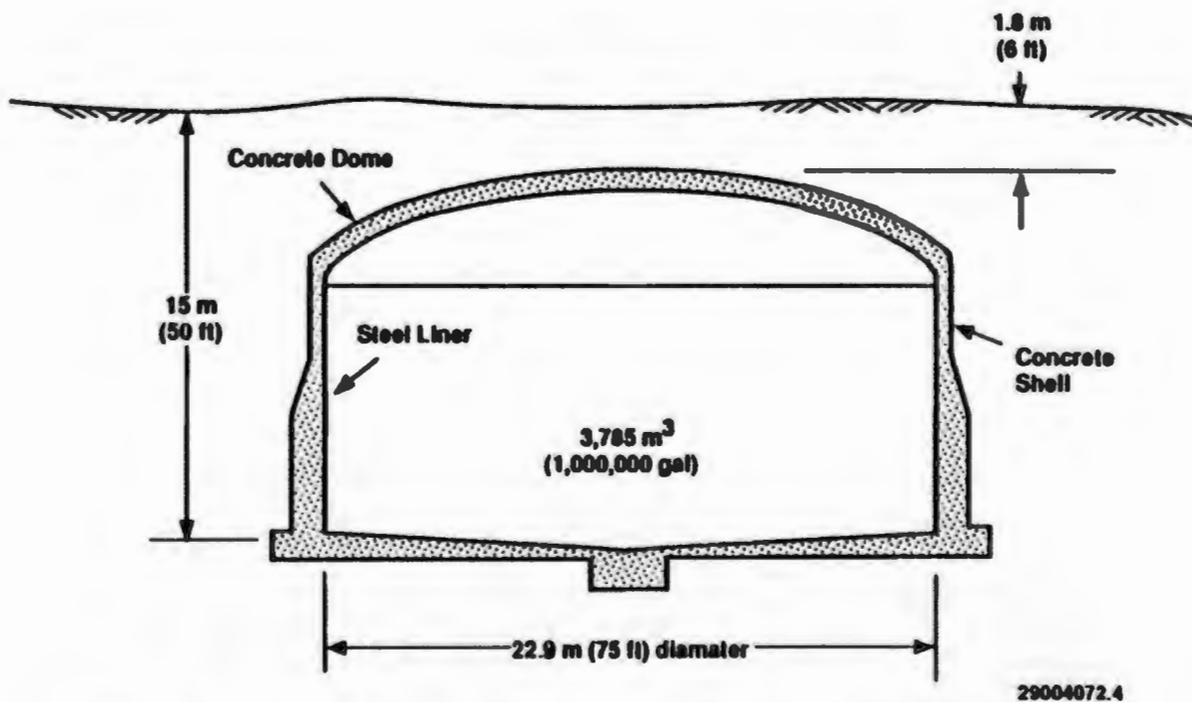
Figure 5-4. 100-Series, Type IV, Seventy-Five Foot Diameter, Single-Shell Tank

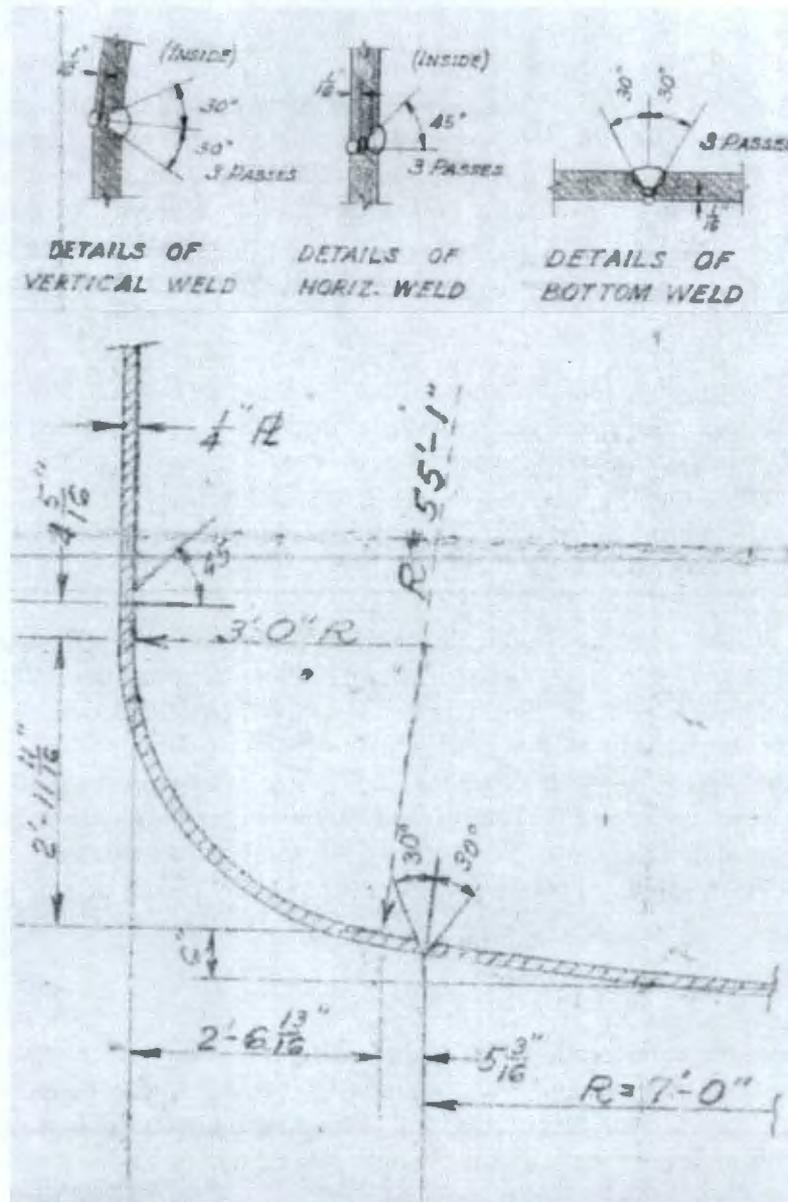
of the 3-pass, beveled, double welded, butt joint weld for the bottom and horizontal welds for the knuckle as well as the vertical wall weld.

Figure 5-5. Construction Drawing for 241-B, -C, -T, and -U Farm, 200-Series Tanks Bottom Knuckle Weld (Drawing D-23)

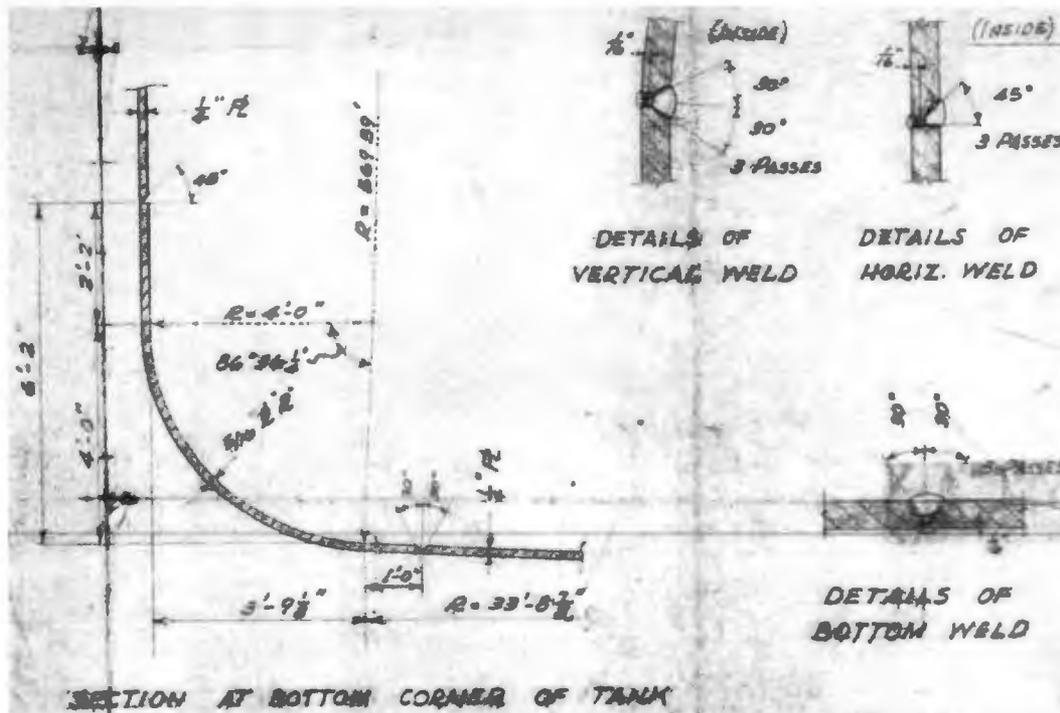
knuckle as well as the vertical wall weld. The 100-Series, Type II tanks are similar to the 200-Series, Type I tanks with the exception of the knuckle radius and material thickness.

Figure 5-6. Construction Drawing for 241-B,-C,-T,-U, and -BX Farm, 100-Series, Type II Tanks Bottom Knuckle Weld (Drawing D-3)

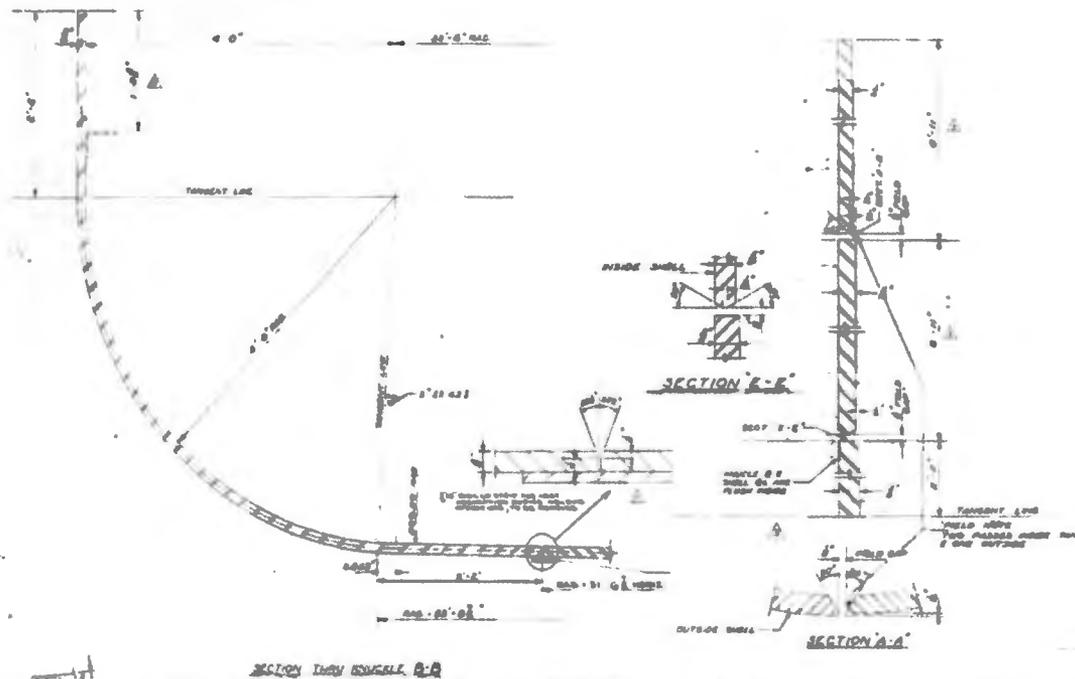
Figure 5-8. Construction Drawing for 241-BY Farm, 100-Series, Type III Tanks Bottom Knuckle Weld
(Drawing H-2-1313, 75 Foot Tank Steel Plate Details)

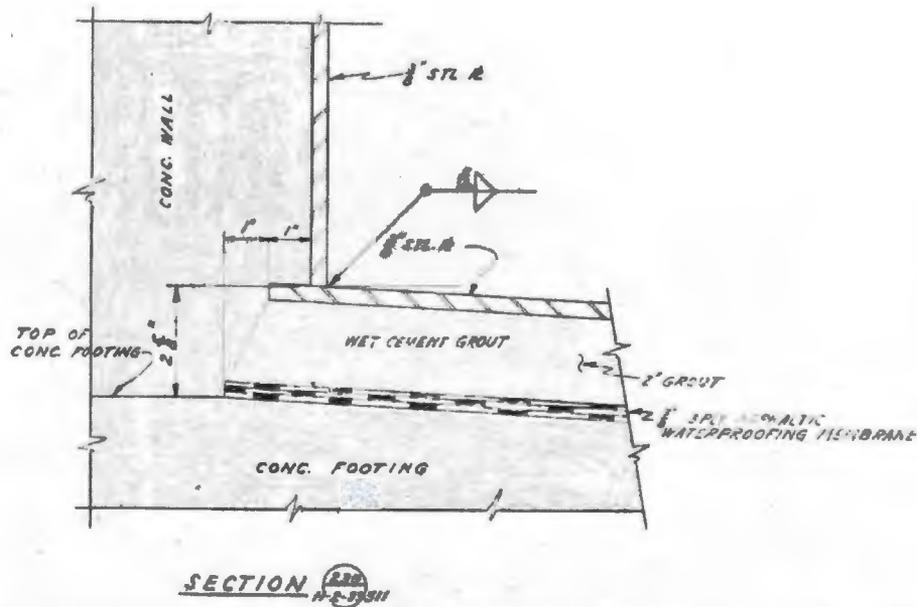
Figure 5-9. Construction Drawing for 241-SX Farm, 100-Series, Type IV Tanks Bottom to Wall Transition Weld
 (H-2-39511, 75 Foot Storage Tanks Composite Section Waste Disposal Facility 241-SX)

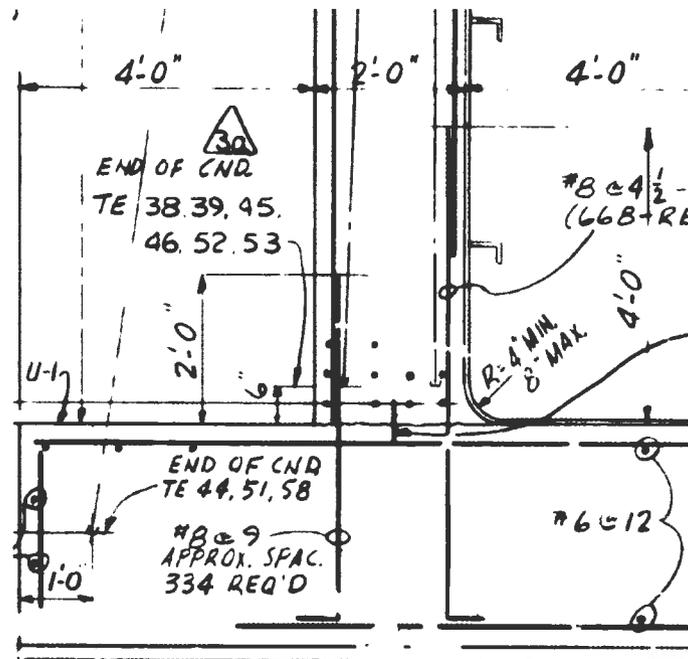
joints in the cylindrical section and subassemblies of the bottom shall be double welded butt joints with full penetration welds (HWS-8237).

Figure 5-11. Construction Drawing for 241-AX Farm, 100-Series, Type IV Tanks Bottom to Wall Transition
(H-2-44562, *Structural Waste Storage Tanks Composite Section & Details*)

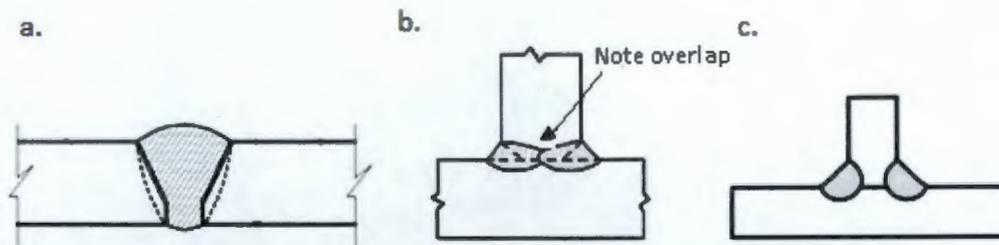
Figure 5-12. Weld Types used in Tank Liners (a) 3-pass full penetration square butt weld, (b) double bevel fillet weld, (c) double fillet weld (AWS B1. 10M)

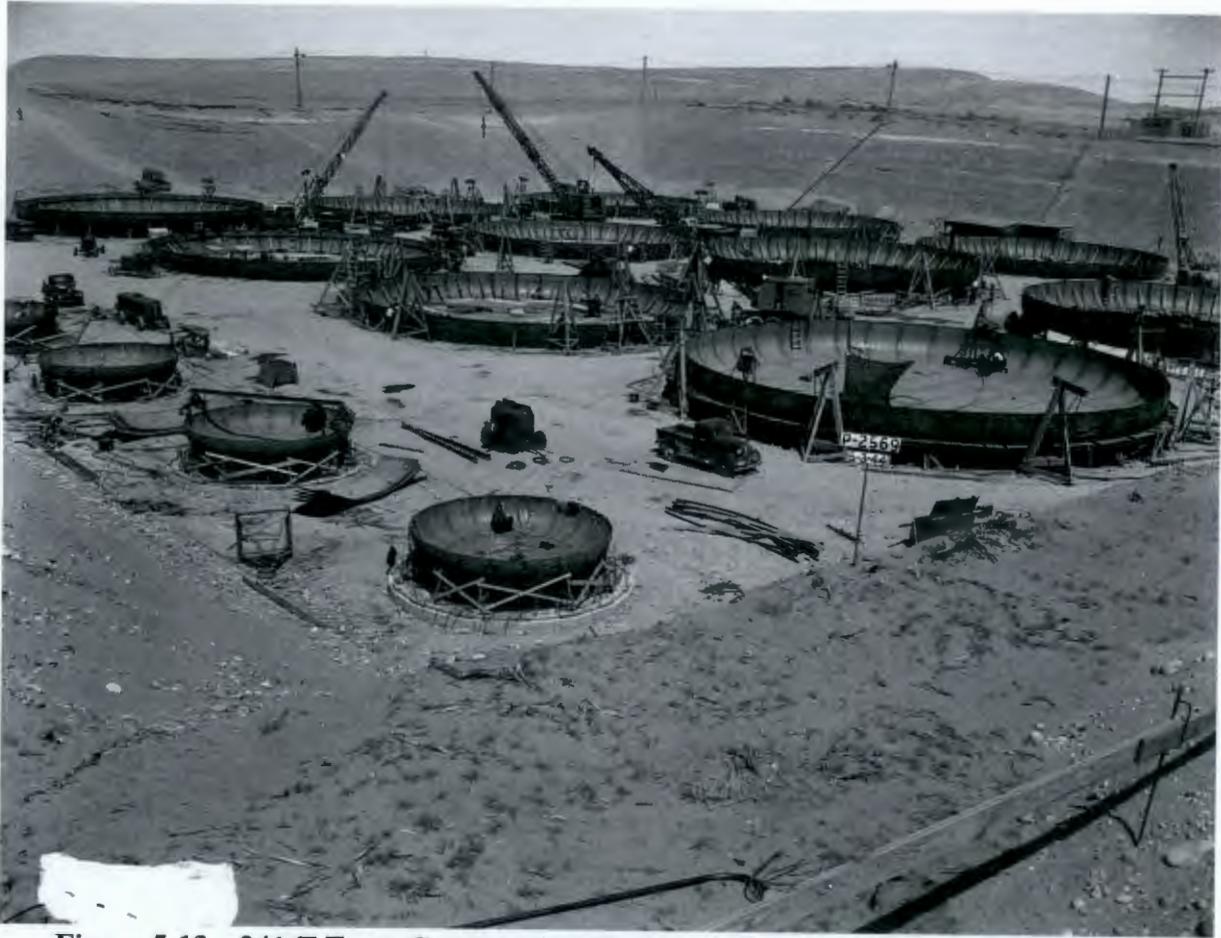
Figure 5-13. 241-T Farm Construction Showing the Bottom Knuckle Transition in 200-Series (Front) and 100-Series (Back), Photo P2569, May 3, 1944

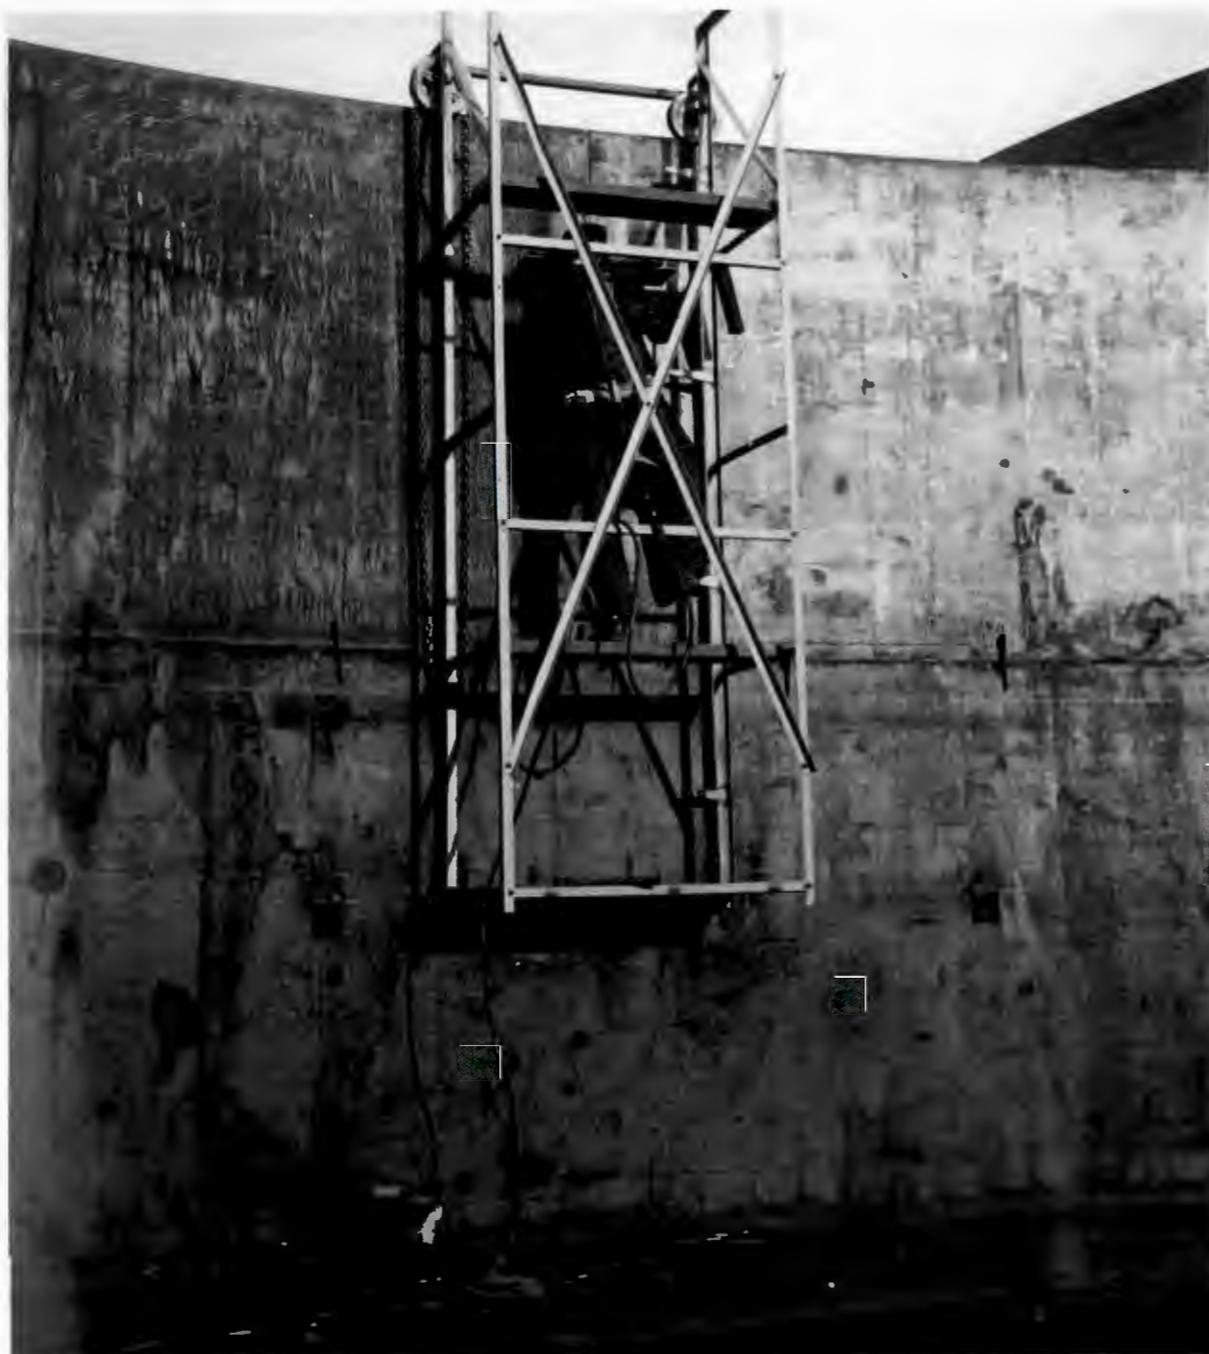
Figure 5-14. 241-SX Farm Construction Showing Welding of Vertical Wall and the Bottom to Wall Transition, Photo 2367, November 9, 1953

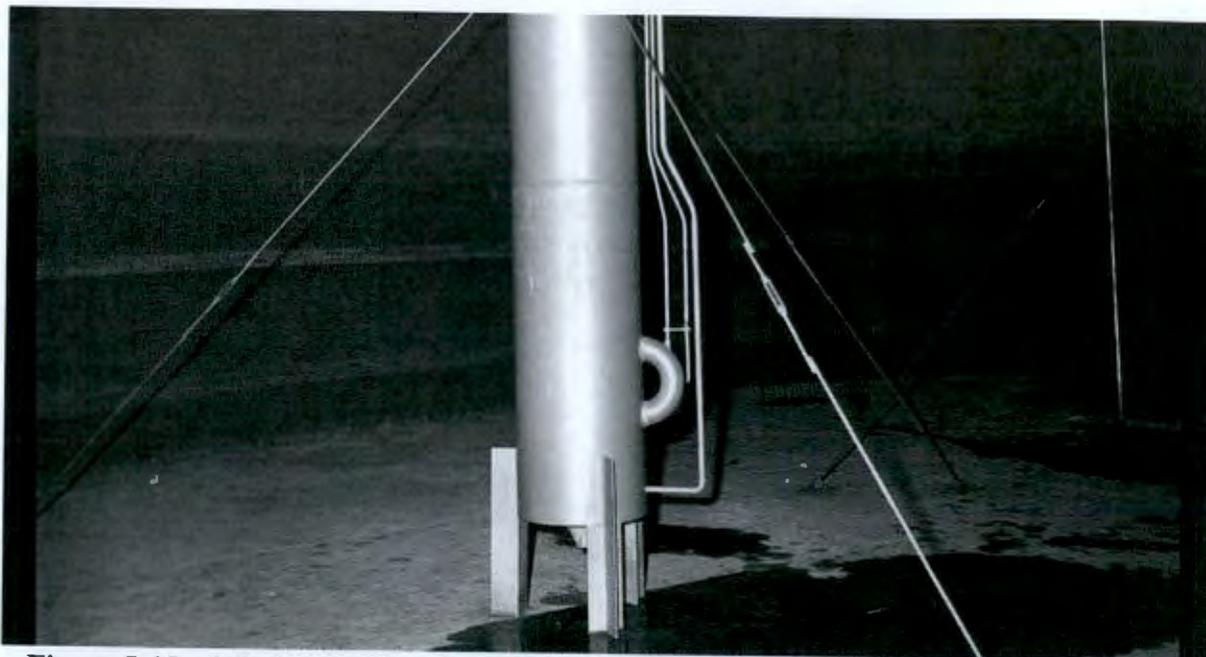
Figure 5-15. 241-A Farm Internal Tank Bottom, Wall and Air-Lift Circulator Showing the Corner Joint between the Sidewall and Bottom Liner

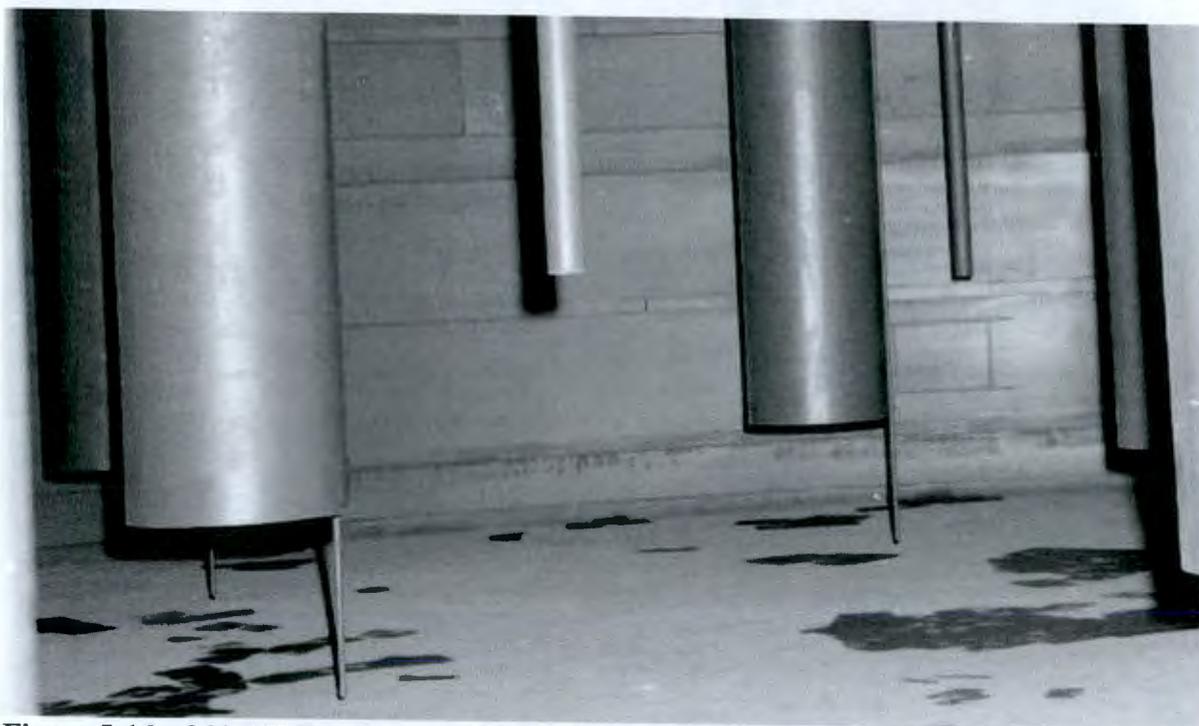
Figure 5-16. 241-AX Farm Internal Tank Bottom, Wall and Air-Lift Circulators Showing the Bottom to Wall Transition, Photo 37937-2, October 26, 1964

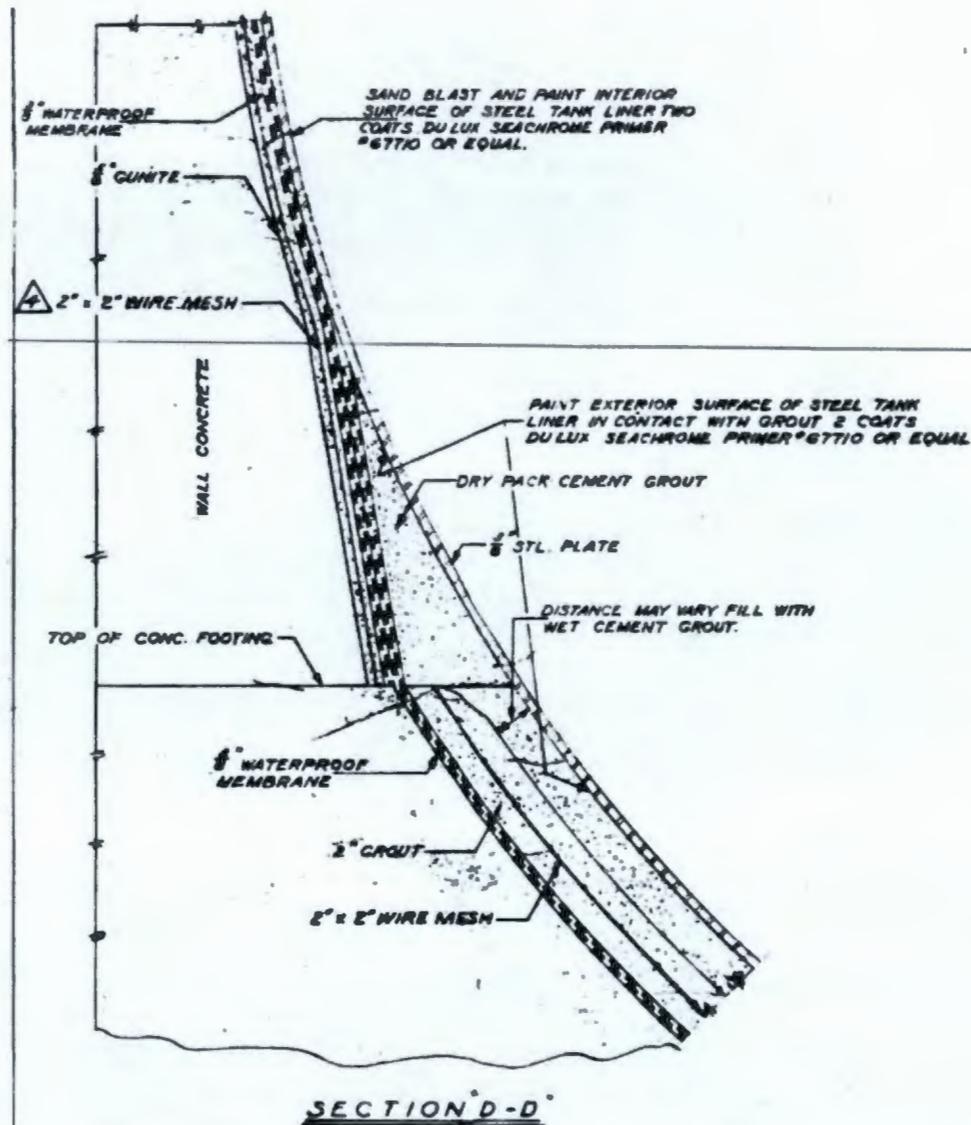
Figure 5-17. 241-TX Farm Asphalt Membrane, Typical of External Tank Liner for 100-Series Tanks Constructed Prior to 241-SX Tank Farm

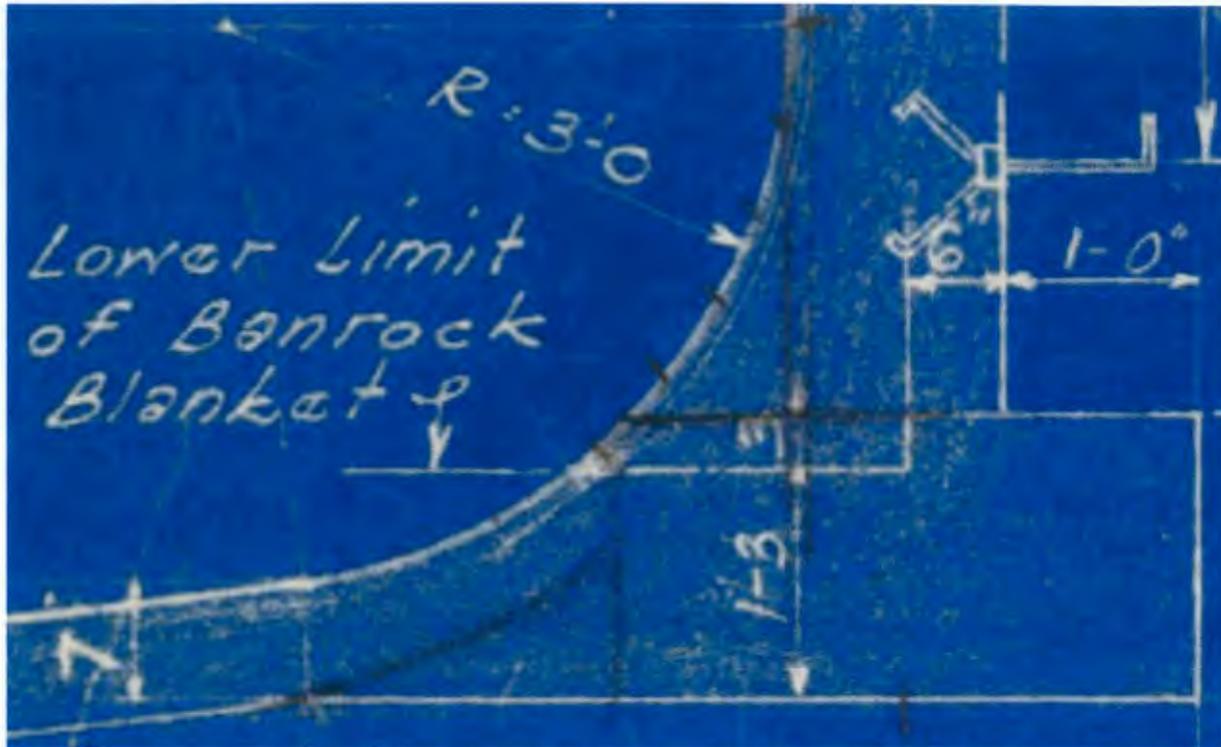
gunite prior to placement of the concrete wall. There is no indication from the available information whether the blanket material is yielding or rigid. The extent of the wire mesh blanket material is shown in Figure 5-18.

Figure 5-18. 200-Series Tank Wire Mesh Blanket Lining Material on the External Tank Liner for 200-Series Tanks

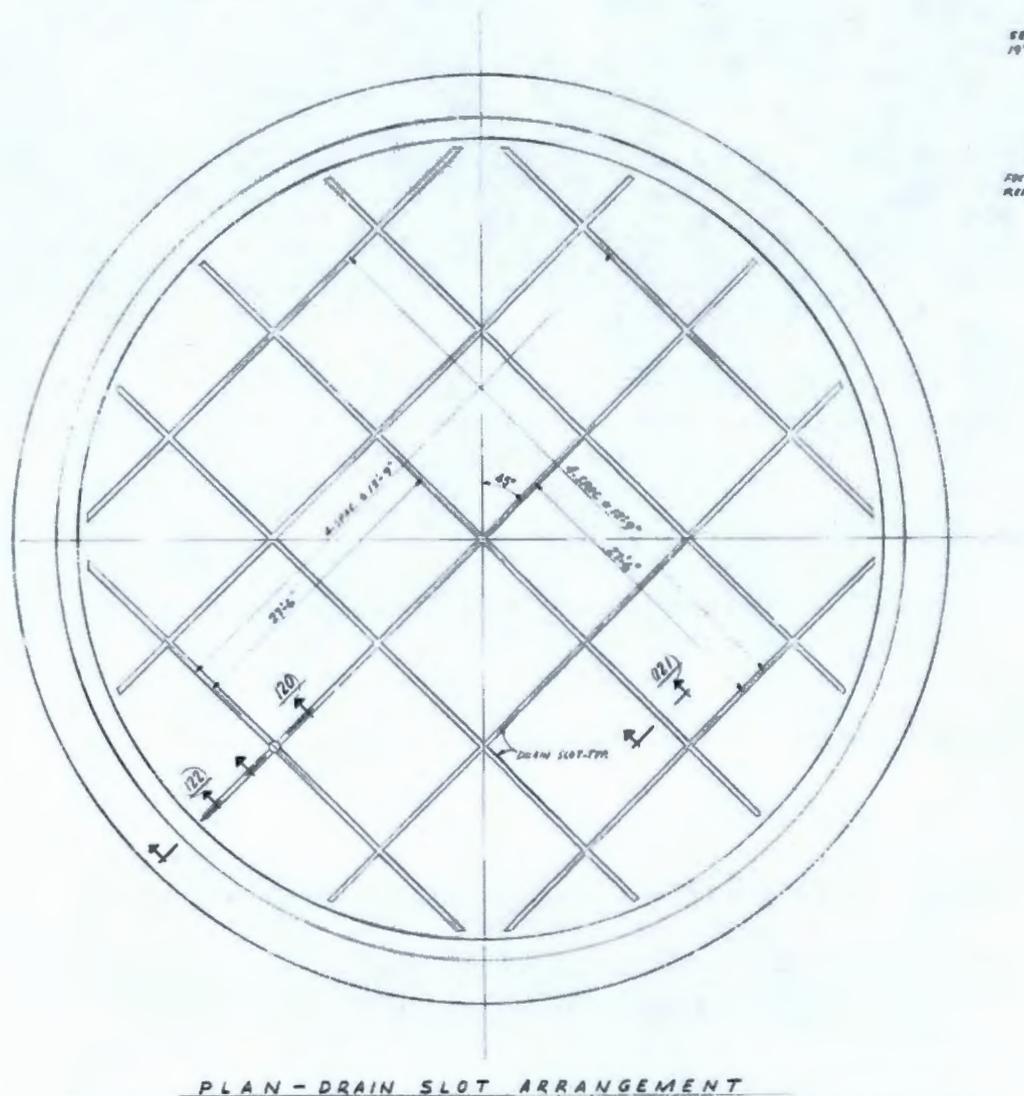
One design aspect that differentiates AX Farm from the other SST farms is the presence of drain slots underneath the tank bottom liner. These drain slots are 5 in. wide, 2 ½ in. wide, and spaced 13-ft 9 in. apart (square array). Although the intention of the drain slots was to direct and collect any liquid that may be present underneath the tank to a detection sump, the drain slots also provide an engineered vent path for any gases that may be present or form underneath the tank bottom liner. Figure 5-19 shows a plan view of the base mat with the drain slot arrangement (H-2-44563, *Structural Waste Storage Tanks Drain Arrangement and Details 241-AX*). These slots connect, via a 12-in. pipe that travels under the foundation, to a 24-in. diameter leak detection well. This well extends up to grade where it is enclosed within a leak detection pit. Vapor or gas formed under the bottom liner could eventually make its way through the drain collection pipe and to the leak detection well.

Figure 5-19. 241-AX Farm Tank Basemat Drain Slot Arrangement
