DOCUMENT RELEASE AND CHANGE FORM	1a. Doc No: RPP-RPT-55804 Rev. 01 1b. Project Number: <input checked="" type="checkbox"/> N/A
---	--

Common Factors Relating to Liner Failures in Single-Shell Tanks

Abstract: This report fulfills the requirement for target T04 for Hanford Federal Facility Agreement and Consent Order milestone M-045-91F. The goal of this report is to identify the common factors that may have contributed to liner failures in single-shell tanks. The tanks with probable liner failures are identified through the process identified in RPP-32681, Rev. 0, "Process to Assess Tank Farm Leaks in Support of Retrieval and Closure Planning."

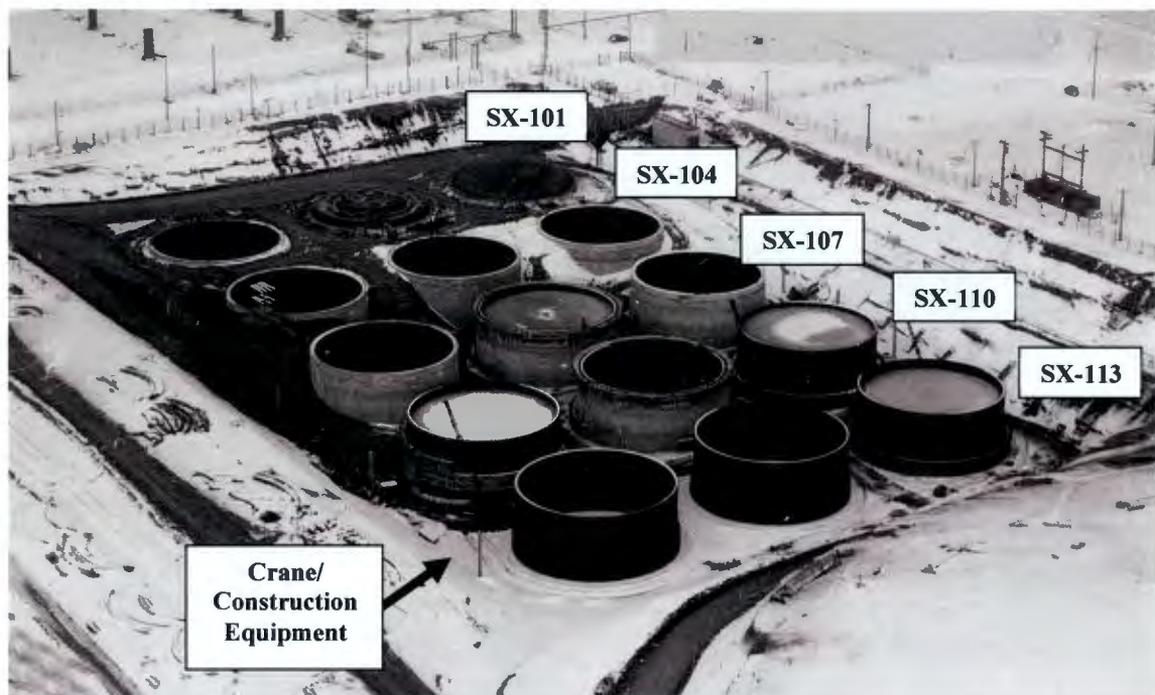
One of the most severe examples of the potential risk from brittle fracture was found in SX Farm. Figure 5-20 below is a picture taken of SX Farm during construction (IDMS Photograph 2471-PHOTO). The photograph was taken on January 20, 1954 on a day when the high temperature was 11°F and the low was -6°F. The winter of 1953-1954, during which this picture was taken, was one of the coldest and harshest recorded at the Hanford Site. Specifically, during the two week period surrounding this photograph (1/16/1954 to 1/29/1954) the temperature rarely reached above freezing with an average daily high temperature of 24°F and dipped into single digits throughout the period with an average daily low temperature of 9°F.

Figure 5-20. 241-SX Tank Farm Construction Photograph Taken January 20, 1954

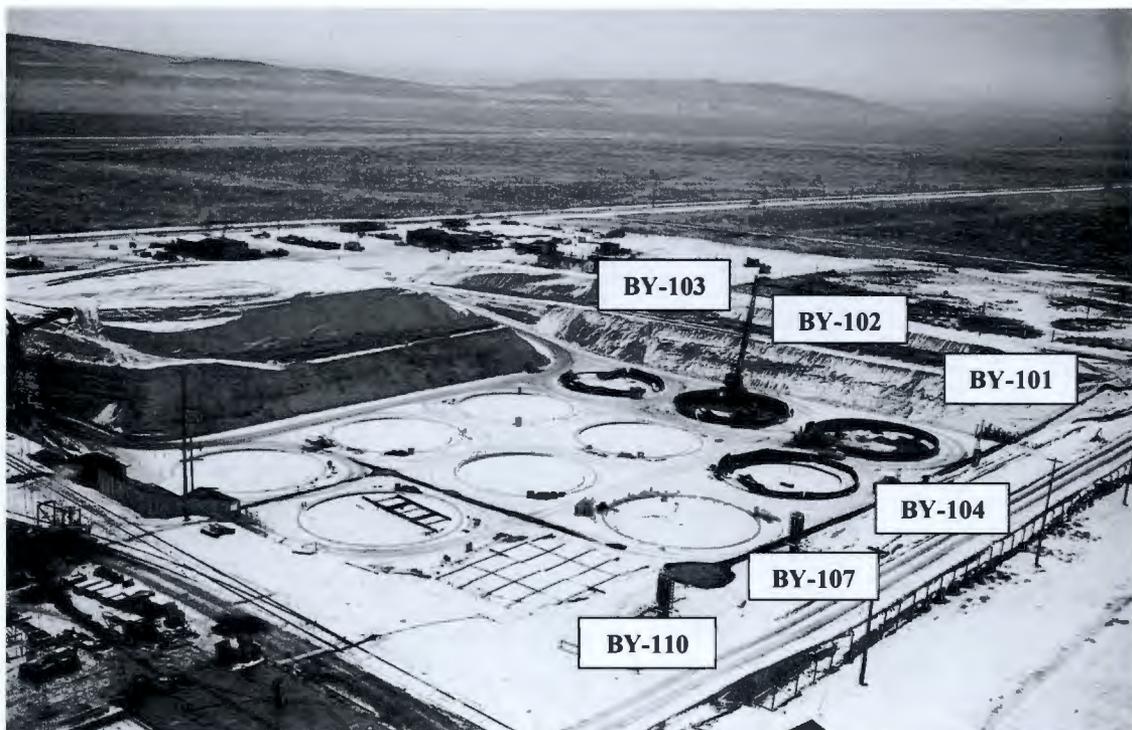
Another extreme example of cold weather construction was found in BY Farm. Whereas the extreme cold weather hit SX Farm during the concrete wall pouring portion of the construction, the cold weather hit BY Farm construction through ongoing liner fabrication. Figure 5-21 and Figure 5-22 show that significant construction activities, including welding of the steel plates, were taking place through January and February 1949. Similar to the conditions found in SX Farm, during the time period between January 19, 1949 and February 9, 1949, the daily high temperature was rarely above freezing with an average of 26°F and the daily average low temperature of 7°F, at one point dropping to -11°F. The extremely cold temperatures coupled with the clear evidence of ongoing construction activities suggest a significant opportunity to develop cracks with impacts to the steel.

Figure 5-21. 241-BY Tank Farm Construction Photograph Taken January 19, 1949

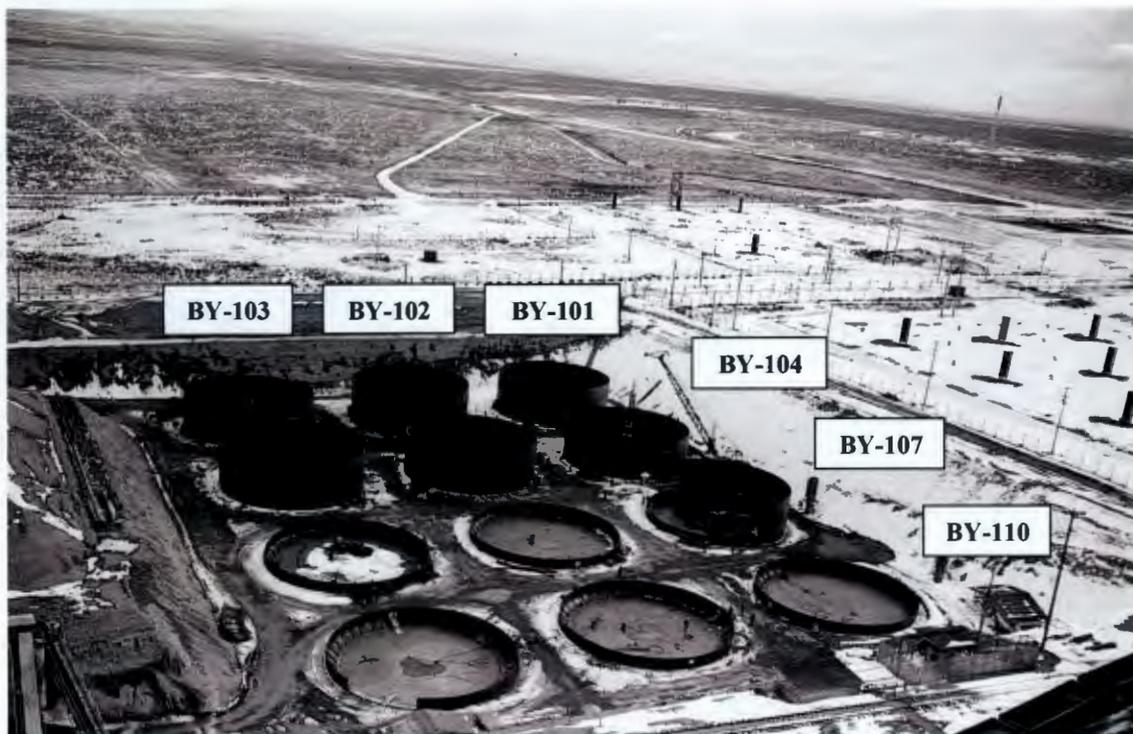
Figure 5-22. 241-BY Tank Farm Construction Photograph Taken February 9, 1949

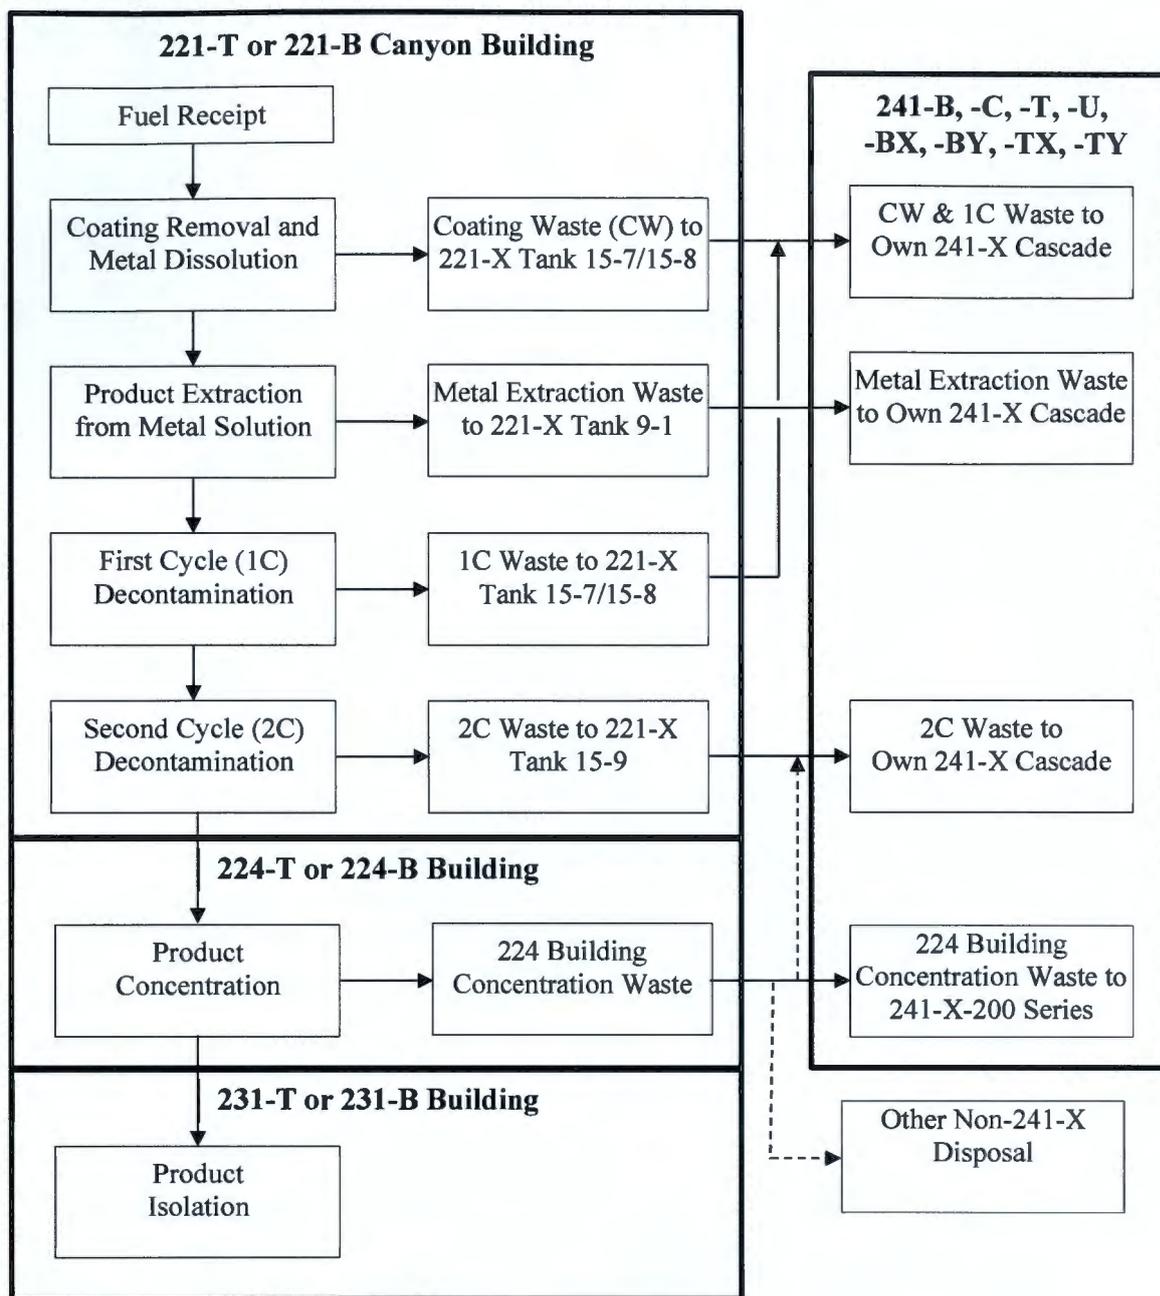
Figure 5-23. Bismuth Phosphate Simplified Schematic Showing Major Waste Streams Sent to Single-Shell Tanks

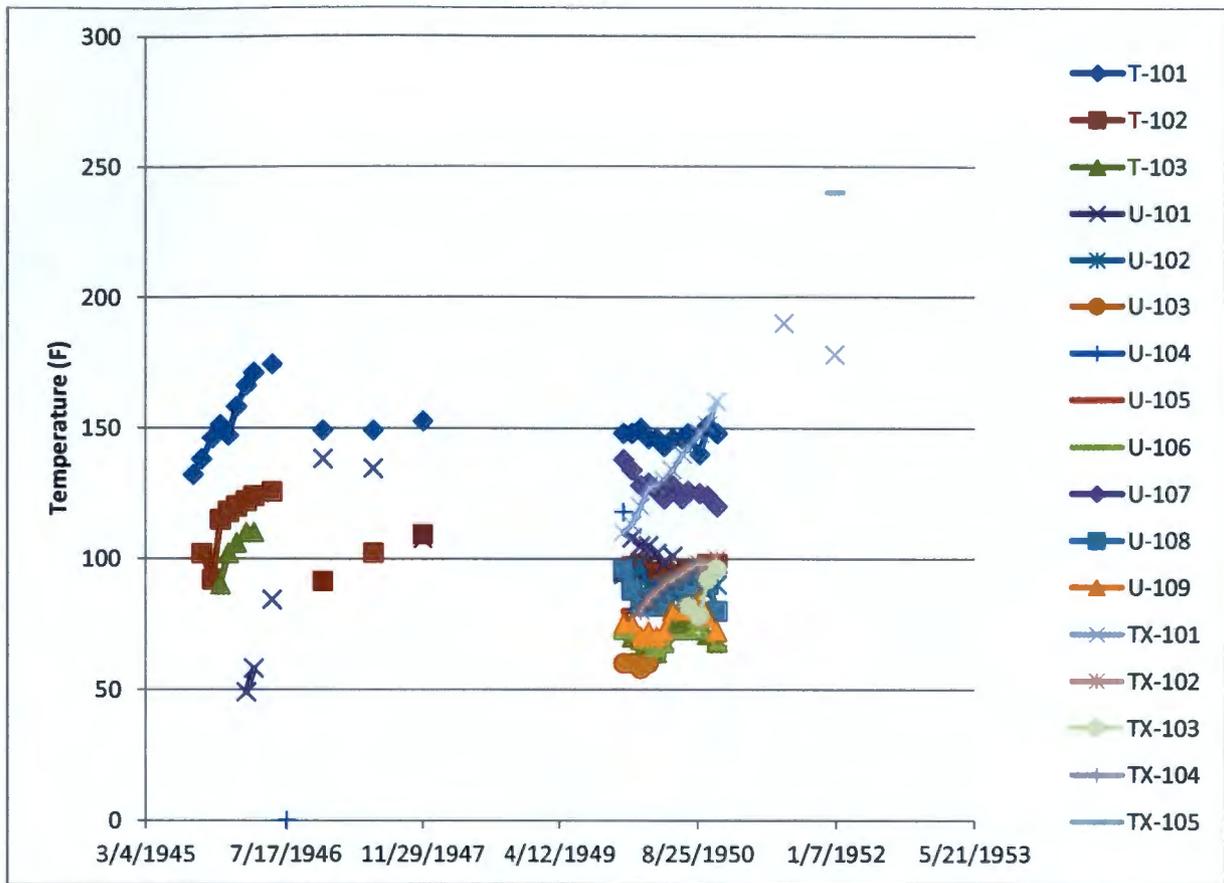
Figure 5-24. 200 West Area Metal Waste Tank Temperatures, 1945-1952

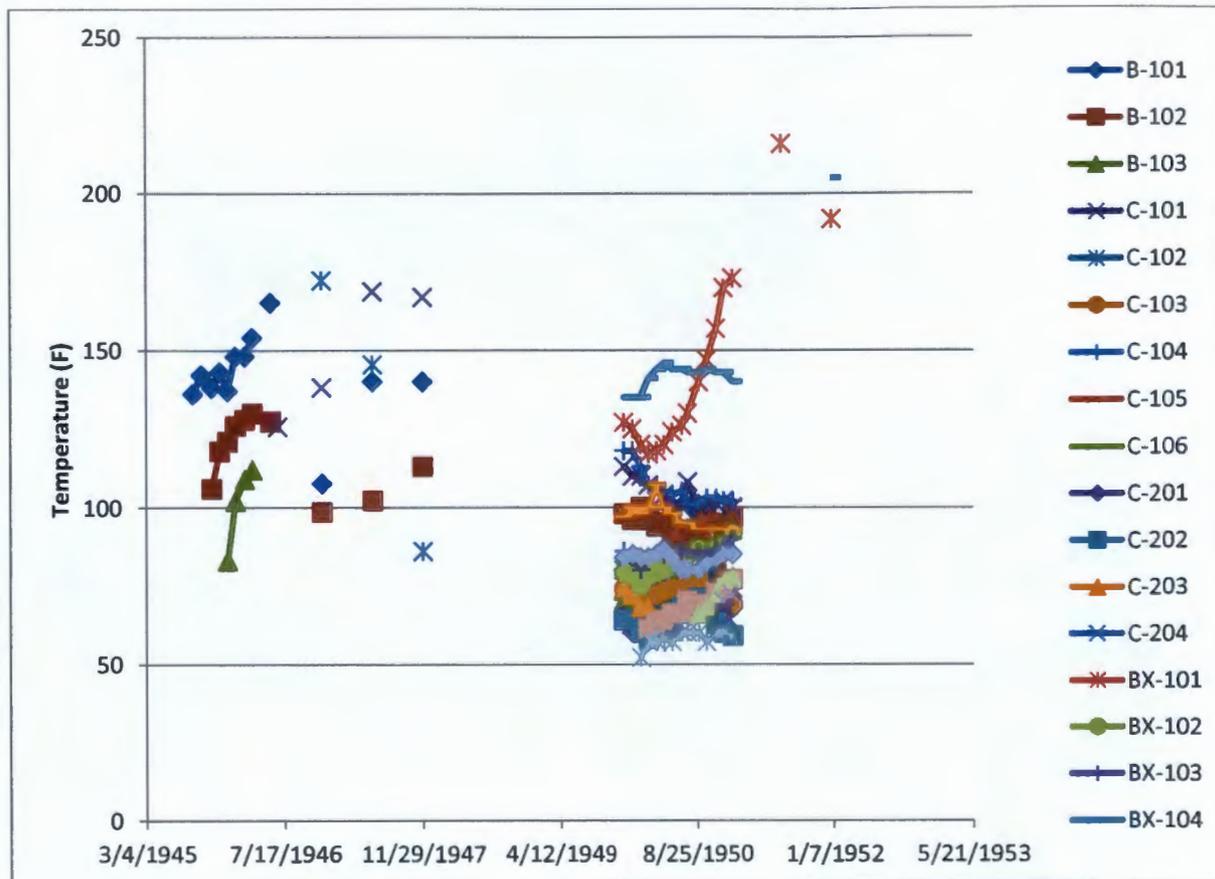
Figure 5-25. 200 East Area Metal Waste Tank Temperatures, 1945-1952

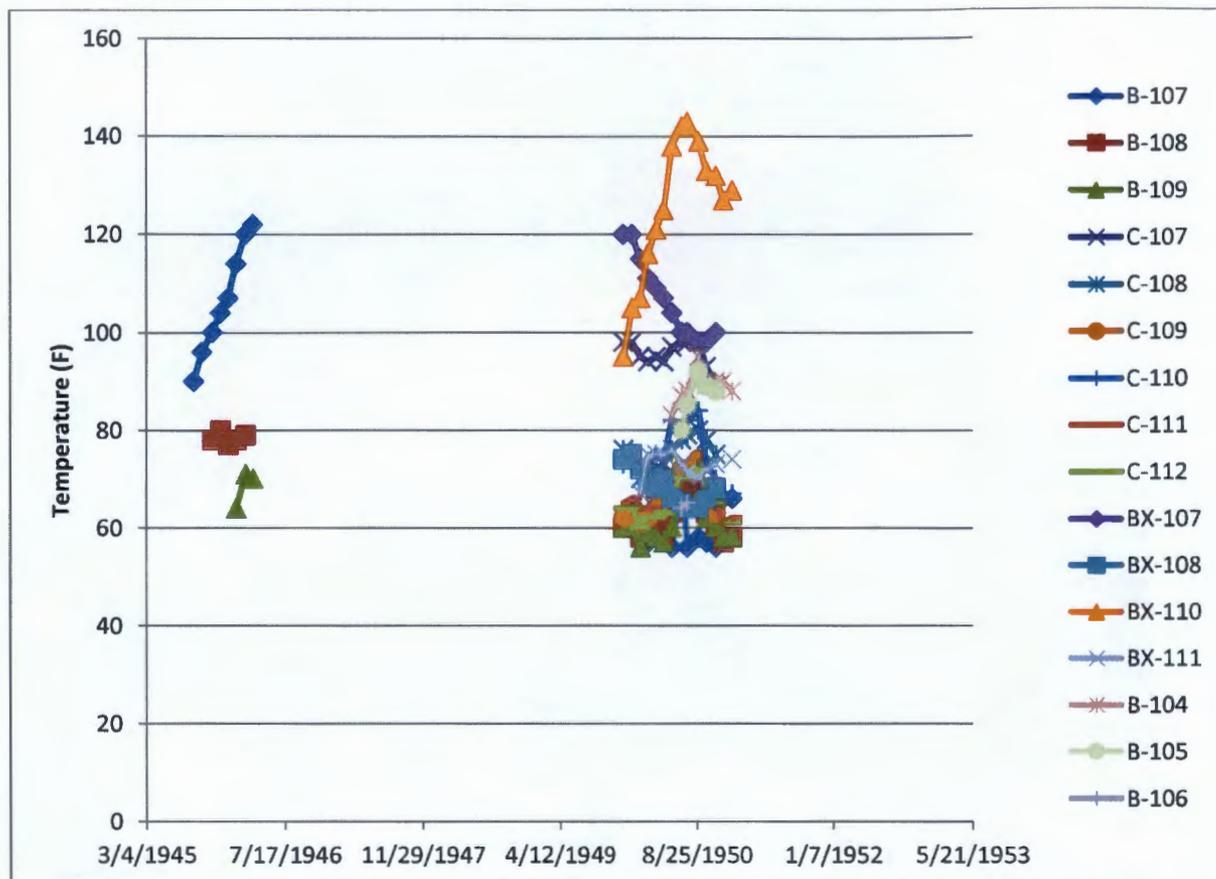
Figure 5-27. 200 East Area Coating Removal and First Cycle Decontamination Waste Tank Temperatures, 1945-1952

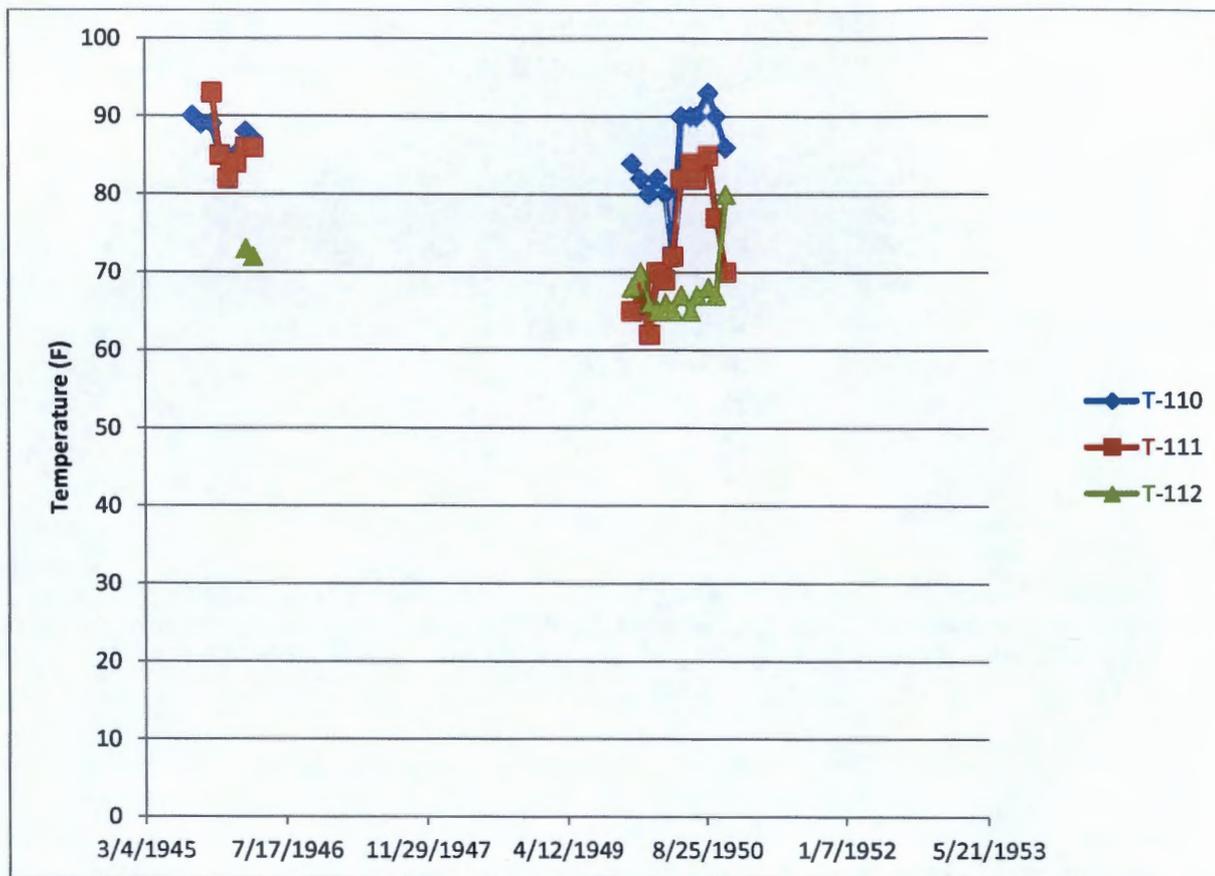
Figure 5-28. 200 West Area Second Decontamination Cycle Waste Tank Temperatures, 1945-1952

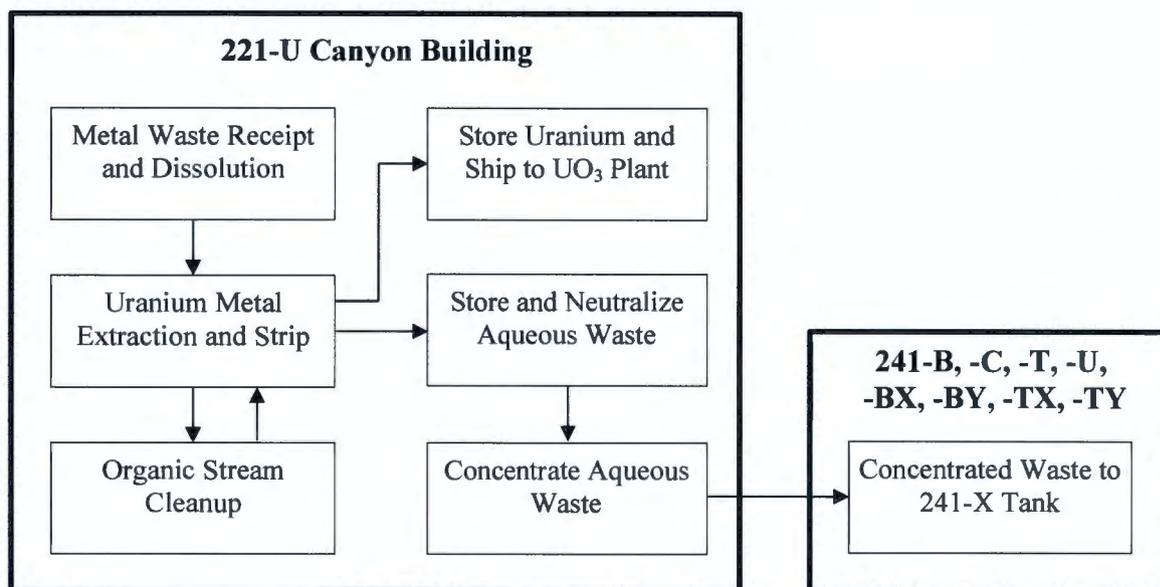
The following process description is based on HW-19140 and HW-24301, *TBP Plant Operating Procedure*. The TBP process uses the preferential extractability of uranyl nitrate by TBP to separate uranium from the plutonium and fission products with which it is associated in the BiPO₄ process metal waste. Uranyl nitrate, the product of uranium dissolution in nitric acid, is very soluble in aqueous solutions and forms an organic-soluble complex with TBP. When an aqueous solution containing uranyl nitrate is contacted with an organic solution containing TBP, the uranium can be preferentially transferred into the organic phase by adding a salting agent (nitrate or nitric acid) to the aqueous phase. The fission elements and plutonium, if maintained trivalent, remain in the aqueous phase. This preferential distribution makes the separation of uranium from plutonium and fission products possible in the TBP process. Figure 5-30 provides a simplified schematic identifying the major waste stream of the BiPO₄ process.

Figure 5-30. Metal Recovery or Tributyl Phosphate Process Simplified Schematic Showing Major Waste Stream Sent to Single-Shell Tanks

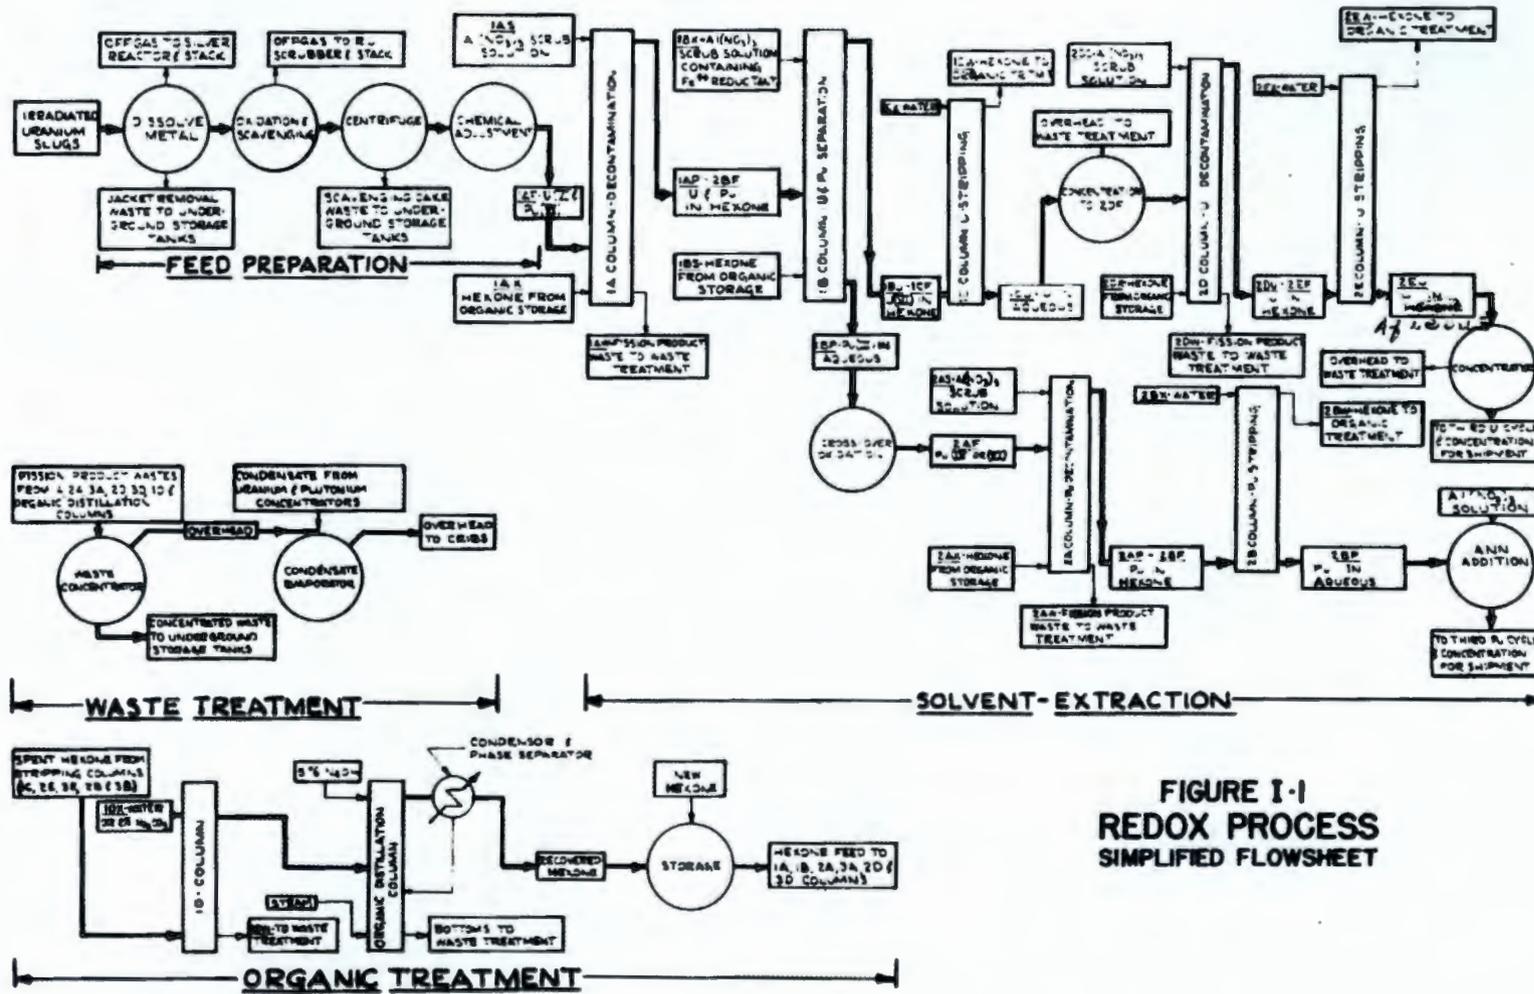
FIGURE I-1
REDOX PROCESS
SIMPLIFIED FLOWSHEET

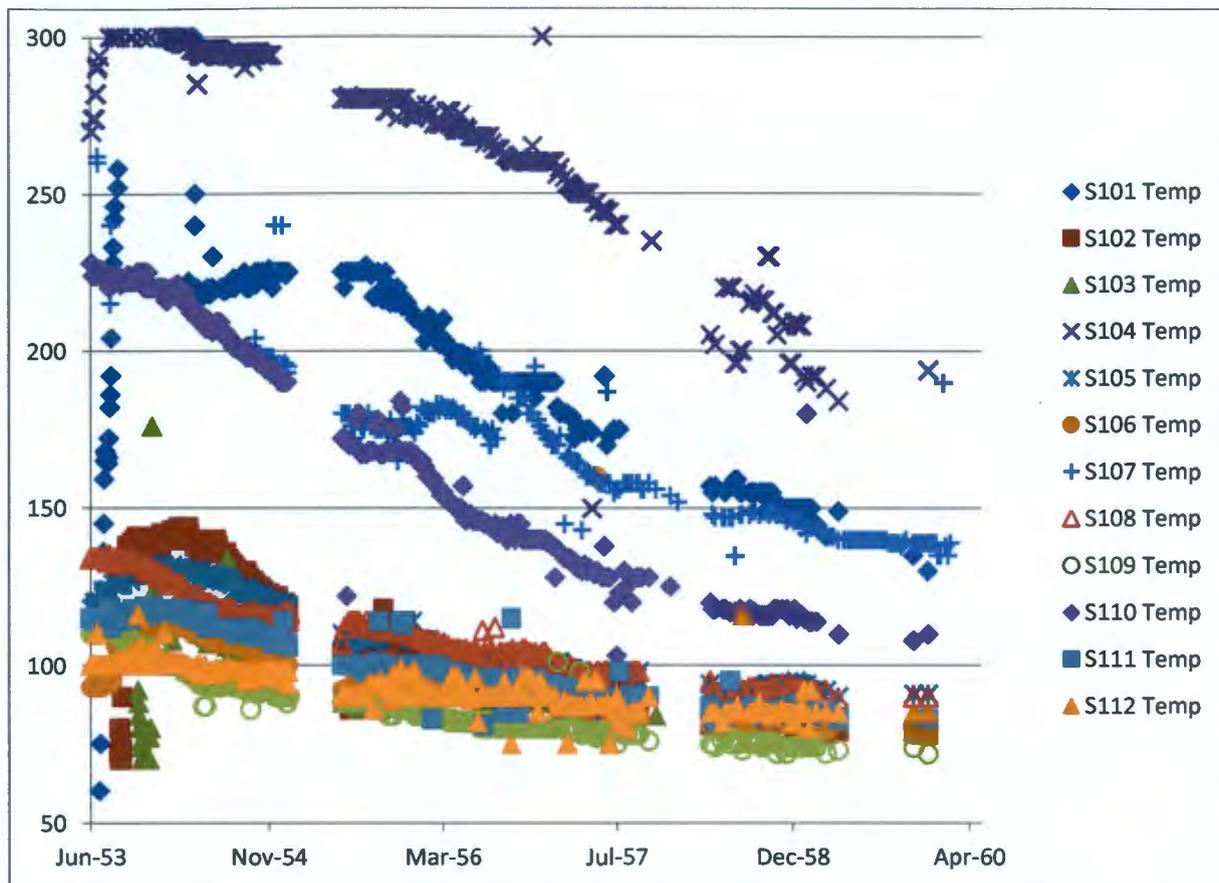
Figure 5-32. 241-S Farm Tank Content Maximum Temperatures When Filled with REDOX Waste, 1953-1960

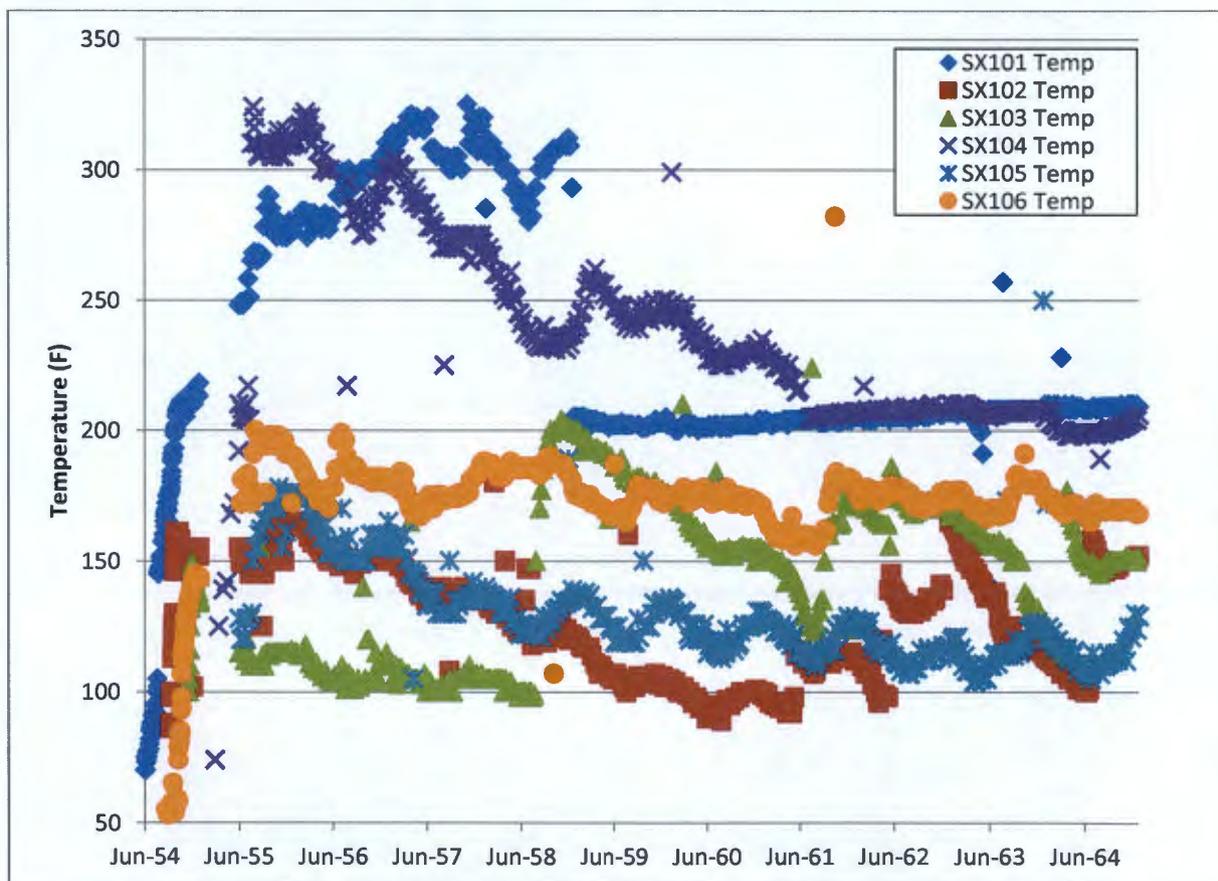
A temperature chart from 1954-1955 (RPP-RPT-58371) shows that the thermocouples in tanks SX-101 and SX-104 were lowered on July 13, 1955 with significant step changes in temperatures, 15°F in tank SX-101 and 106°F in tank SX-104. Available temperature data after the step change in July 1954 in tank SX-101 shows a gradual increase in the maximum temperature typically less than 3°F per day and a steadying out of temperature in SX-104.

Figure 5-33. 241-SX-101 to 241-SX-106 Tank Content Maximum Temperatures at the Time of Filling with REDOX Waste, 1954-1964

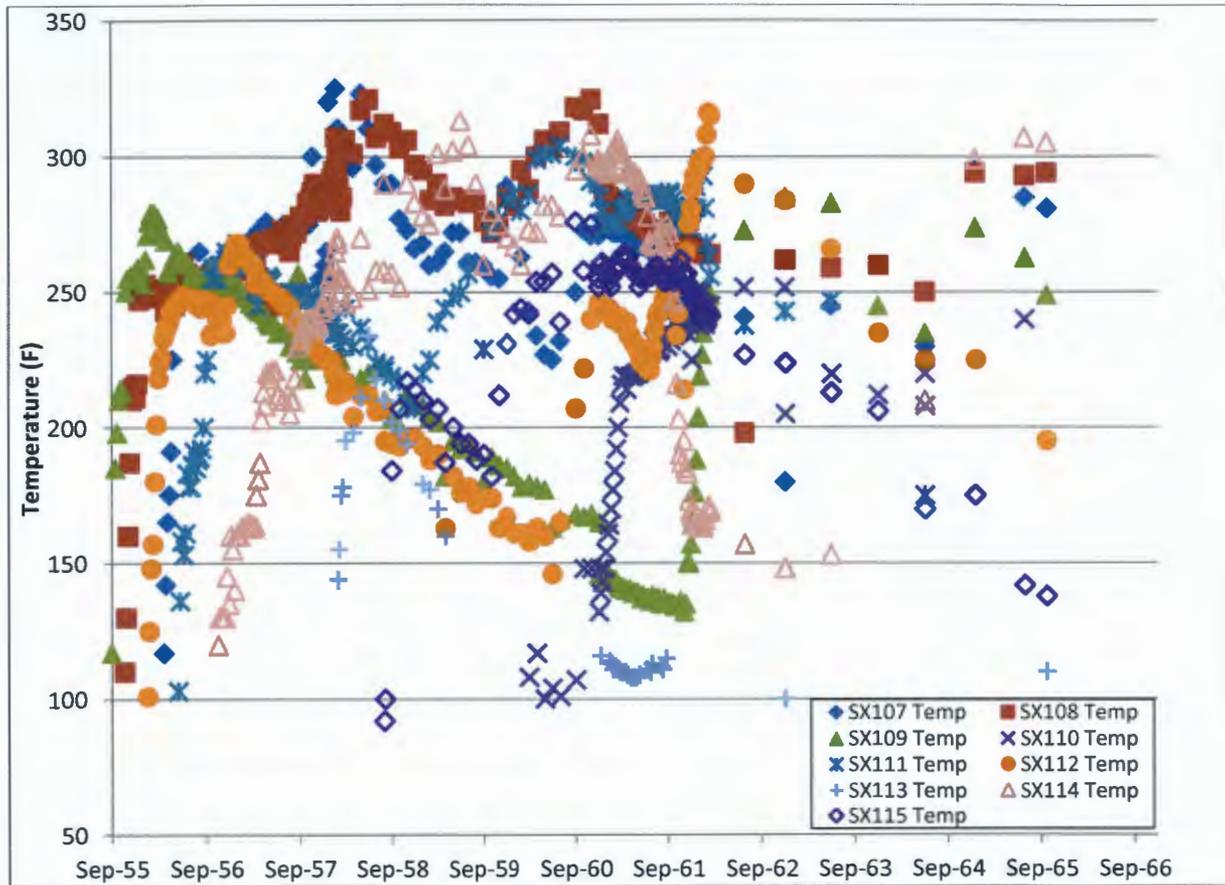
In the last nine tanks of SX Farm, the waste was not cascaded so all tanks were exposed to higher temperatures. Temperature profiles for tanks SX-107 through SX-115 during the time of REDOX operation are shown in Figure 5-34. These temperatures were generally measured 2 to 3 in. from the tank bottom. The maximum temperature for each tank ranged from 234°F in tank SX-113 to 390°F (not shown on plot) in tank SX-107⁵. Tank SX-113 failed within five months of the first addition of waste and had not been completely filled.

Figure 5-34. 241-SX-107 to 241-SX-115 Tank Content Maximum Temperatures at the Time of Filling with REDOX Waste, 1955-1965

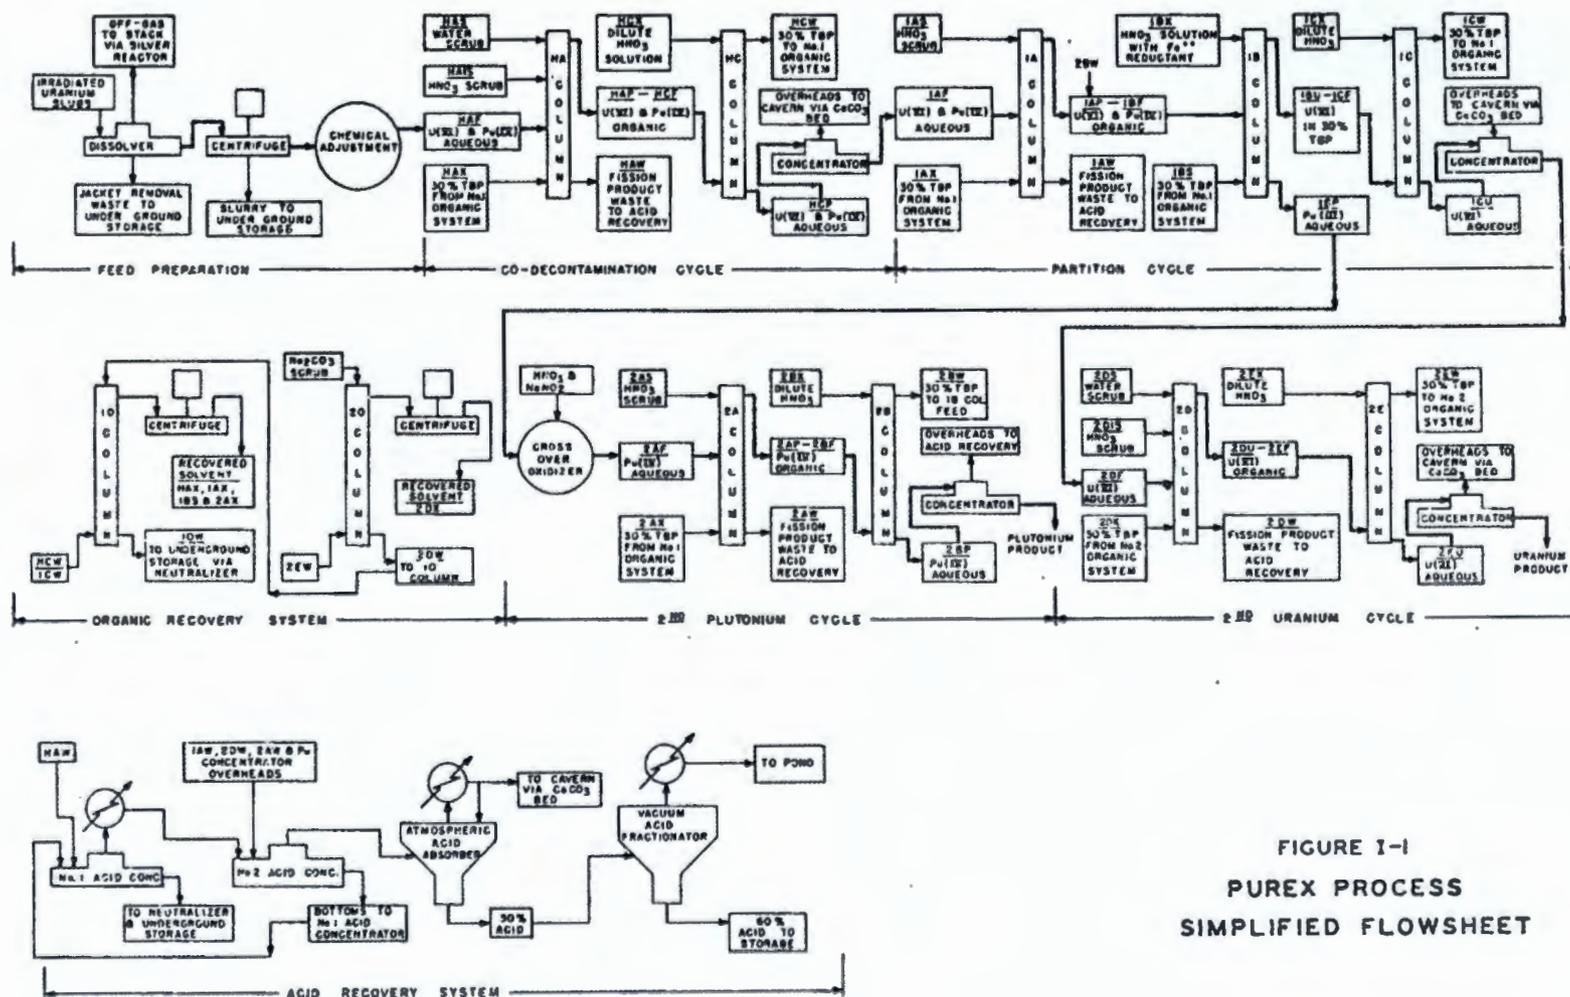
FIGURE I-1
PUREX PROCESS
SIMPLIFIED FLOWSHEET

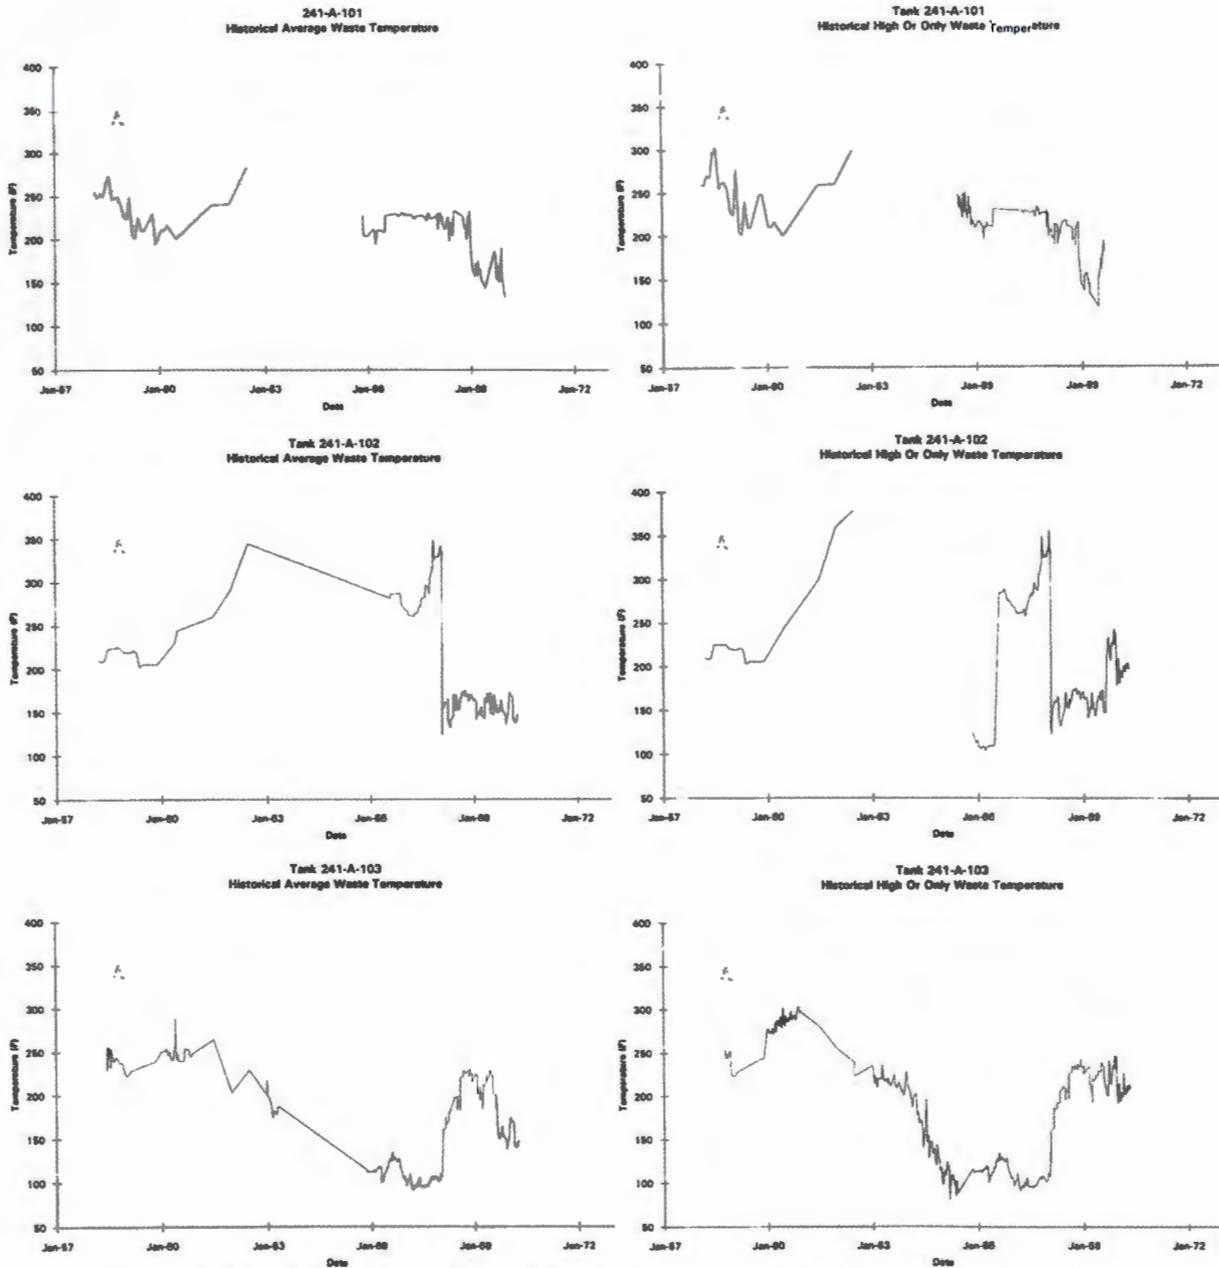
Figure 5-36. 241-A Tank Farm Waste Average and Maximum Temperatures, 1957 to 1972

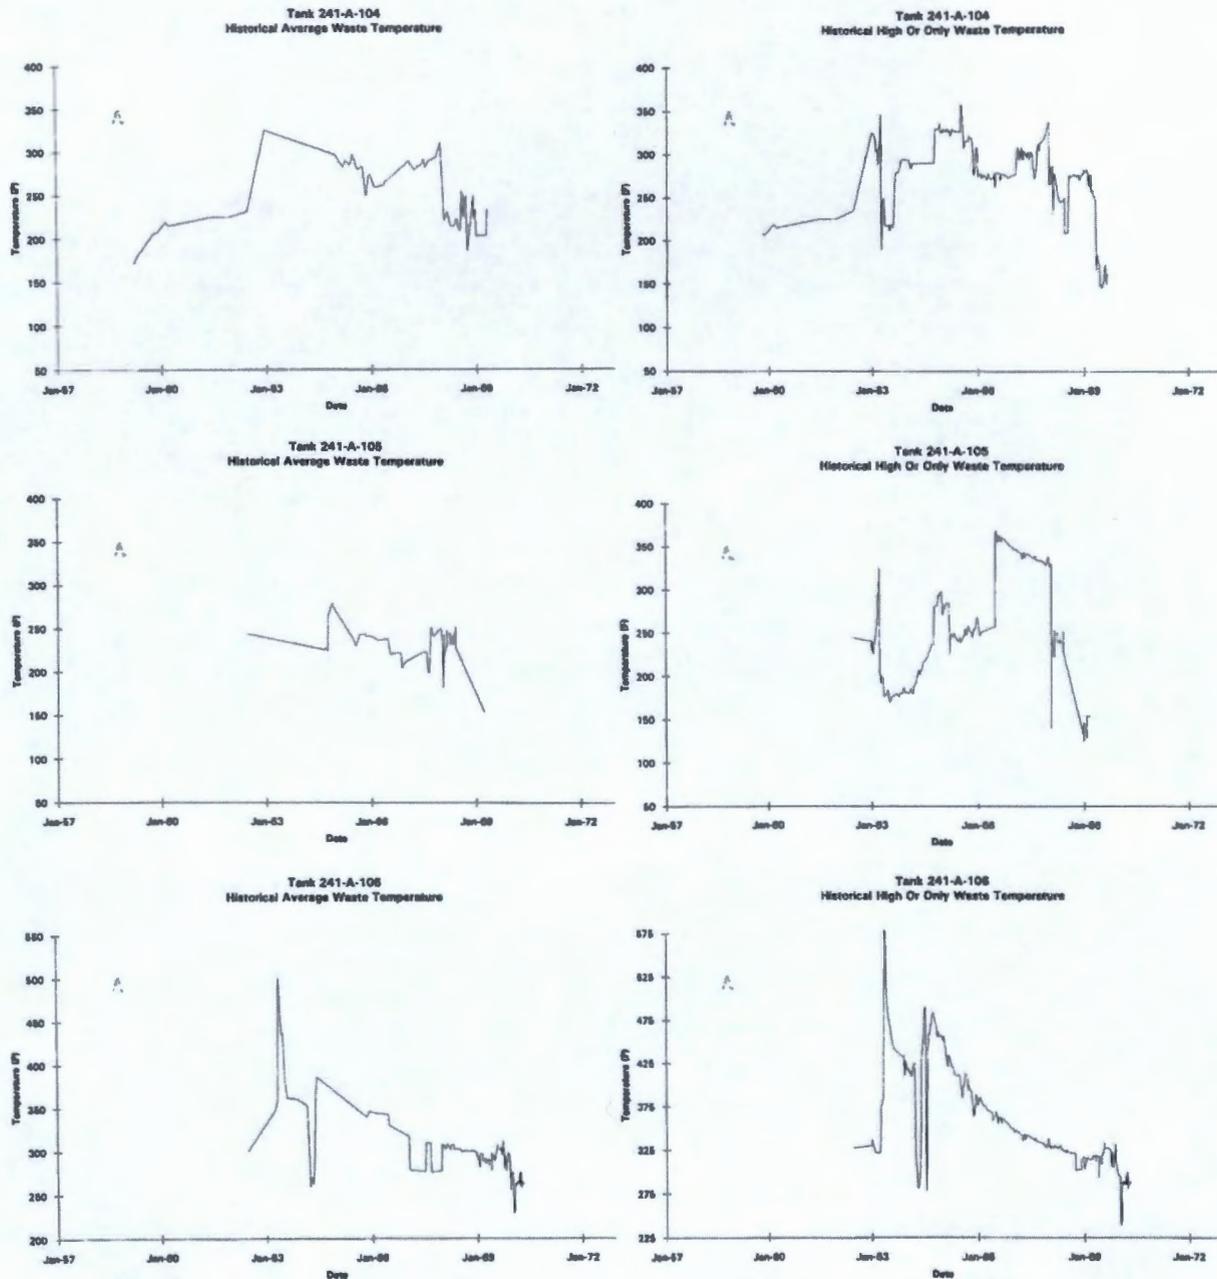
Figure 5-37. 241-A Tank Farm Waste Average and Maximum Temperatures, 1957 to 1972

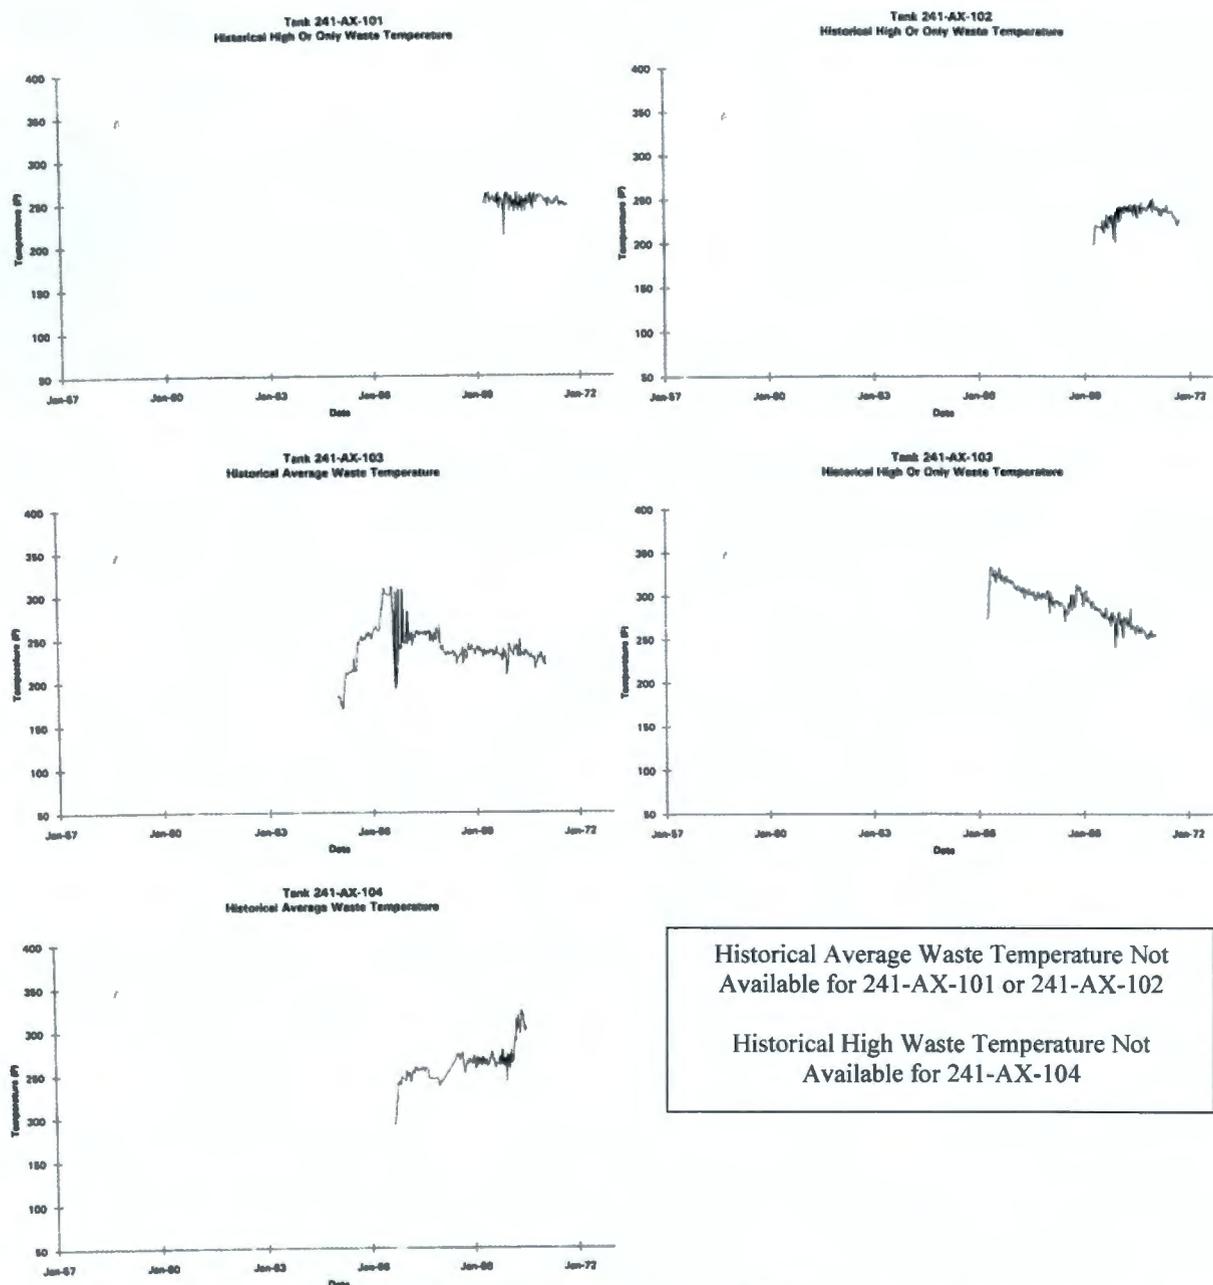
Figure 5-38. 241-AX Tank Farm Waste Average and Maximum Temperatures, 1957 to 1972

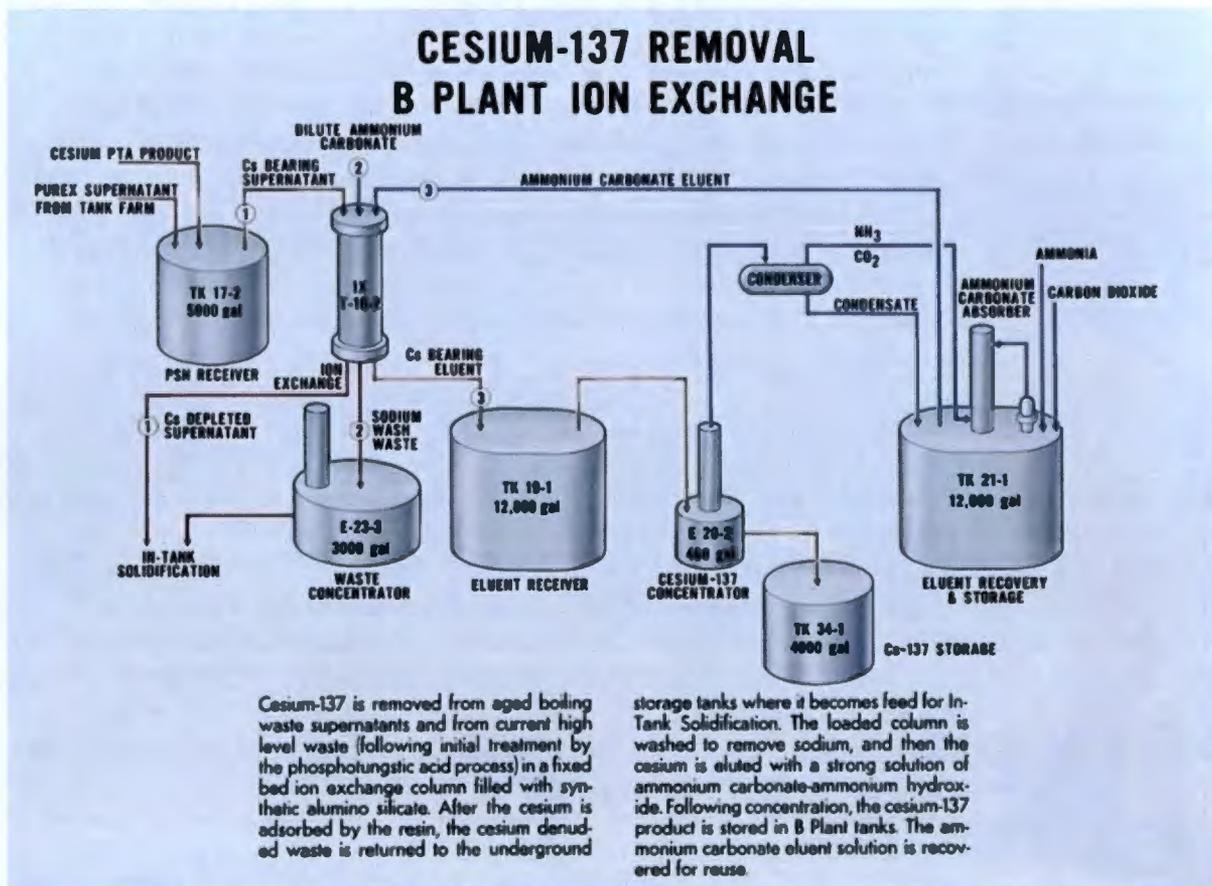
ion exchange cycle using feed from the cesium recovery process described in the above paragraph. After feeding the column to load it with cesium, the column was scrubbed to remove sodium, potassium and rubidium with dilute ammonium carbonate and ammonium hydroxide. The cesium was then eluted with concentrated ammonium carbonate – ammonium hydroxide flush solution. The solution with eluted cesium was concentrated, recovering the ammonium carbonate from the overheads. The waste stream from loading and the scrub solution were sent back to cesium recovery for recycle through the recovery process. If the streams contained low enough concentration of cesium they could alternately be processed as low level waste through the concentrator.

Figure 5-41. B Plant Cesium Recovery Ion Exchange Process, Circa 1967
