DOCUMENT RELEASE AND CHANGE FORM	1a. Doc No: RPP-RPT-55804 Rev. 01 1b. Project Number: <input checked="" type="checkbox"/> N/A
---	--

Common Factors Relating to Liner Failures in Single-Shell Tanks

Abstract: This report fulfills the requirement for target T04 for Hanford Federal Facility Agreement and Consent Order milestone M-045-91F. The goal of this report is to identify the common factors that may have contributed to liner failures in single-shell tanks. The tanks with probable liner failures are identified through the process identified in RPP-32681, Rev. 0, "Process to Assess Tank Farm Leaks in Support of Retrieval and Closure Planning."

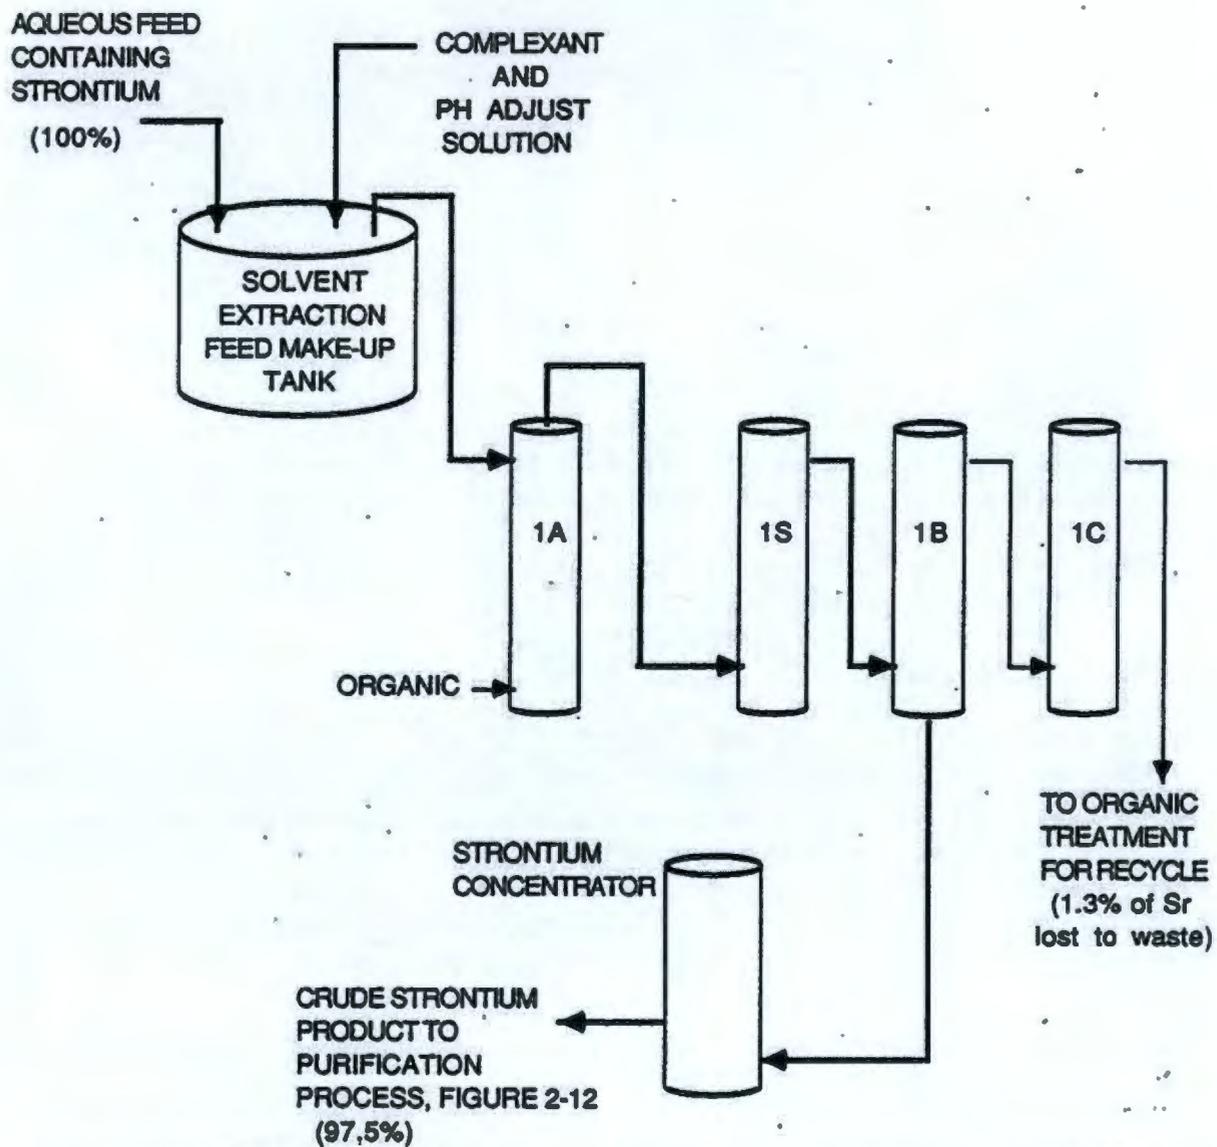
for removal of yttrium, traces of rare earths, and organic degradation products (ISO-100, p. 522). The organic is butted for return to the solvent extraction process. The aqueous waste streams from organic treatment are collected in a waste storage tank.

Figure 5-42. B Plant Strontium Recovery Solvent Extraction Process Simplified Flow Diagram

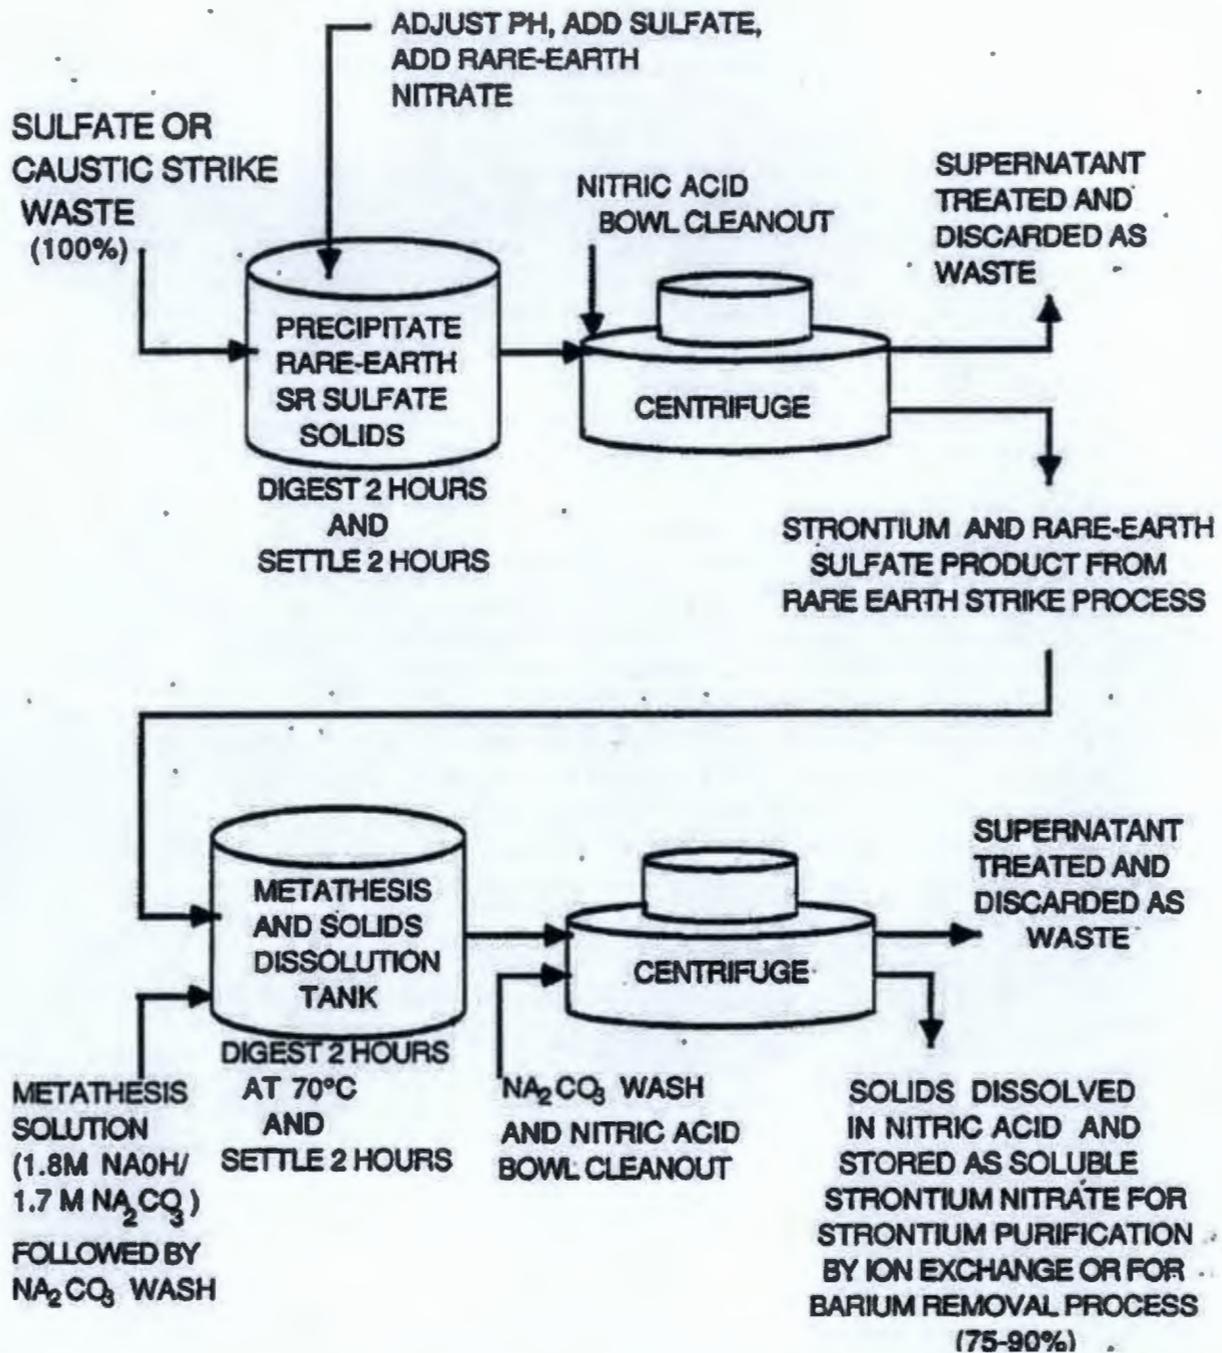
Figure 5-43. B Plant Strontium Purification Rare-Earth Sulfate Strike Process Simplified Flow Diagram

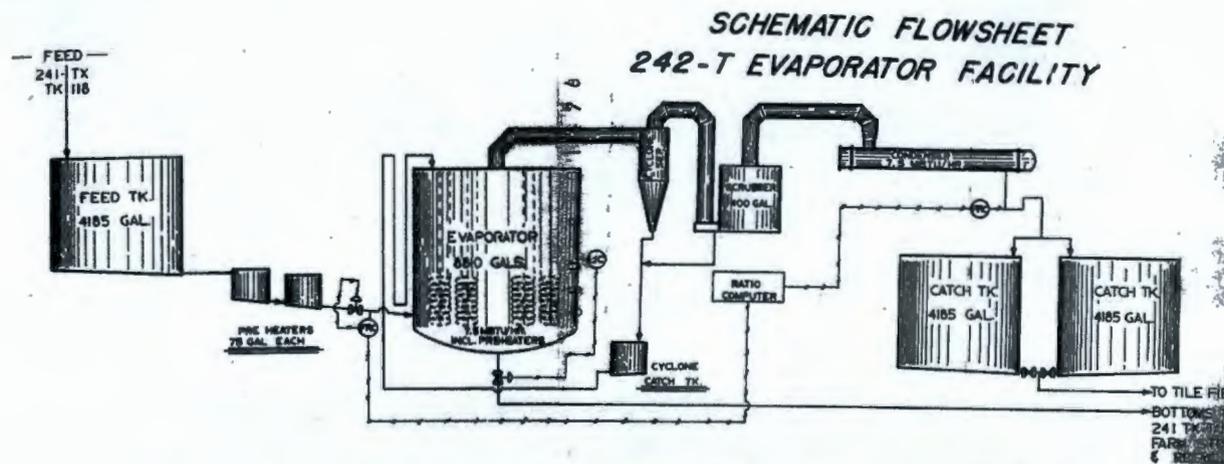
Figure 5-44. 242-T Evaporator Schematic Flow Diagram, Circa 1955

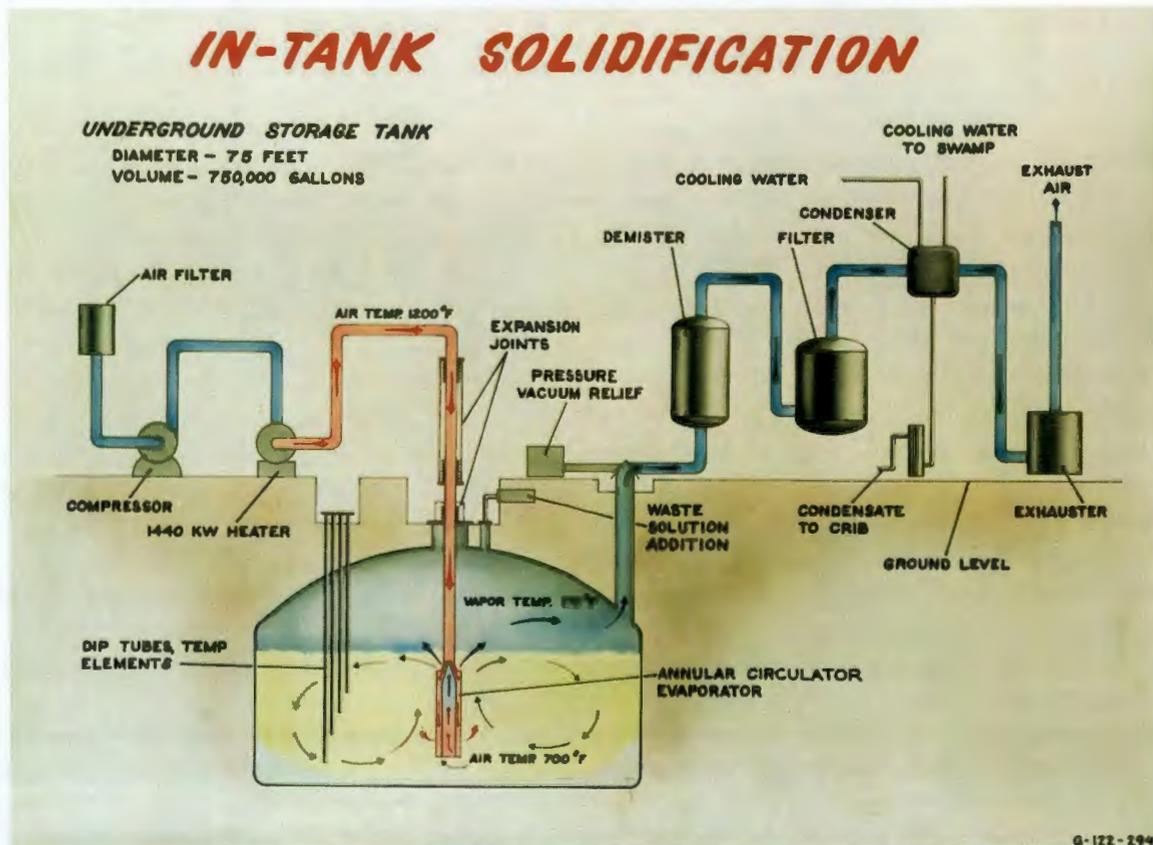
Figure 5-46. In-Tank Solidification Prototype Unit Flow Diagram

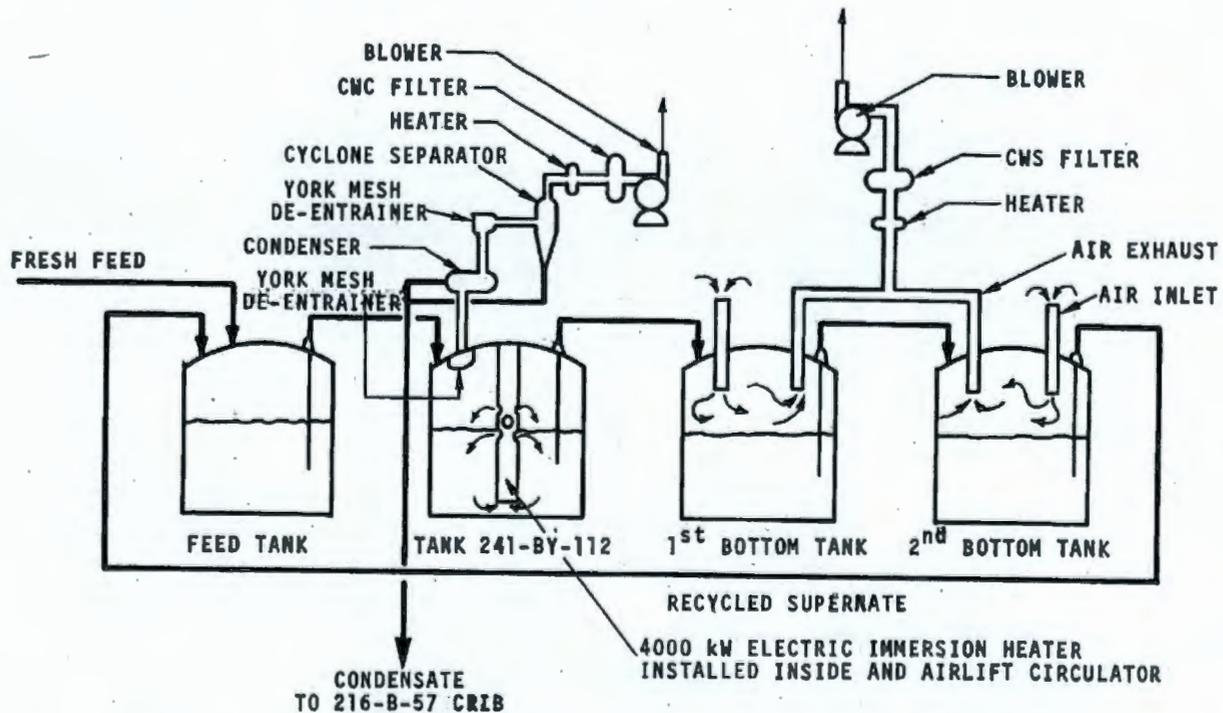
Figure 5-48. In-Tank Solidification Unit 2 (ITS-2) Simplified Flow Diagram

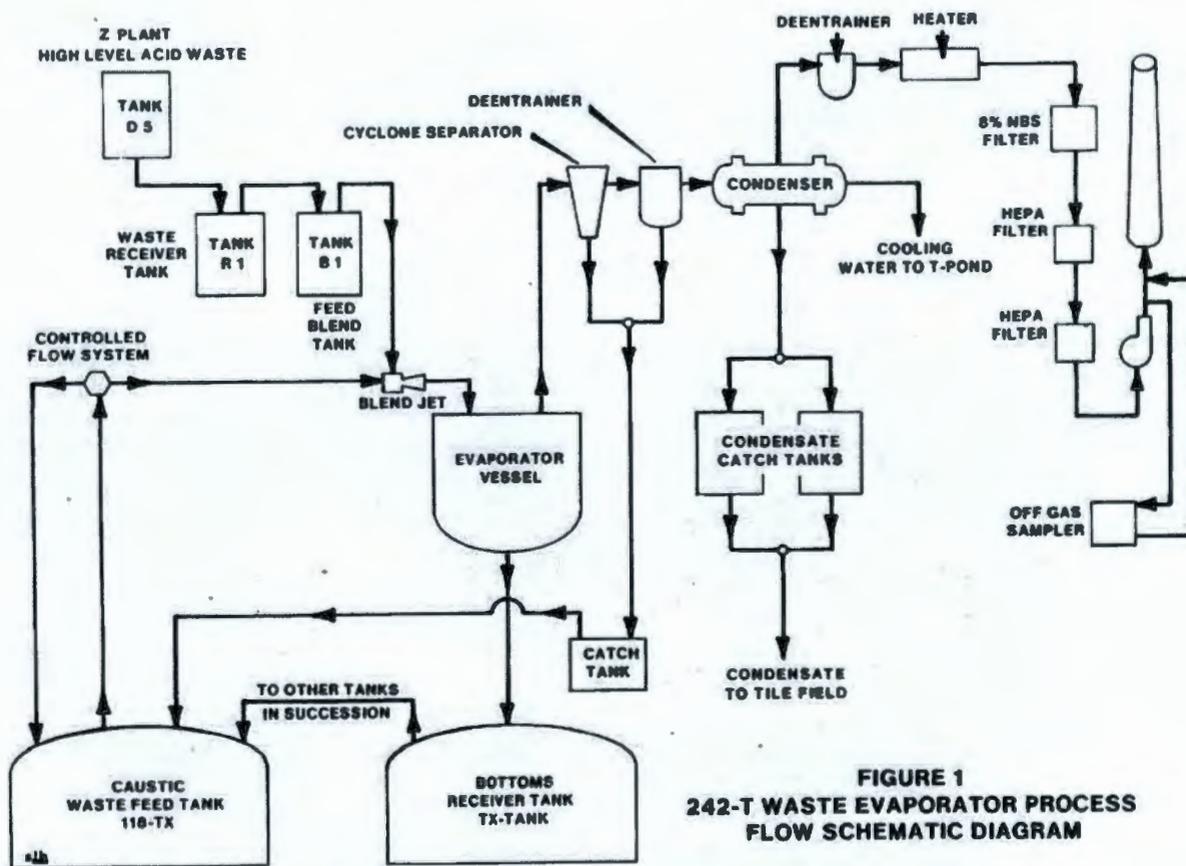
Figure 5-49. 242-T Waste Evaporator Process Flow Schematic Diagram, Circa 1974

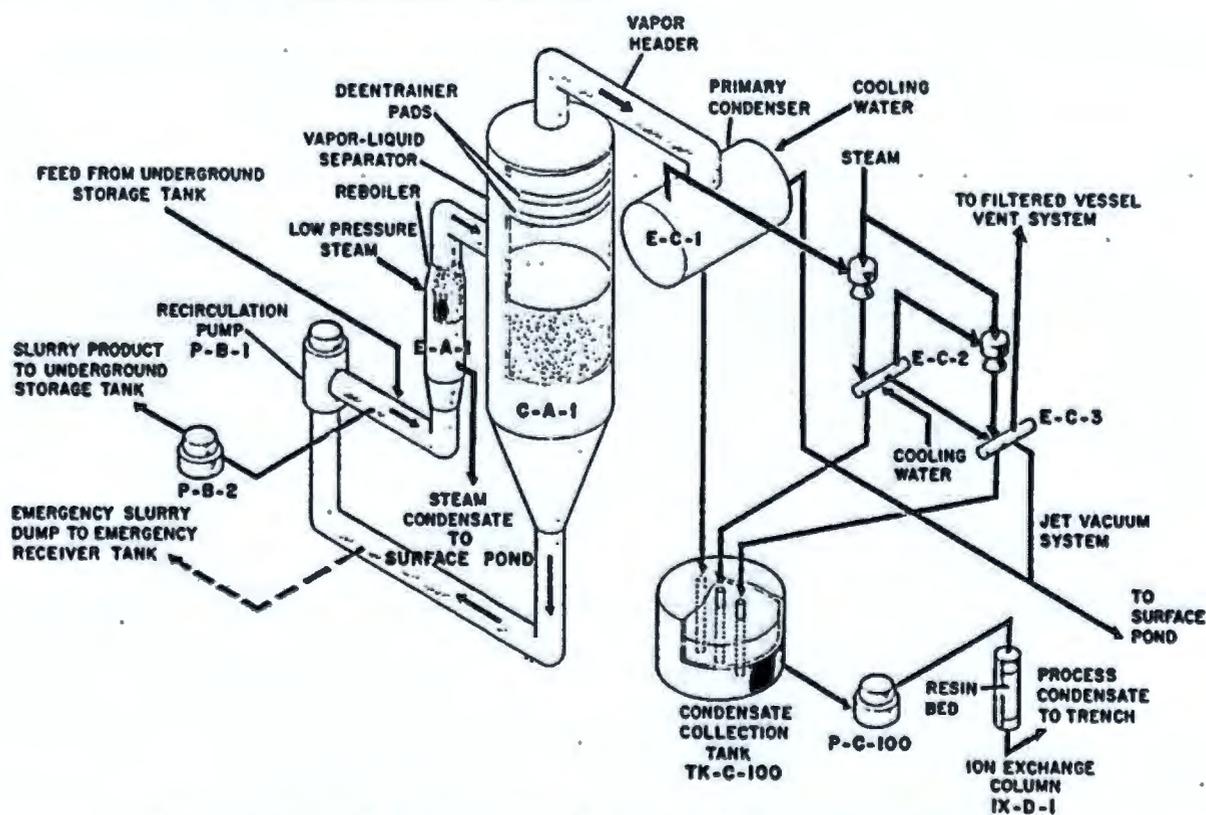
Figure 5-50. 242-S Evaporator Isometric Flow Diagram, Circa 1973

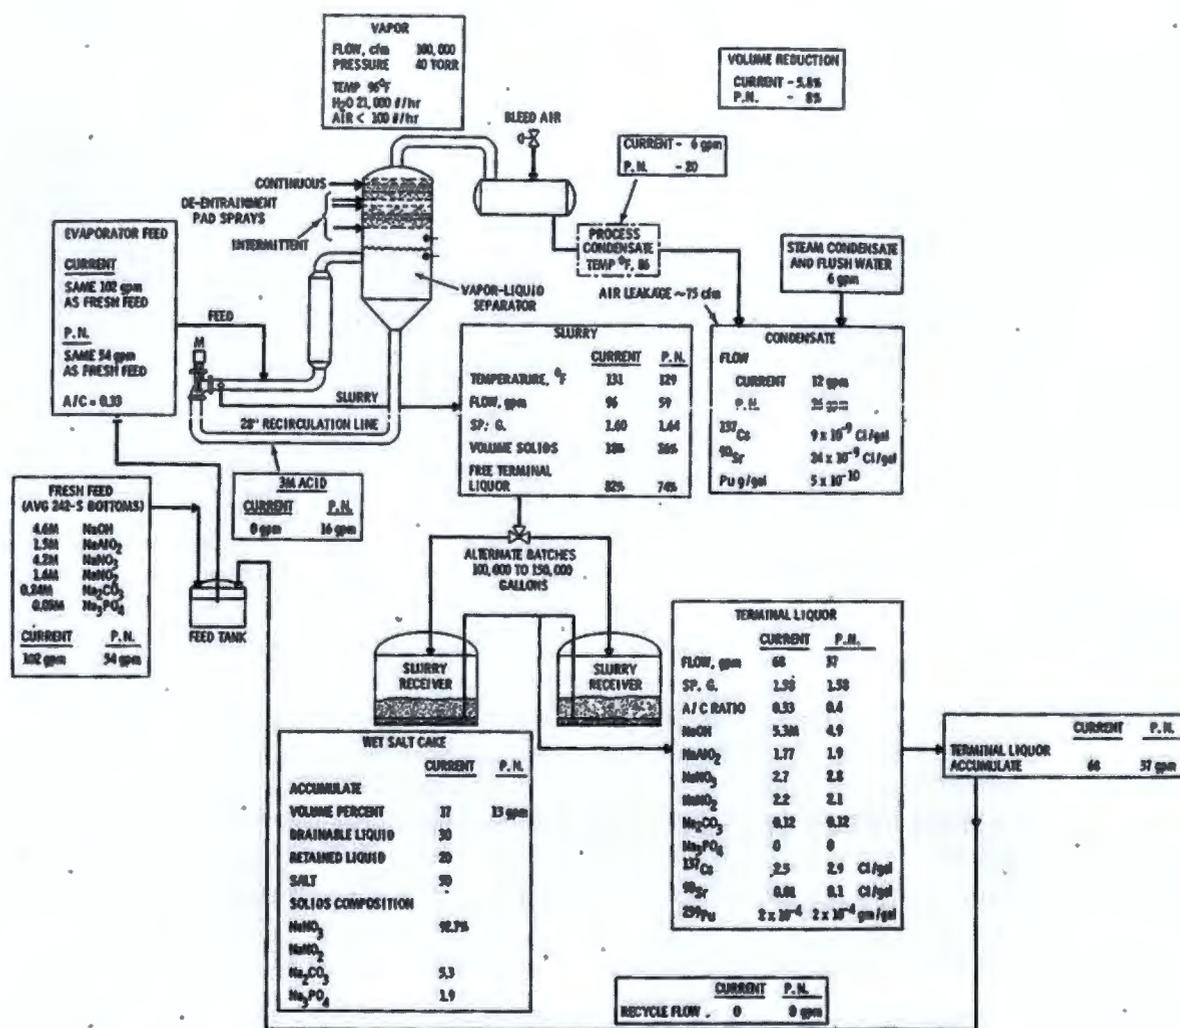
Figure 5-51. 242-S Evaporate Partial Neutralization Flow Diagram

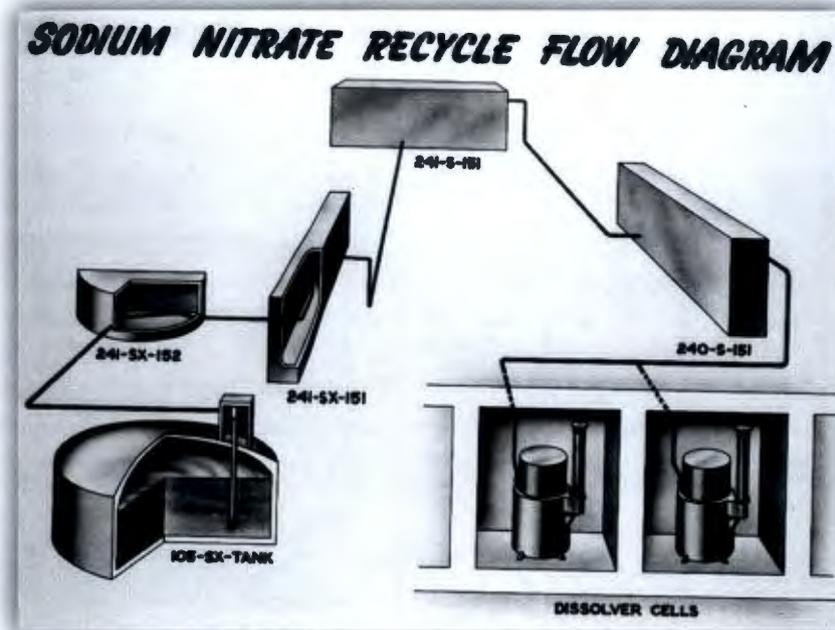
Figure 5-52. Sodium Nitrate Recycle Flow Diagram (IDMS document number 34213-1)

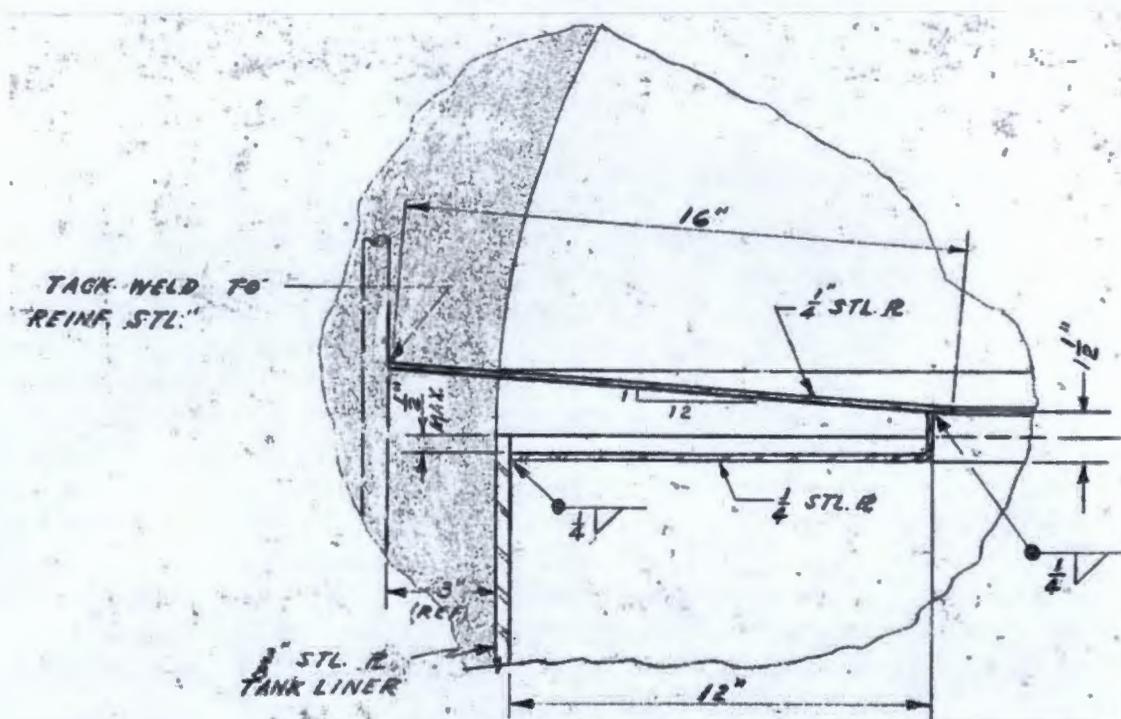
Figure 5-54. 241-SX Tank Liner Top Design

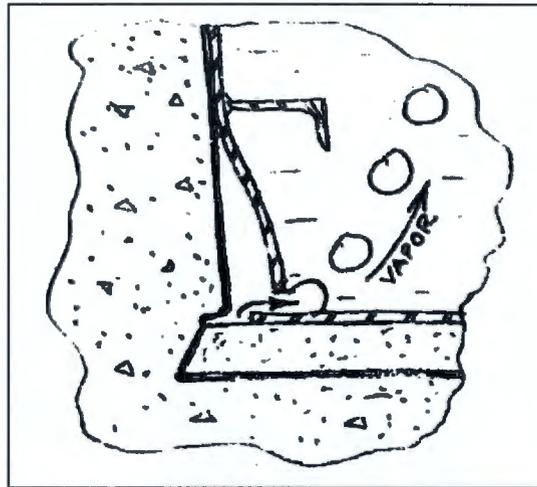
**Figure 5-56. Vapor Escape through Rupture of a Joint
(HW-57274 Fig. 8)**

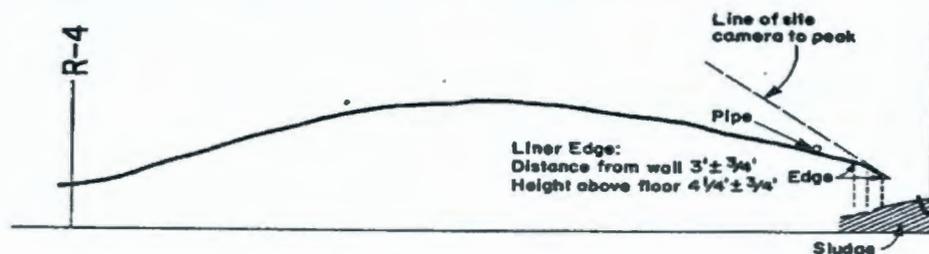
Figure 5-57. Rupture of Liner in Tank A-105 (TRAC-0022)

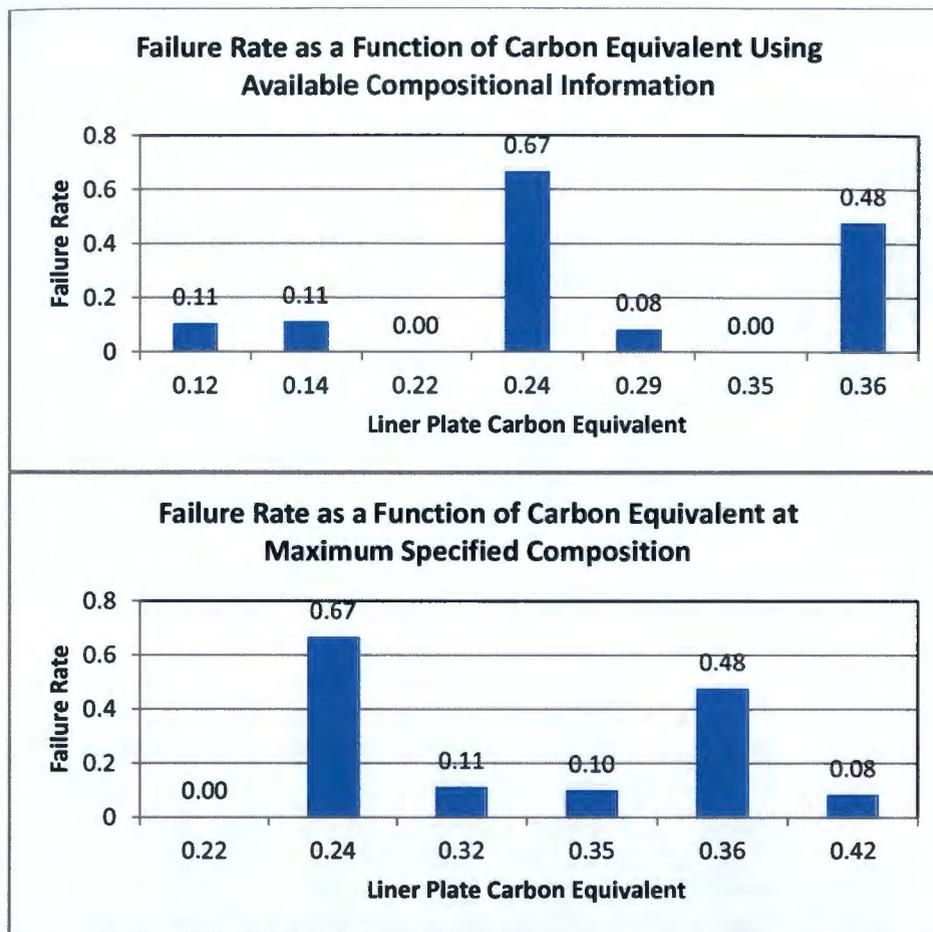
Figure 6-1. Tank Liner Failure Rate as a Function of Liner Plate Carbon Equivalent, with and without Compositional Information

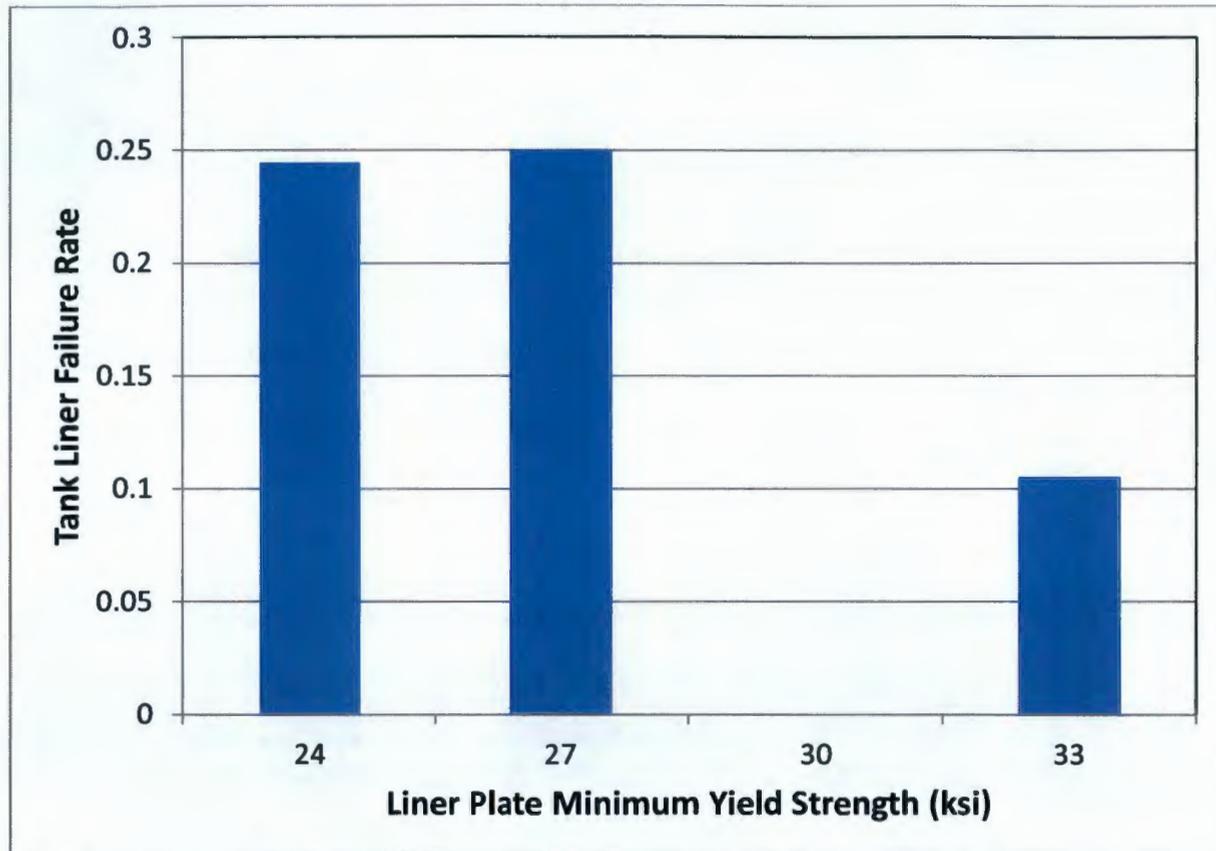
Figure 6-2. Tank Liner Failure Rate as a Function of Liner Plate Minimum Yield Strength

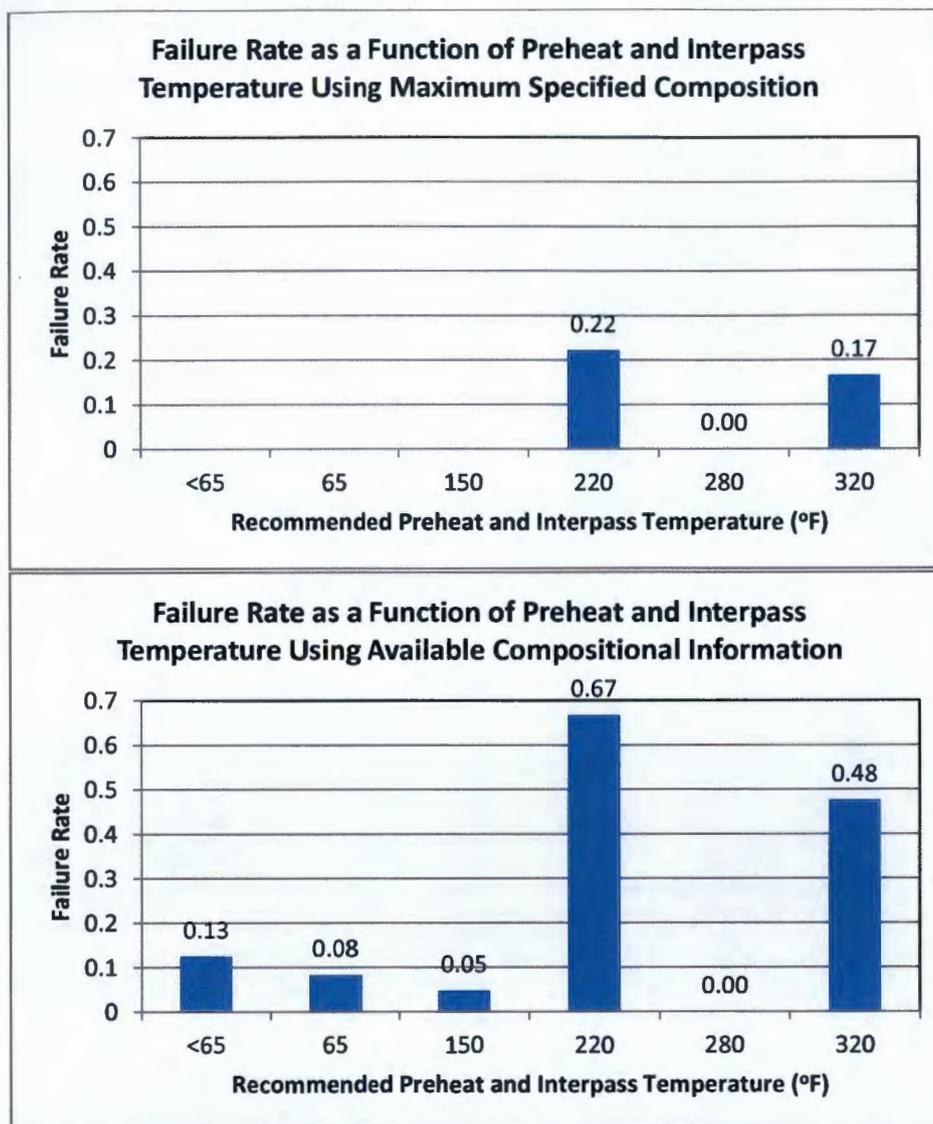
Figure 6-3. Tank Liner Failure Rate as a Function of Preheat and Interpass Temperature, with and without Available Compositional Information
