### D4 Project Soils or Below Grade Structures Deferral Form

SUBJECT: **POST-DEMOLITION SUMMARY REPORT FOR THE 166-N FUEL OIL PUMP HOUSE, 166-N FUEL OIL UNLOADING STATION, AND 1715-N FUEL OIL STORAGE TANKS 1-5**

**Post Demolition Summary Report for the 166-N Fuel Oil  
Pump House, 166-N Fuel Oil Unloading Station,  
and 1715-N Fuel Oil Storage Tanks 1-5**

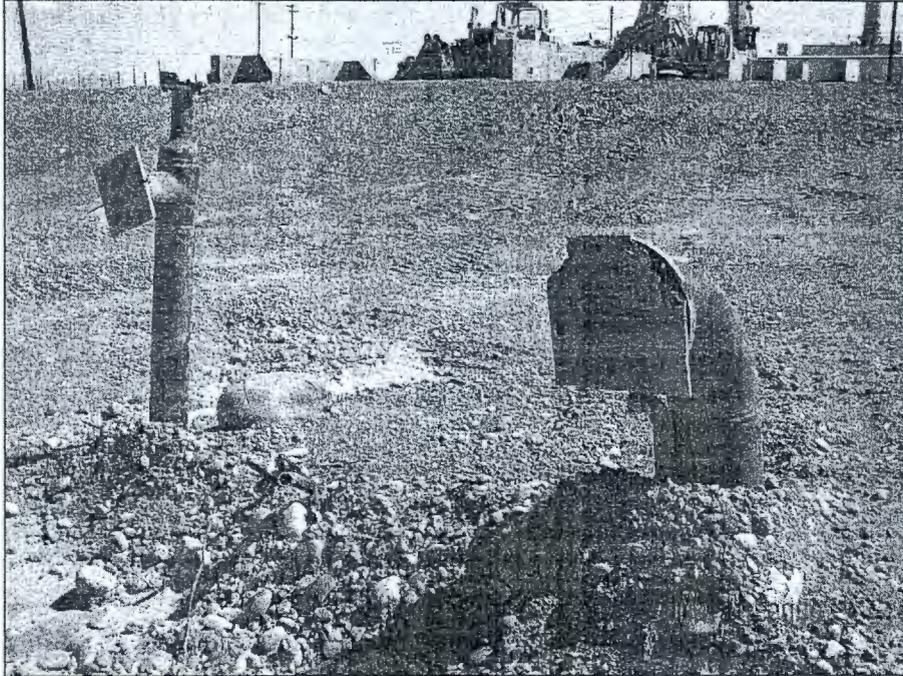
**Figure 7 - 1715-N-5 Fuel Oil Storage Tank After Demo – Pipes Left In Place**

A number of pipes were found to contain significant amounts of fuel oil. These pipes were located and left in place, as agreed to during discussions with Field Remediation (see Attachment 5). The locations of these pipes may be seen on the attached civil surveys. The 8-inch pipe going to the 184-ND fuel oil storage tanks was left with fuel oil mostly filling the pipe. The 12-inch line connecting the 166-N Pump House and the 1715-N-5 tank was left in place with approximately 3-4 inches of oil in the line. The lines were capped and disconnected at valves FOSV-762-2 and FOSV-727-4 (refer to drawing H-1-29300, rev. 17, sheet 1/2). For a picture of these pipes see Figure 7 "1715-N-5 Fuel Oil Storage Tank After Demo - Pipes Left In Place"; the locations of these pipes are documented in Attachment 5, "Civil Survey for 1715-N-5 Fuel Oil Storage Tank - Detail of Vertical Pipe Ends Protruding from Ground".

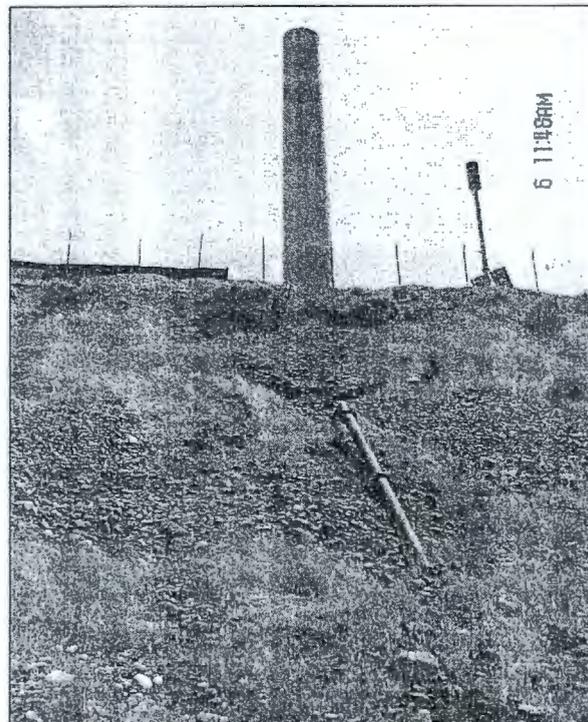
**Figure 8 - 166-N Fuel Oil Unloading Station Pipe Near River Shoreline – Pipe Left  
In Place**

An additional underground pipe was left in place that connects to the 166-N Unloading Station. This pipe is pictured in Figure 8, "166-N Fuel Oil Unloading Station Pipe Near River Shoreline – Pipe Left In Place".
