FROM: M. L. Proctor *mlp*  
Sample Design & Cleanup Verification  
Manager  
H4-22/372-9227SUBJECT: **300-284 SAND BLASTING AREA NEAR 3221 BUILDING FOR REMEDIAL  
ACTION**

## **300-284 SAND BLASTING AREA NEAR 3221 BUILDING REMOVE, TREAT, AND DISPOSE REPORT**

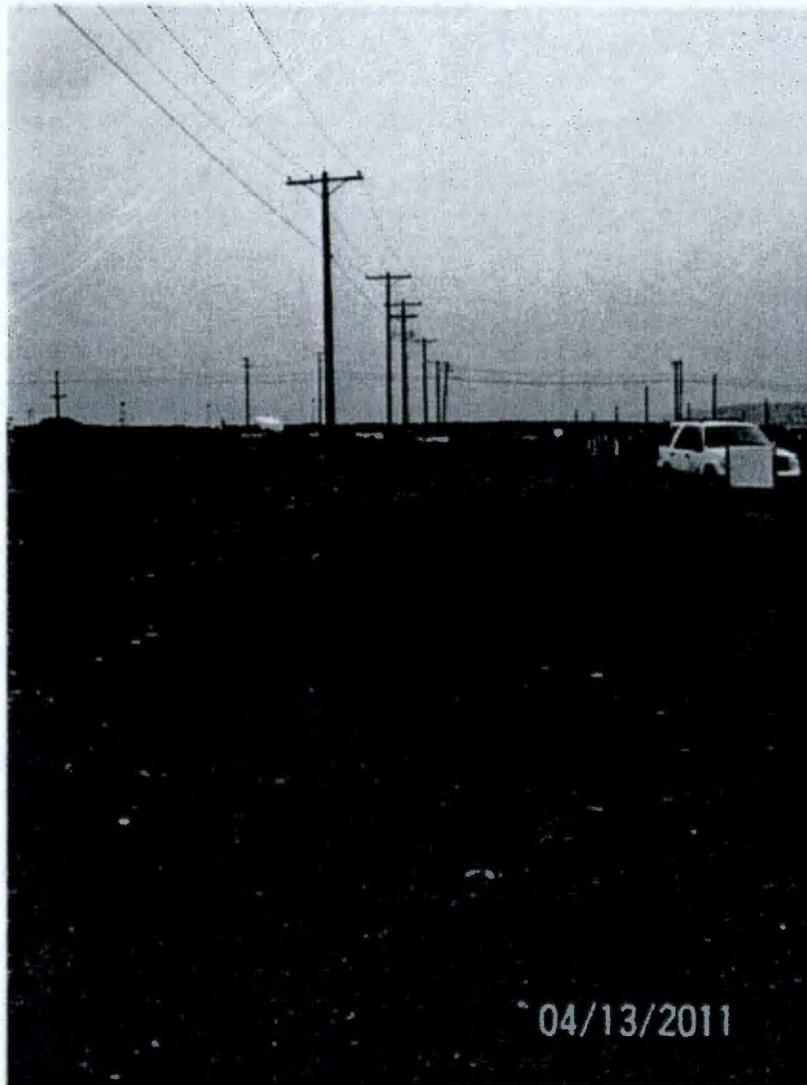
**Figure 4. The 300-284 Waste Site, Looking North  
(April 13, 2011).**

The 300-284 waste site was walked down on April 13, 2011, to assess existing conditions (Figure 4). The waste site was located using WSP coordinates and a global positioning system (GPS) handheld device. There was no evidence of garnet sand on the surface, and the entire site is covered with gravel, most likely as backfill material. The western boundary of the site is bordered by asphalt and overhead power lines, which are visible in the photographs in Figures 3 and 4. The eastern part of the waste site is being used as a road.

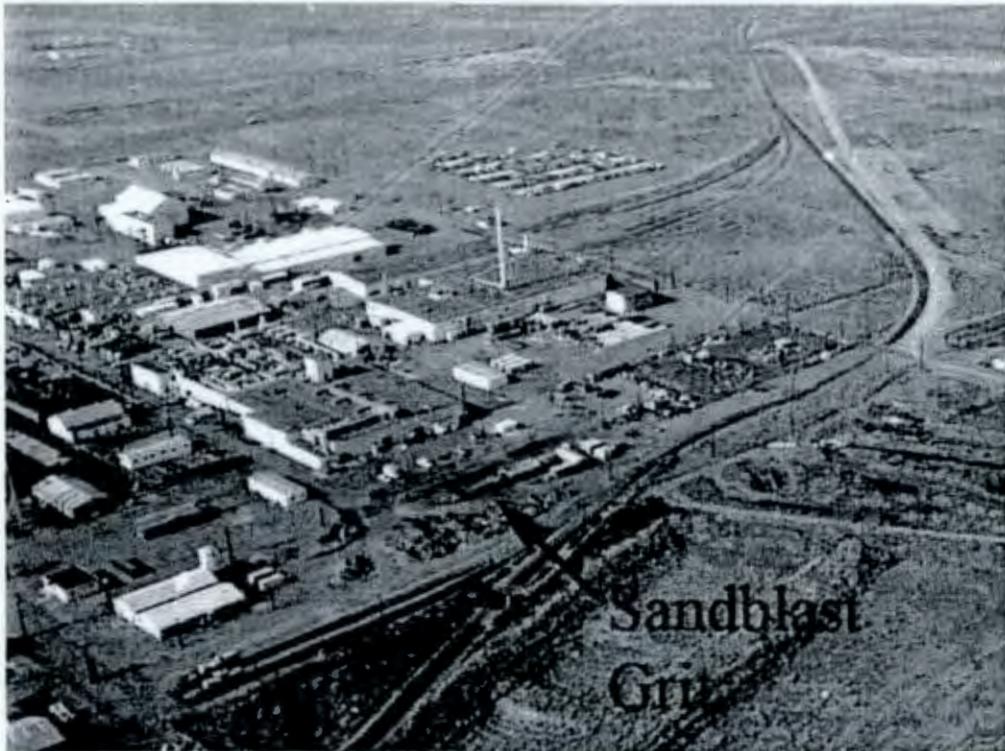
Historical Photo Number: 8604511-47CN

As can be seen in photograph 19861024 [6604511-47CN], the site shows evidence of sandblasting both inside the walled area and outside the walled area, especially to the south and the east.

Description: Red staining is visible in the aerial photograph.
