232Z Demolitions Report

As Left Characterization

Document Type: RPT Program/Project: PFP Closure

Date Published
June 2017

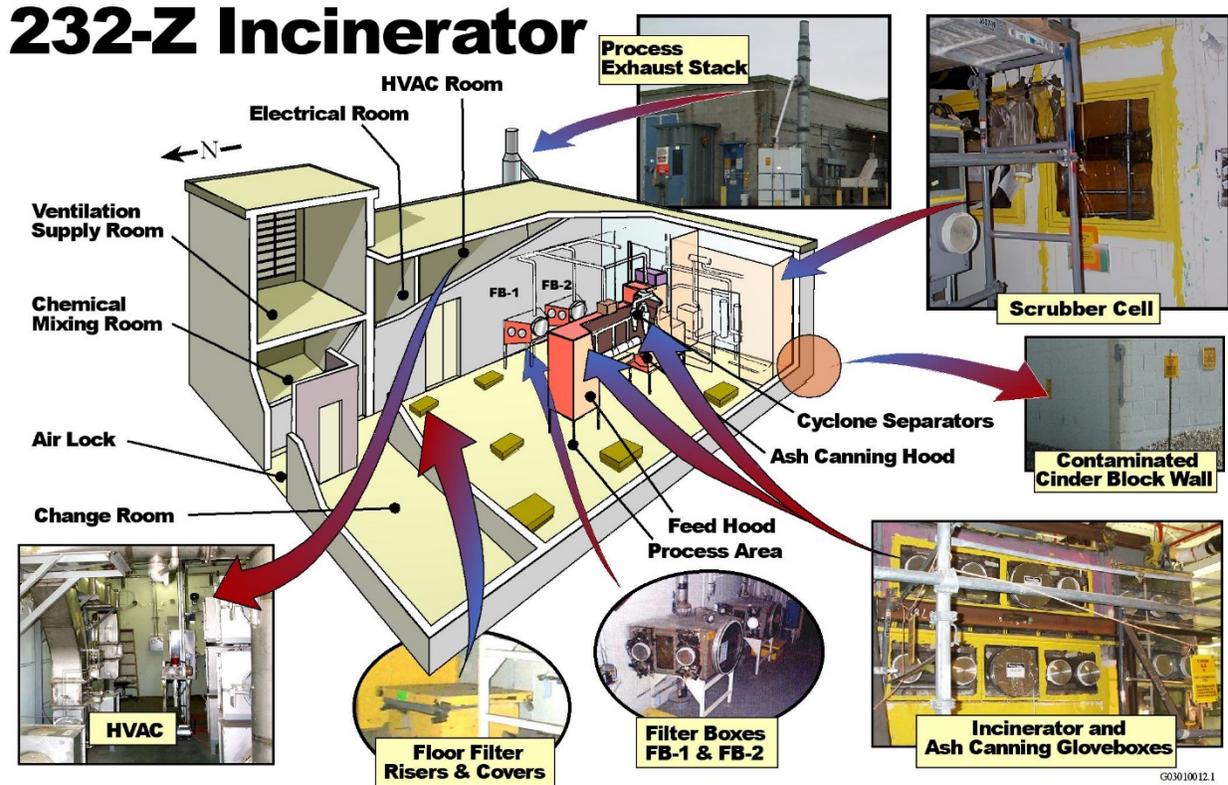
Figure 2. 232Z Building Cutaway

The 232Z Building was designed and built during the late 1950s and early 1960s to house a combustible waste incinerator. The building was approximately 11.3 m (37 ft) wide and 17.4 m (57 ft) long. It is a single story, over the process and storage areas, with two stories over the service areas at the north end. The walls are cinder block construction; the two roofs are 4.6 m (15 ft) and 5.8 m (19 ft), respectively, above-grade. They were constructed of concrete over metal decking with insulation and built-up asphalt covering. The 232Z Building is divided into functional areas, including the Process Room and Chemical Mixing Rooms, and the Storage, Change, Ventilation Supply, and Electrical Rooms (Figure 2).

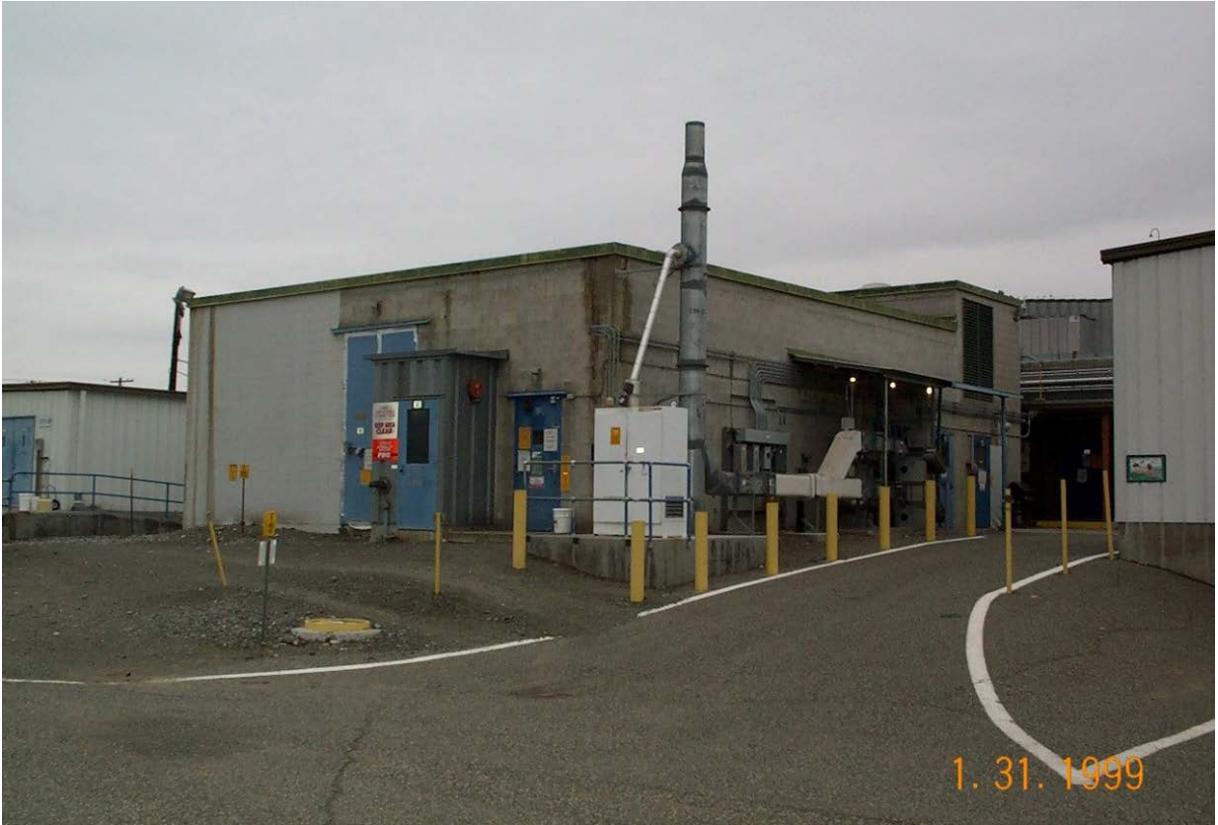
Figure 3. 232Z Building and 296Z014 Stack Before Demolition

Figures 3 and 4 show the 232Z Building and associated 296Z014 stack before and after demolition. Subsequent demolition of the 2736ZB and 2736ZC Buildings is addressed in CWR-PFP-00006, *2736Z Complex Demolition Report*.

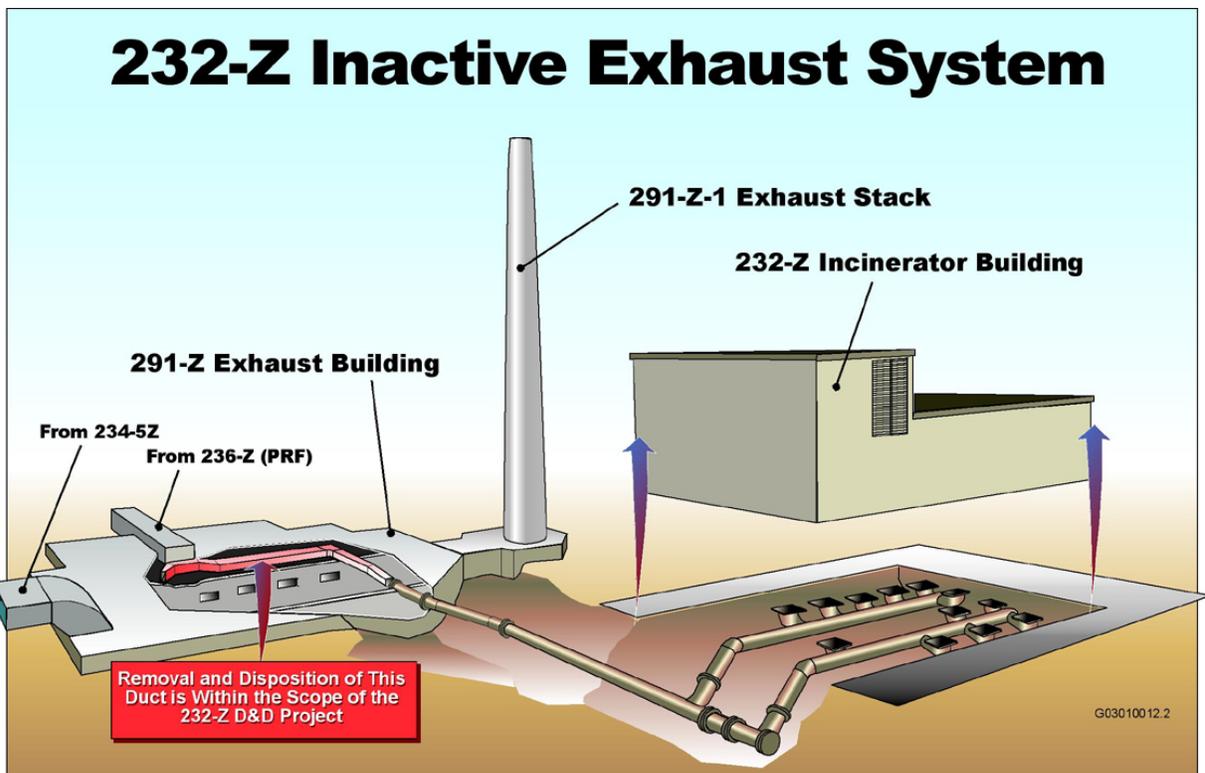
Figure 5. 232Z Inactive Exhaust System

Endpoint completion and associated documentation for 232Z were addressed and compiled in HNF-29916, *232-Z Facility End Points Completion Document*. All applicable endpoints were addressed except for endpoint 17. The final sealing of the slab with material having a 20-year life was deferred to the PFP yard closure. Additionally, while the below-grade ducting from 232Z to 291Z was characterized, isolated, and grout filled up to 291Z, the disposition of the 232Z ducting in 291Z (shown in Figure 5) that was included in the original scope associated with 232Z, was deferred to the PFP removal action per 06-AMCP-0270, "Completion of Hanford Federal Facility Agreement and Consent Order (Tri-Party Agreement) Interim Milestone M-083-40, "Complete Transition and Dismantlement of the 232Z Building Incinerator," due September 30 2006."

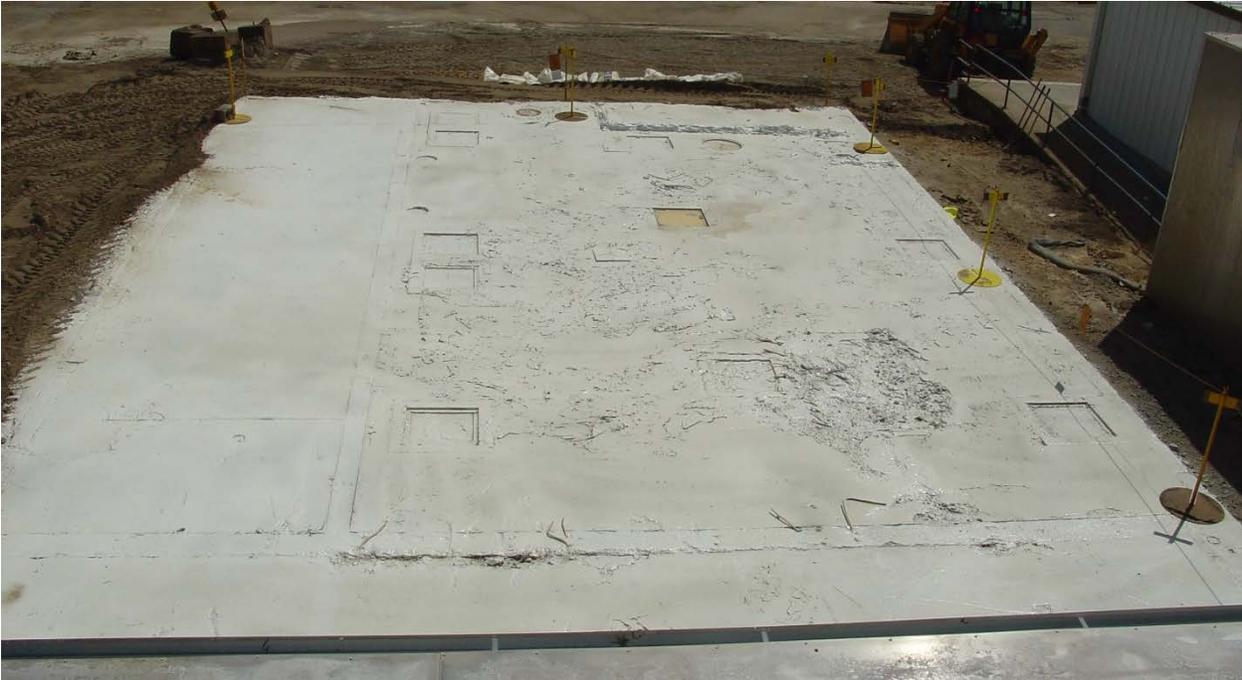
Figure 6. 232Z Slab with Fixative Applied

Fixative was applied to the 232Z Building slab (Figure 6), and it has been covered with gravel (Figure 7).

The 232Z slabs were left with fixative applied and covered with gravel (Figures 5 and 6). Buried line isolations were sealed at the slab boundaries; the below-grade duct between the slab and the 291Z Building was grout filled.
