TS-PIC-89713  
March 1989

# AERIAL PHOTOGRAPHIC ANALYSIS OF ROCKWELL HANFORD OPERATIONS AREA 1100 Richland, Washington

EPA Region 10

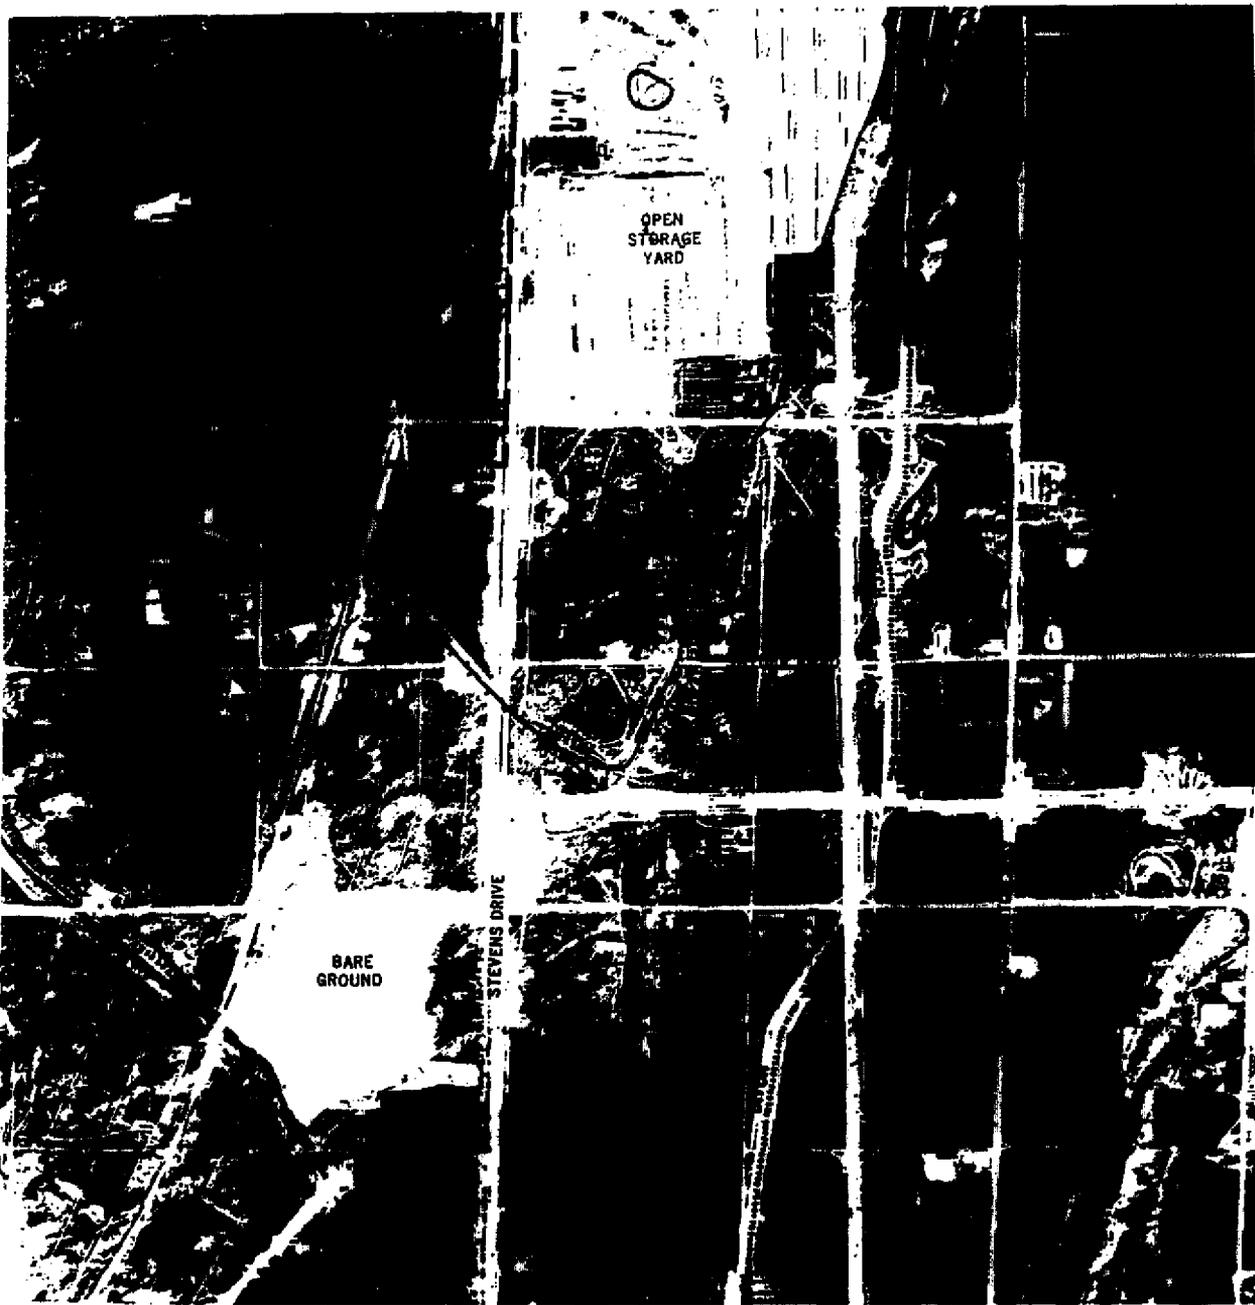
Figure 3. Future location of Rockwell Hanford Operations Area 1100, May 23, 1948. Approximate scale 1:9,500.

9 3 1 9 2 3 1 3 7 0  
The 1948 photograph (Figure 3) shows the southern portion of the future location of the Rockwell Hanford Operations Area 1100; complete photocoverage of this area was not obtainable for this year. The study area is located on the north side of Richland, Washington on a topographic bluff approximately one mile west of the Columbia River. The region was originally farmland as revealed by cropland patterns and orchards. The region was also served by irrigation ditches. The 1948 photograph reveals widespread ground scars from new construction, new roads, and new ditches/channels. A large trench is west of the future study site; however, no waste disposal is visible.

The future study site currently consists of inactive farmland transected by several vehicle trails and unsurfaced roadways. A large open storage yard, on the east side of Stevens Drive contains numerous boxes/crates and construction materials.

Surface drainage flows southwest off the bluff west of Stevens Drive, and flows southeast off the bluff, east of Stevens Drive.
