Annual Meeting Between the U.S. Department of Energy, Office of River Protection (DOE-ORP) and the State of Washington, Department of Ecology (Ecology) to Discuss Interim Measures Completed in Fiscal Year 2013 and Planned for Fiscal Year 2014

(6) Document Title: Interim Surface Barrier Inspection and Maintenance FY2012		(7) USQ No.: R- <input checked="" type="checkbox"/> N/A	
(8) Change/Release Description: Initial release		USQ Evaluator _____ Sign/Date _____

Interim Surface Barrier Inspection and Maintenance FY2012

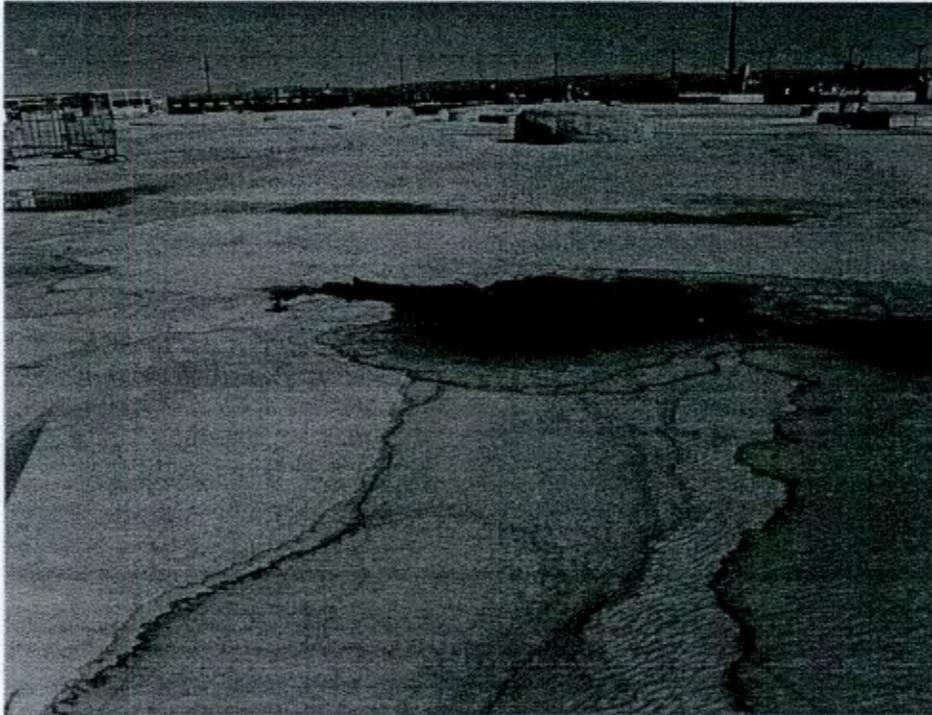
Figure 1. Tears and Delamination Found on the 241-T Tank Farm Barrier.

Abstract: Interim surface barriers (ISBs) are interim measures placed over known areas of underground contamination. The barriers are impermeable surfaces meant to reduce infiltration of meteoric water. Meteoric water (precipitation in the form of rain or snow) is the primary driving force for migration of contamination towards groundwater. Some minor deterioration was detected at the 241-T Tank Farm ISB in March and September 2010, but it was not considered significant enough for corrective maintenance. By the following year deterioration had progressed and a work package was established in August 2011. The repair work was not performed until September 2012 due to temperature restrictions. Figures 1 and 2 are examples of deterioration found on the ISB. Figures 3 and 4 show examples of repairs completed in September 2012. The largest repair was located on the north end of the barrier near tank 241-T-103.

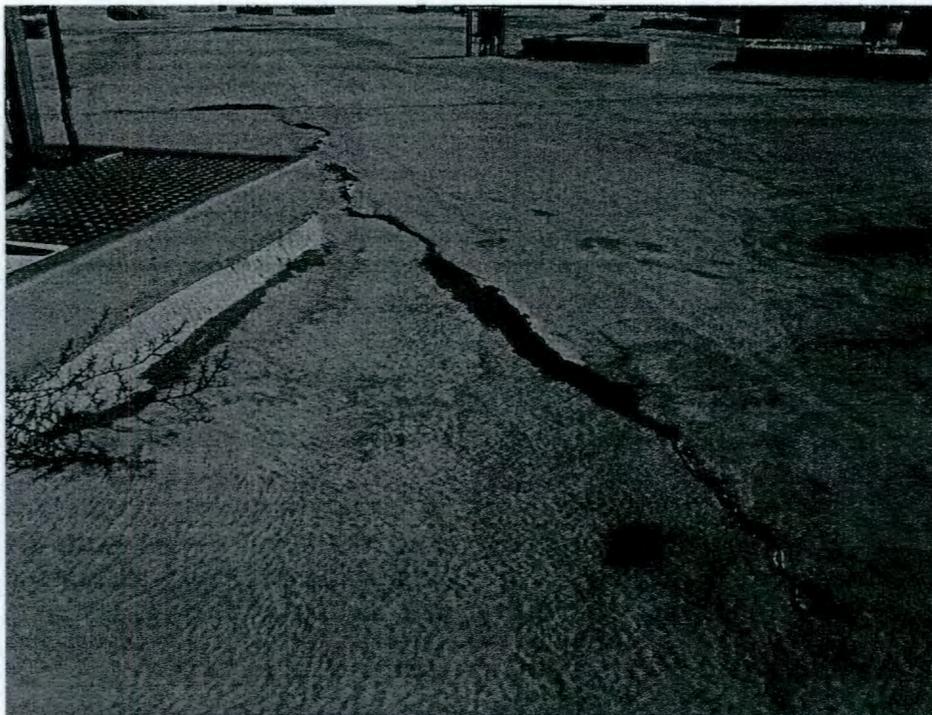
Figure 2. Tears and Delamination Found on the 241-T Tank Farm Barrier.

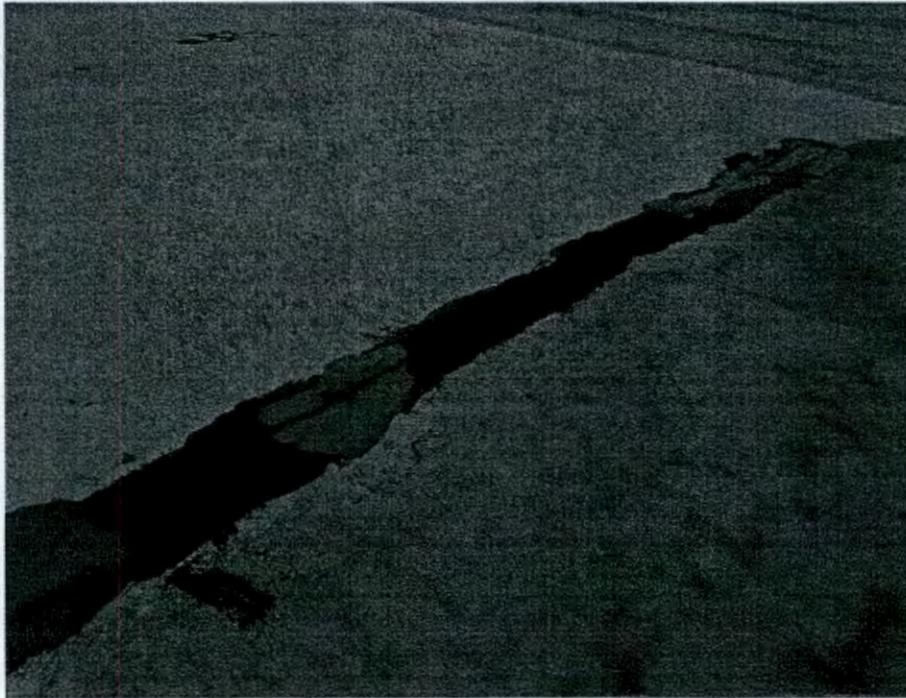
Figure 3. Repair of the Largest Tear Found to Date Located on the North End of the Barrier near Tank 241-T-103.

- Maintenance of T Farm Interim Surface Barrier – In response to a question from Michelle Hendrickson, a paper was provided (RPP-54796, attached) that shows repair of the large tear to the T farm interim surface barrier. About 75-80% of the needed repairs were completed last summer before the weather got too cold. The additional repairs are being done this year. It was requested that the repairs continue to be tracked.
