FACILITY STATUS CHANGE FORM

Date Submitted: 7-28-2014 Originator: Dan Saueressig Phone: 509-521-5326	Area: 100-N Facility ID: 100-N AOC Area 7 Action Memorandum: 100-N Ancillary Facilities	Control #: D4-100N-0064
--	---	-----------------------------------

100-N ANCILLARY FACILITIES REMOVAL ACTION SAMPLING DETERMINATION FORM

Determination Number
SDF-100N-038

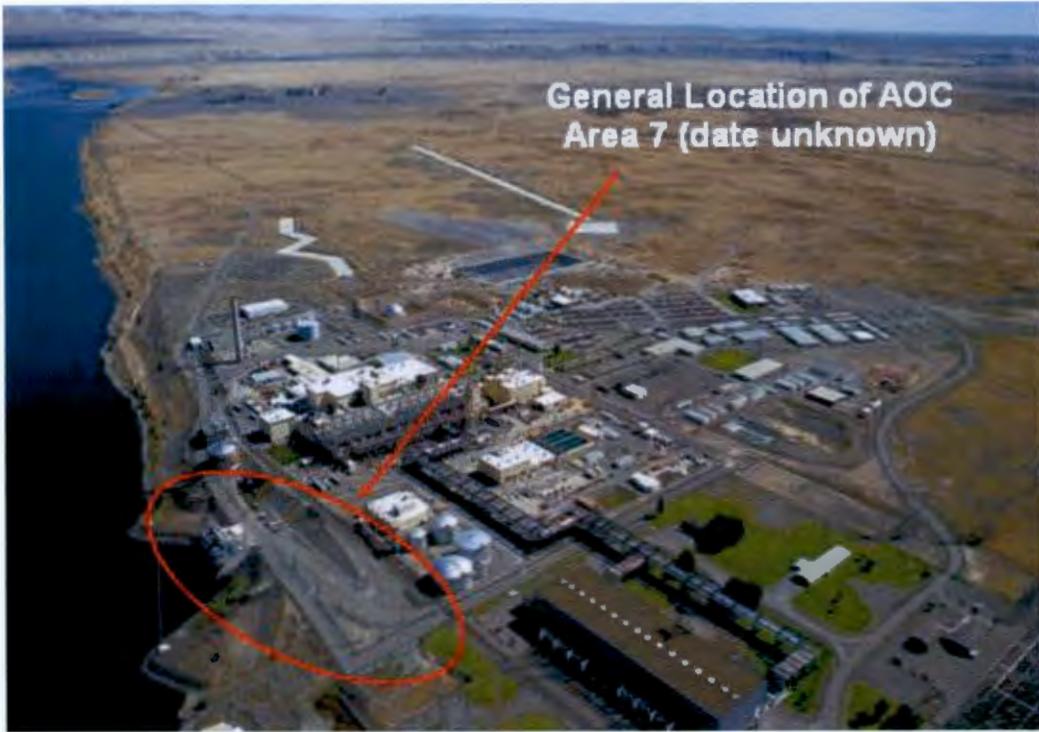
Photo 2. AOC Area 7 at 100-N

General Location of AOC Area 7 (date unknown)

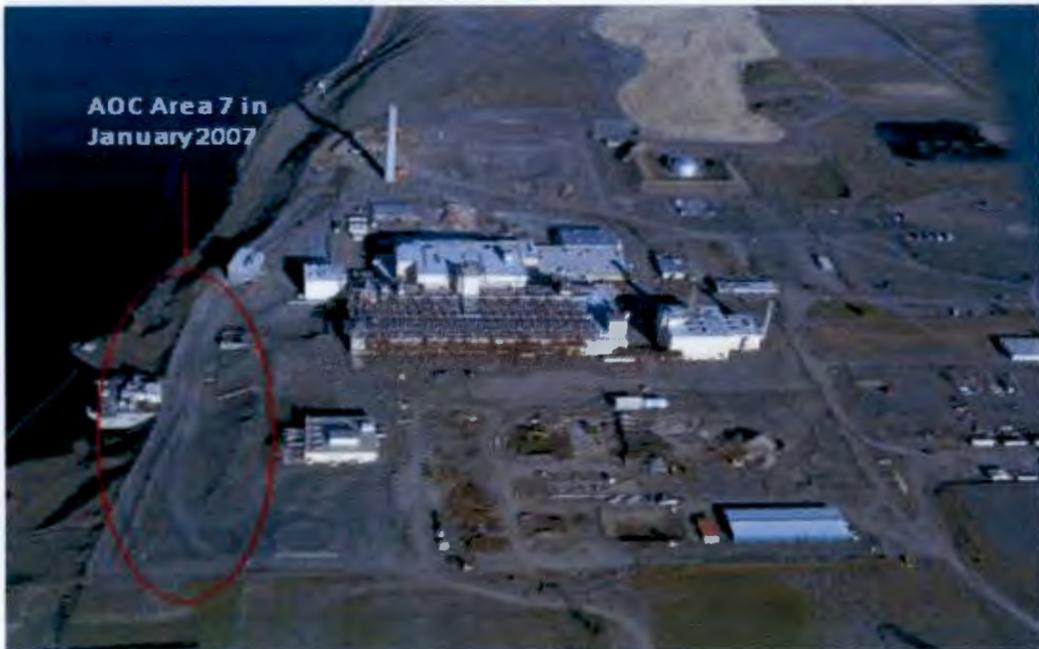
Photo 3. AOC Area 7 in January 2007

AOC Area 7 in January 2007

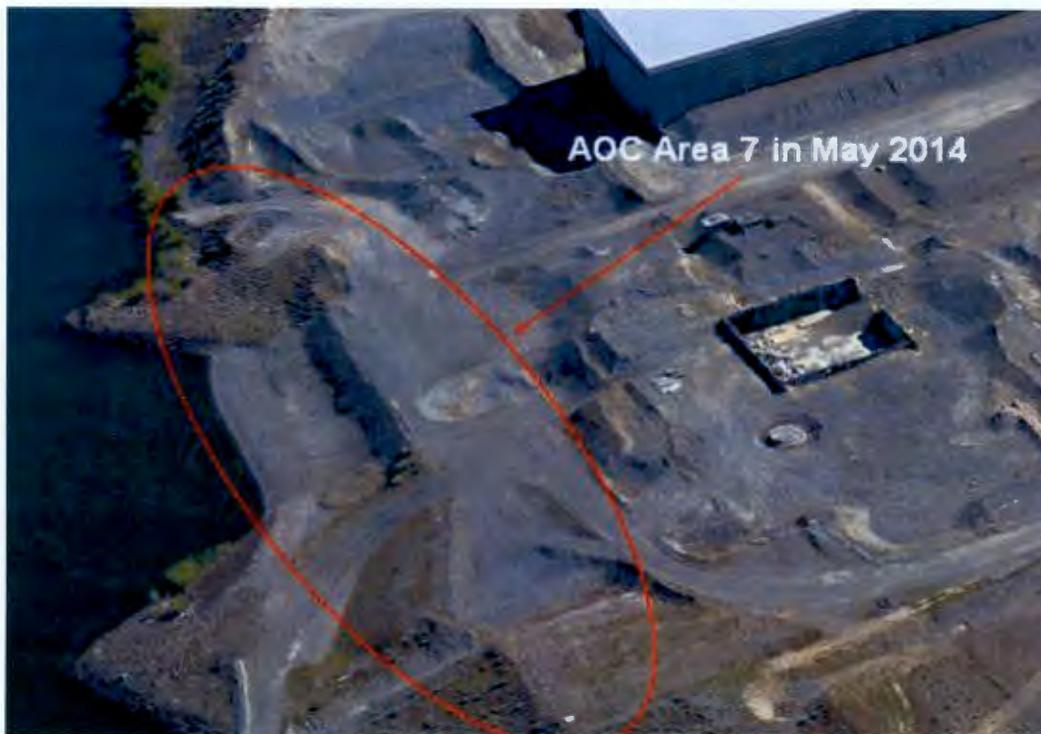
Photo 5. AOC Area 7 in May 2014

The 100-N AOC Area 7 consists of 1 small area on the west (river) side of N Reactor that provided access to the following ancillary facilities; 181-N River Pumphouse, 1908-N Outfall, 1304-N Emergency Dump Tank, 1300-N Emergency Dump Basin and the rear entrance to the 107-N Basin Recirculation Facility. A portion of this area is currently being backfilled and contoured/sloped in preparation for revegetation.

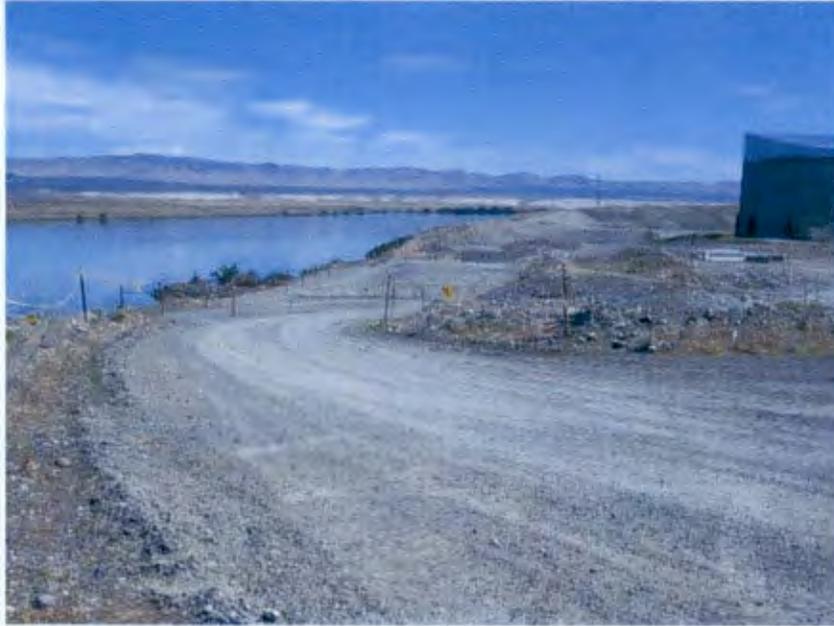
Photo 1. Road Down to AOC Area 7 (facing north)

Mark. I went out to 100-N on Tuesday, inspected AOC Area 7, and took photographs (attached). I didn't see any stains or anomalies. The area looks good. Contact me if you have any questions. Clay

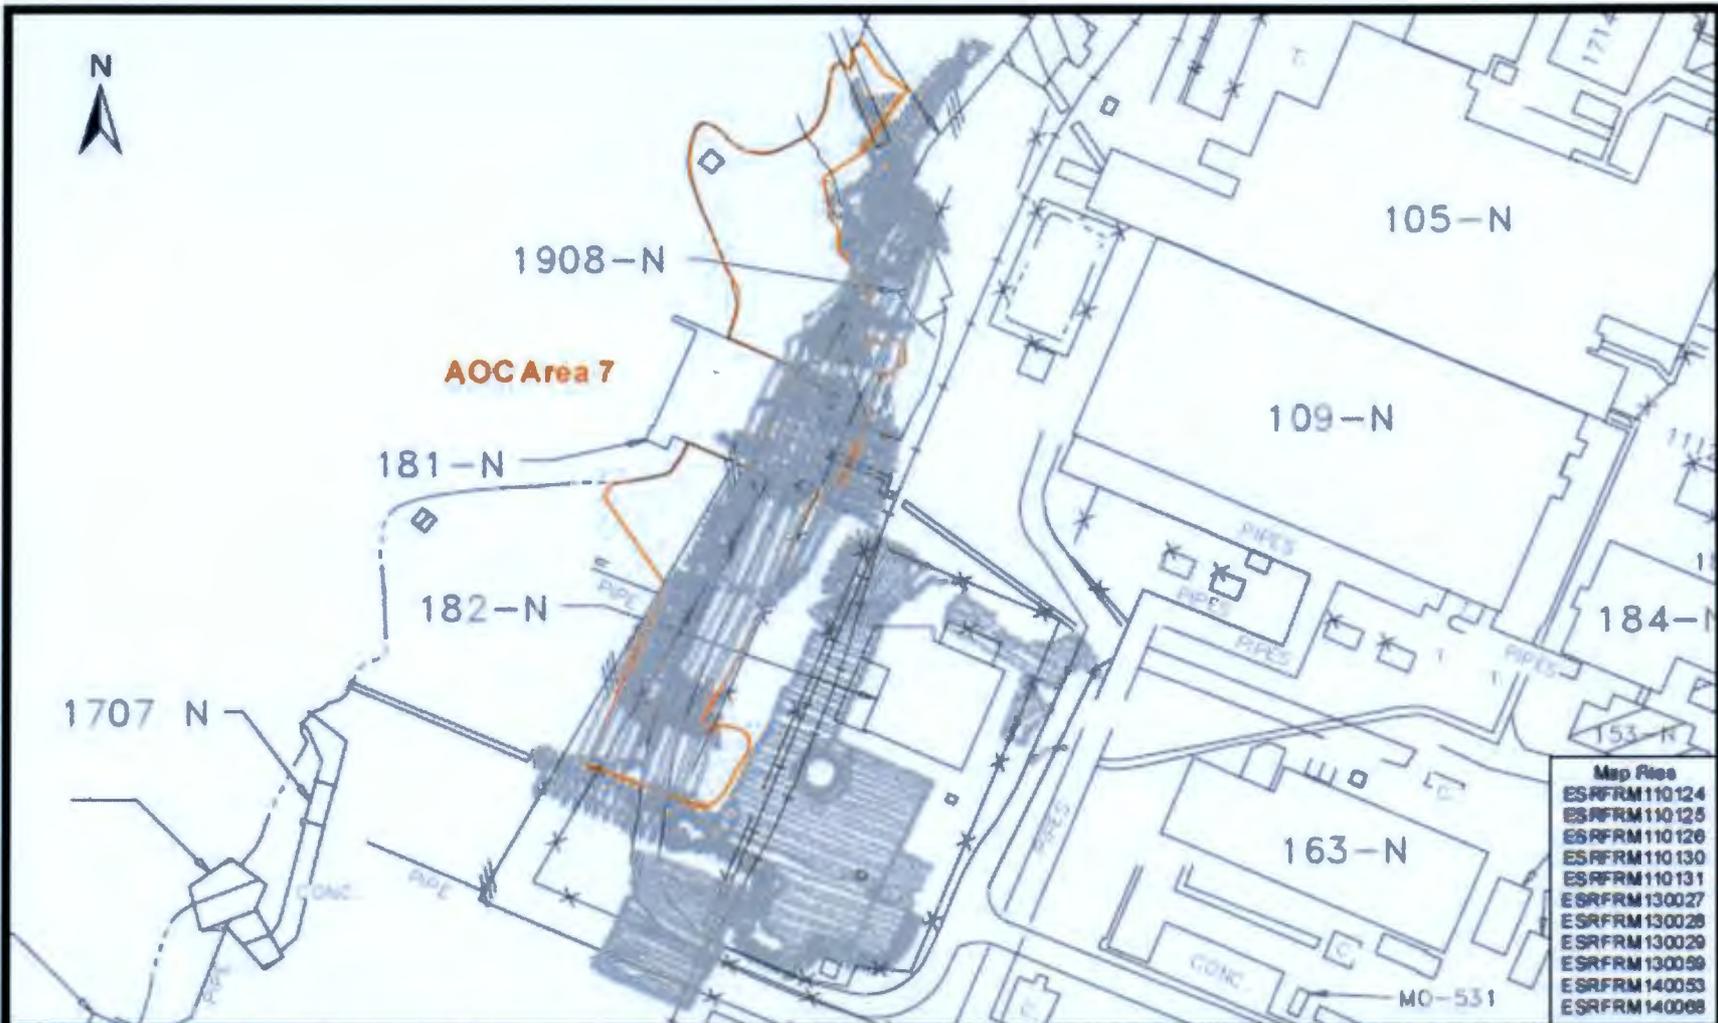
100N
AOC Area 7
GPERS Radiological Survey
Gamma Track Map

Radiological surveys of AOC Area 7 for beta and gamma contamination using GPERS identified no contamination greater than 1.5 x background. Composite diagrams of the surveys are presented in Attachment 4. The entire area was not surveyed due to inaccessible areas (fall hazards or unstable, steep vegetated terrain directly adjacent to shoreline); however, these areas were not used for management of radiological waste and during high river flows many areas were under water. In addition, hundreds of in-process hand held surveys never indicated that radiological contamination was discovered south of the reactor or within the Field Remediation waste sites in AOC Area 7.

Legend		Summary Statistics	
NET CPM		Number of Data Pts: 40,062	
X	<1.5x bkg	Type of Survey: Gamma	
●	1.5x bkg - 5000	Max GCPM: 3,140	
●	5000 - 10000	Avg Bkg CPM: 1,229	
●	10000 - 25000	Survey Dates: 06/01/2011 through 07/18/2014	
●	25000	Area Surveyed: 17,496 m ²	
		Project File: 100N_AOC_70	
		Plot File: 100N_AOC_70_2

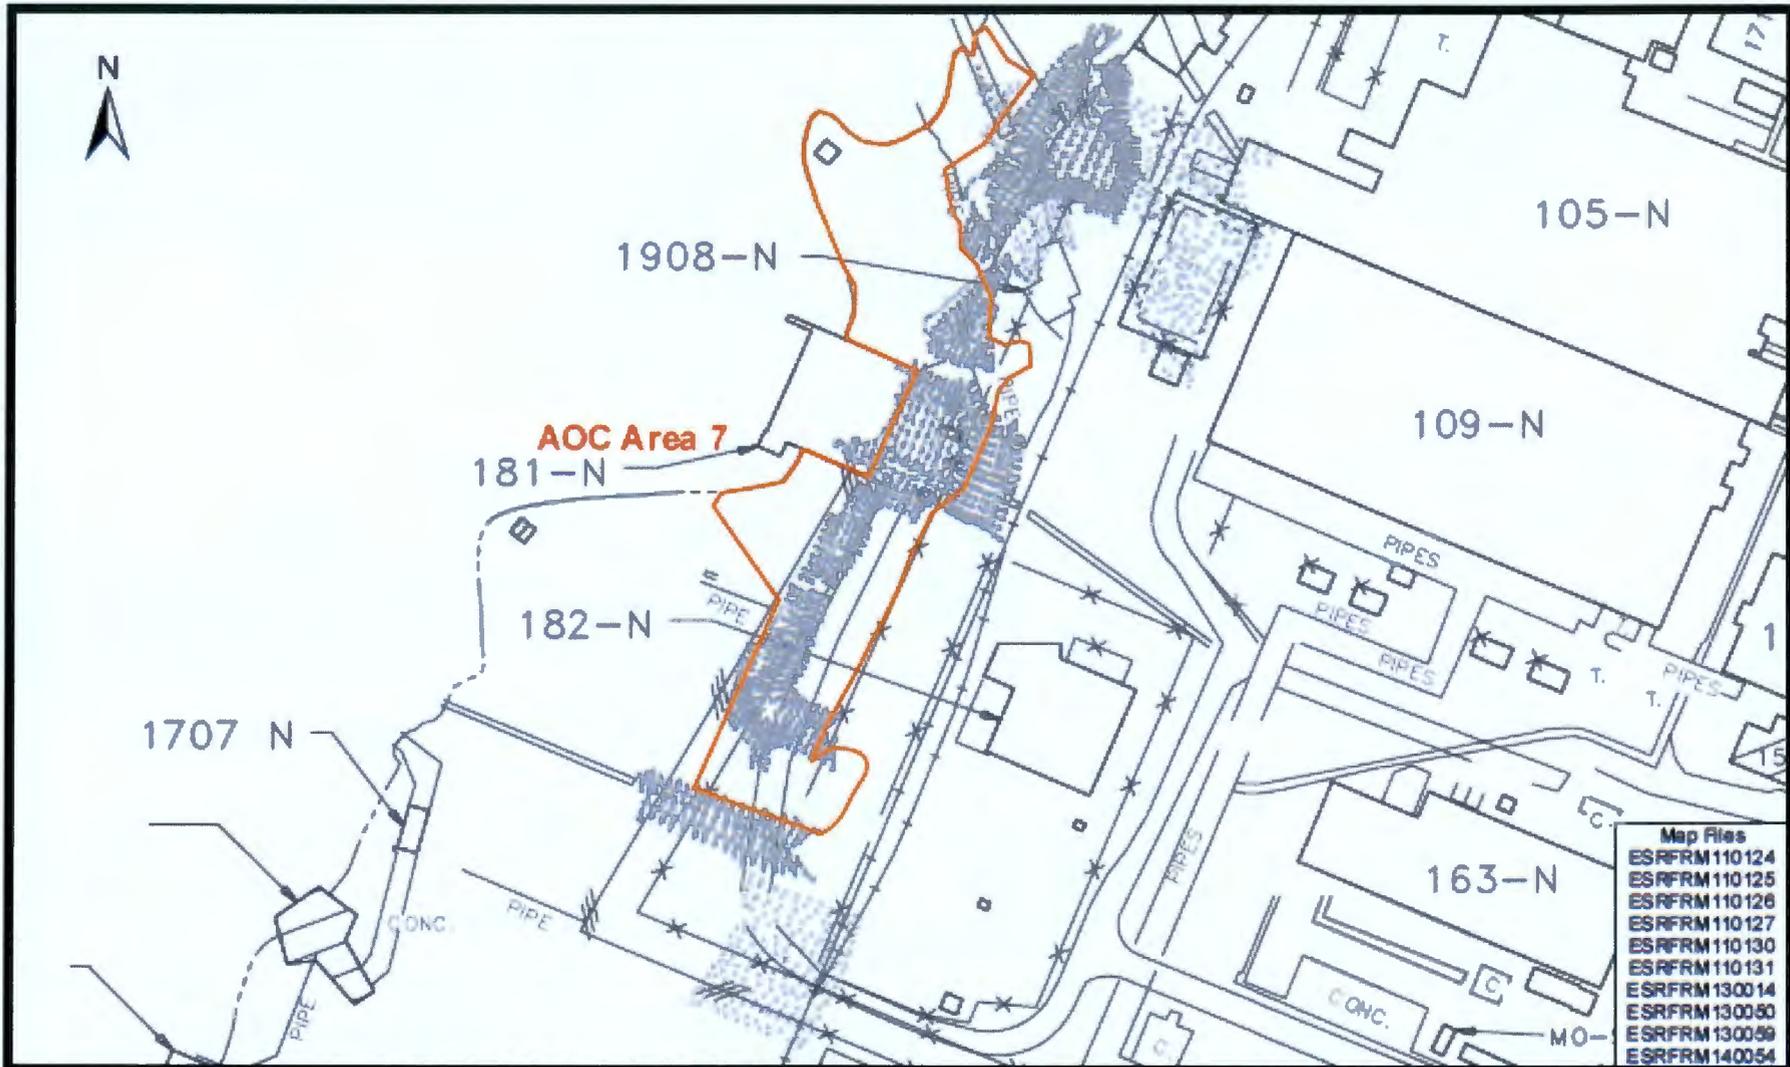
100N
AOC Area 7
GPERS Radiological Survey
Beta Track Map

Legend	Summary Statistics
NET CPM	Number of Data Pnts: 25,653
X <1.5 x bkg	Type of Survey: Beta
● 1.5x bkg - 5000	Max GCPM: 1,167
● 5000 - 10000	Avg Bkg CPM: 394
● 10000 - 25000	Survey Dates: 06/01/2011
● 25000	through 06/03/2014
	Area Surveyed: 8,823 m ²
	Project File: 100N_AOC_7B
	Pdf File: 100N_AOC_7B_1
