### FACILITY STATUS CHANGE FORM

<b>Date Submitted:</b> Jul 19, 2012 <b>Originator:</b> David Warren <b>Phone:</b> (509) 539-6040	<b>Area:</b> 100-N <b>Facility ID:</b> 1908-N Reactor Outfall <b>Action Memorandum:</b> 100-N Ancillary Facilities	<b>Control #:</b> D4-100N-0038
---	---	-----------------------------------

100-N D4 Project Facility Completion Form

## Evaluation of 1908-N Monolith Concrete Sample

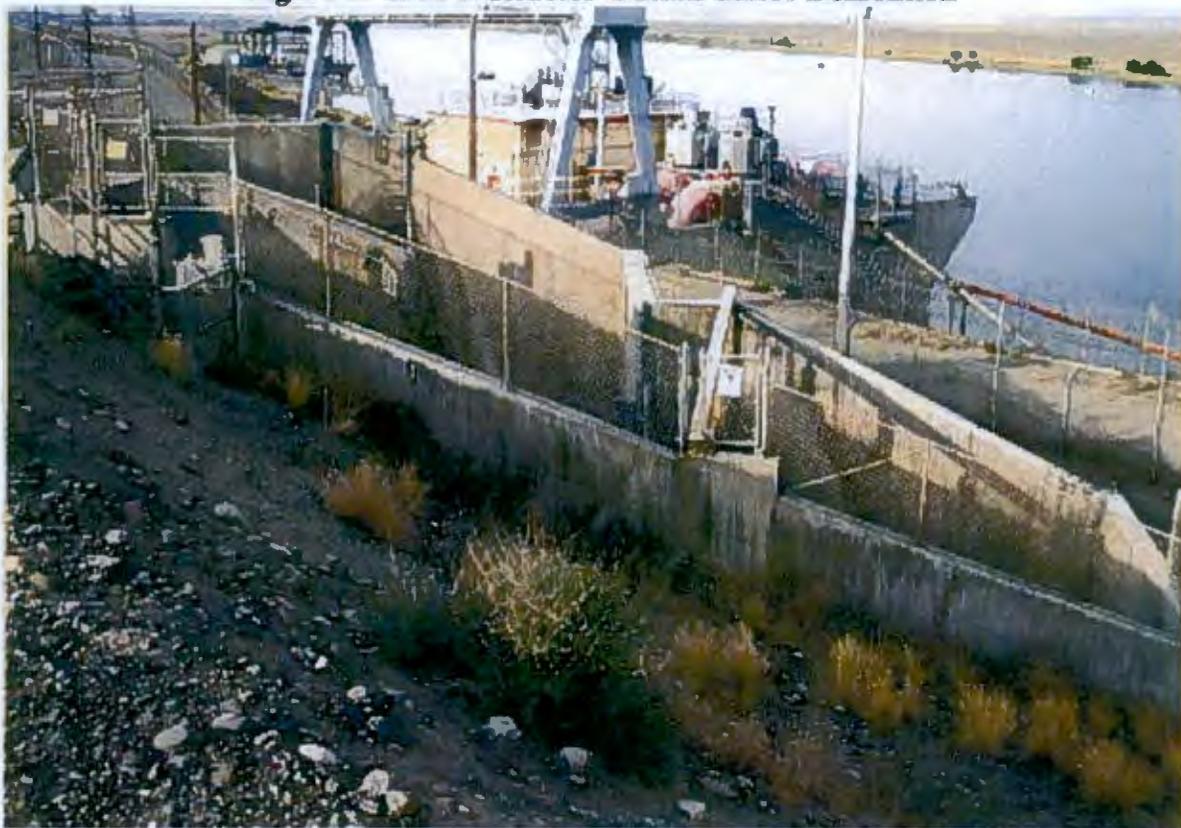
**Figure 1. 1908-N Reactor Outfall before Demolition**

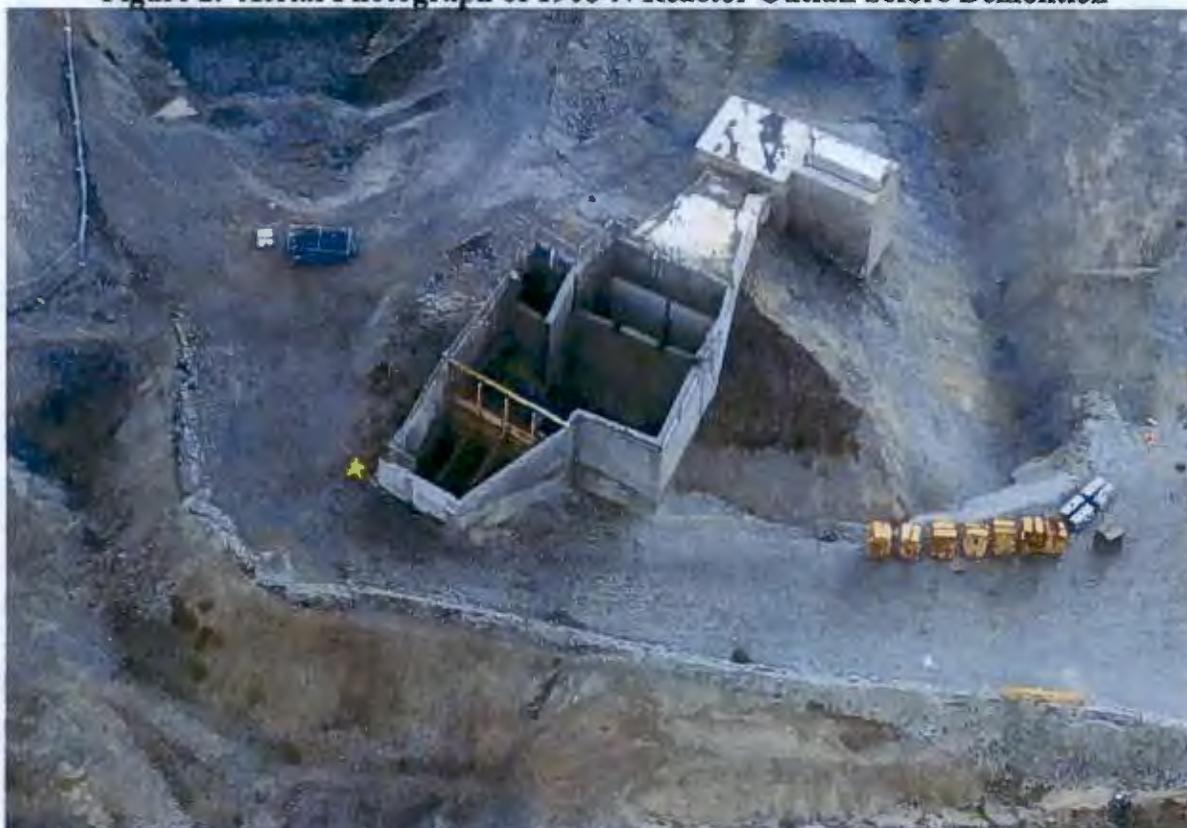
**Figure 2. Aerial Photograph of 1908-N Reactor Outfall before Demolition**

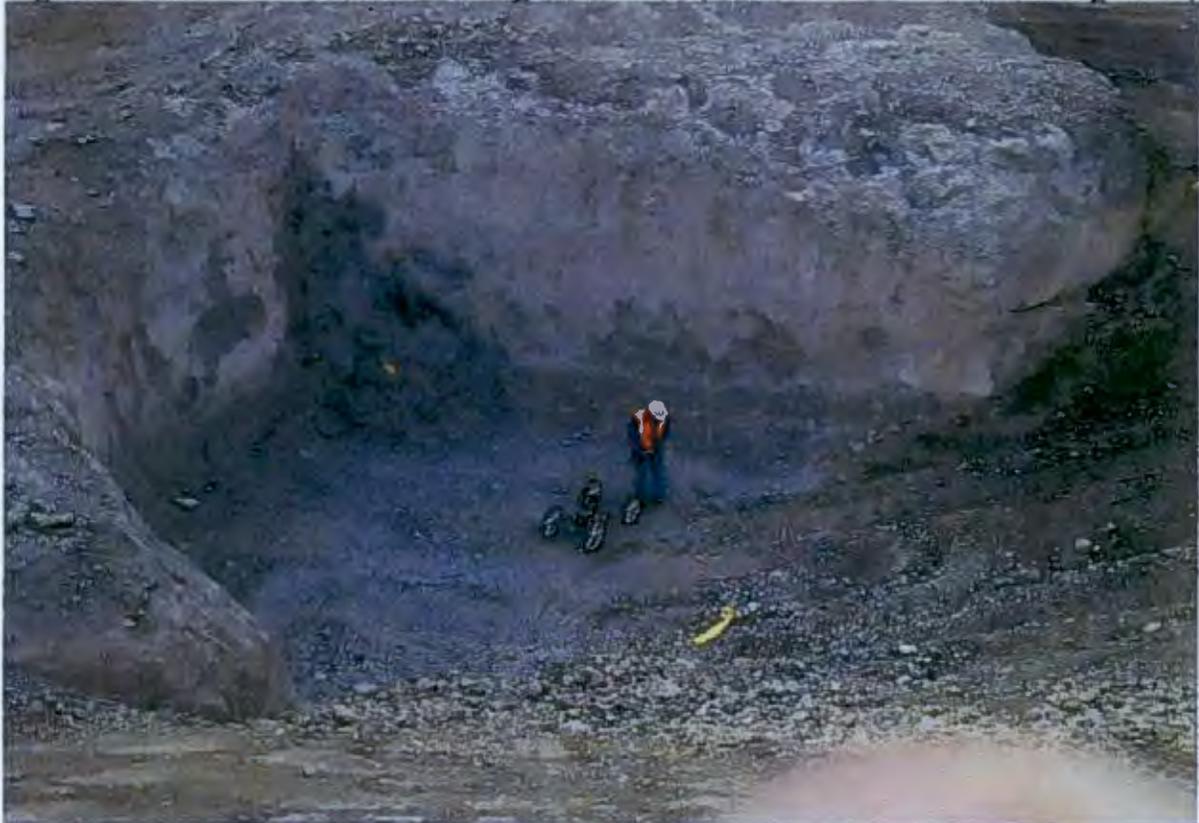
**Figure 3. 1908-N excavation following Demolition (monolith on left and in background)**

There was one anomaly encountered during demolition of the 1908-N facility, that being the lean fill concrete monolith base that the structure was constructed upon. In consultation with the Department of Ecology, the monolith was sampled and analyzed and it was subsequently determined that it did not contain any contaminant in sufficient concentration to threaten the groundwater or the Columbia River. As a result of this analysis and determination, the Washington State Department of Ecology provided approval of leaving the monolith in place (See Attachment 5 CCN 166186).

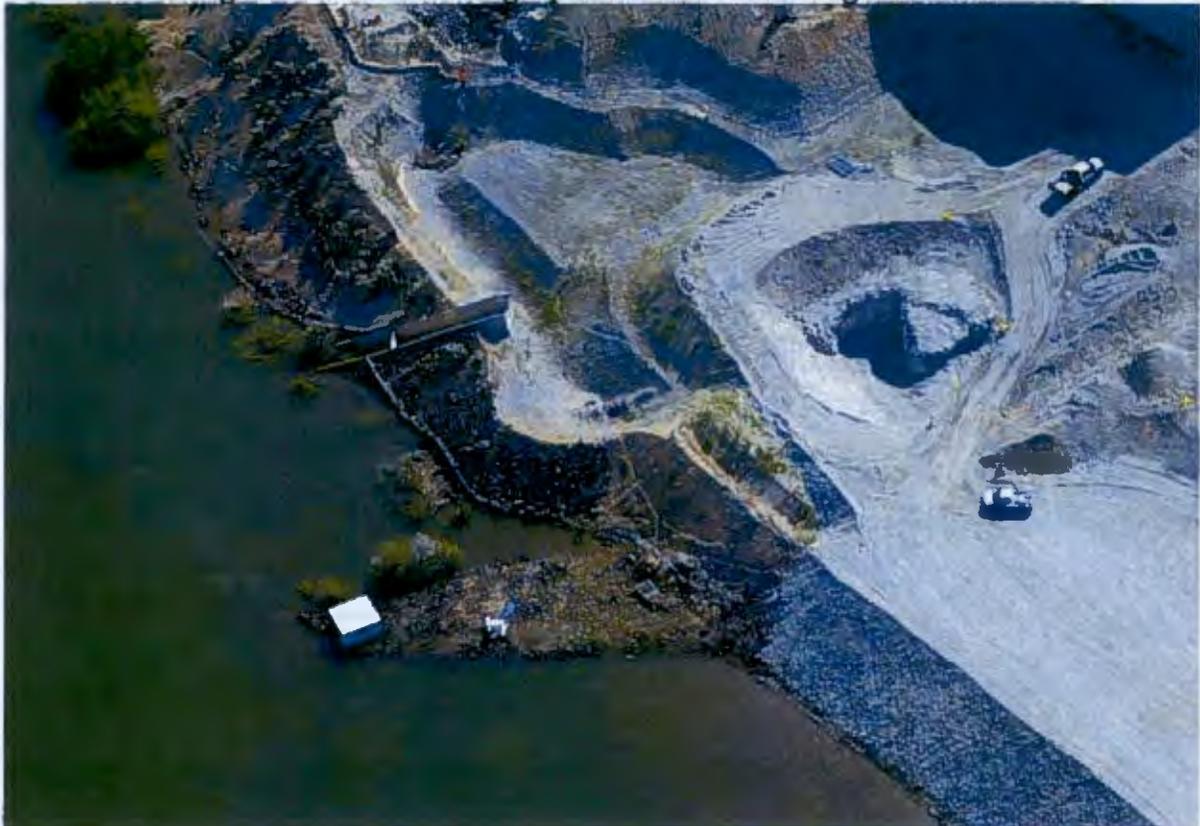
**Figure 4. Aerial Photograph of 1908-N following Demolition**

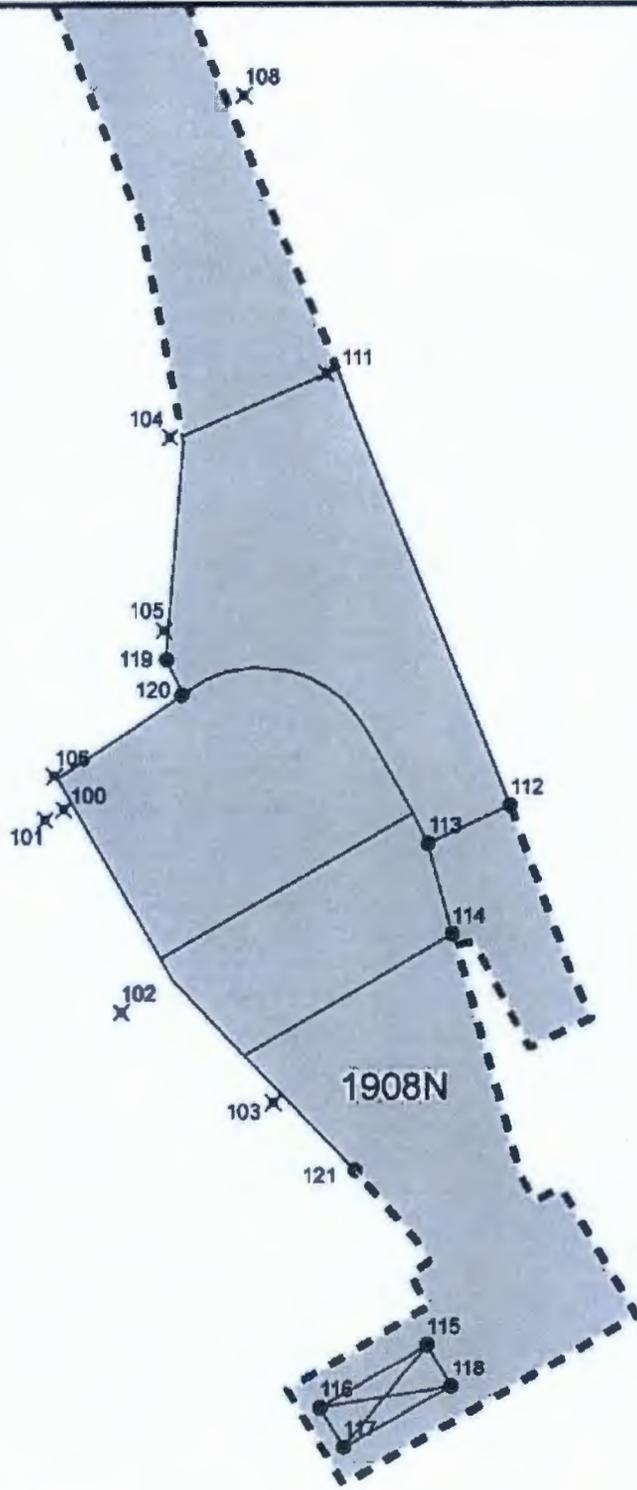
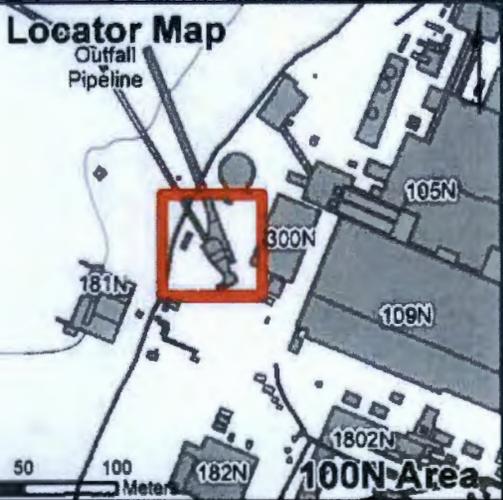
## GPS Pre Demo Report For 1908N

- x GPS Point Locations
- GIS Derived
- Building Location (Pre Demolition)
- - - 1908N Below Grade

US State Plane 1983; Zone: Washington South 4802;  
NAD83, NAVD88; Units are in Meters  
Elevation Data Derived from 2008 LIDAR Data

Pre- and post-demolition Global Positioning System (GPS) survey(s) of 1908-N were performed in June of 2012. All surveys are included in Attachment 4.

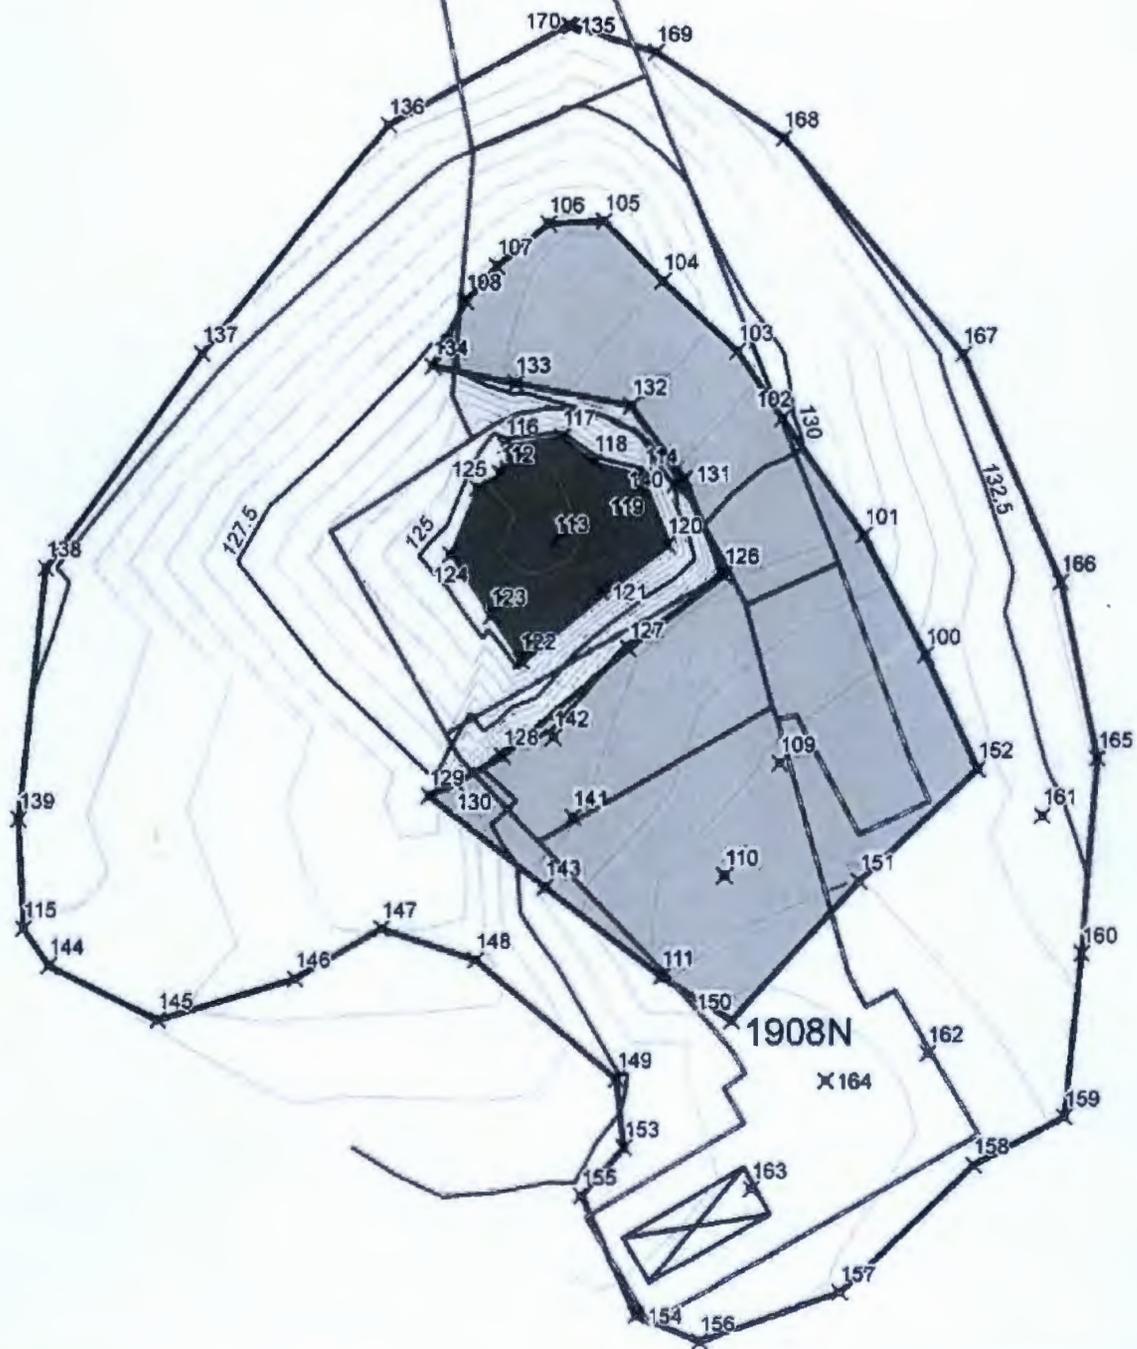
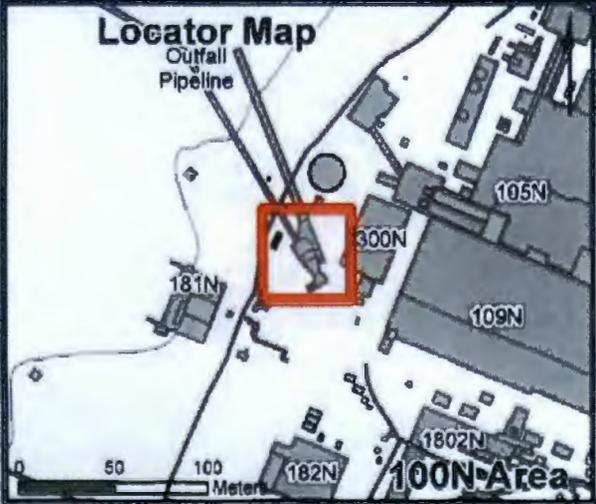
## GPS Post Demo Report For 1908N

US State Plane 1983; Zone: Washington South 4802;  
NAD83, NAVD88; Units are in Meters

- x GPS Points (See Survey Report for Point Details)
- Major Contour 2.5m
- Minor Contour .5m
- Excavation Toe
- Excavation Daylight
- Monolith
- - - 1908N Below Grade (Pre Demolition)
- Building Location (Pre Demolition)

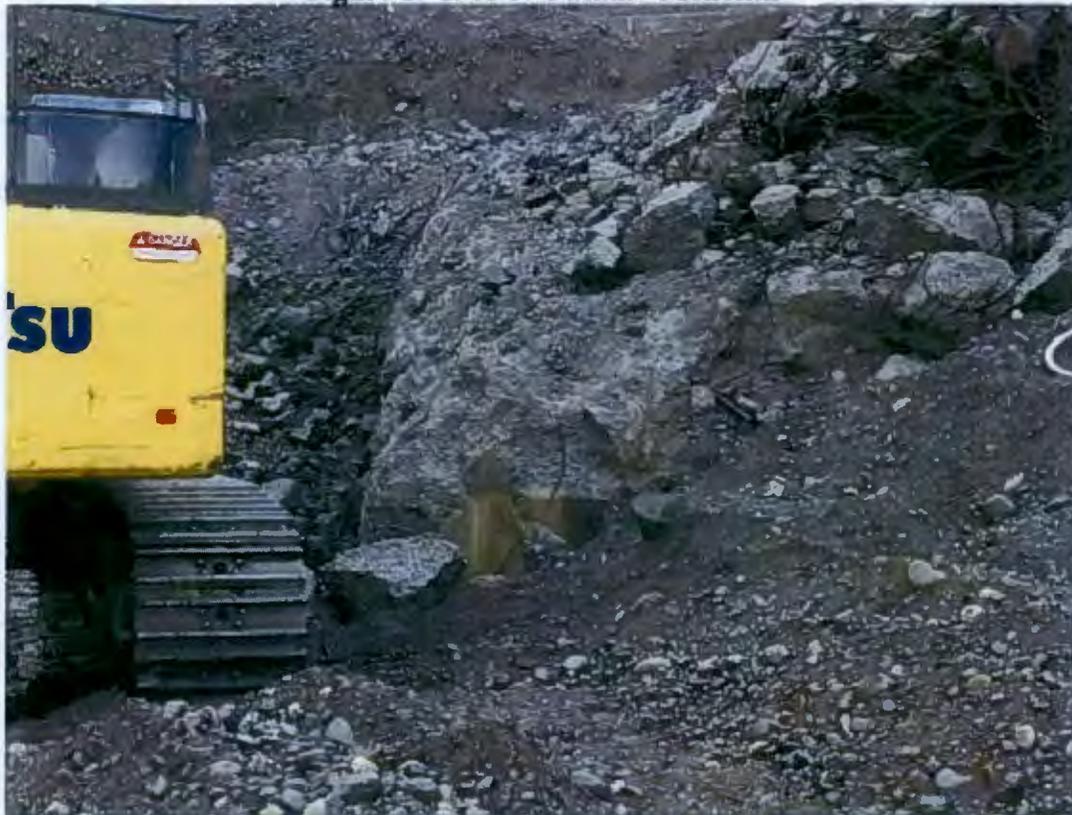
On April 26, 2002, a sample of concrete was collected from the 1908-N concrete monolith that remains after demolition of the 1908-N Outfall structure (Figure 1). The sample was chipped from the monolith and submitted for laboratory analysis to evaluate potential contaminant concentrations and make a decision concerning whether or not this material may remain in place or requires removal as provided in the *Removal Action Work Plan for 100-N Area Ancillary Facilities* (DOE-RL 2012). The concrete sample was collected in accordance with ENV-1, *Environmental Monitoring & Management*, to fulfill the requirements of the *100-N Area Remedial Action Sampling and Analysis Plan for CERCLA Waste Sites* (SAP) (DOE-RL 2006a).

Figure 1. 1908-N Outfall - Monolith

Evaluation of the results provided in Table 3 indicate that all COPCs were either undetected or were quantified below remedial action goals (RAGs) and soil lookup values with the exception of copper and zinc which were detected above the soil RAGs for protection of the Columbia River. However, based on RESRAD modeling discussed in Appendix C of the 100-N Area RDR/RAWP (DOE-RL 2006b), residual concentrations of copper and zinc are not predicted to migrate more than 3 m (9.8 ft) in 1,000 years, based on copper, having the lowest partitioning coefficient, 22 mL/g. The vadose zone underlying the concrete monolith at the 1908-N outfall is approximately 4.4 m (14.5 ft) thick. Therefore, residual concentrations of copper and zinc are predicted to be protective of groundwater, and thus, the Columbia River.

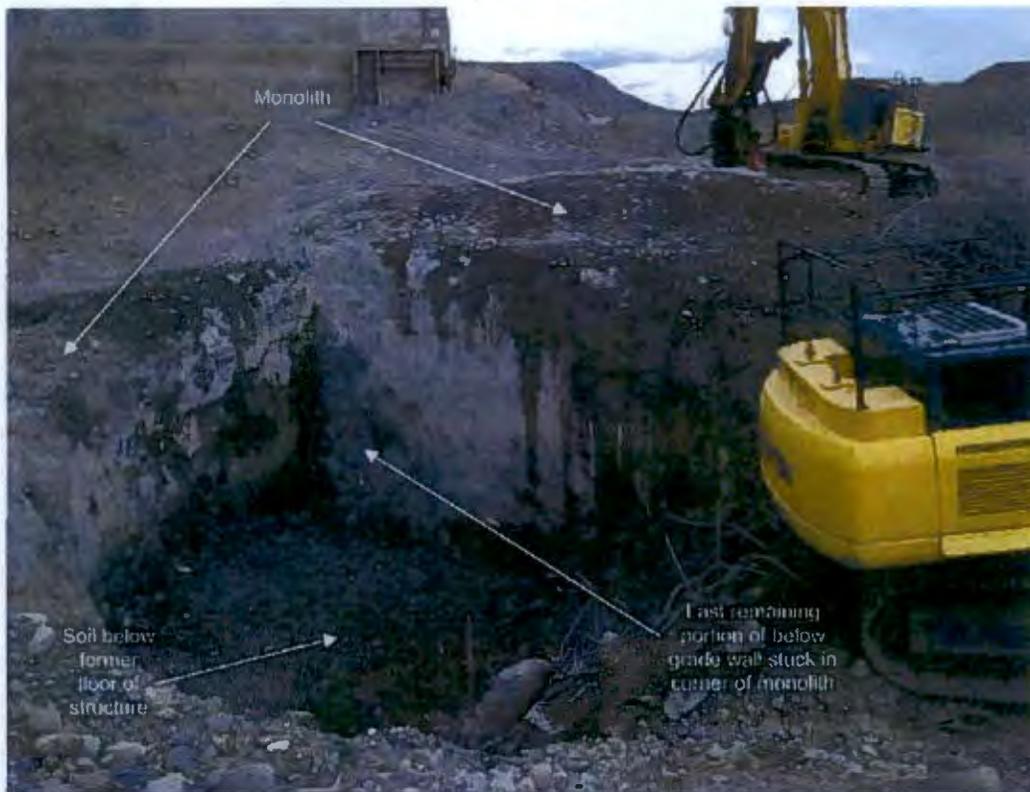
View of monolith below grade (facing east).

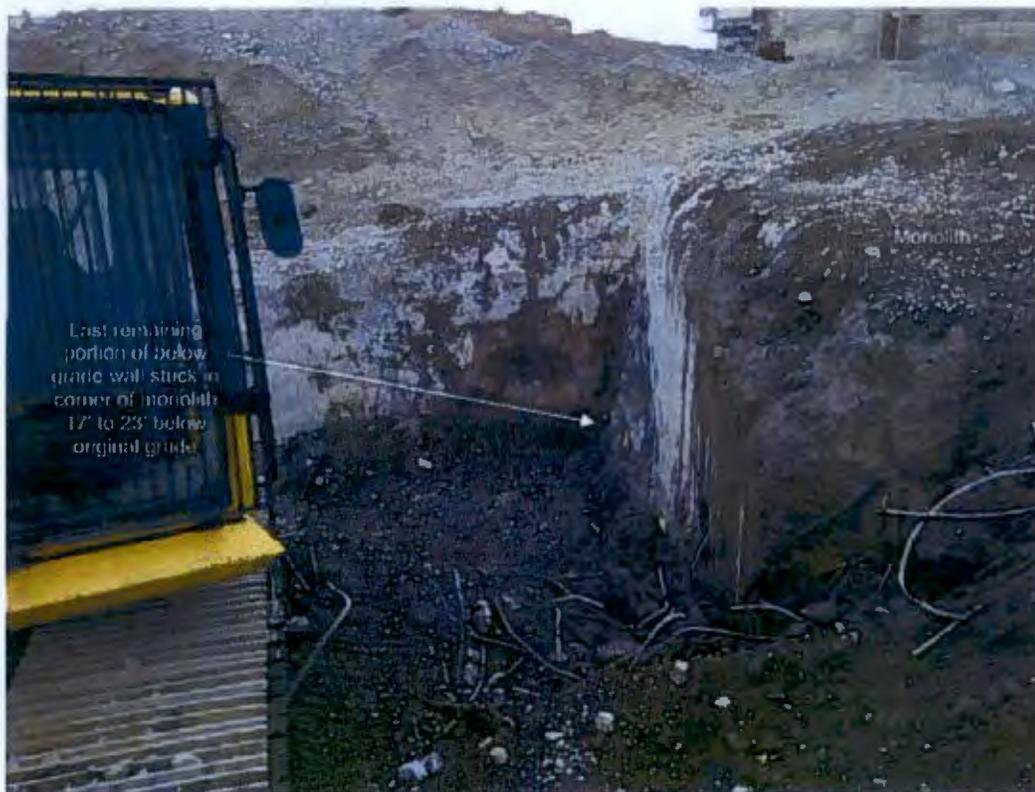
View of monolith below grade (facing north).
