SITE ASSESSMENT CHECKLIST AND REPORT FOR UNDERGROUND STORAGE TANKS 130-K-3A AND 130-K-3B REMOVAL

**SITE ASSESSMENT REPORT
USTs 130-K-3A, 130-K-3B**

UST Site Owner:	U.S. Dept of Energy, Richland Field Office
Owners Address:	825 Jadwin, P.O. Box 550, Richland, WA 99352
Site ID Number:	012763
UST ID Number:	130-K-3A 130-K-3B
Date Removed:	May 13, 1993
Site Assessment Complete:	May 26, 1993

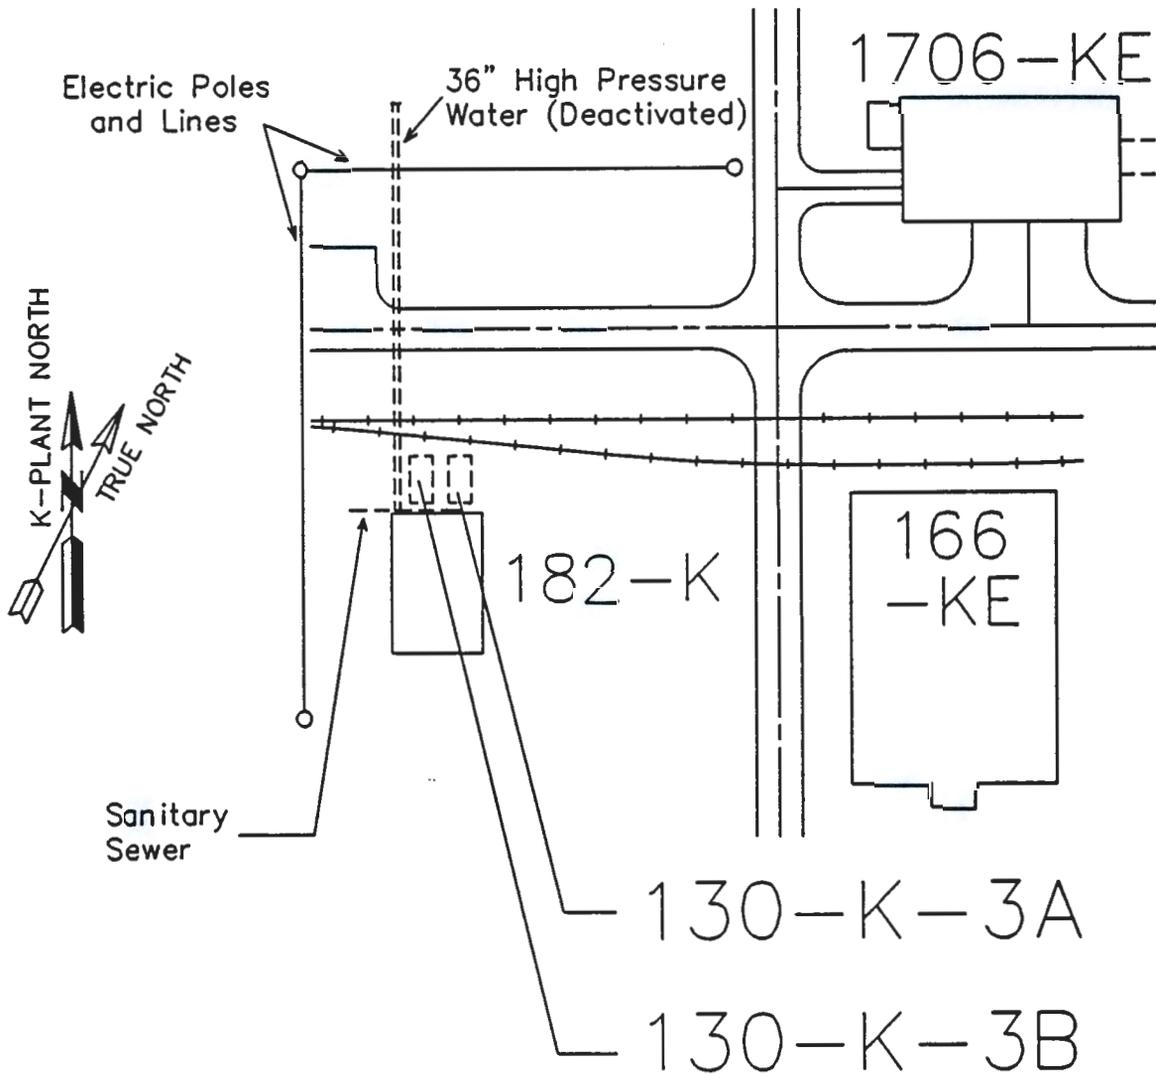
Figure 3: 130-K-3A/-3B
UST Location

The underground storage tanks 130-K-3A and 130-K-3B were located adjacent to one another in the 100 K Reactor Area of the Hanford reservation (Figure 3, Page SA7). The two steel tanks each had a 17,500 gallon capacity, were buried 5' apart and 5' north of the 182K pumphouse. These tanks were 9'6" in diameter and 33' long. They supplied diesel fuel to three engines located within the pumphouse. The engines ran pumps used for backup cooling water for the 105 KE and 105 KW Reactors.

The UST system was located approximately 5' north of the 182 K Pumphouse. The pumphouse housed pumps that were designed to supply the 105 K East and 105 K West Reactors with emergency cooling water (Figure 3, Page SA7).

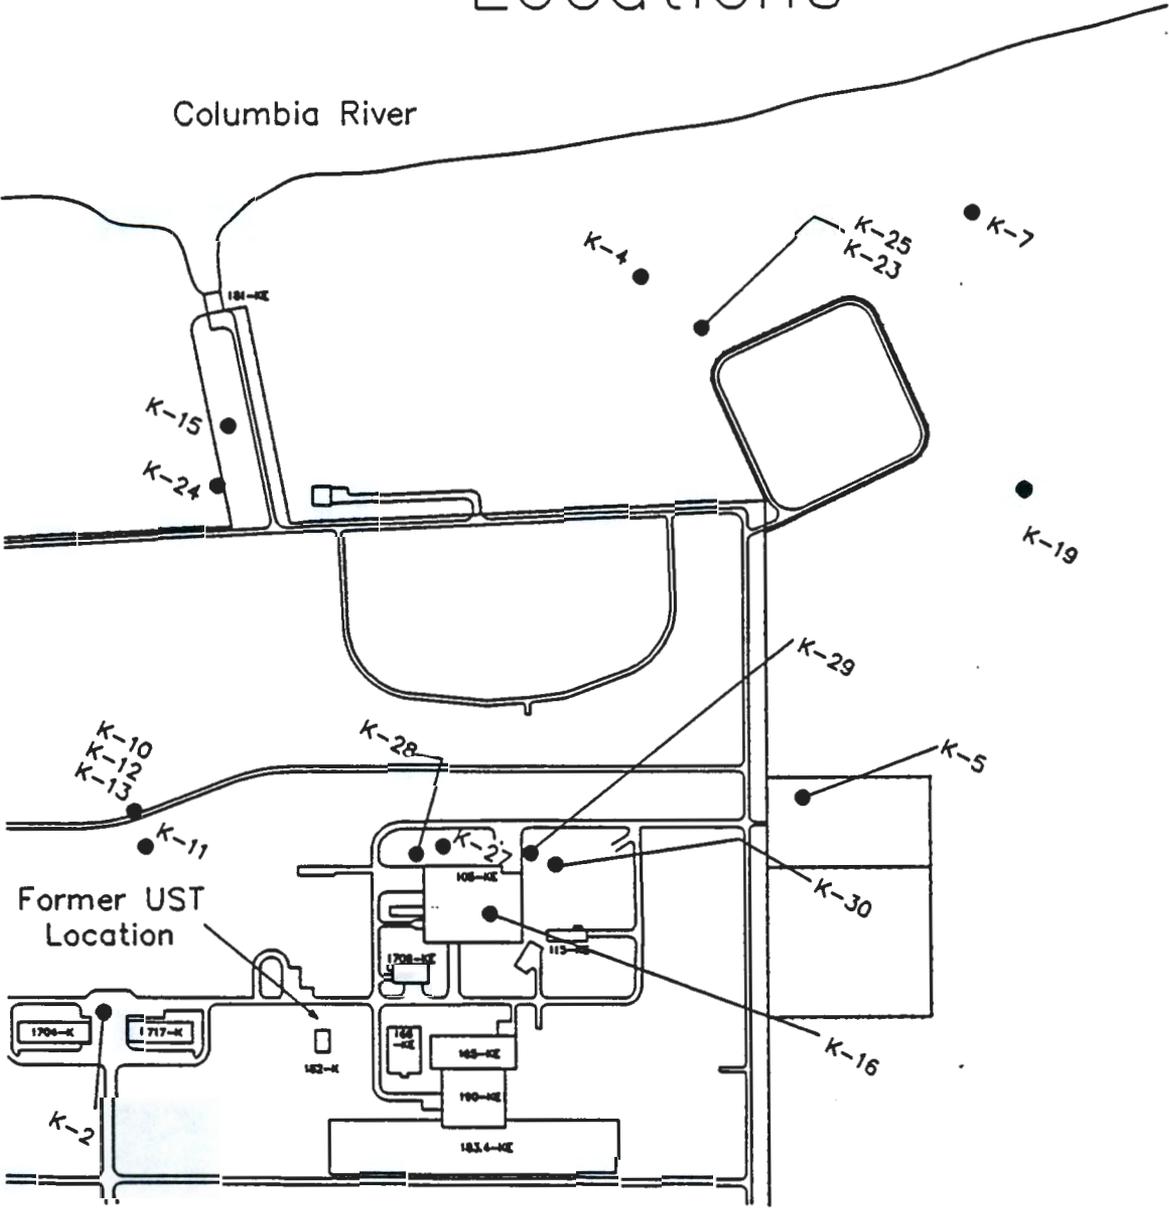
Figure 4: 100K Area Monitoring Well Locations

The 130-K-3A and 130-K-3B single shell UST system was not installed with a leak detection system. Figure 4 (Page SA11) shows monitor well locations in the 100K area.

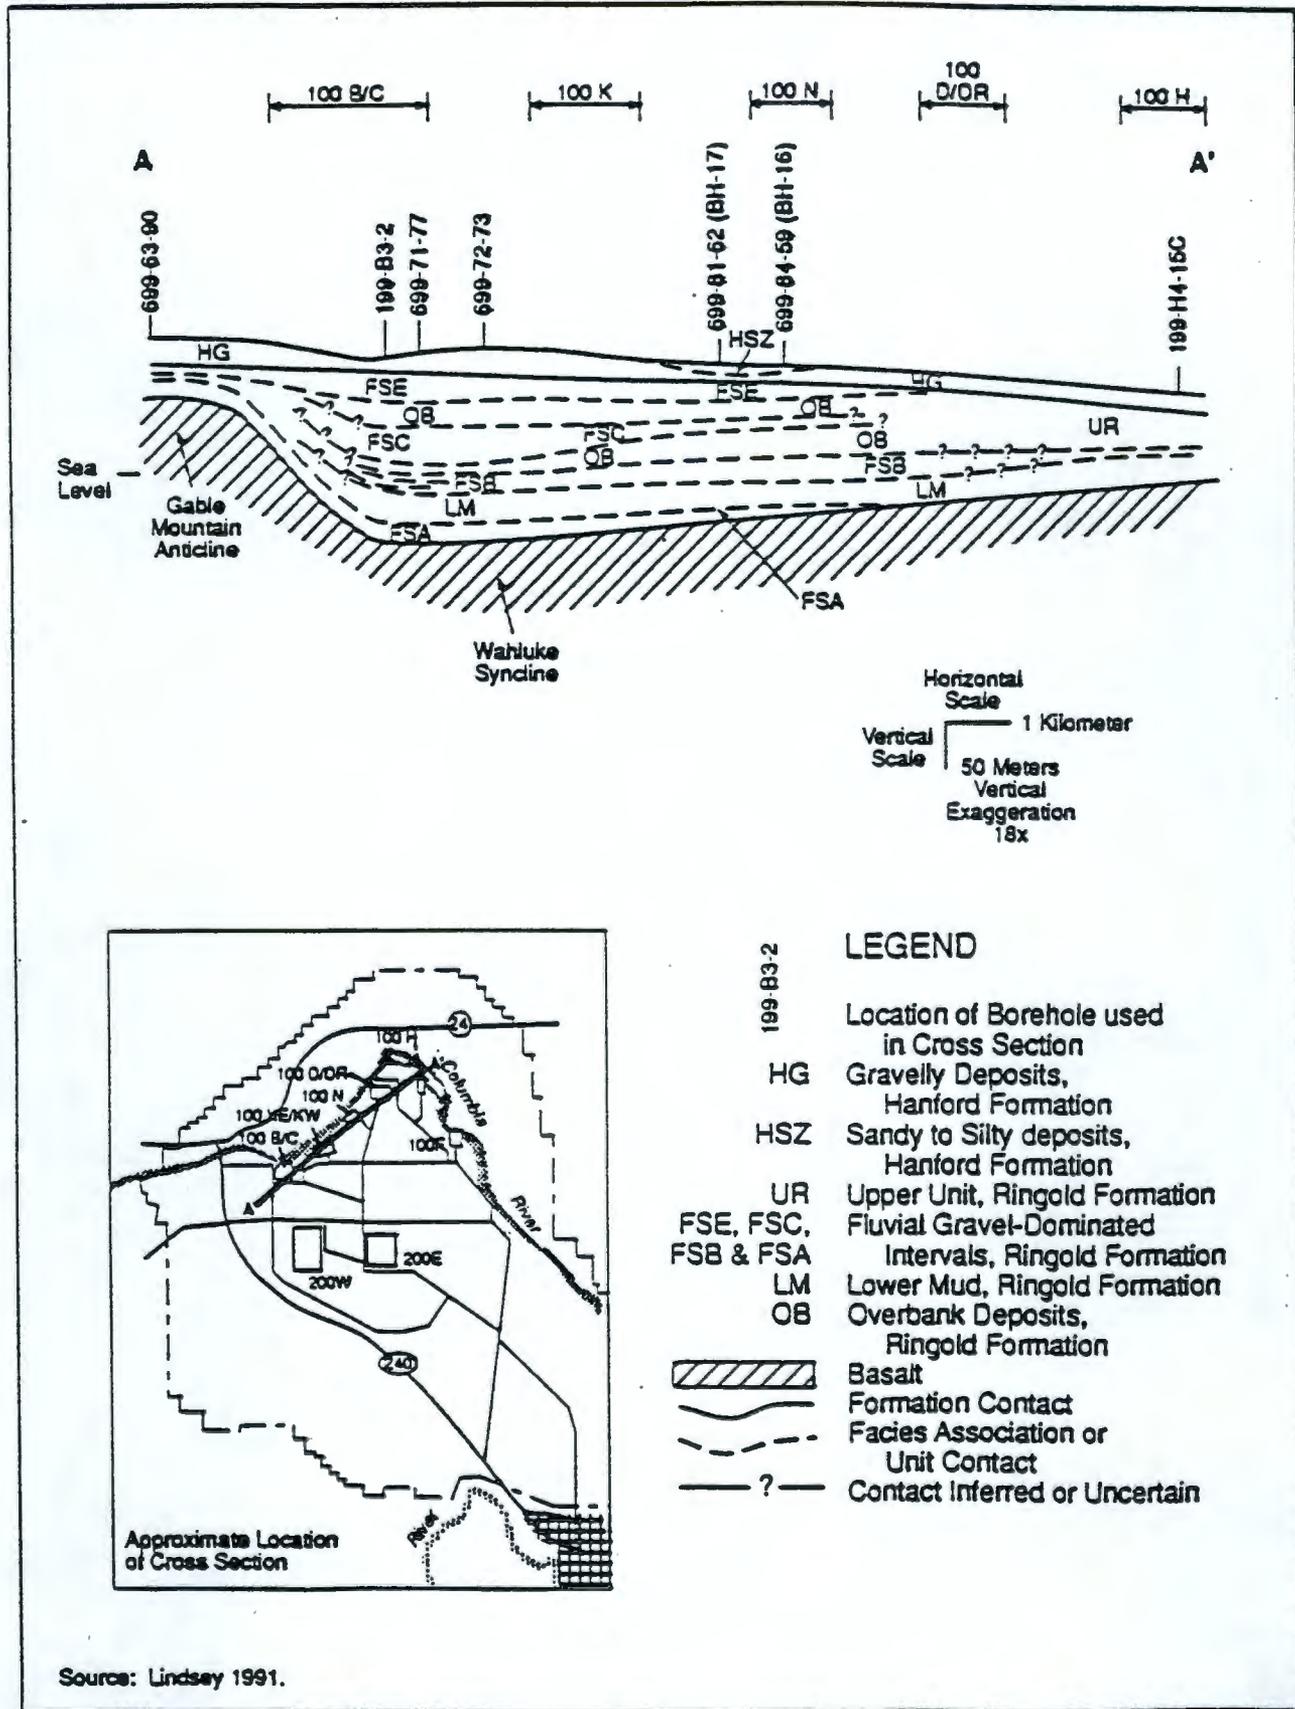
Figure 5: Northeast to Southwest Geological Cross Section of the Suprabasalt Sediments Across the Western Wahiuke Syncline in the 100 Area.

The native geology consists of the Columbia Plateau, which is a broad plain formed by the Miocene Columbia River Basalt Group. The flood basalts of the Group form the bedrock of the Pasco Basin. The major structural geology of the Pasco Basin is a sub-parallel series of west- to northwest-trending folds known as the Yakima Fold Belt. The 100 K Area lies within the Wahluke syncline (DOE/RL, 1992). A geological cross section of the Wahluke syncline is presented in Figure 5 (Page SA14). The Hanford formation in the vicinity of the 100 K Area is estimated to be approximately 50 feet thick and is in disconformable contact with sands and gravels of the upper Ringold Formation (Figure 6, Page SA15). The vadose zone within the 100 K Area includes stratigraphic units such as fill, loess, alluvium, the Hanford formation and the Ringold Formation (DOE/RL, 1992). The soil within the Hanford Formation would be classified as "GM, silty gravels, gravel-sand-silt mixtures" as designated by the Unified Soil Classification System.

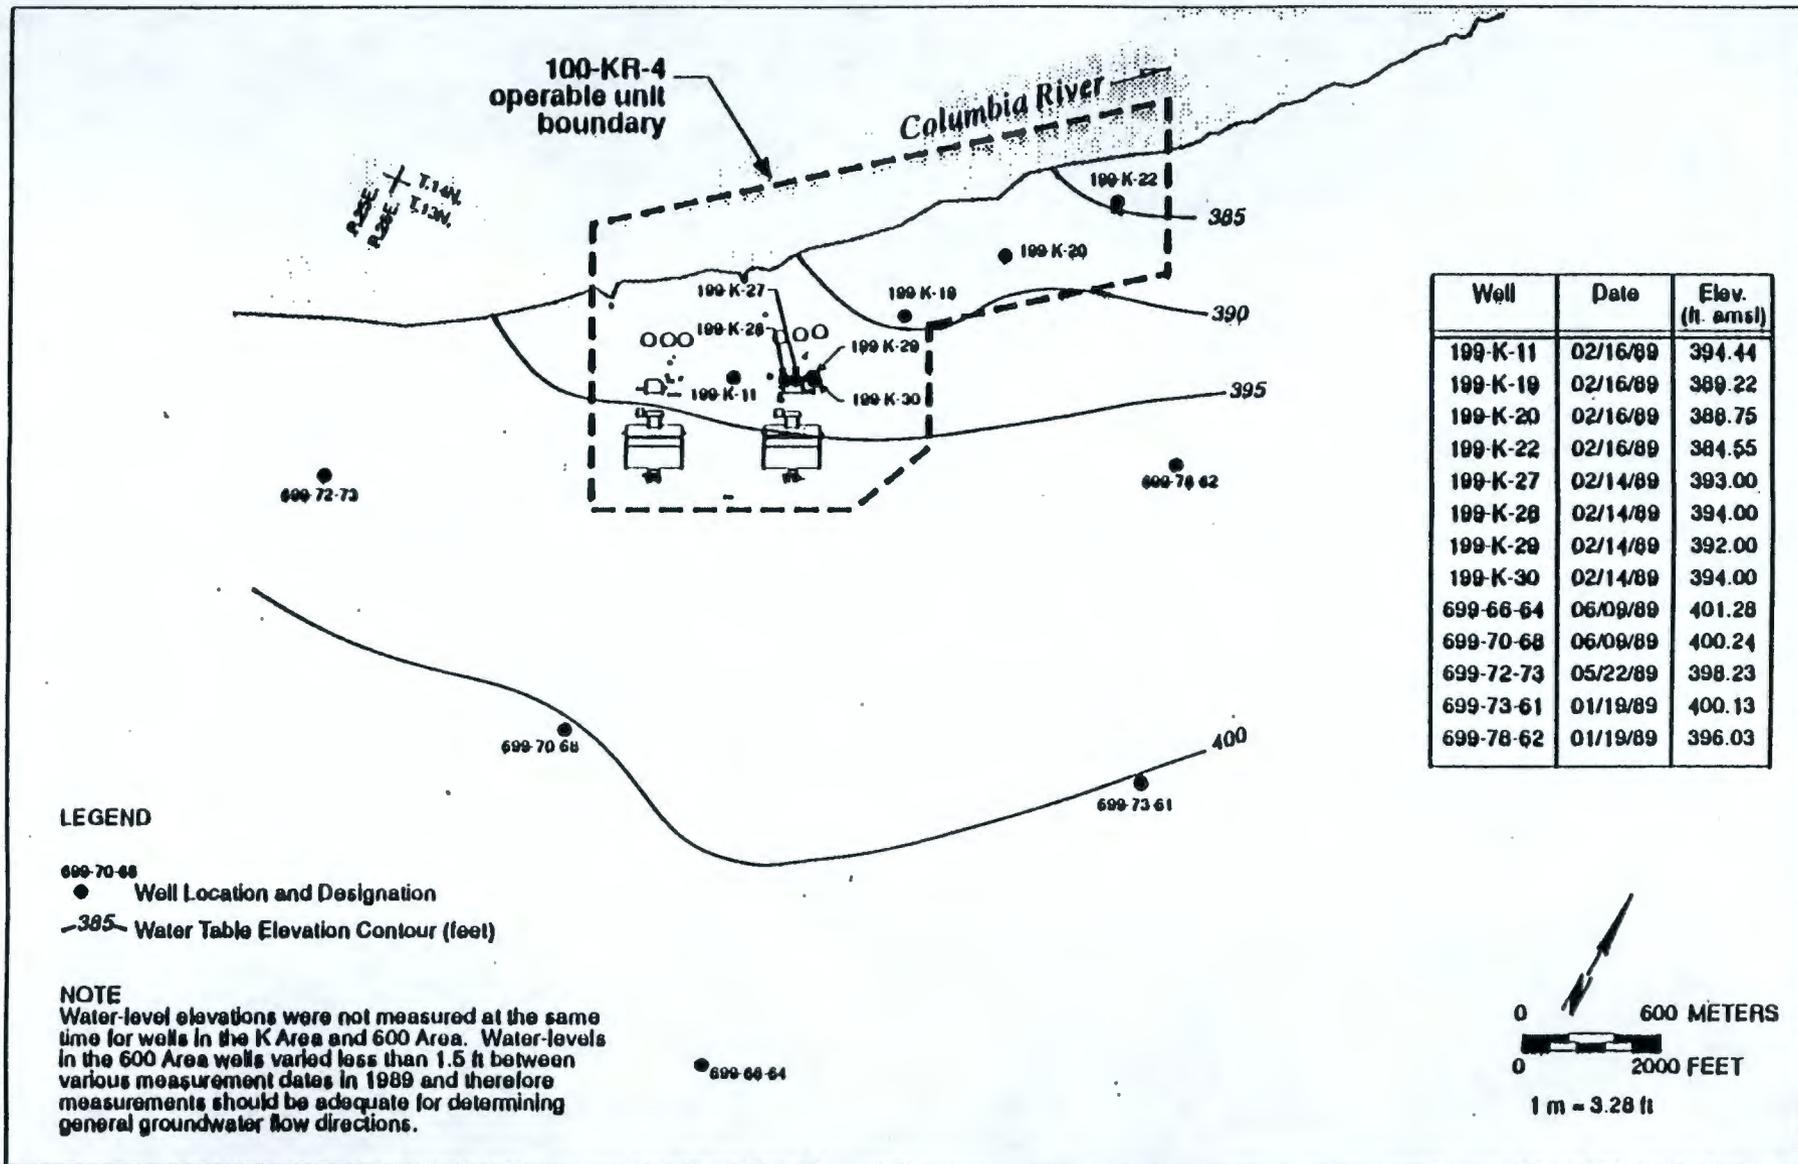
Figure 7: Water Table Contour Map of the 100K Area in 1989.

Groundwater in the 100 K Area occurs in unconfined and confined aquifers. The ground water nearest to the surface is in an unconfined aquifer located approximately 50 to 75 feet below ground surface (Figure 7, Page SA17). Its flow is directed primarily through the Ringhold Producing Layer. A cemented layer is present in the central portion of the 100 K Area. This zone could effect groundwater flow and contaminate transport. The hydraulic conductivities of similar material on the Hanford Site range from 20 to 6000 feet per day. The gradient is relatively flat, .0009 to .004, increasing near the river. The groundwater flow is generally in a northern direction, toward the Columbia River. Local groundwater flow may have been disturbed (during Reactor operation) due to groundwater mounding from the release of water to nearby facilities (DOE/RL, 1992). Depth to ground water near the river varies with fluctuations in the river height.

Groundwater flow in the unconfined aquifer normally moves north toward the Columbia River. The 130-K-3A and 130-K-3B USTs are approximately 2250 feet from the river.

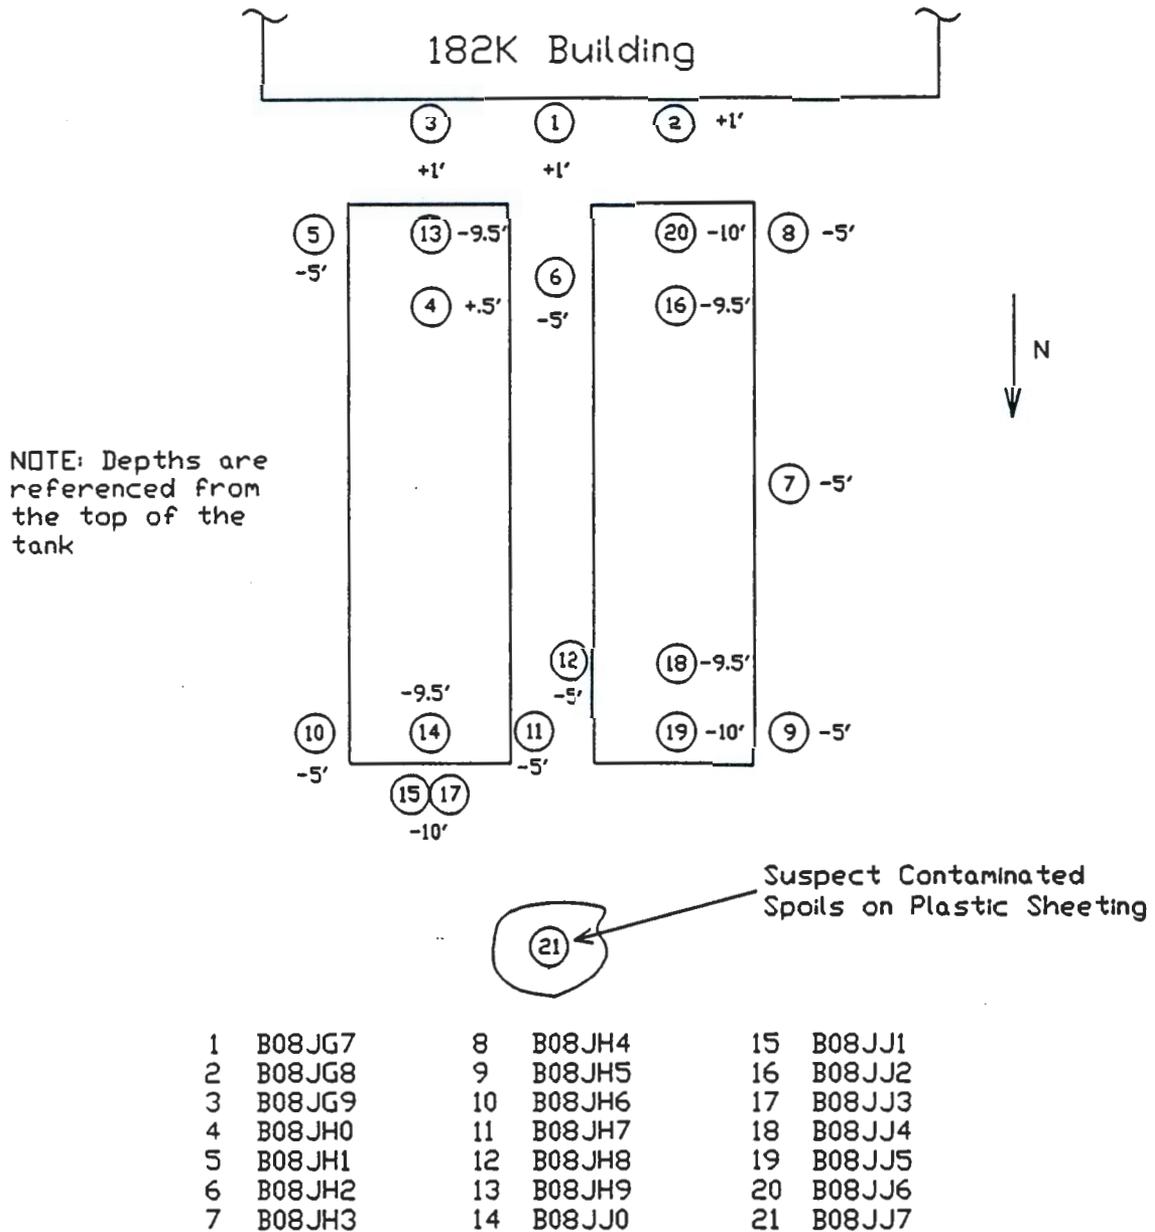
Figure 8: Sample Locations and Depths

Sample ID	Sample Location
B08JG7	Directly under elbow of 130-K-3B piping as it entered the 182K building.
B08JG8	Under piping at the end of the 130-K-3B tank.
B08JG9	Under the 130-K-3A piping as it entered the building.
B08JH0	Under 130-K-3A piping as it exited the tank.
B08JH1	Under the roll of the 130-K-3A tank, SE corner.
B08JH2	Between 3A and 3B tanks 12' north of south end.
B08JH3	Under the roll of the 3B tank, center on west side.
B08JH4	SW corner of 3B under roll
B08JH5	NW corner of 3B under roll
B08JH6	NE corner of 3A under roll
B08JH7	NW coner of 3A under roll
B08JH8	NE corner of 3B under roll

Sample ID	Sample Location
B08JH9	2' north of south end of 3A cradle
B08JJ0	2' south of north end of 3A cradle
B08JJ1	North end of 3A excavation
B08JJ2	South end of 3B excavation
B08JJ3	Duplicate of B08JJ1
B08JJ4	2' south of north end of 3B cradle
B08JJ5	North end of 3B excavation
B08JJ6	South end of 3B cradle
B08JJ7	Suspect contaminated soil sample for characterization

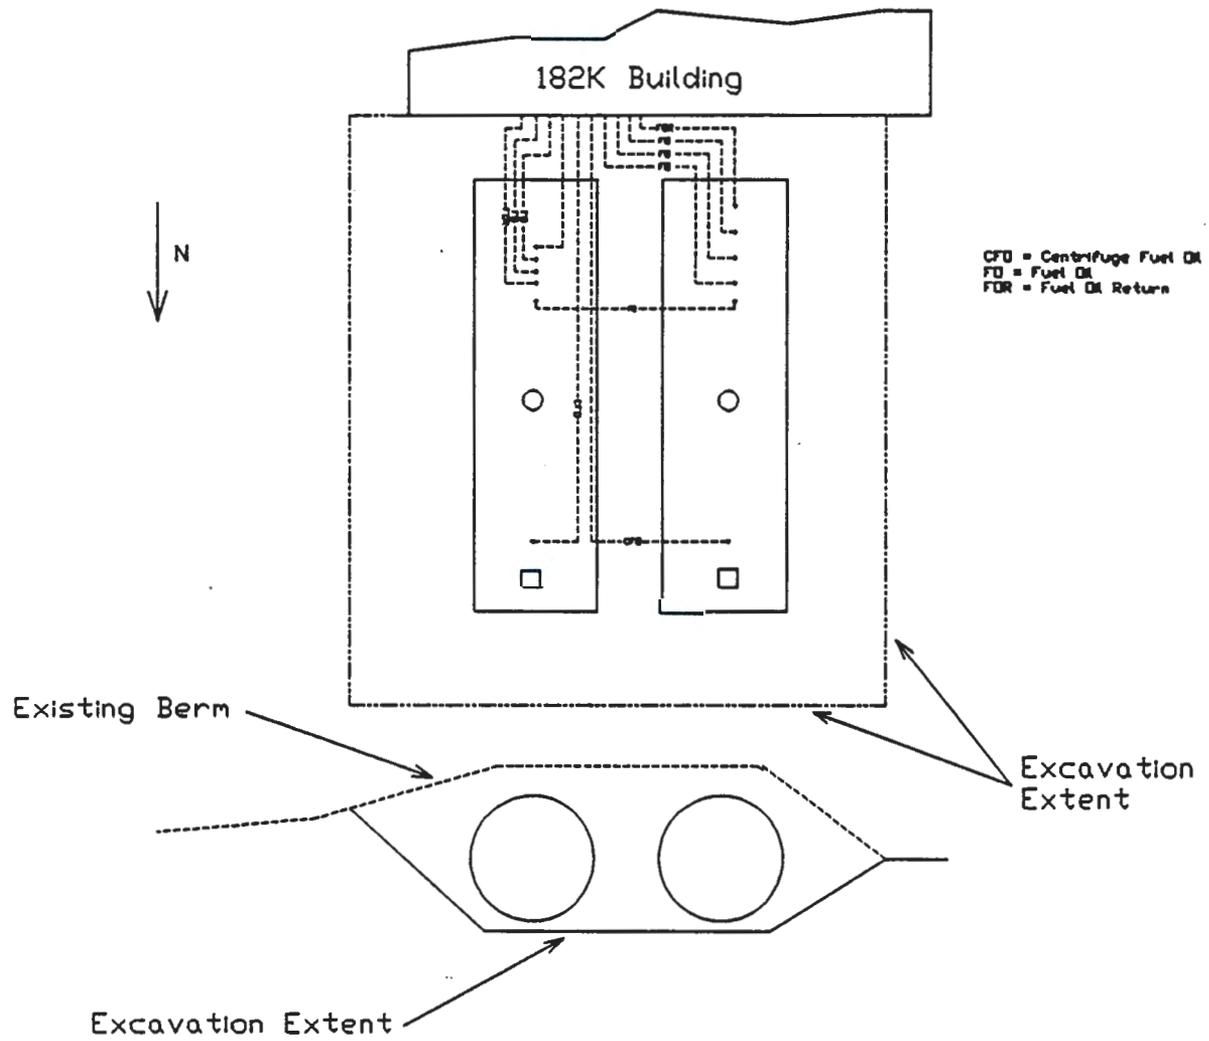
Figure 9: 130-K-3A/-3B Excavation

The tanks were covered by a bermed mound of soil with the top of the mound 5' above grade level. The top of the tank was ~3½' above grade and covered by 1½' of the soil berm. A 24" diameter manway (¼" thick bolted steel plate cover) was located in the center of each tank. All piping associated with this tank utilized welded joints with no threaded couplings. The piping and conduit associated with each tank is described below:

There was no groundwater in the excavation, but there were indications of water runoff around the tanks. The bottom of each cradle had a one foot wide settled region that looked like water was present, but had soaked into the ground. The backfill had settled slightly, leaving an indentation length-wise under each tank.
