## FACILITY STATUS CHANGE FORM

Date Submitted:	Area: 200E	Control Number: D4-PUREX-035
Originator: Daniel Turlington	Facility ID: 275EA	Phone: 509-373-0176

The required facility removal actions were performed in accordance with the DOE/RL-2010-33, Rev. 0, *Removal Action Work Plan for Central Plateau General Decommissioning Activities*.

275EA was constructed in 1944 in the 200E area north of PUREX. The building was used as a warehouse to store non-radioactive parts and miscellaneous building materials for the PUREX Canyon such as electrical jumpers, wire rope slings, etc.

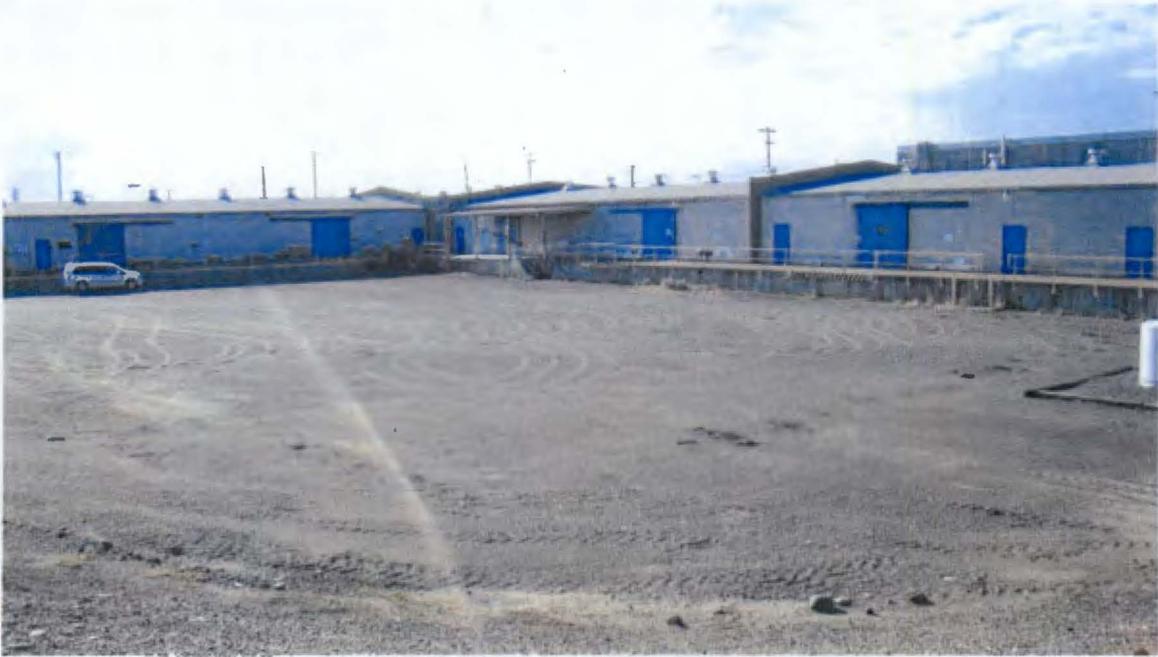
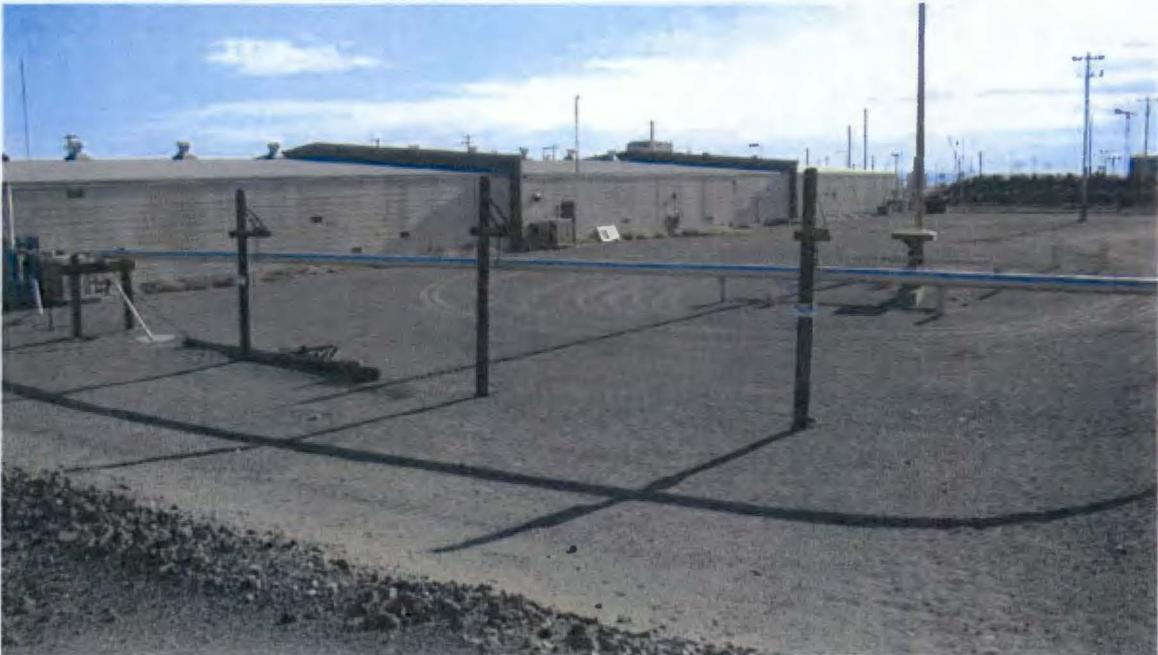
Pre-demo 275 EA

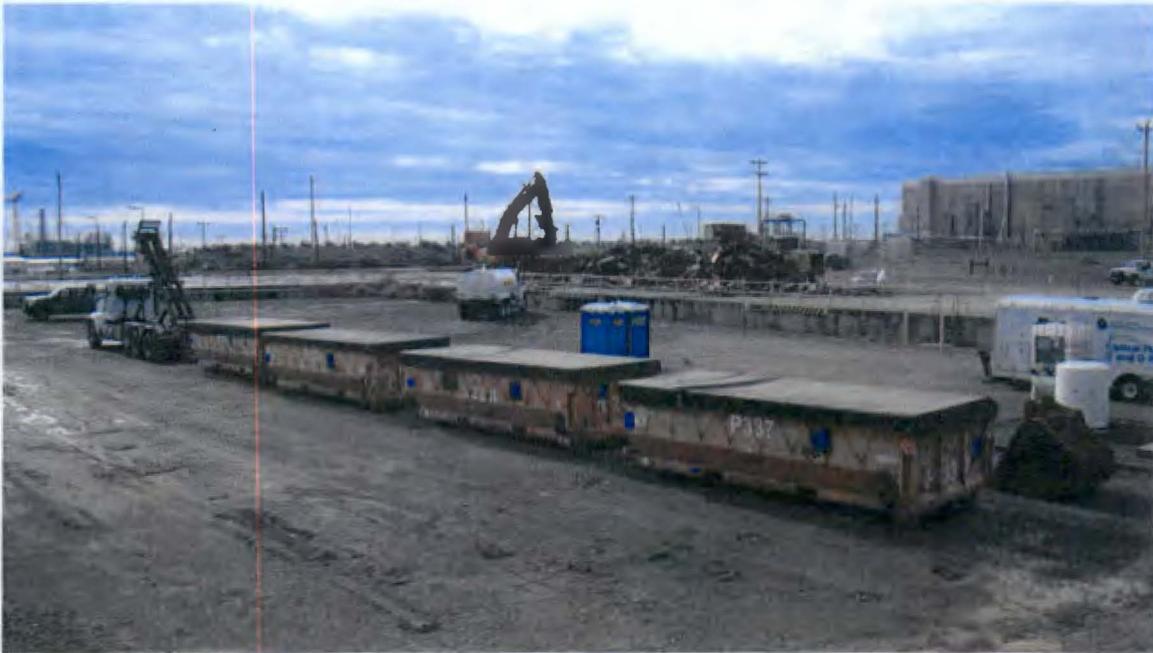
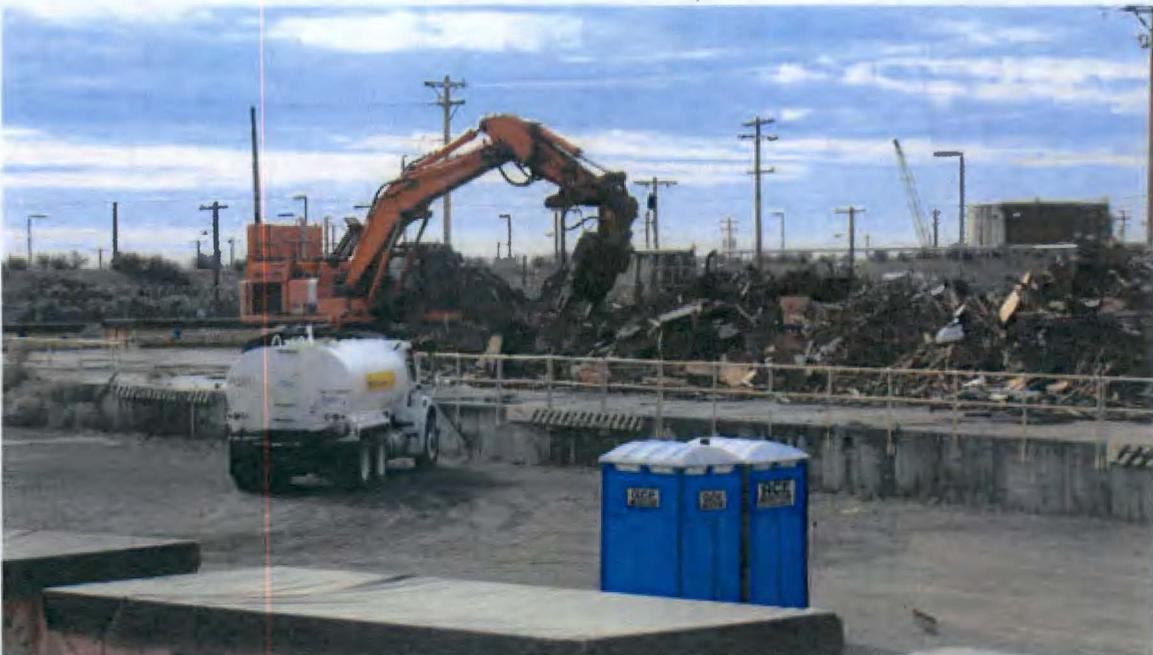
During Demo 275 EA

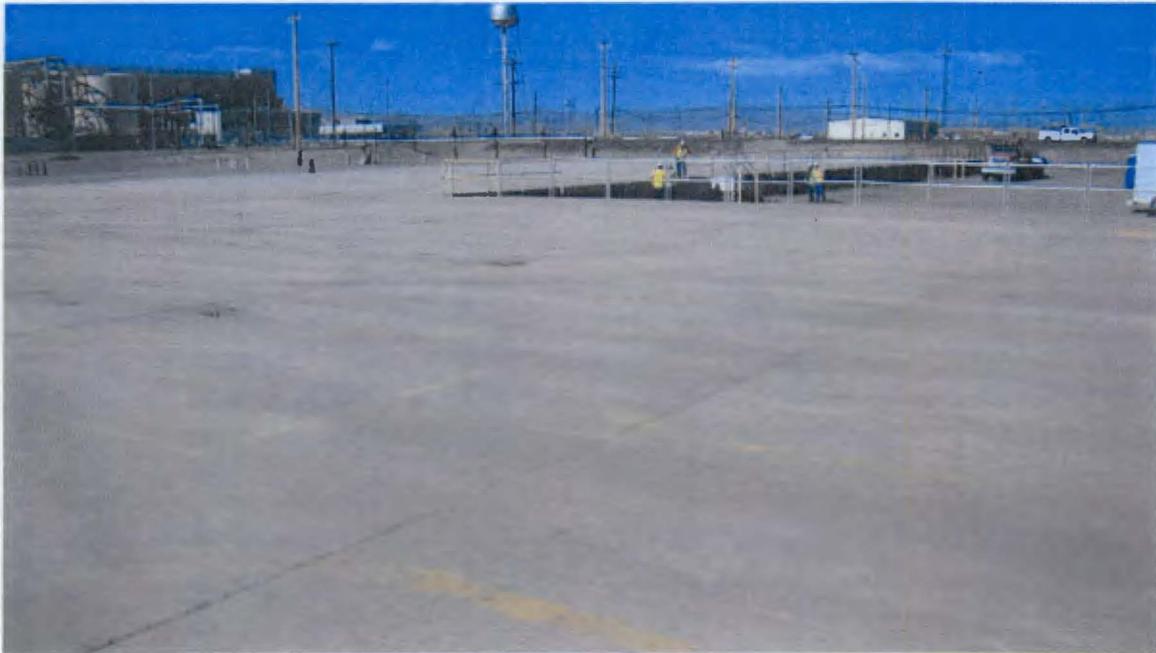
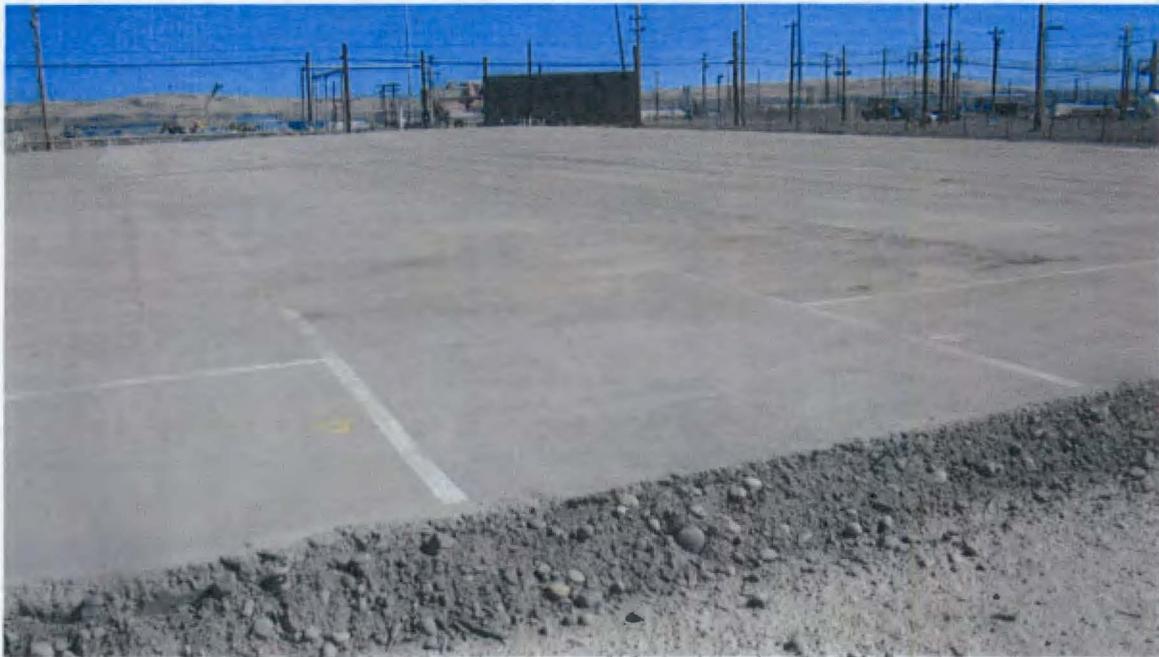
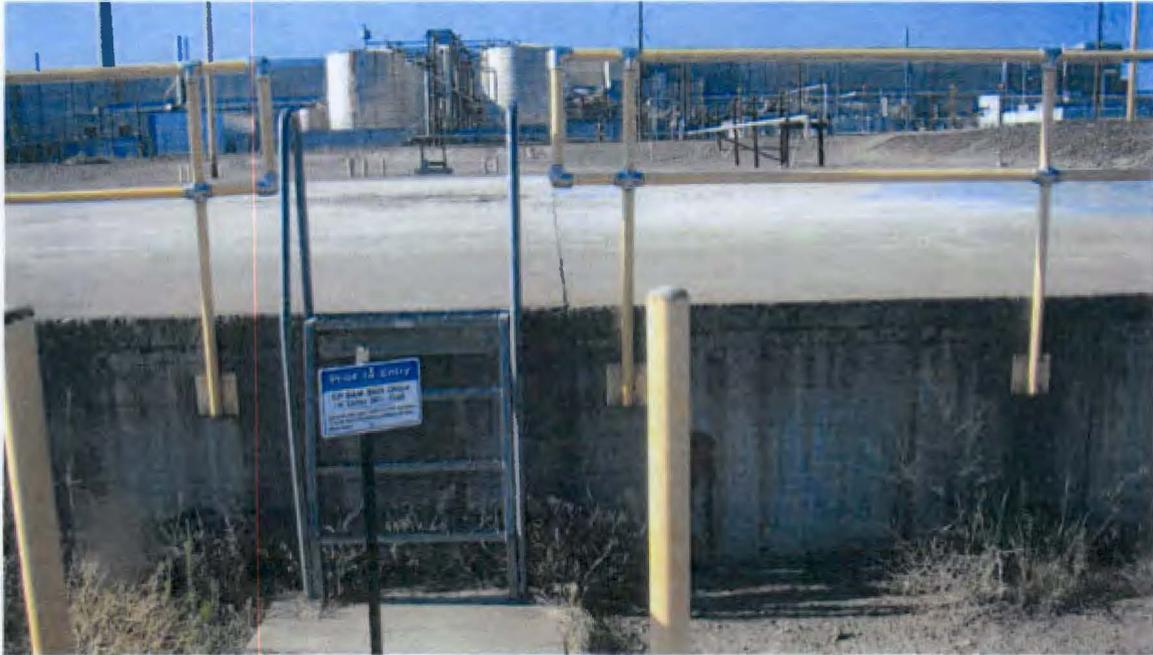
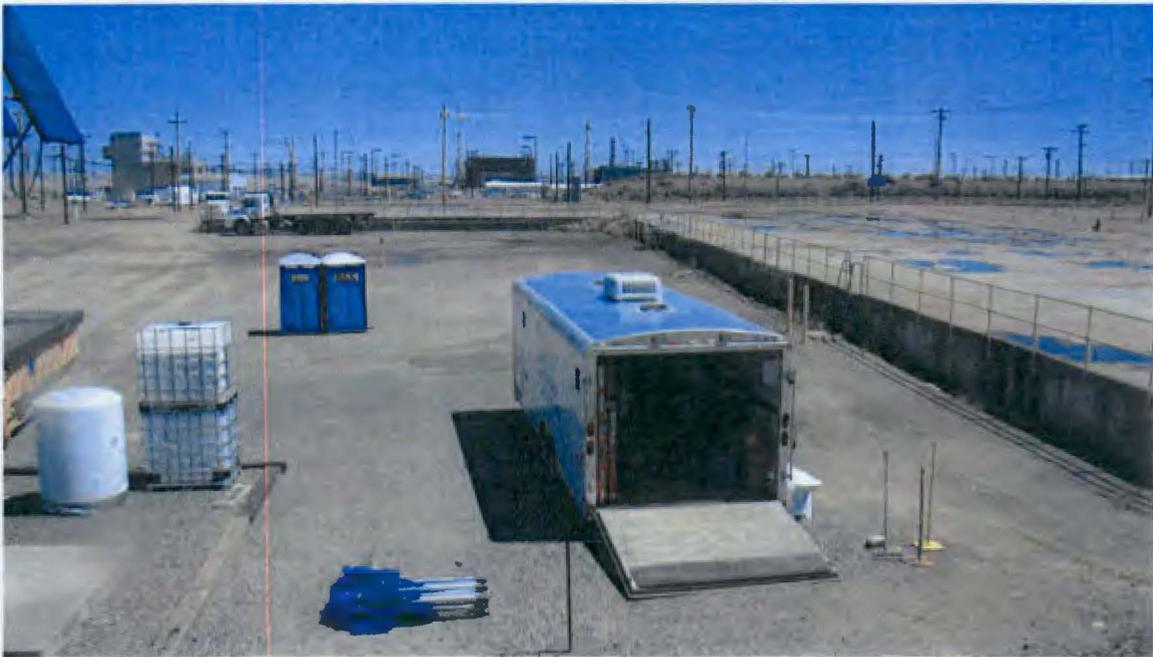
The 275EA warehouse facility was completely removed down to its remaining slab. No safety hazards remain. CPSM Entry restriction and project ownership signs with contact information were posted as entry precautions for others.

Post Demo 275 EA

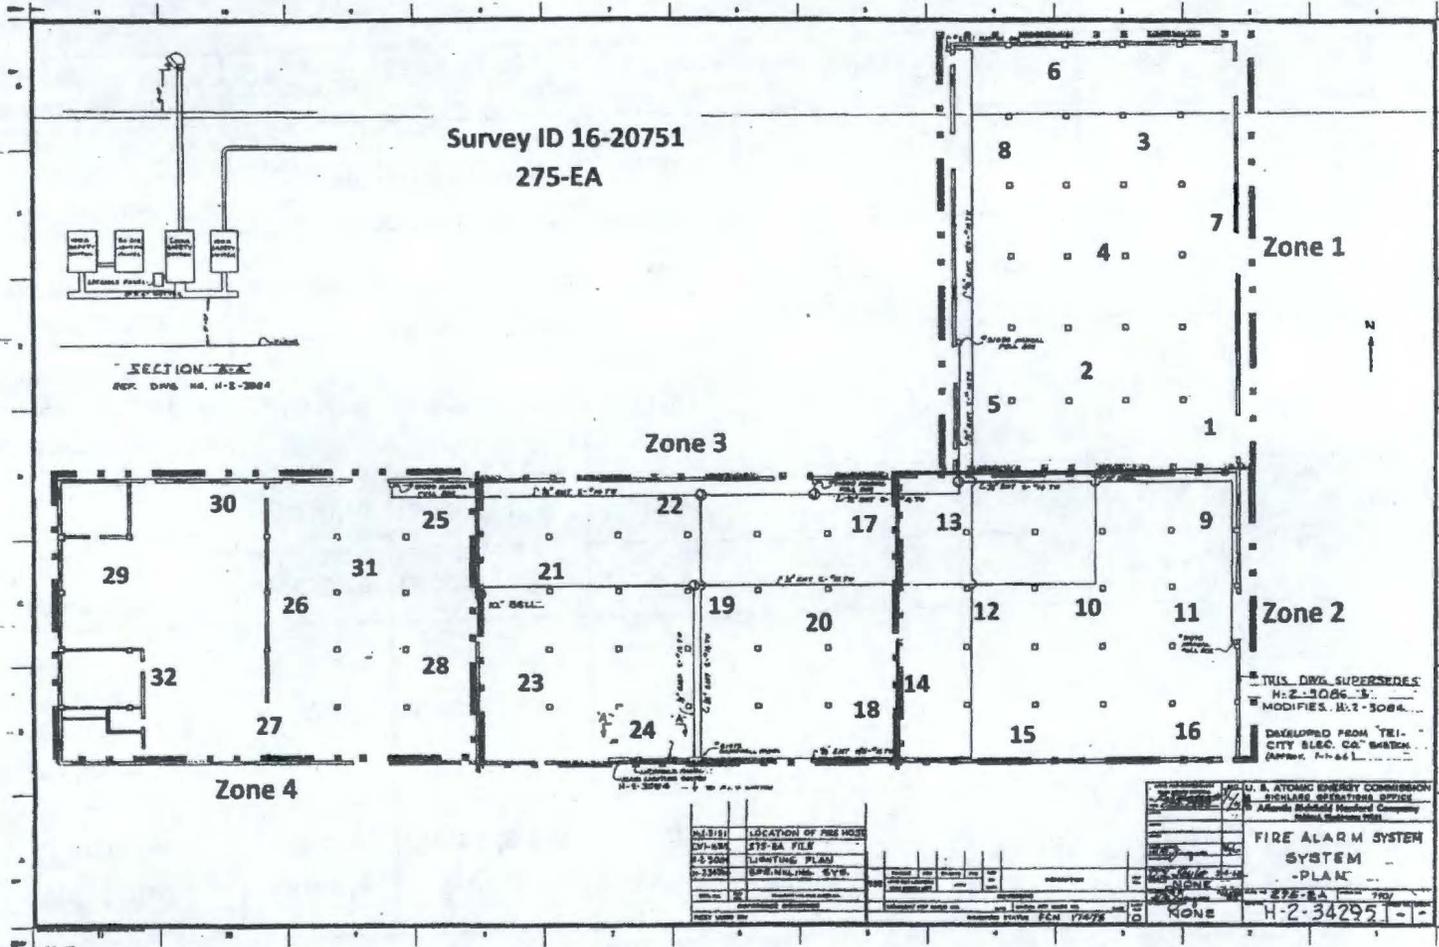
APPENDIX B

Beryllium verification sampling was conducted by a CHPRC Industrial Hygiene Technician (IHT) on April 20, 2016. 31 bulk samples were collected. A drawing of the building with the sample locations is provided in Appendix B. Bulk samples were collected on visibly dusty surfaces and areas to determine if the beryllium in the dust collected is distinguishable from the background beryllium in local soils. All of the samples were bulk samples because of the highly visible amounts of dust deposited on surfaces in the facility.

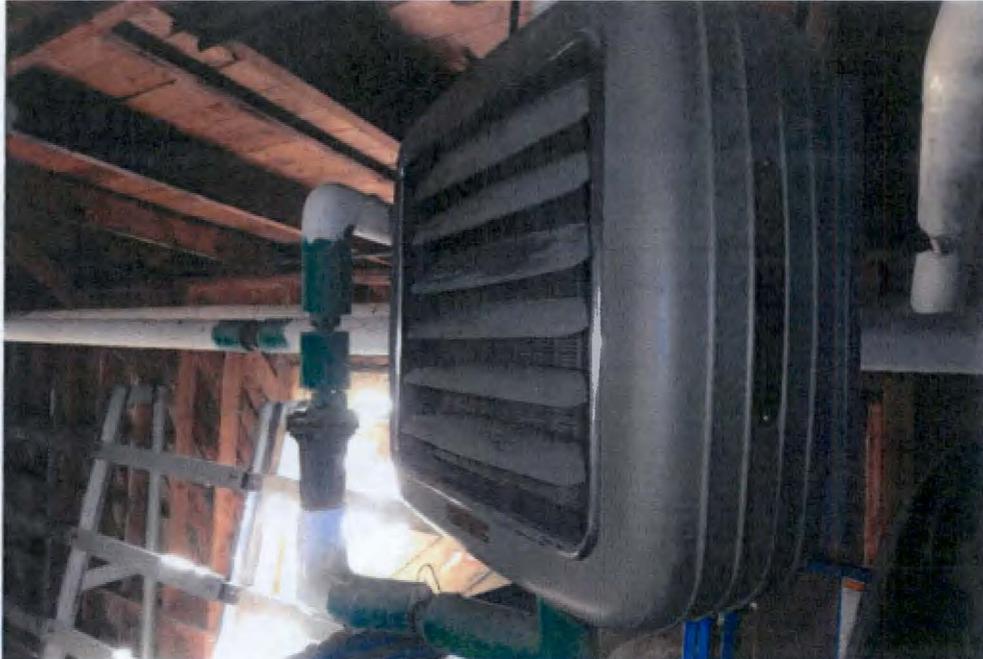
Photograph 1

Front grille of ceiling mounted heater (16-20751-001 sample) 0.97 ug/g – highest beryllium concentration

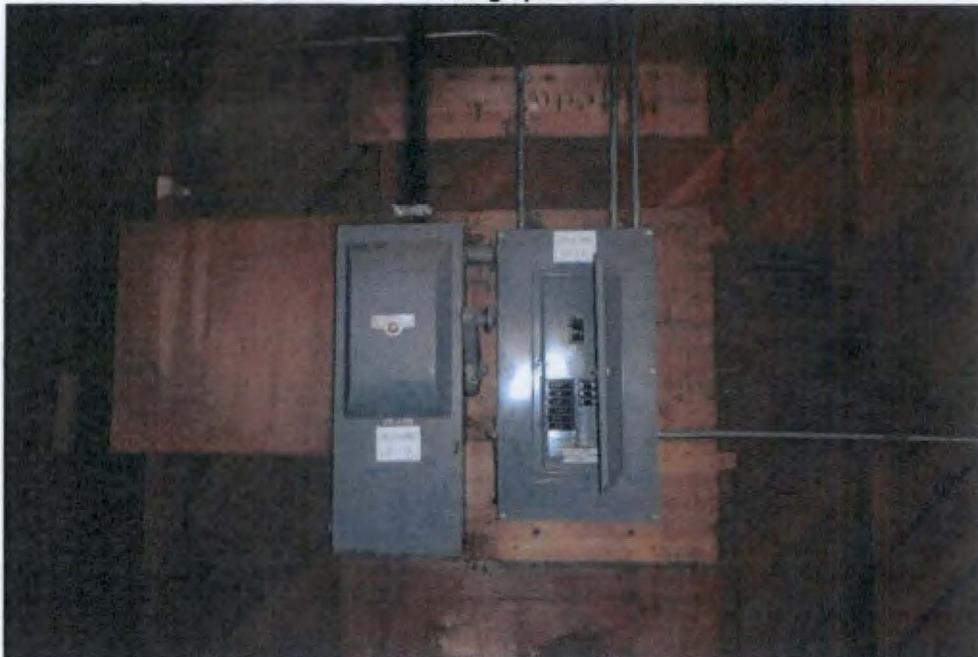
Photograph 2

Top of disconnect and lighting panel (16-20751-005 sample) 0.75 ug/g

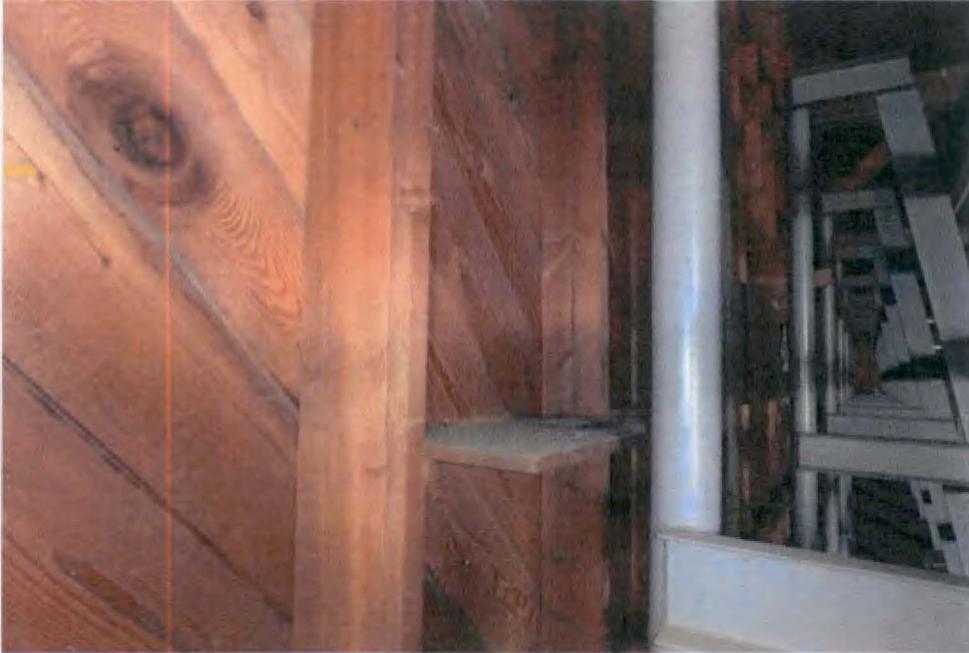
Photograph 3

Horizontal surface on north wall for unknown usage (16-20751-006 sample) 0.87 ug/g

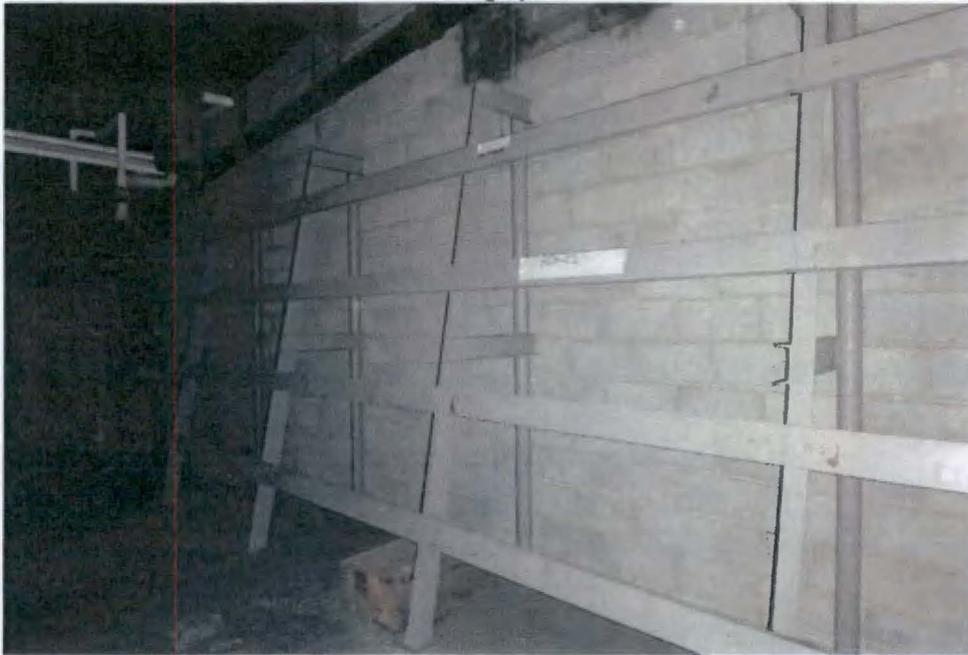
Photograph 4

Storage rack on west wall for unknown usage (16-20751-014 sample) 0.78 ug/g

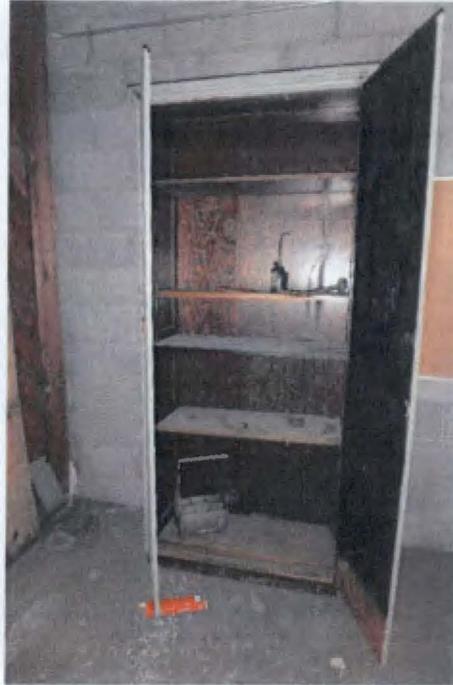
Photograph 5

Shelves inside storage cabinet for unknown items (16-20751-017 sample) 0.84 ug/g

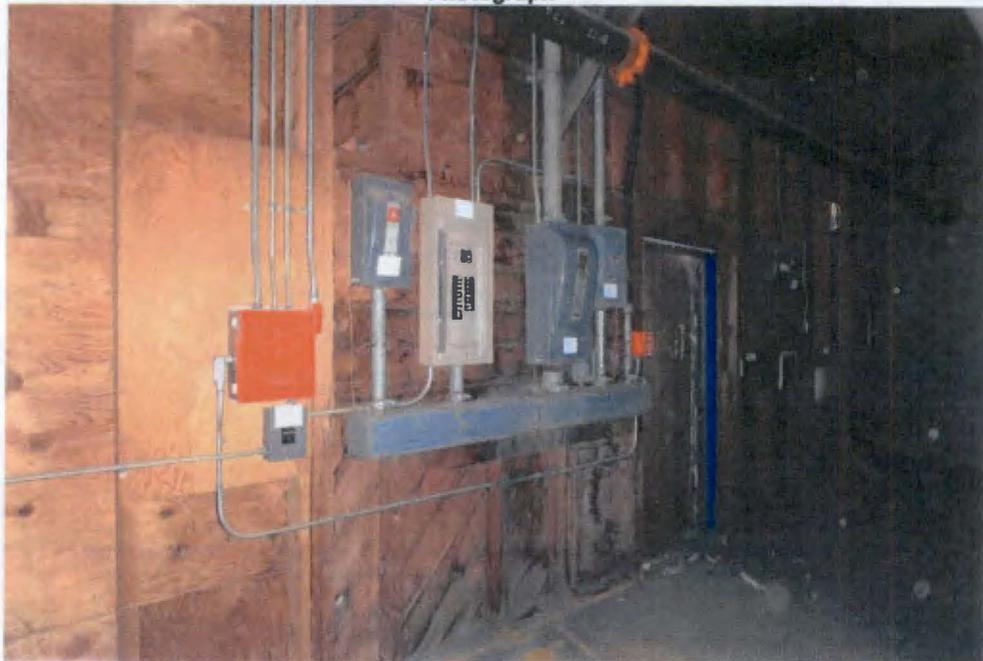
Photograph 6

Gutter/wireway below electrical panel boxes on south wall (16-20751-024 sample) 0.62 ug/g

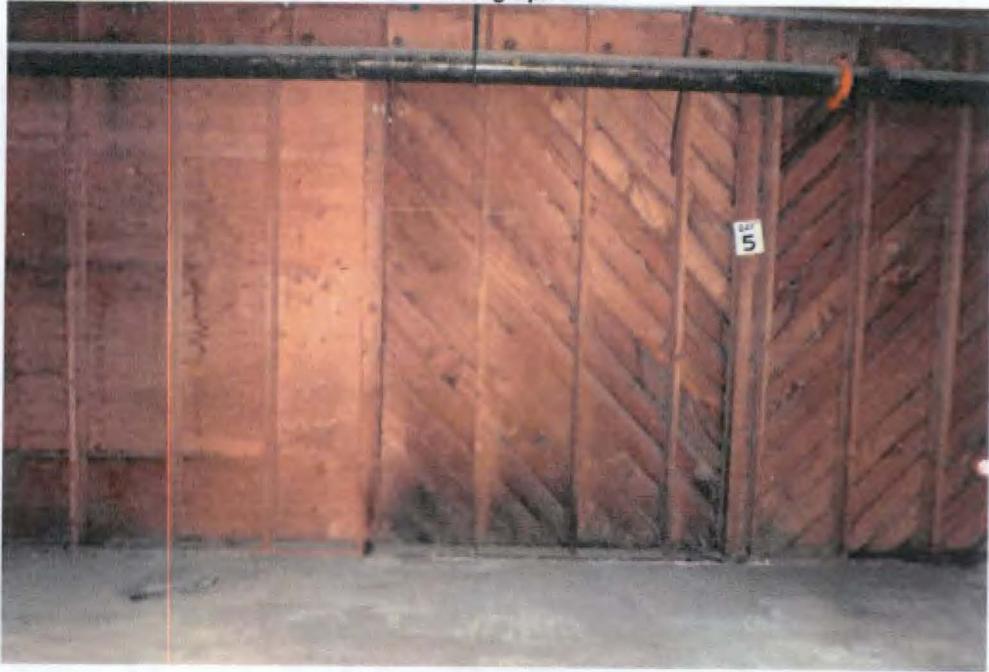
Photograph 7

Floor sill plate on south wall (16-20751-027 sample) 0.58 ug/g

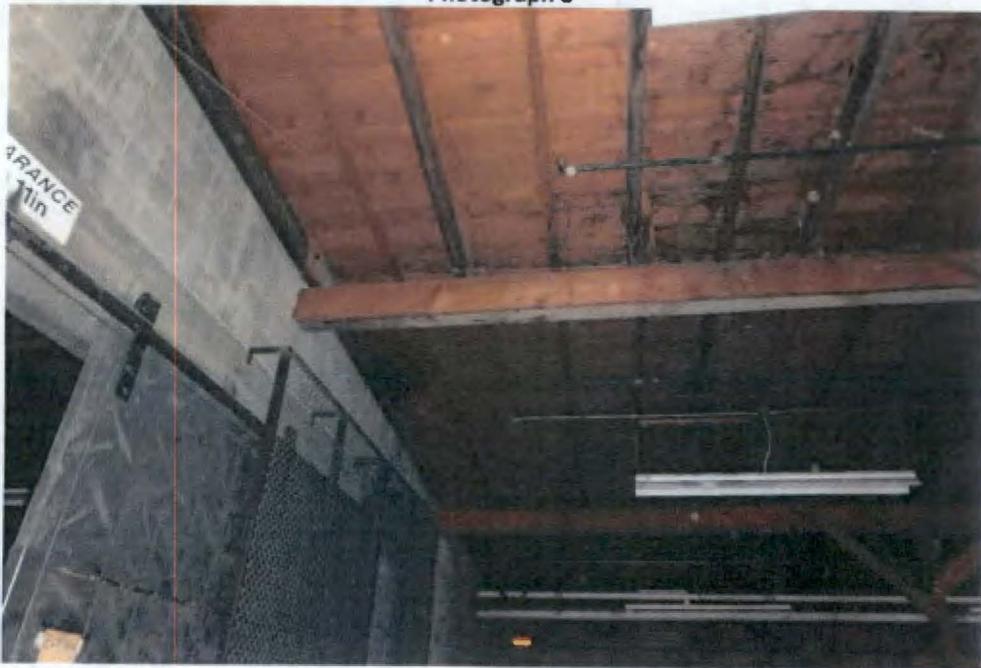
Photograph 8

Structural wood beam on east wall (16-20751-028 sample) 0.55 ug/g

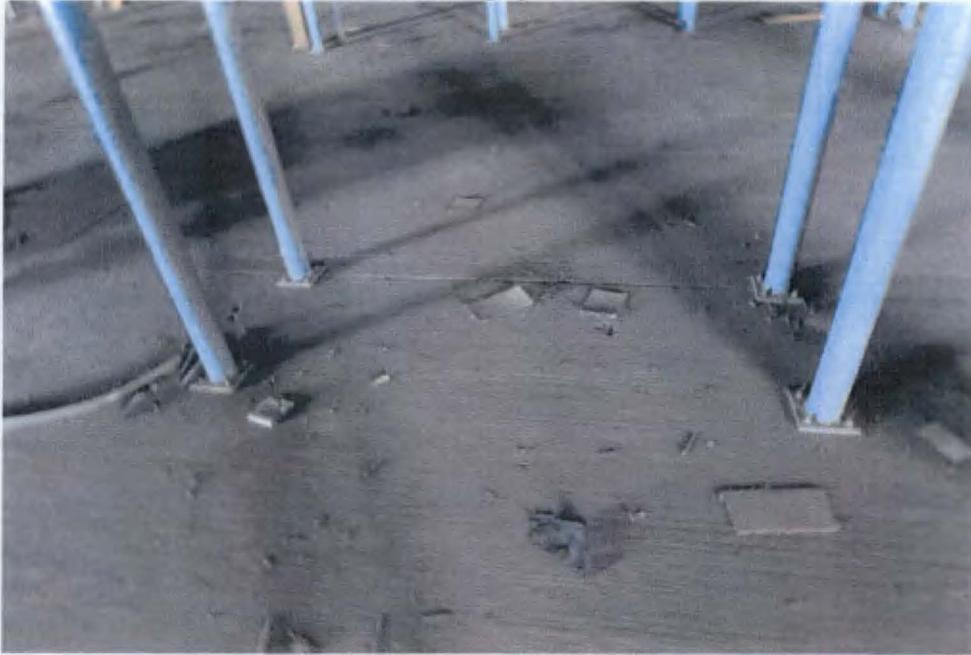
Photograph 9

Floor in NE Corner (16-20751-002 sample) 0.71 ug/g

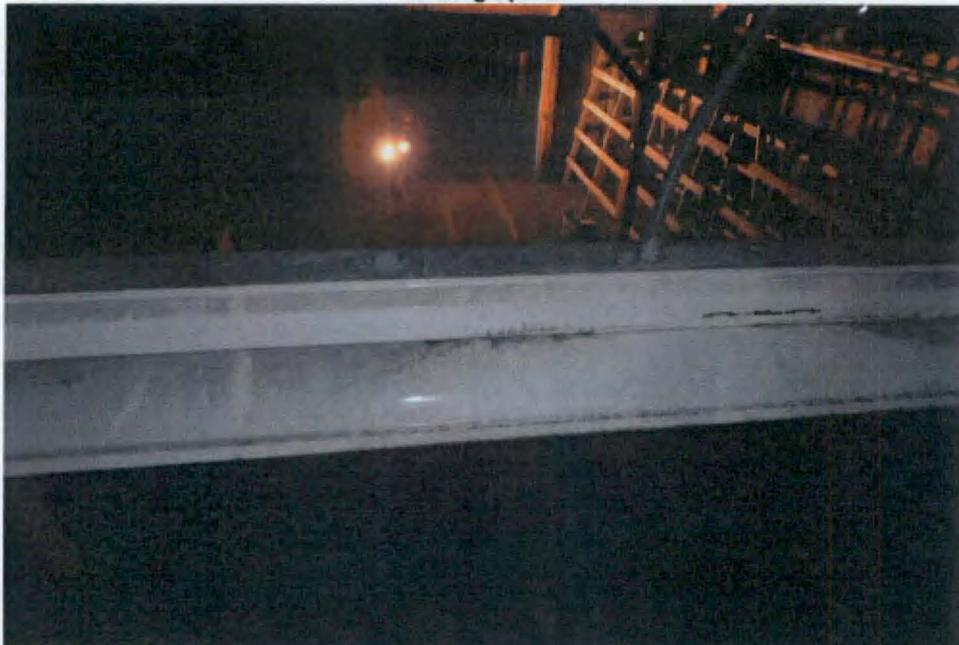
Photograph 10

Top of light in east side (16-20751-010 sample) 0.93 ug/g

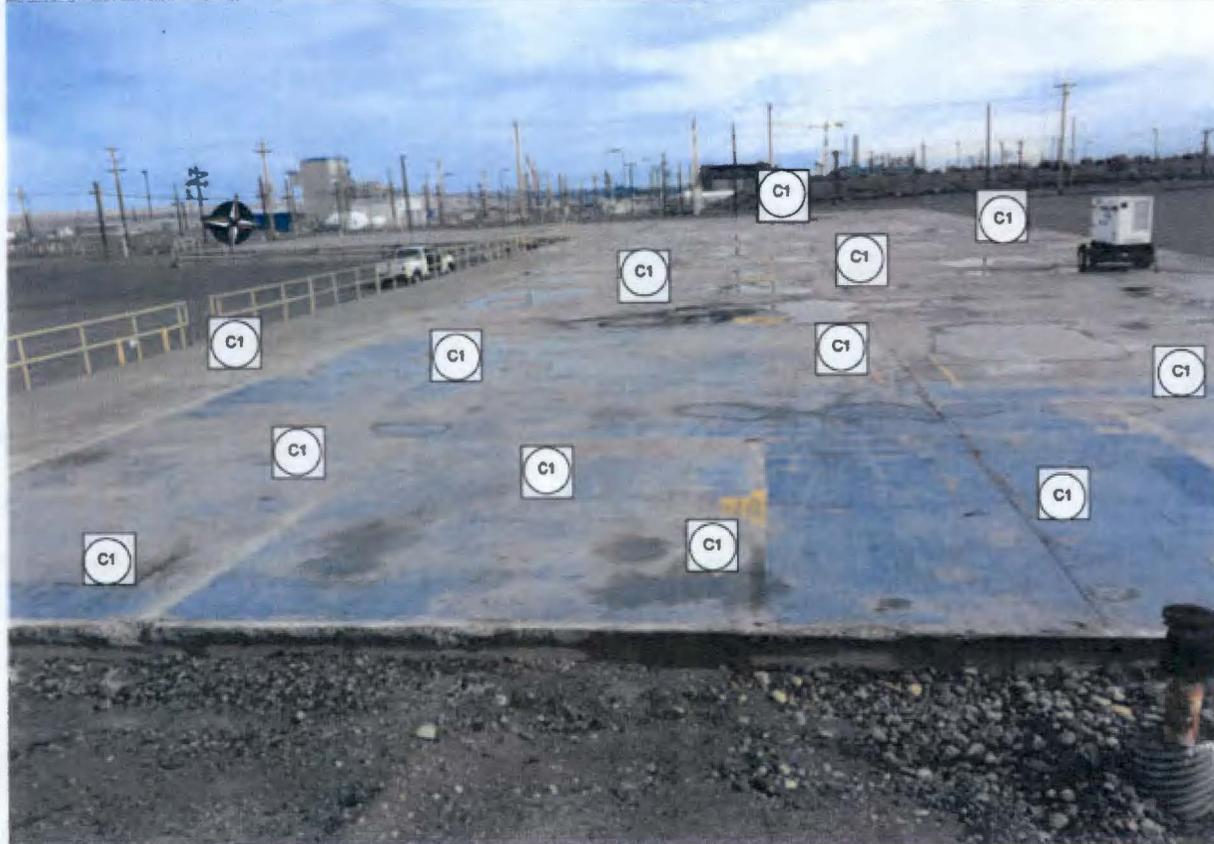
**Map Name: 275EA Pad**

**Map Description: survey**

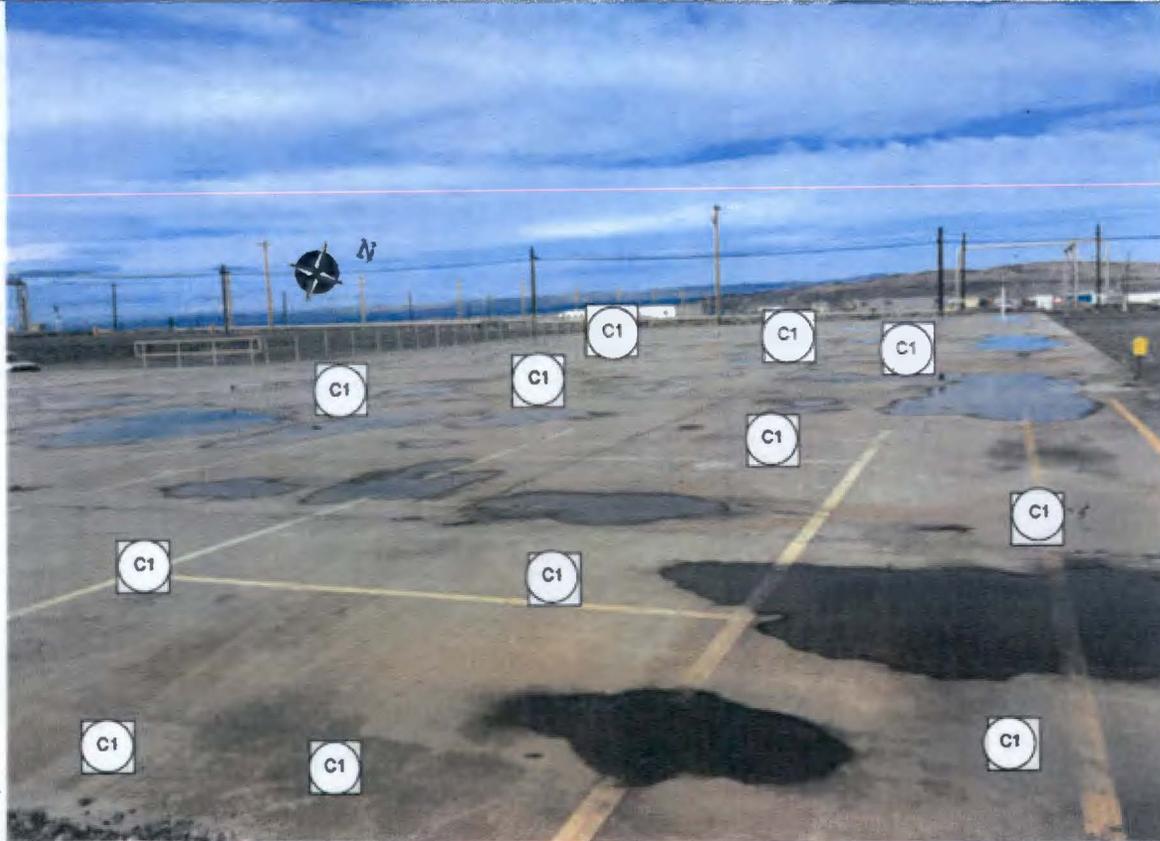
**Map Name: 275EA**

**Map Description: Concrete pad**
