BHI-00448
Rev. 0

White Bluffs, 100-IU-2 Operable Unit Technical Baseline Report

Date Published
December 1995

Bechtel Hanford, Inc.
Richland, Washington

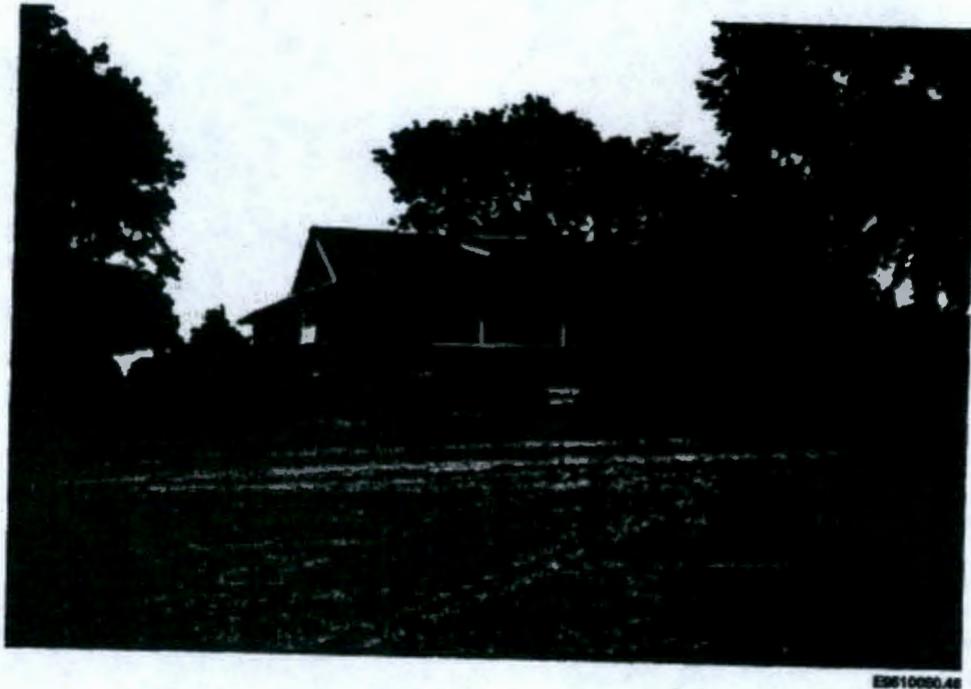
Photograph 2. Typical Home Utilized by the Manhattan Engineering District.

The majority of the site homes were one-story wood frame buildings containing from two to eight rooms (Appendix B, photograph 2). About one-third of the homes contained modern plumbing and inside facilities. Buildings that were placed into service were checked for safety and fire hazards and upgraded electrically for refrigerators and electric ranges. Others that were deemed uninhabitable were boarded up and padlocked, sold, or demolished.

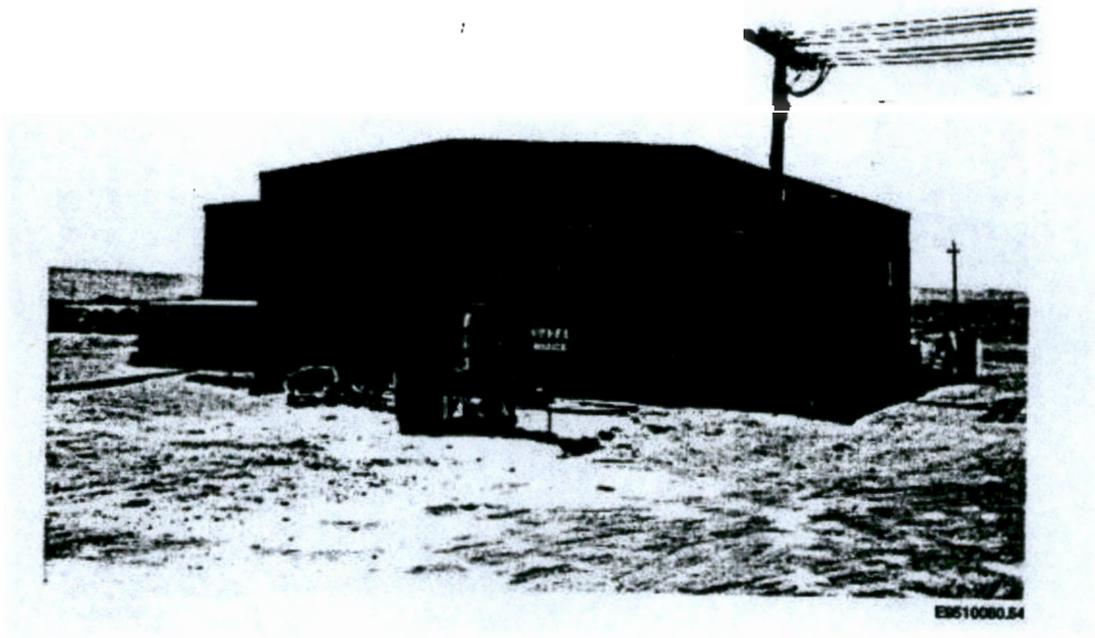
Photograph 5. TC-10 Welding Test Shop Looking South.

Located directly west of the site described in Section 4.15 was the Pipe Testing Shop (Appendix A, map 4). This facility was reportedly used as the quality control test and training facility for welders who worked in the Main Pipe Fabrication Shop at White Bluffs (Appendix B, photograph 5).

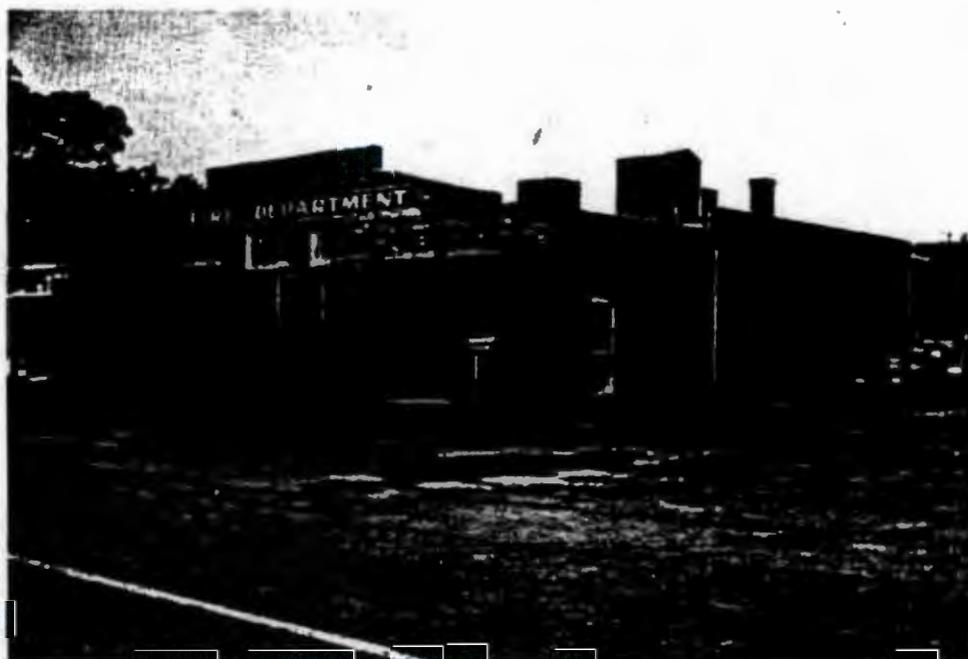
Photograph 8. White Bluffs Fire Station Looking Southwest.

- **Site Number 37:** Fire Station located at the northwest corner of First Avenue and Federal Avenue (Appendix B, photograph 8).
- **Site Number 38:** Service Division Engineer Office located north of Federal Avenue between First and Second Avenues.

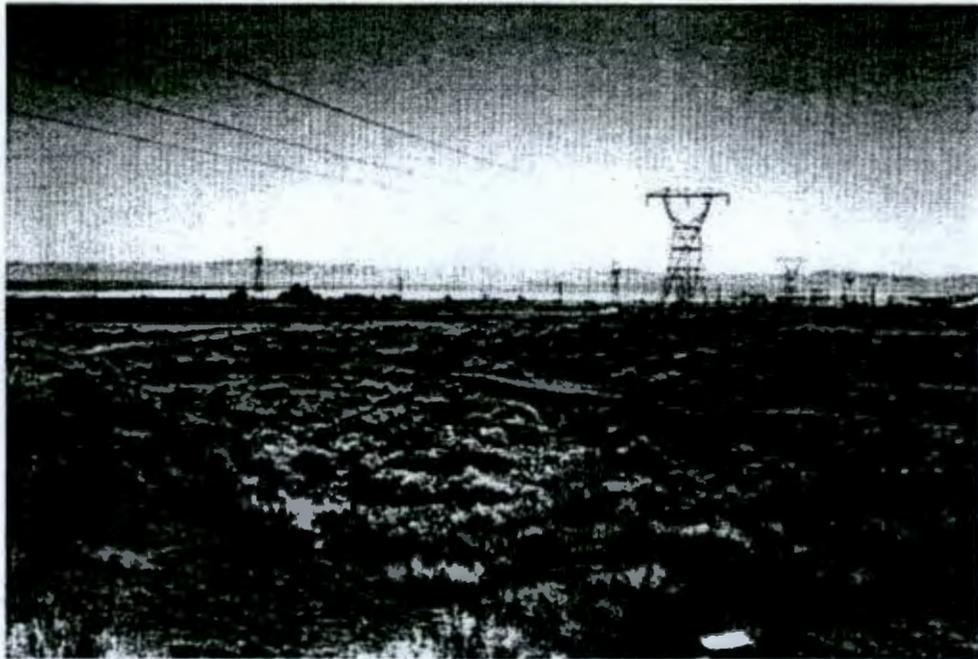
Photograph 27. Suspect Waste Disposal Trench.

Located east of the site described in Section 4.2.4 and along a power line road at WCS83S coordinates E578340 N147021 is a large disposal trench (Appendix A, map 8). This trench can clearly be seen in a 1948 aerial photograph and measures about 90 m long by 40 m wide. It appears as an open trench with industrial wastes filling about one-third of the site. These wastes consist of wooden and metallic debris. There is evidence of chemical or oil dumping and burning along the east side of the trench. This evidence includes discolored soils and empty 55-gal drums that are bulging as if their contents had been burned within the drums (BHI 1994b) (Appendix B, photograph 27).

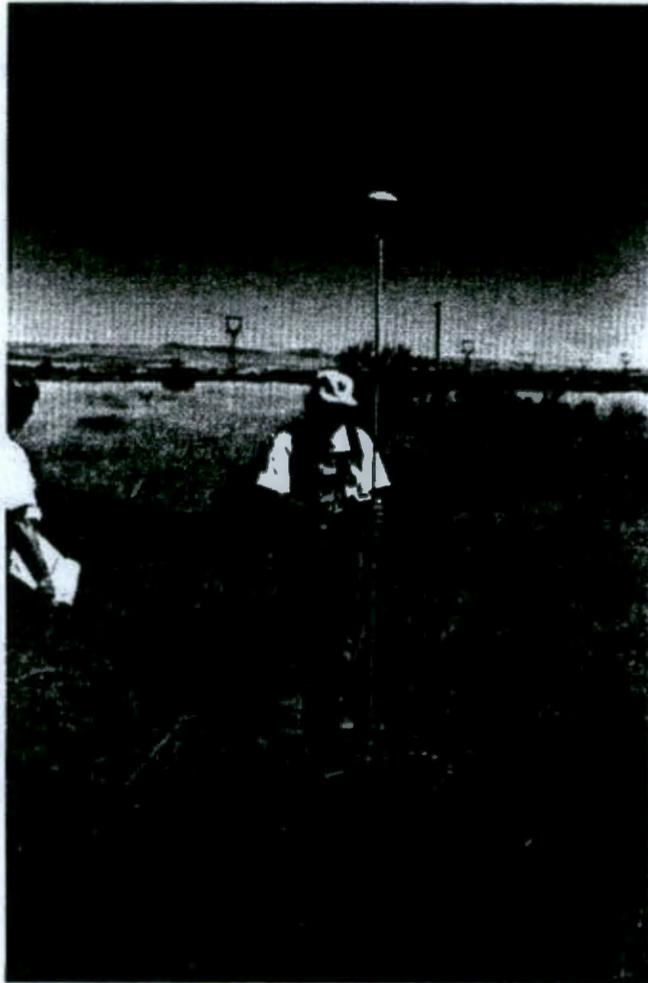
Photograph 39. Burn Pile and Debris Looking Northeast.

Directly west of the site described in Section 4.3 at WCS83S coordinates E578168 N147351 and E578193 N147350 are two debris piles (Appendix A, map 10). The first is a small burn pile and appears to be domestic-type debris. The second consists of 5-gal military-type drums (Appendix B, photograph 39).

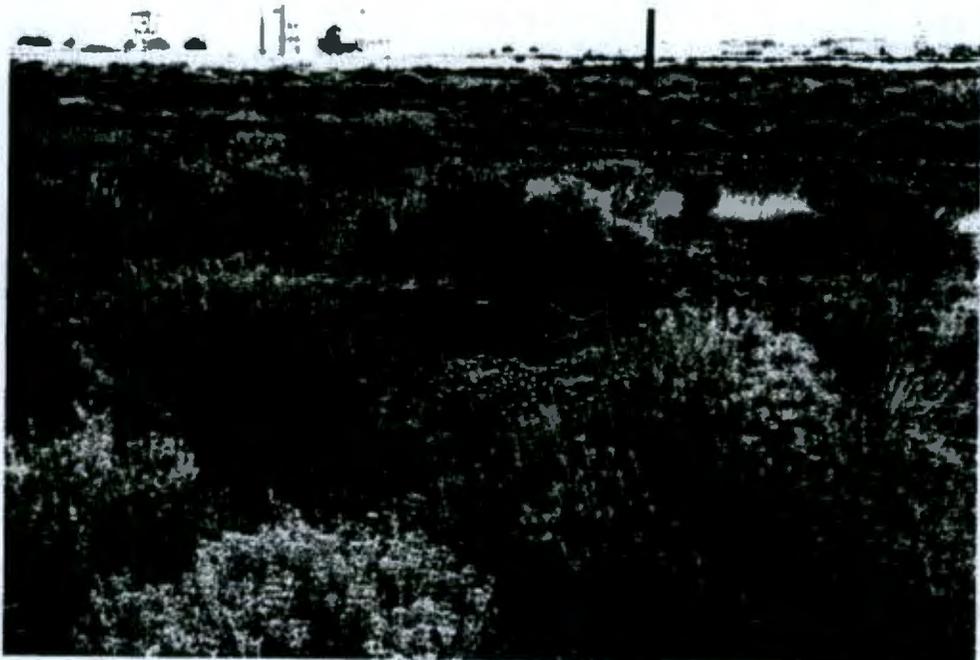
Photograph 41. Burn Site and Paint Disposal Area Looking East.

Located east of the White Bluffs City Dump described in Section 4.8 and just west of the present railroad tracks at WCS83S coordinates E578485 N147534 is evidence of surface burning and paint disposal (Appendix A, map 7). The site measures about 40 m long by 25 m wide. The site is adjacent to Route 2 North and at the southern end of what appeared to be a large warehouse storage area. The entire area is littered with burned wood, partly burned roofing materials, glass, nails, metallic debris, and isolated paint cans (BHI 1994b). There is evidence of surface disposal of paint materials in dried paint chips and deposits (Appendix B, photograph 41).

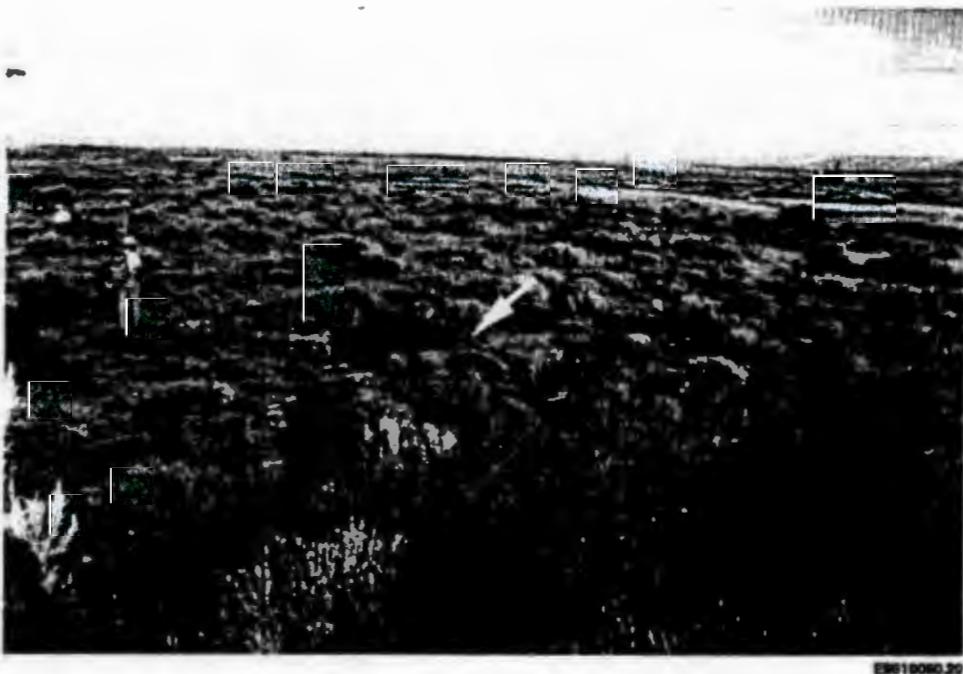
Photograph 42. Suspect Automotive Repair Shop Looking North.

Located west of and slightly north of the site described in Section 4.9 at WCS83S coordinates E578022 N147571 are the remains of what appears to have been an automotive repair shop (Appendix A, map 8). Surface indications consist of jack stands, car parts, wooden debris, and other metallic debris. This site is very close to a few depressions once thought to be the original drain field for excess water generated by the Priest Rapids Ice House (Appendix B, photograph 42).

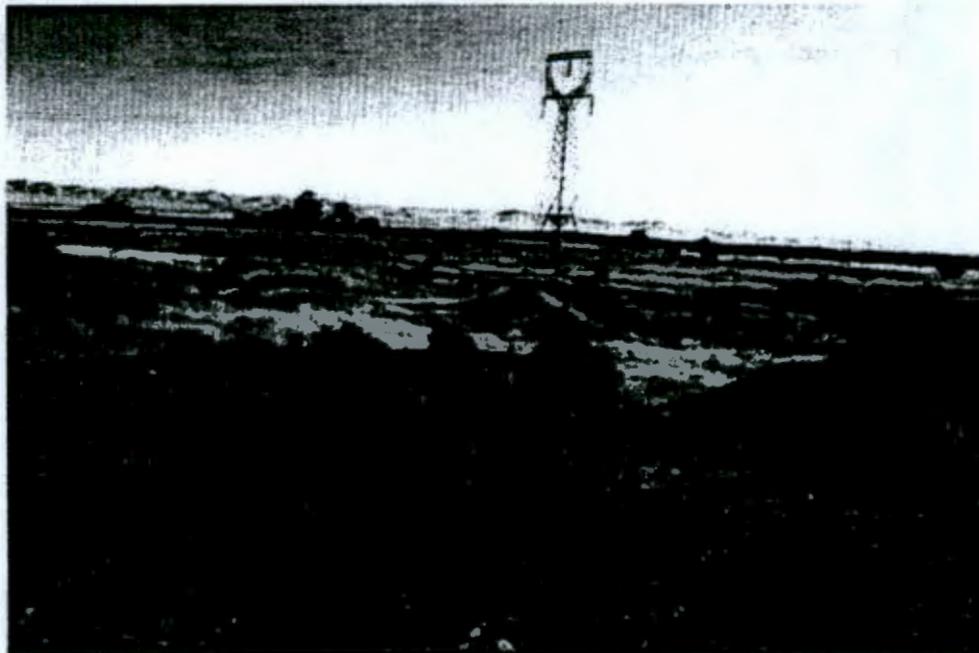
Photograph 43. Original Priest Rapids Ice House Drain Field Looking Northeast.

Located just northwest of the site described in Section 4.10 at WCS83S coordinates E577999 N147609 (approximate center; Appendix A, map 7) are three large depressions thought to be the original drain field for waste water generated at the ice house. The site originally was marked by a steel post and wooden rail fence that can still be found around much of the site, which measures about 40 m long by 30 m wide. It is unknown if this site was used for the disposal of any other wastes or used for any other purpose. A 1948 aerial photograph indicates that waste water was likely to have been disposed of at the site (Appendix B, photograph 43).

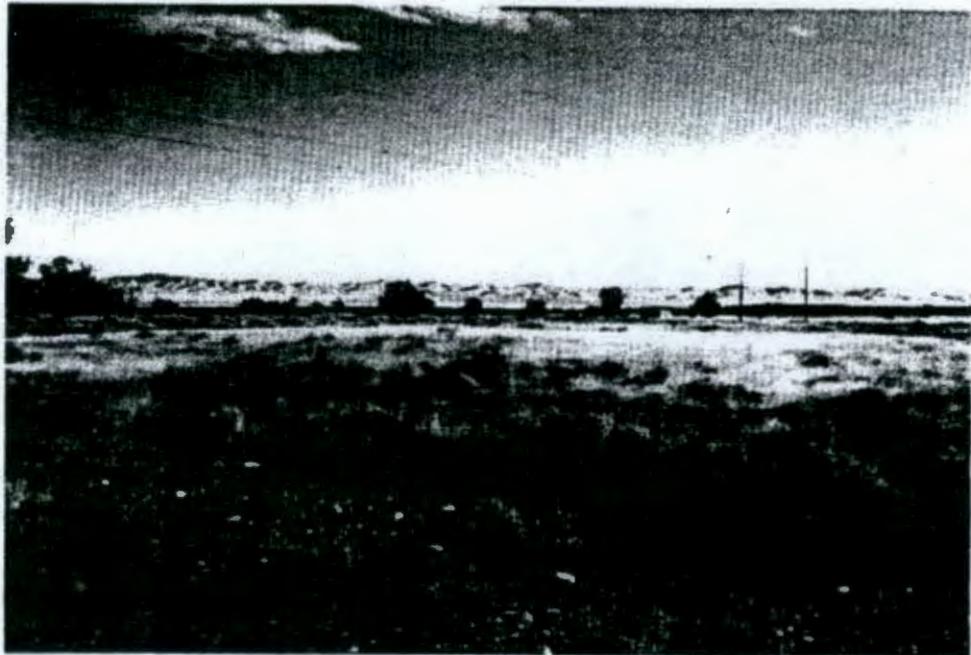
Photograph 44. Spare Parts Burning Pit Looking East.

Located just west of the site described in Section 4.11 at WCS83S coordinates E577872 N147634 (approximate center) is a dug-out burning pit (Appendix A, map 7). It is known to have been in operation from 1943 to 1948. It was used for the disposal of industrial and commercial wastes, which included flammable wastes, solvents, and waste oils. The site appears to have been backfilled with coal ash and may have also been used to dispose of other solid wastes (Appendix B in BHI 1994b). Evidence at the site indicates that it was about 110 m long by 65 m wide (Appendix B, photograph 44).

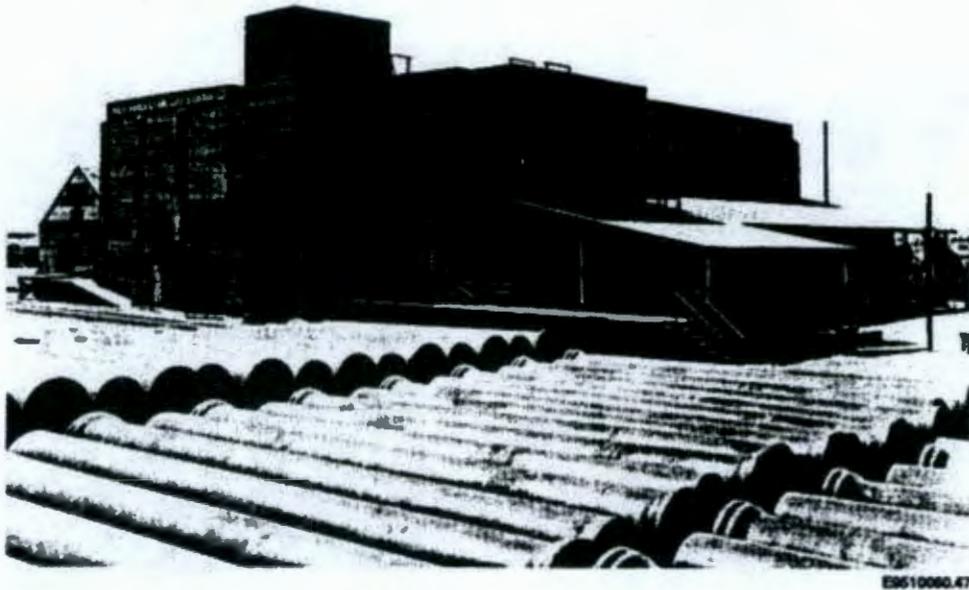
Photograph 46. Priest Rapids Ice House Looking Southeast.

Located northeast of the site described in Section 4.13, across a small roadway at WCS83S coordinates E578148 N147765 (approximate center), was the Priest Rapids Ice Plant and Cold Storage Facilities (Appendix A, map 7; Appendix B, photograph 46).

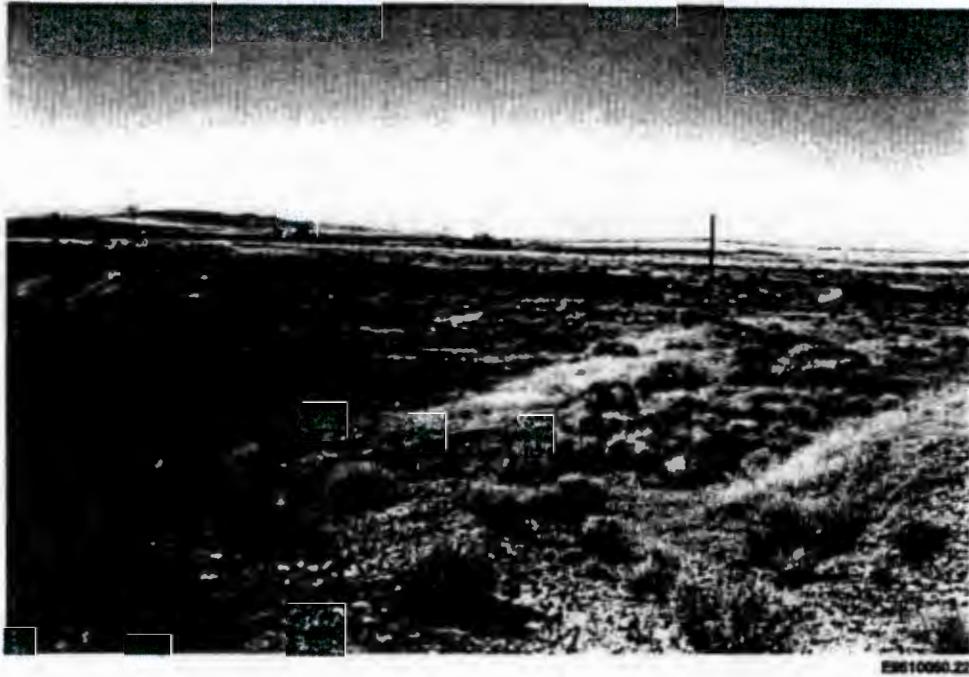
Photograph 49. Spare Parts Machine Shop Landfill and Pit Looking Southwest.

the warehouses. The borrow pit was dug in a semicircle to the northeast of these facilities; hence, it was named the horseshoe pit (Appendix B, photographs 49 and 50).

Photograph 50. Spare Parts Machine Shop Landfill and Pit Looking West.
