FACILITY STATUS CHANGE FORM

Date Submitted: February 13, 2013	Area: 300 Area	Control #: D4-300-033-1
Originator: Chris Strand	Facility ID: 3727	
Phone: 554-2720	Action Memorandum: Action Memorandum #3

3727 Classified Storage Vault

Attachment 2: Project Photographs

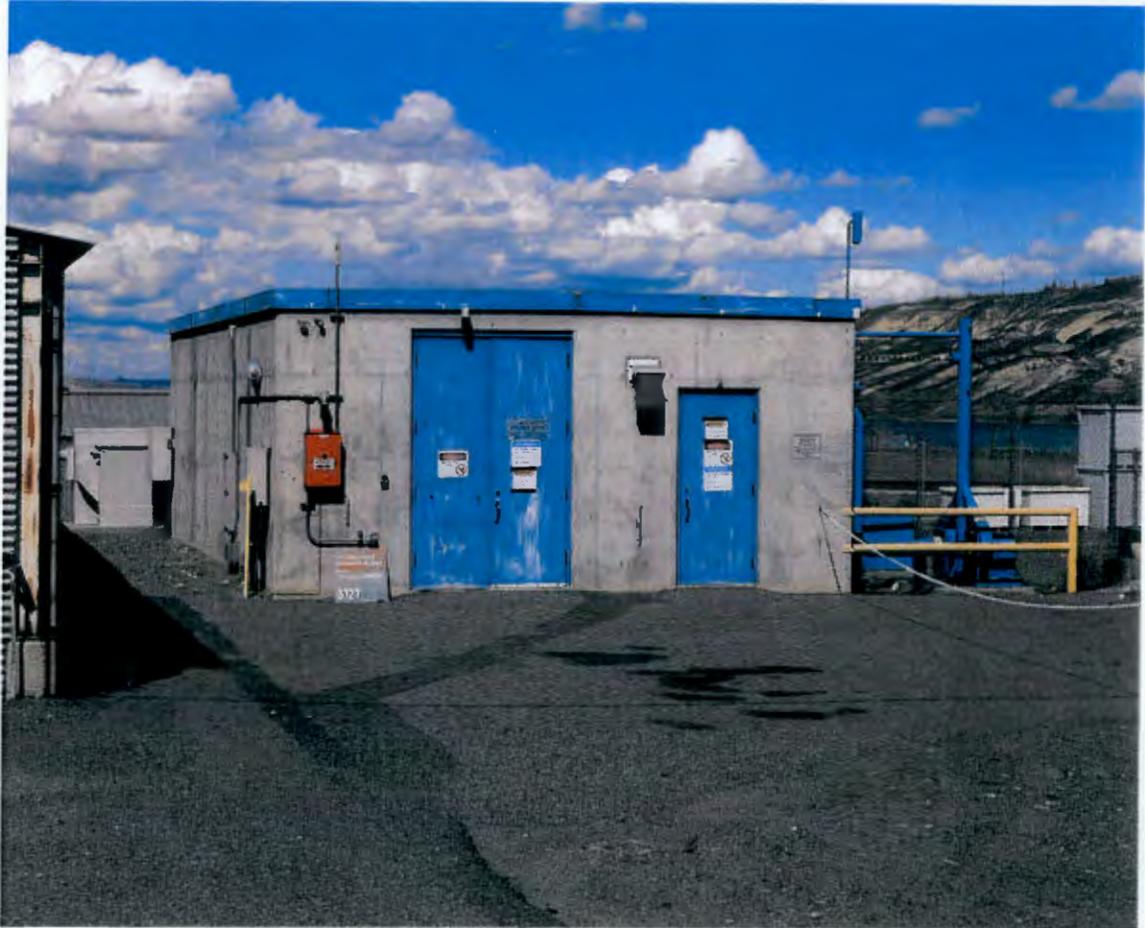
Photograph 1: 3727 looking north, March 31, 2006.

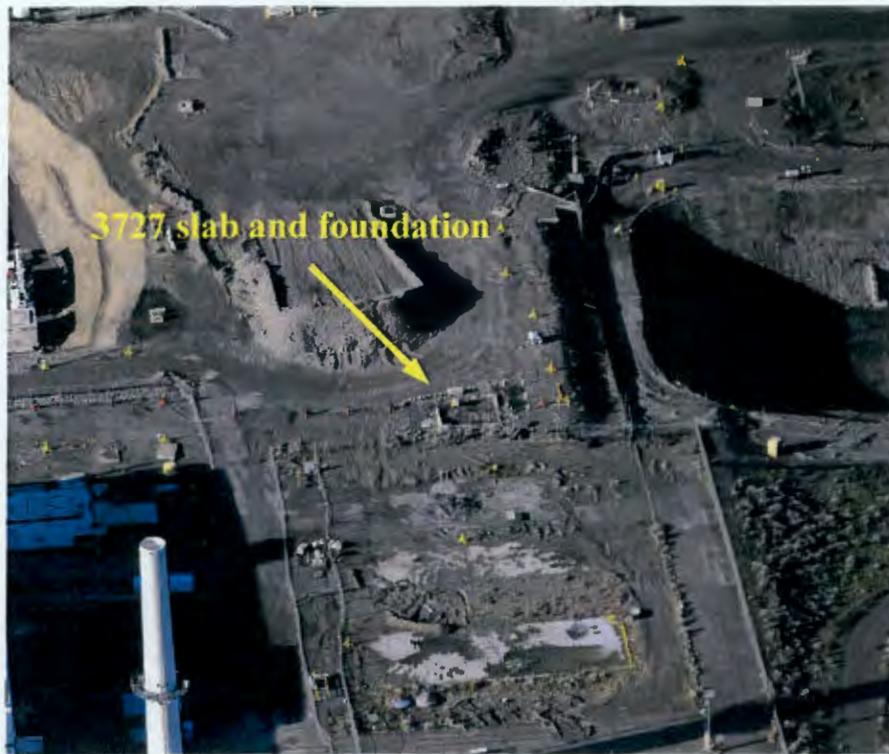
Photograph 2. Aerial view of 3727 foundation, looking west on December 4, 2012.

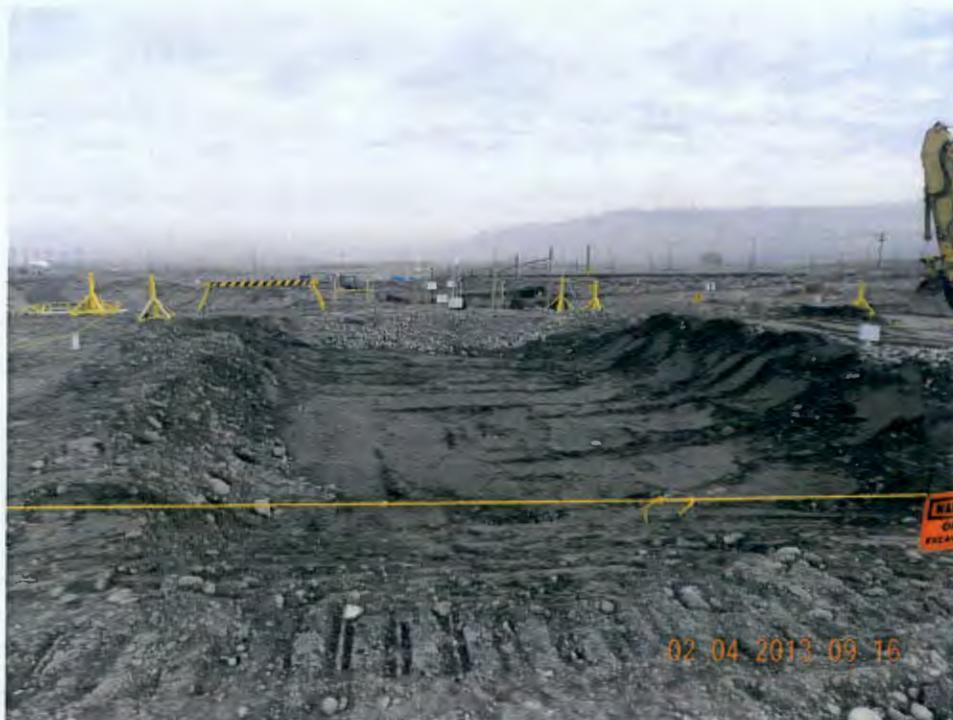
Photograph 3. 3727 excavation looking north, February 4, 2013.

No anomalies were discovered during demolition. Soils beneath the slab and foundation displayed no visual evidence of staining or discoloration. A final GPERS survey of the excavation following below-grade demolition identified no radiological contamination.

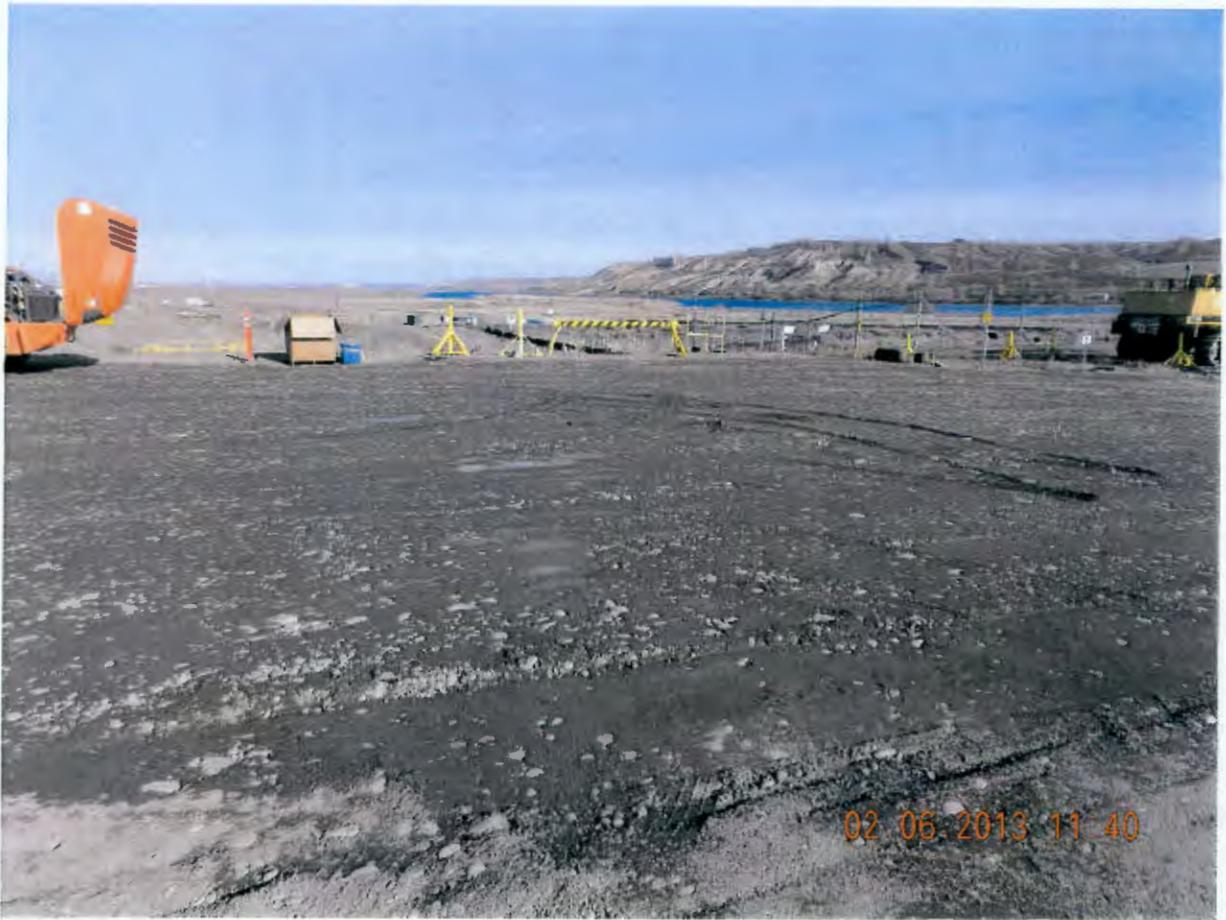
Photograph 4. 3727 backfilled, looking northeast on February 6, 2013.

All above-grade structures and foundations were removed. Excavations were backfilled to grade with clean fill. GPERS surveys were performed prior to backfill. No radiological or Industrial Hygiene postings remain.

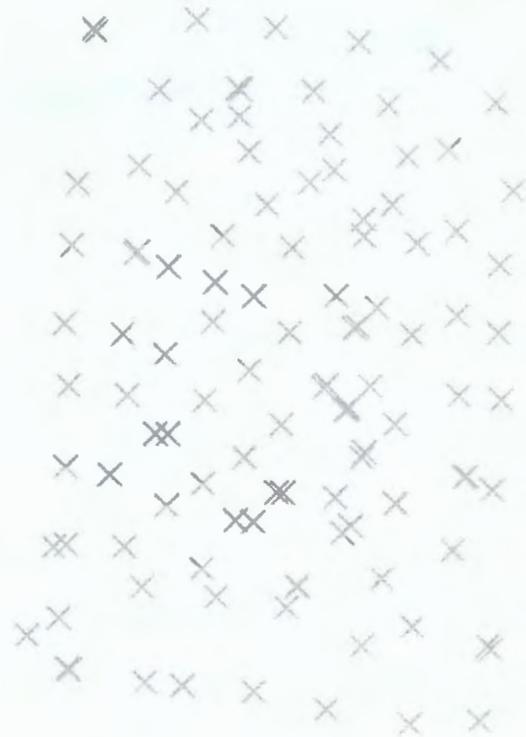
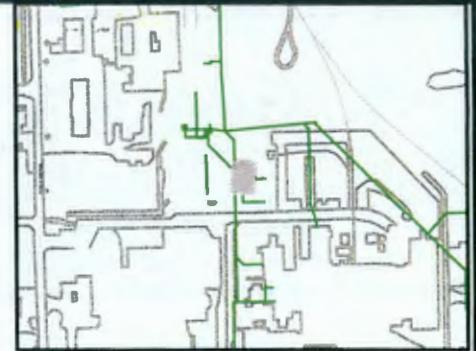
← Bkg Location
100 meters W
390 cpm

Coverage File: D4_031
Number of Data Pnts: 115
Type of Survey: beta
Max GCPM: 598
Avg Bkg CPM: 390
Survey Date: 1/31/13
Area Surveyed: 198 m²
Project File: ESRFRM130015B
Pdf File: ESRFRM130015BC

3727 Excavation
GPERS Radiological Survey
Beta Track Map

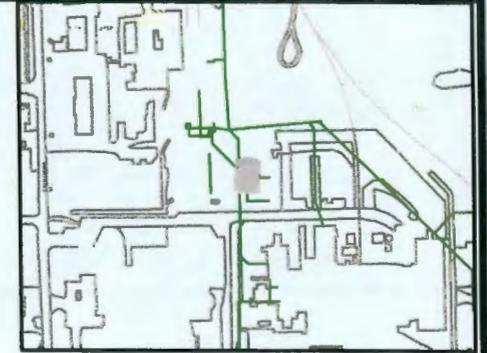
← Bkg Location
100 meters W
1551 cpm

Coverage File: D4_031
Number of Data Pnts: 1481
Type of Survey: gamma
Max GCPM: 2038
Avg Bkg CPM: 1551
Survey Date: 1/31/13
Area Surveyed: 198 m²
Project File: ESRFRM130015G
Pdf File: ESRFRM130015GC

300 D4 3727 Excavation GPERS Radiological Survey Gamma Track Map
