RHO-RE-SR-37 P

Closeout Report for the Decontamination and Decommissioning of the 203-S, 204-S, 205-S Facilities

September 1984

Olaf Rasmussen
Process Engineering Department
Research and Engineering

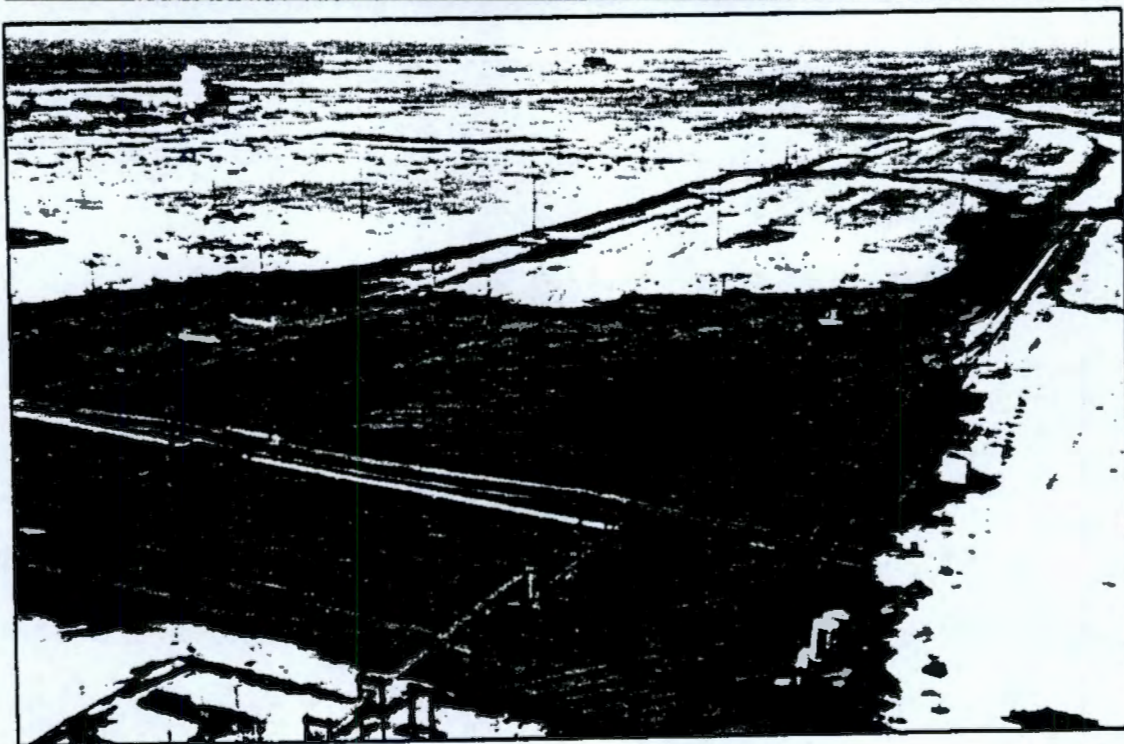
FIGURE 1. The 203-S, 204-S, 205-S Site Before and After Decontamination and Decommissioning.

The 203-S, 204-S, 205-S Decontamination and Decommissioning (D&D) project represents the first major D&D operation carried out by the recently established D&D Team in the U.S. Department of Energy Hanford Site's Chemical Processing Areas. The 203-S, 204-S, 205-S site was an easy and obvious D&D choice from several viewpoints - not only did this D&D operation offer an effective solution to a recognized environmental hazard, it offered a moderately sized facility with a variety of equipment types and structures, including an underground vault, a multistory building, and aboveground tank farms and provided the opportunity to develop D&D expertise in several areas. The lack of extreme radiation levels allowed new employees to acquire skills without a serious radiological hazard. Completion of the project below budget and well ahead of schedule has left Rockwell Hanford Operations (Rockwell) with an experienced and capable team for future D&D operations in the 200 Areas. Figure 1 shows the site before and after D&D.

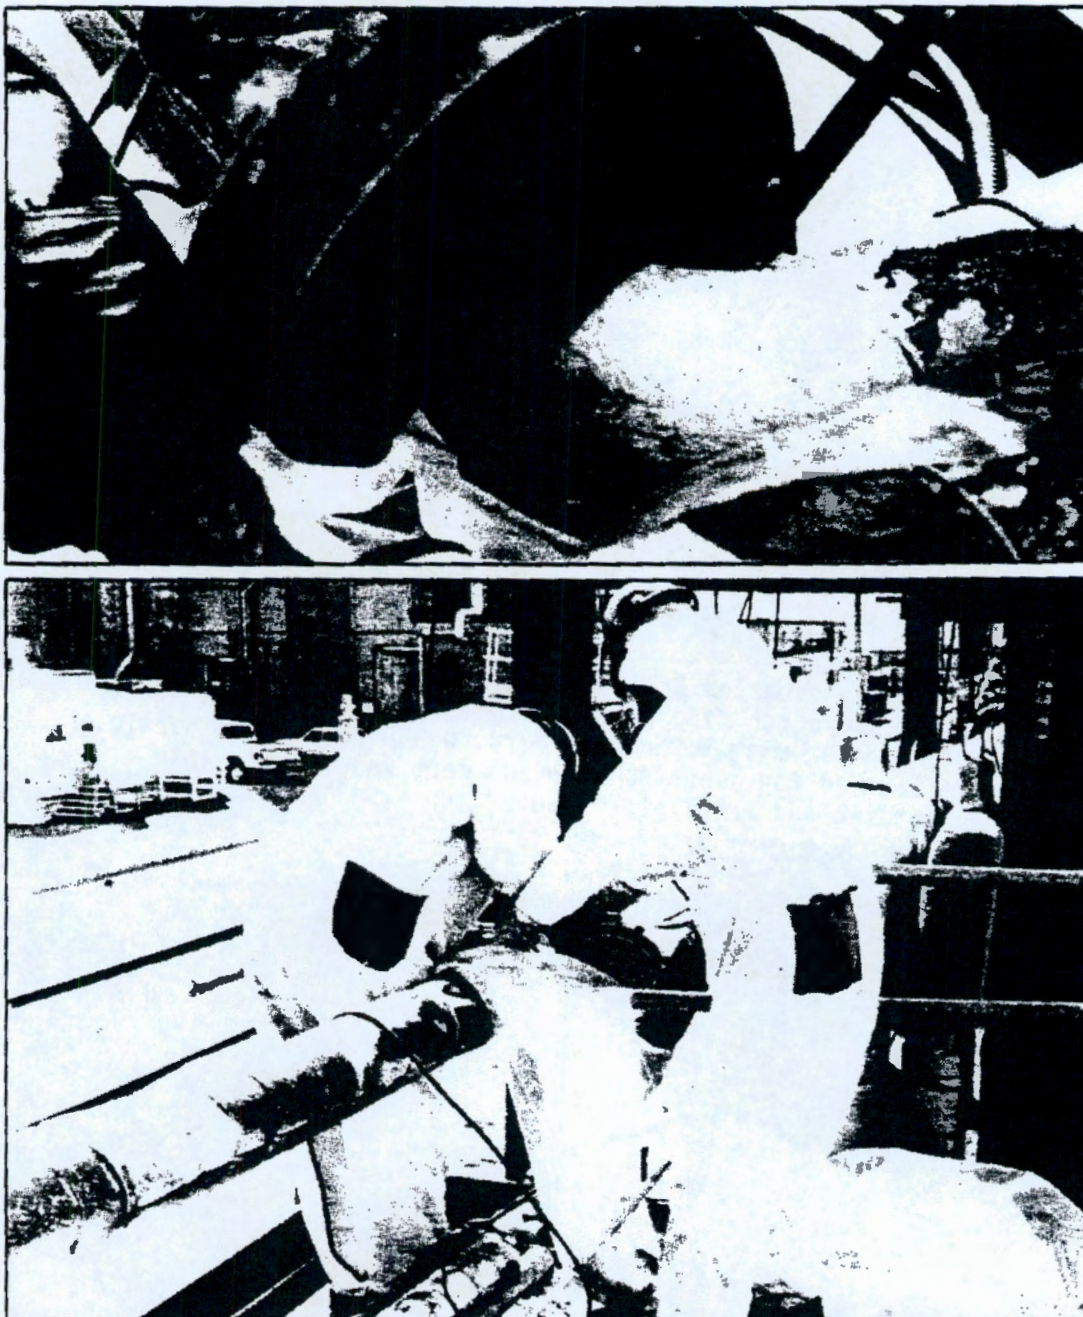
FIGURE 9. Pipe Cutting Operation. A hydraulic crimper (top) was the preferred cutting tool for piping 2 in. or smaller in diameter because the crimper sealed the pipe ends except for two small pinholes. A portable bandsaw (bottom) was used for large-diameter piping where the crimper could not be utilized.

Piping larger than 2 in. in diameter was cut with a saw (Fig. 9). In rare instances, where required by radiological conditions inside the pipe, the line was filled with foam-producing chemicals to fix and immobilize radioactive contamination.

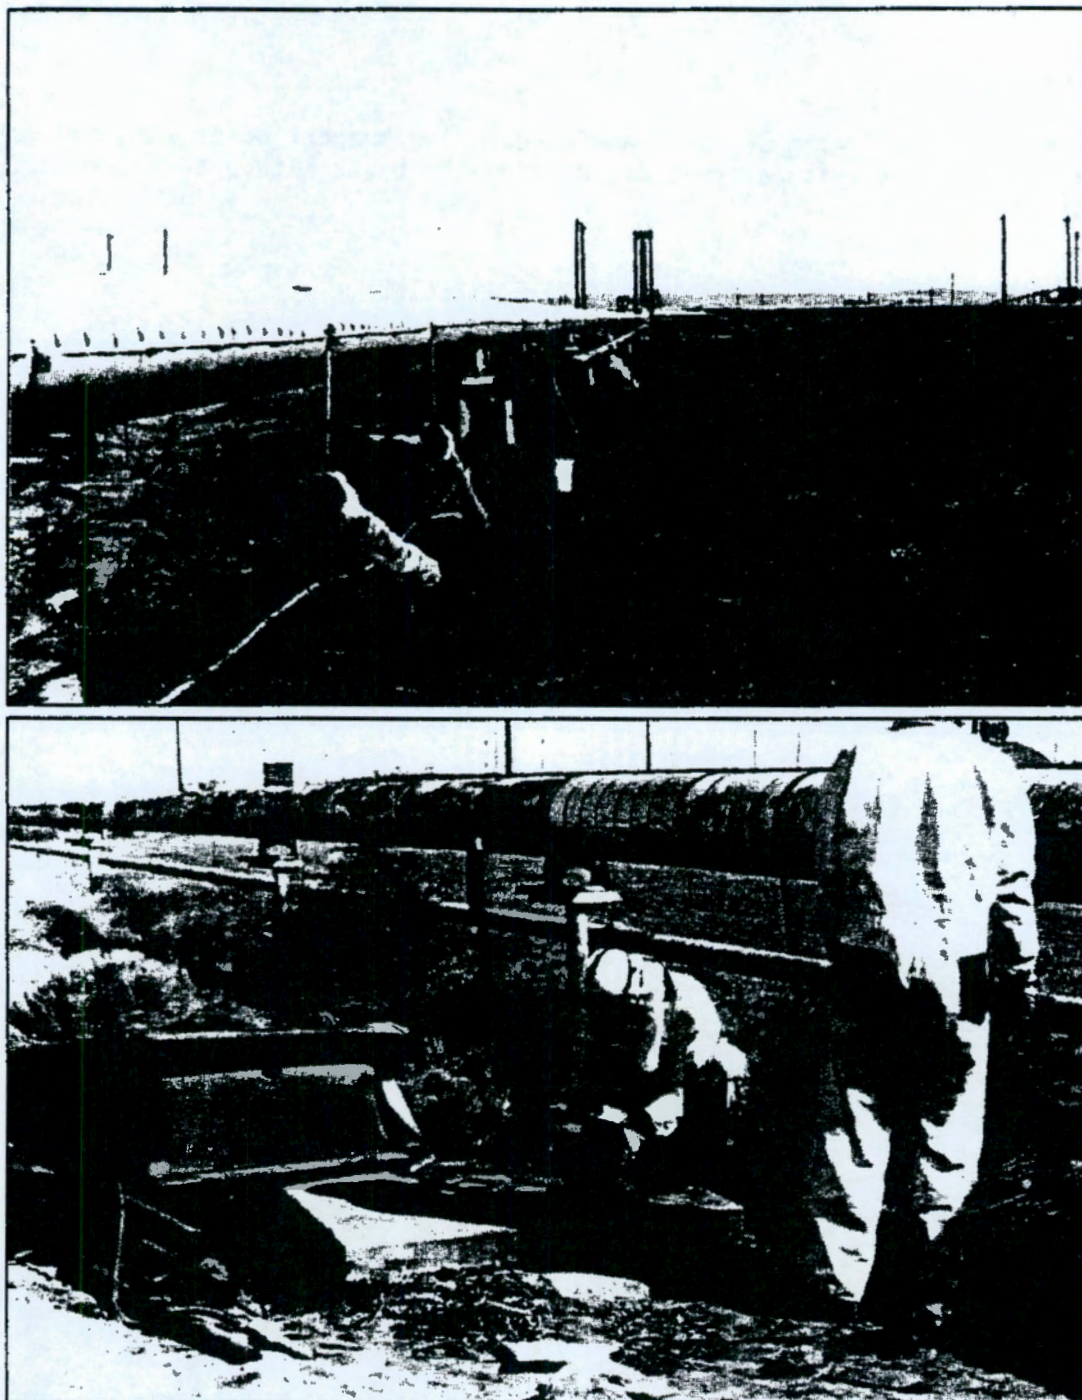
FIGURE 11. Dismantling the Cross-Country Section of the Uranium Nitrate Hexahydrate Line. Note cut-and-wrapped pipe sections (top), and dismantling a pipeline heat trace station (bottom).

The UNH pipeline, leading from the 203-S, 204-S, 205-S area south to the Redox plant and north to the UO_3 Plant, was totally dismantled. The line consisted of nearly a mile of overground-lagged and electrically heat-traced 2-in. stainless steel pipe. The entire pipe was wrapped in plastic by D&D workers. Lagging was only removed at cut points to allow use of the hydraulic crimper. Additional piping related to the UNH system was removed at both Redox and the UO_3 Plant. While much of the pipeline ran cross-country about 2 ft above the ground and allowed dismantling from ground level, cranes and a scissor lift had to be used for the elevated portion of the line in the plant areas. All piping was disposed of by burial. Progression of the UNH line dismantling is shown in Figures 10 through 12.

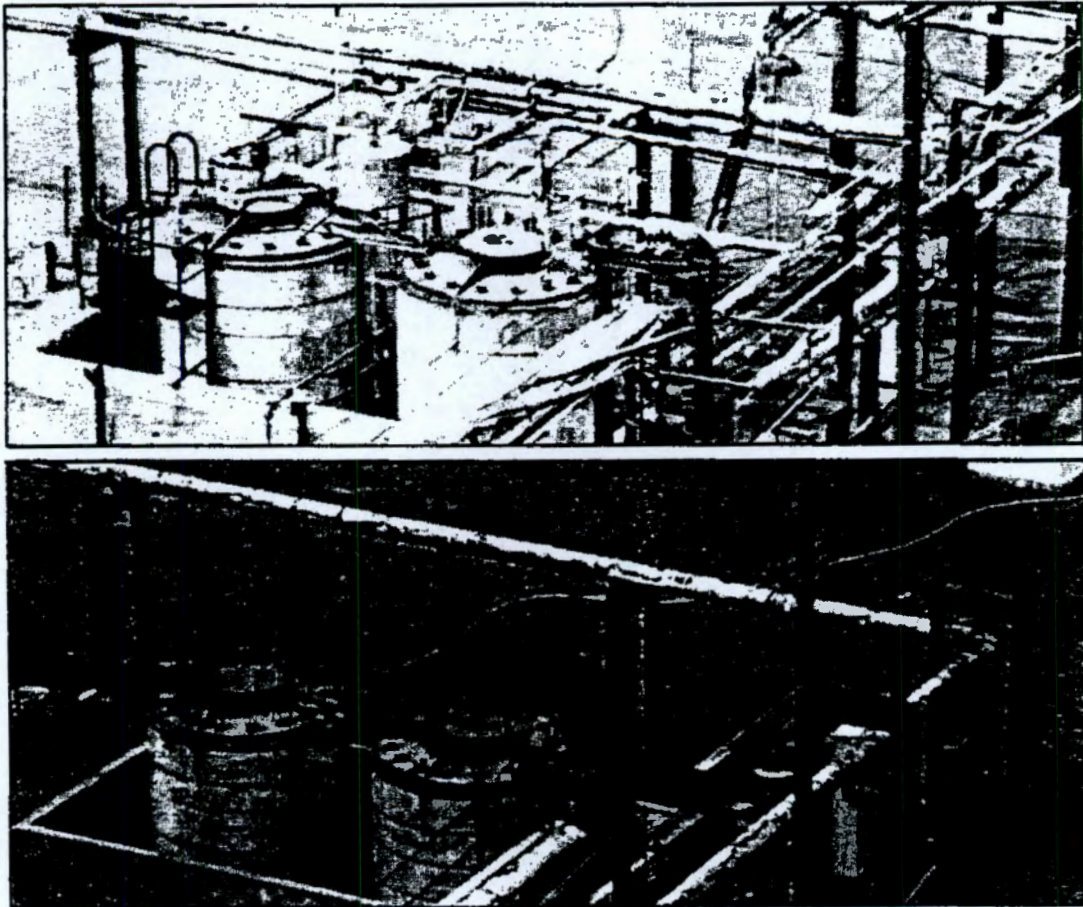
FIGURE 14. The 203-S Area Before and After Piping Removal.

The D&D workers removed a large volume of piping and miscellaneous small equipment such as pumps, agitators, platforms, filters, and electrical systems as the first stage of the 203-S effort. All of this auxiliary equipment was wrapped in plastic and buried (Fig. 13 and 14).

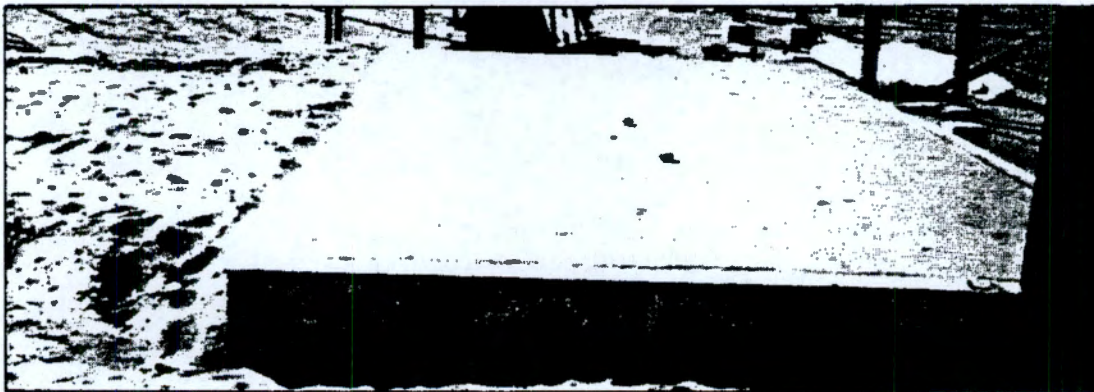
FIGURE 17. The 203-S Basin After Filling with Compacted Soil.

The 203-S Basin was backfilled to the top of the concrete walls with gravel and soil (Fig. 17). Final backfill was left for the 203-S, 204-S, 205-S site fill-and-grading operation at the close of the project.

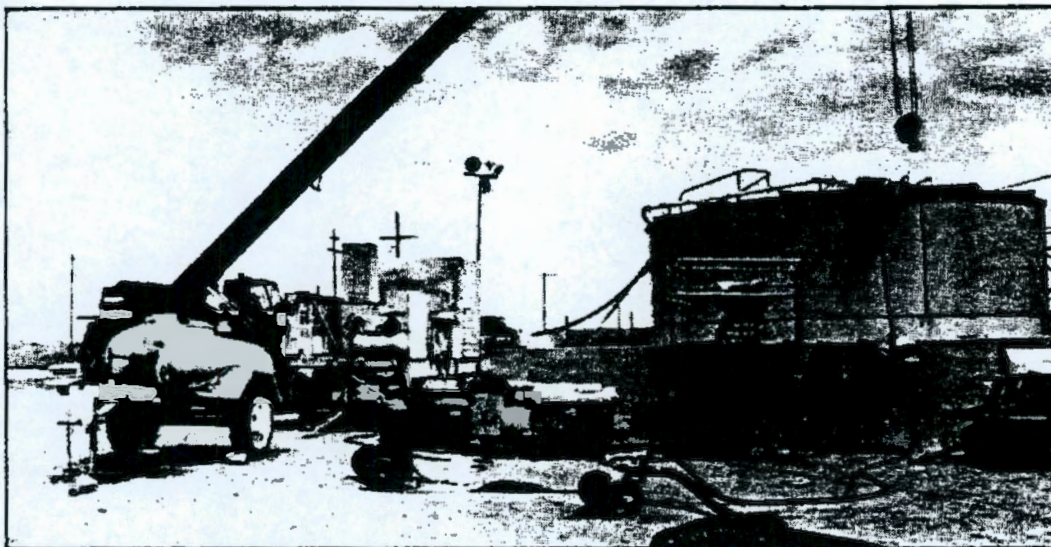
FIGURE 31. Sluicing Support Equipment Outside the Tank. A large array of equipment was required for hot water sluicing, including the high-pressure pump, portable motor starter, diesel generator, and fuel trailer in the foreground. The 7,000-ft³/min Portable Exhauster (left center) was used to draw vapors from the tank and to maintain a vacuum in the vessel.

The sluicing operations carried out during the pre-D&D shutdown/standby phase removed the bulk of the sludge in the four 204-S tanks and left all but Tank 204-S-4 in a transportable condition with a solids heel of 1 ton or less. In spite of an extensive sluicing effort directed toward Tank 204-S-4, the tank still contained 10-12 tons of heavy sludge when sluicing operations were terminated due to lack of progress. The sludge buildup in the tank consisted of old sludge waste from N Reactor decontamination work, and from 300 Area laboratory and process wastes. Radiation levels along the bottom foot of the tank ranged from 3-5 rem/h at contact. Removal of this sludge material was essential for transport of the tank, as engineering calculations indicated that an internal tank load of more than 2 tons could lead to unacceptable stresses in the welds joining the tank bottom to the side. The laboratory tested samples of the sludge material and found that although no practical means of chemical sludge dispersion or dissolution was available, a significant amount of sludge softening could be obtained with hot water. Consequently, Process Engineering, Tank Farm Operations, and Production Support (maintenance) worked out a hot water sluicing system, consisting of a high pressure hot water pump and the commercial tank cleaning machine (Fig. 30 and 31) used in earlier operations.

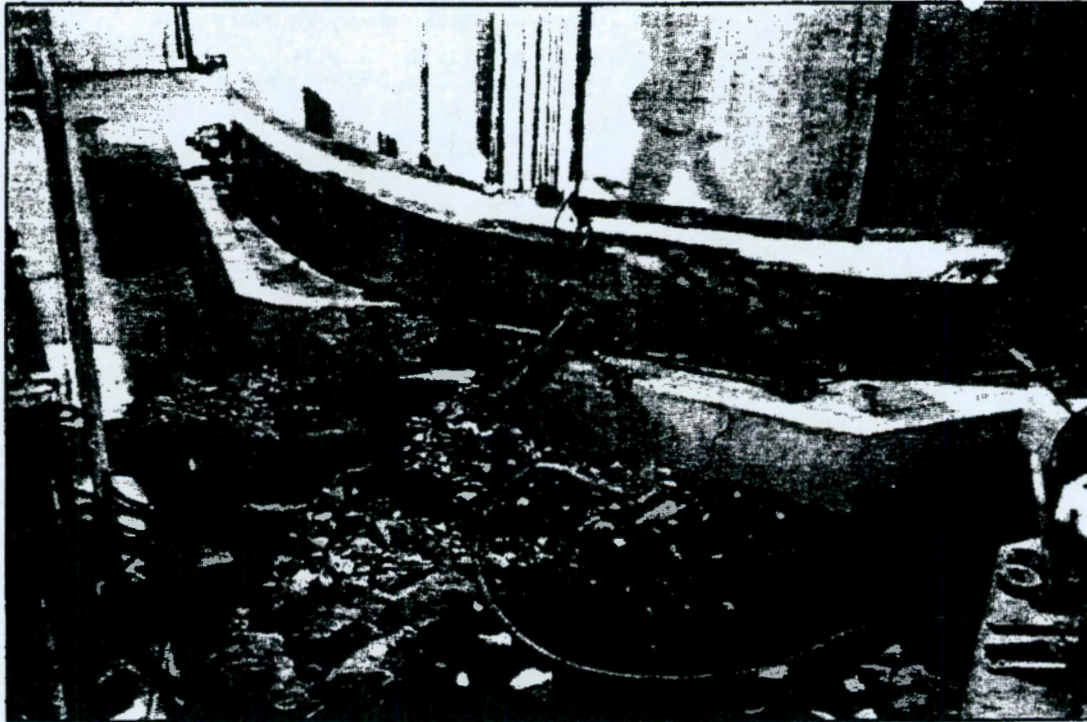
FIGURE 34. Using a Jackhammer to Remove the Tank Drain Line from the Concrete Tank Pedestal. Note the lead sheeting taped to the tank wall to reduce radiation exposure to the jackhammer operator.

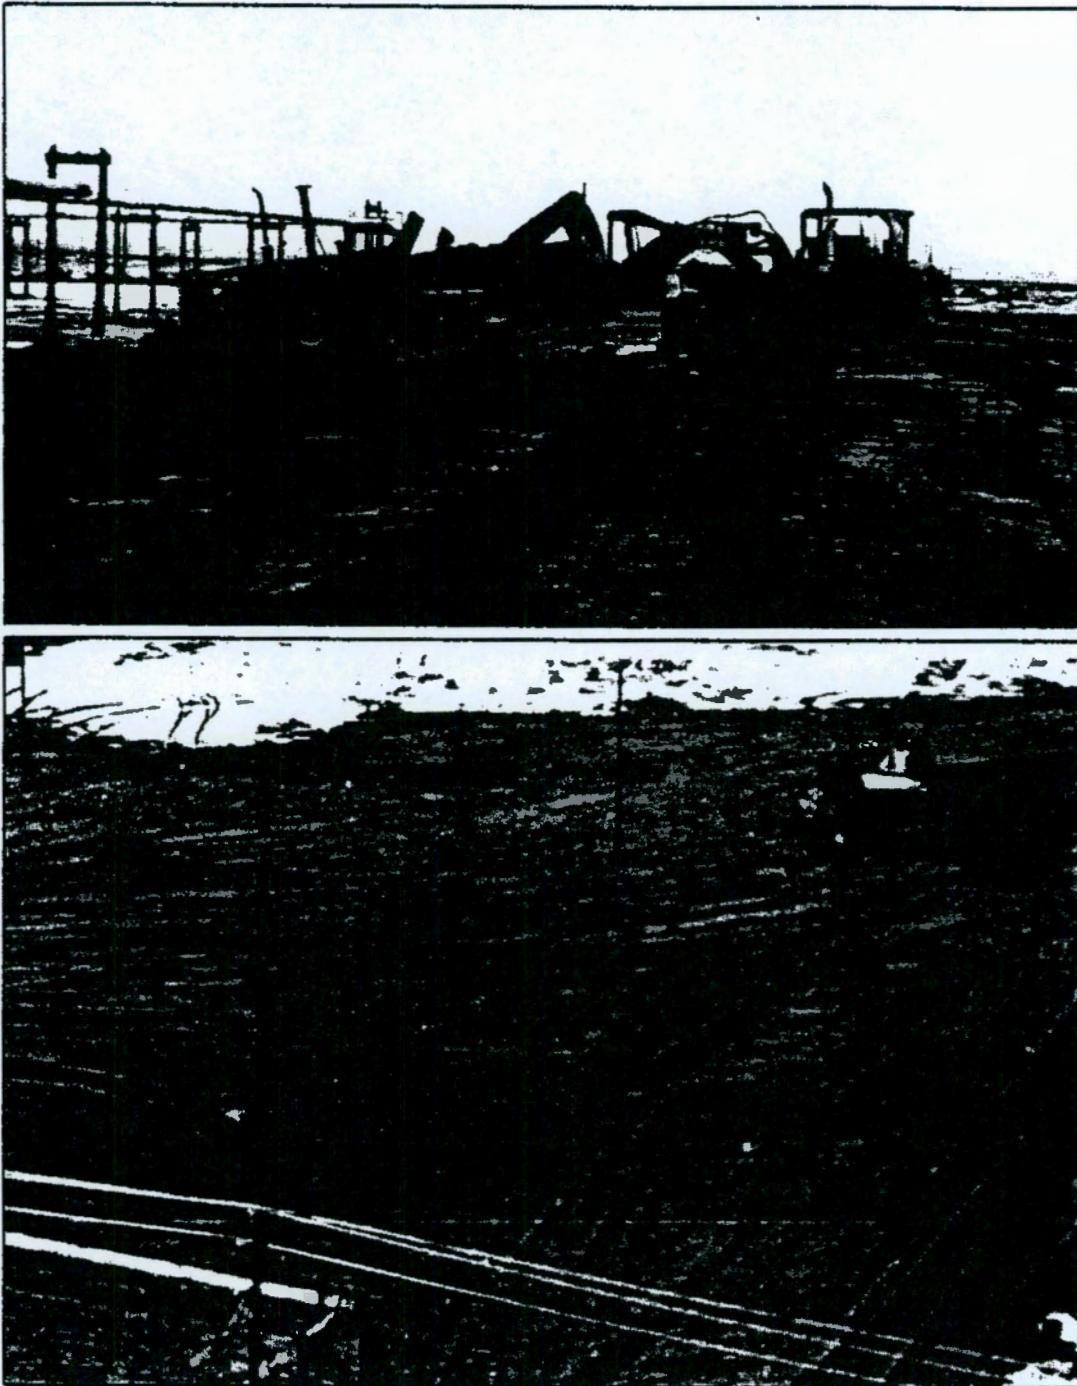
FIGURE 45. Backfilling the 203-S, 204-S, 205-S Site with a Scraper (top) and Performing Final Contouring with a Bulldozer and Grader (bottom). After final grading, the area was mulched and seeded with wheatgrass to stabilize the soil.
