## FACILITY STATUS CHANGE FORM

<b>Date Submitted:</b> Jul 16, 2012	<b>Area:</b> 300 Area	<b>Control #:</b> D4-300-064
<b>Originator:</b> John Harrie	<b>Facility ID:</b> 3705 & 3705BA	
<b>Phone:</b> 509.308.9935	<b>Action Memorandum:</b> Action Memorandum #1

**300 D4**  
**3705, 3705BA, 3719**  
**GPERS Radiological Survey**  
**Gamma Track Map**

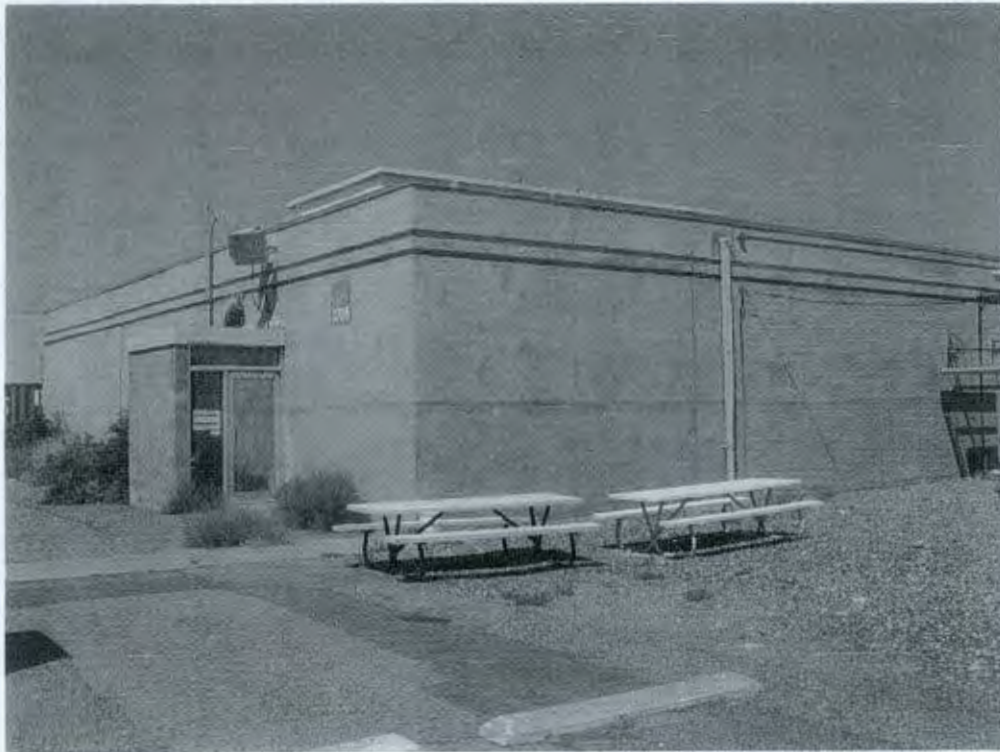
**Figure 1: Looking northwest at the 3705 Building in July of 2004.**

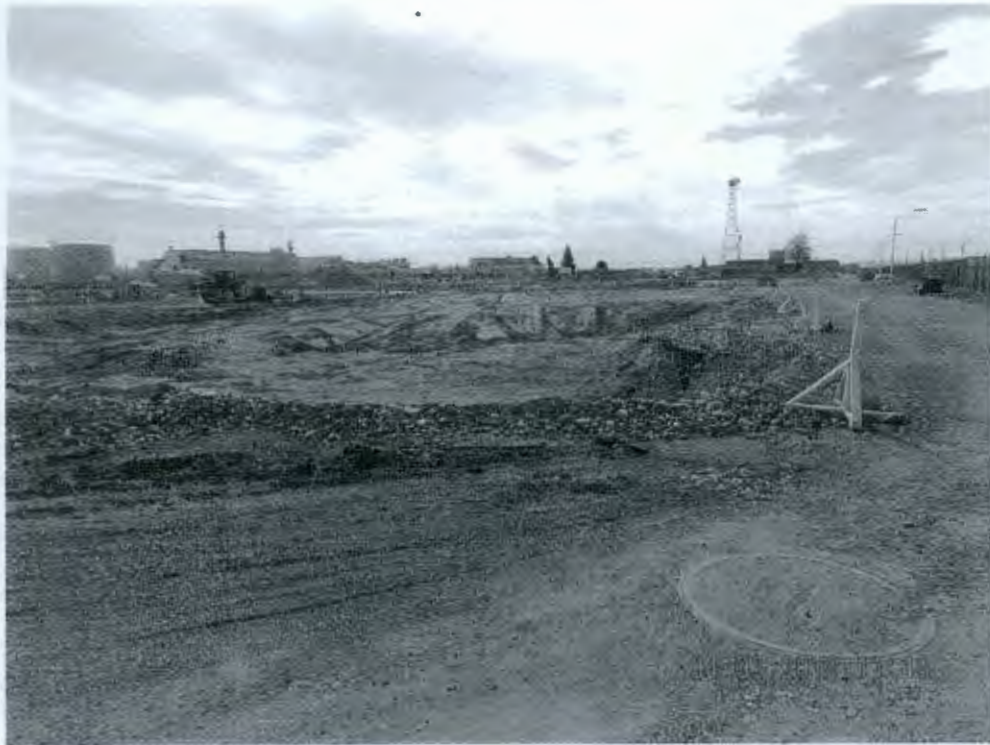
No anomalies were observed during the demolition of the 3705 and 3705BA Buildings. Soil beneath the slab displayed no visual evidence of staining or discoloration. Process sewer removed within the excavation layback.

**Figure 3. Looking south at 3705 and 3705BA following slab removal in April of 2012.**

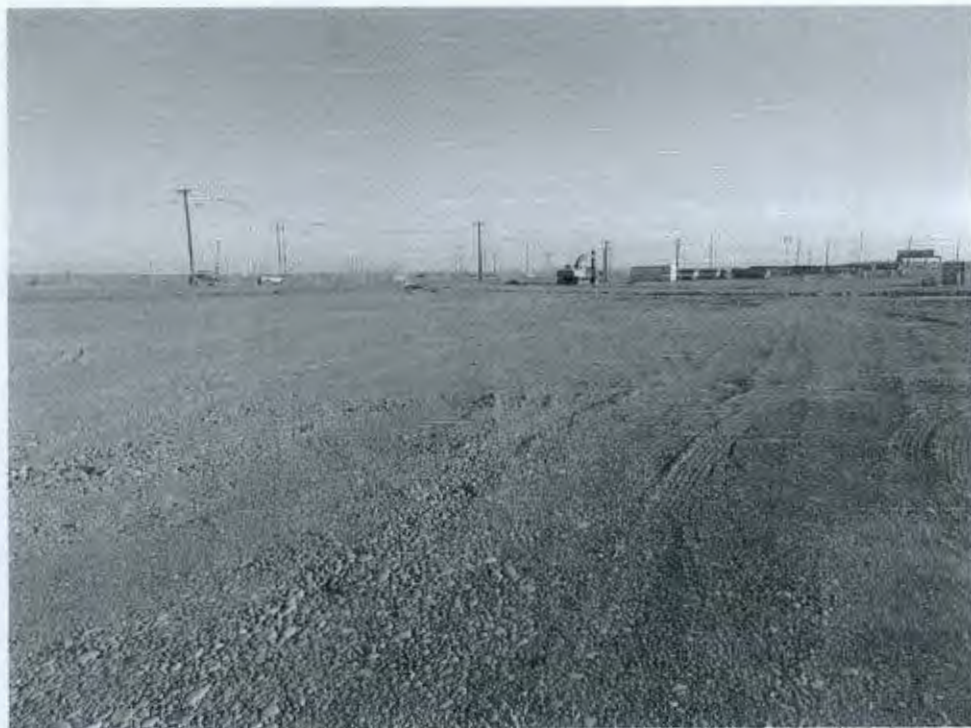
The 3705 and 3705BA building debris and slab foundations were removed and disposed of at EDRF. A GPERS survey is included as Attachment 3. Excavation was backfilled to grade with clean fill. 300-15 segments removed within the excavation layback.

**Figure 4. Looking north at 3705 and 3705BA following backfill in July of 2012.**
