BHI-01106
Draft A

190-C Main Pumphouse Facility Final Report

Bechtel Hanford, Inc.
Richland, Washington

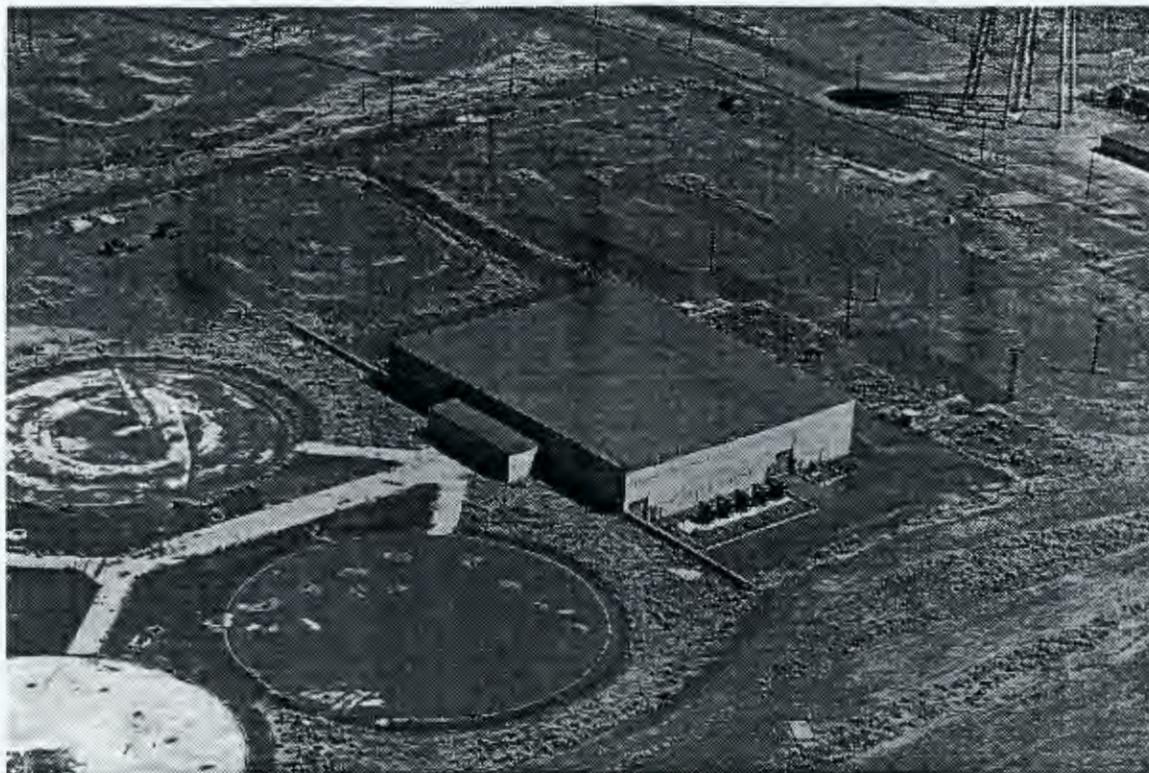
Figure 1. Aerial View of the 190-C Building, Pointing Northeast.

The 190-C Main Pumphouse Facility pumped water to the C Reactor as part of the reactor cooling process after the water was treated/filtered in the 183-C Filter Building/Pumphouse. The water was chemically treated with sodium dichromate and stored in outside tanks located between the 190-C and 183-C Facilities. Physical attributes of the facility are taken from available facility drawings. Figures 1 and 2 are photographs of the facility before demolition.

The 190-C Facility was approximately 48.8 m (160 ft) by 59.7 m (196 ft) by 9.8 m (32 ft), above ground structure, constructed on a reinforced concrete foundation with a full basement. The interior and exterior walls were made of 1.27-cm (0.5-in.)-thick transite totaling approximately 9,290 m² (100,000 ft²). The building contained approximately 1,900 linear feet of asbestos-lagged pipes and valves.

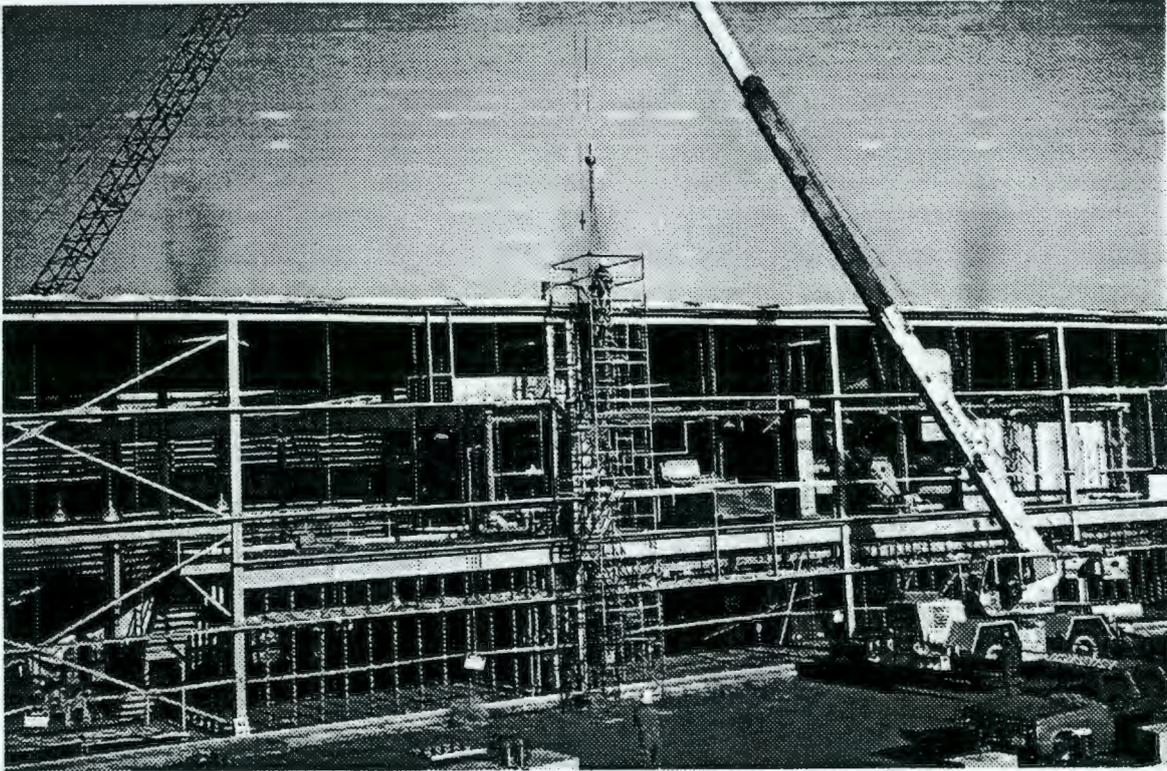
Figure 4. View of the East Side of the Building Without Siding.

Building structural framework was demolished using hydraulic shears and segregated for salvage (Figure 5). Figure 4 shows the east side of the facility with the building's walls removed. The main level concrete floors and pump foundations were demolished and disposed into the basement. Concrete and steel were demolished in place to a depth 0.91 m (3 ft) below grade, and the basement was filled to eliminate future subsidence. Nonrecyclable/nonhazardous debris was placed in the underlying basement, as it was demolished for in-place disposal. A majority of the below-grade water pipes were removed, except some piping that was left in place.

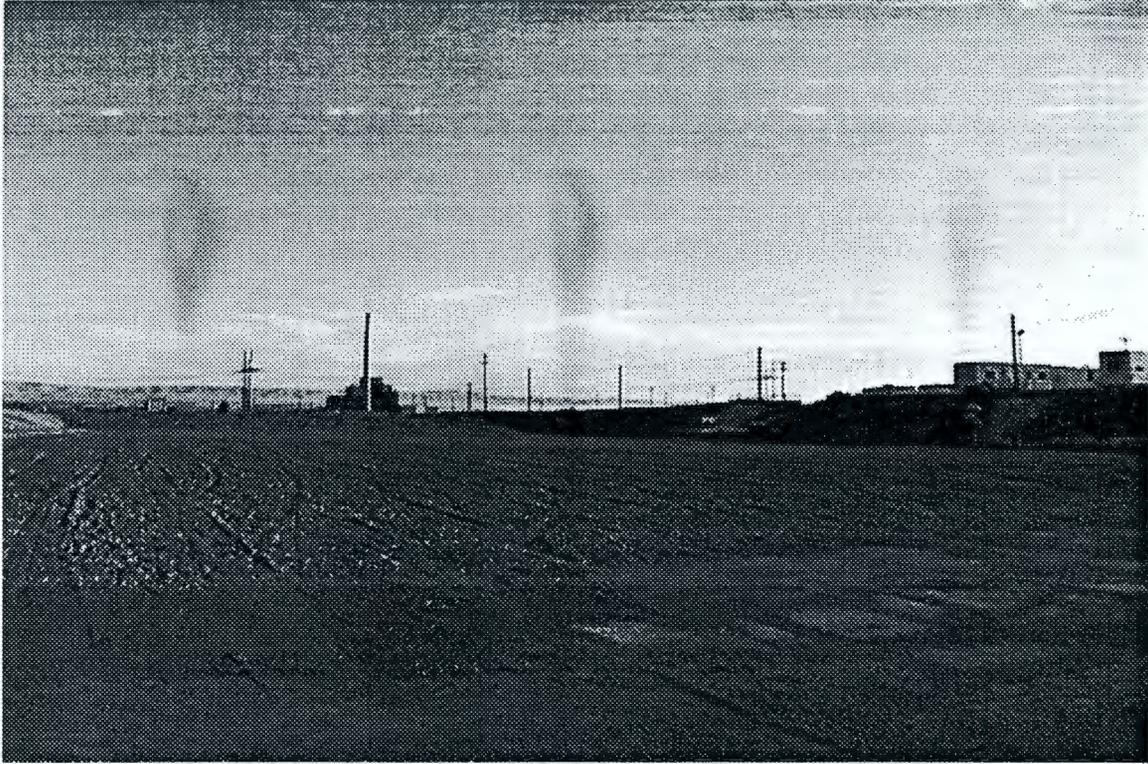
Figure 6. View of Where the 190-C Building Once Stood, View Facing North with the 105-B Reactor in the Background.

Upon completion of the demolition activities, the area was backfilled with a minimum 0.91-m (3-ft)-thick soil/aggregate surface layer placed over the footprint of the facility and graded to match the surrounding terrain (Figure 6). The source of backfill was the 100-B Area Borrow Pit (approximately 5,046 m³ [6,600 yd³]) and the dirt berm that was located north of the 190-C Facility (approximately 10,092 m³ [13,200 yd³]). Figure 7 shows a northwest view after all site restoration activities were completed.
