FACILITY STATUS CHANGE FORM

| Originator: David Warren | Facility ID: 1926-N Valve Pit | |
| Phone: 539-6040 | Action Memorandum: 100-N Ancillary Facilities | |

D4 Project Facility Completion Form

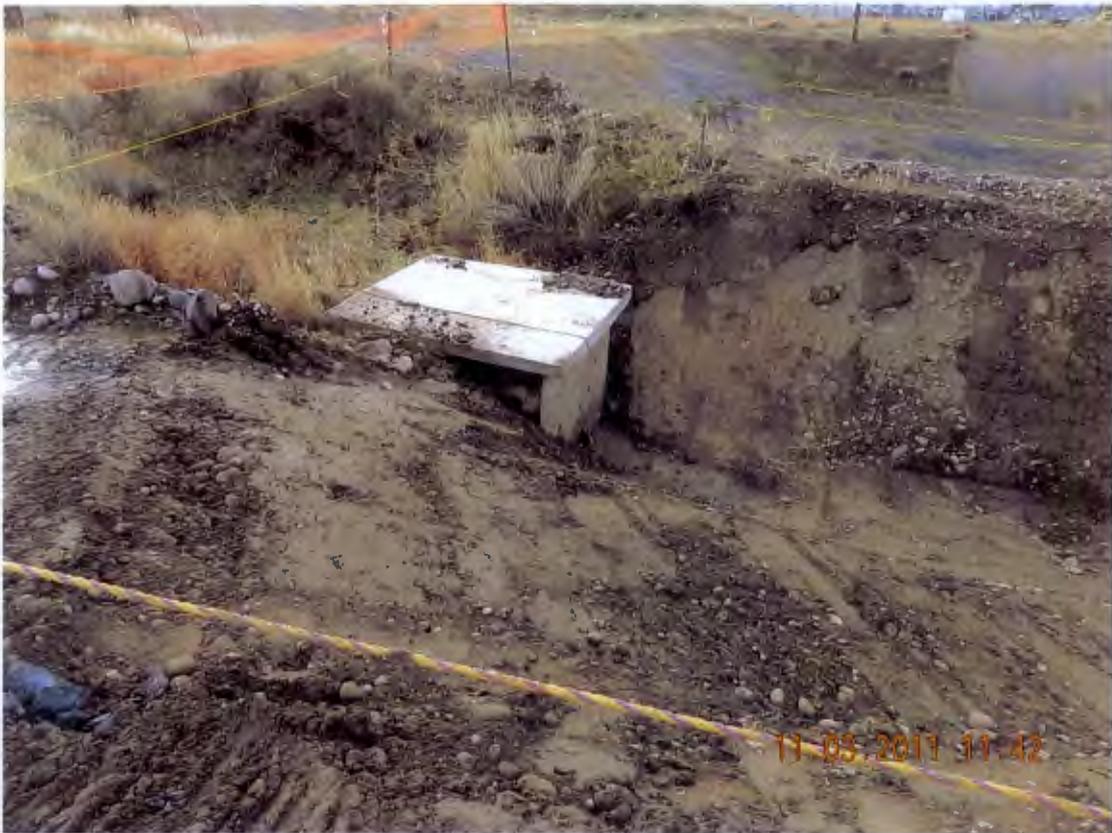
1926-N Valve Pit Pre-Demolition

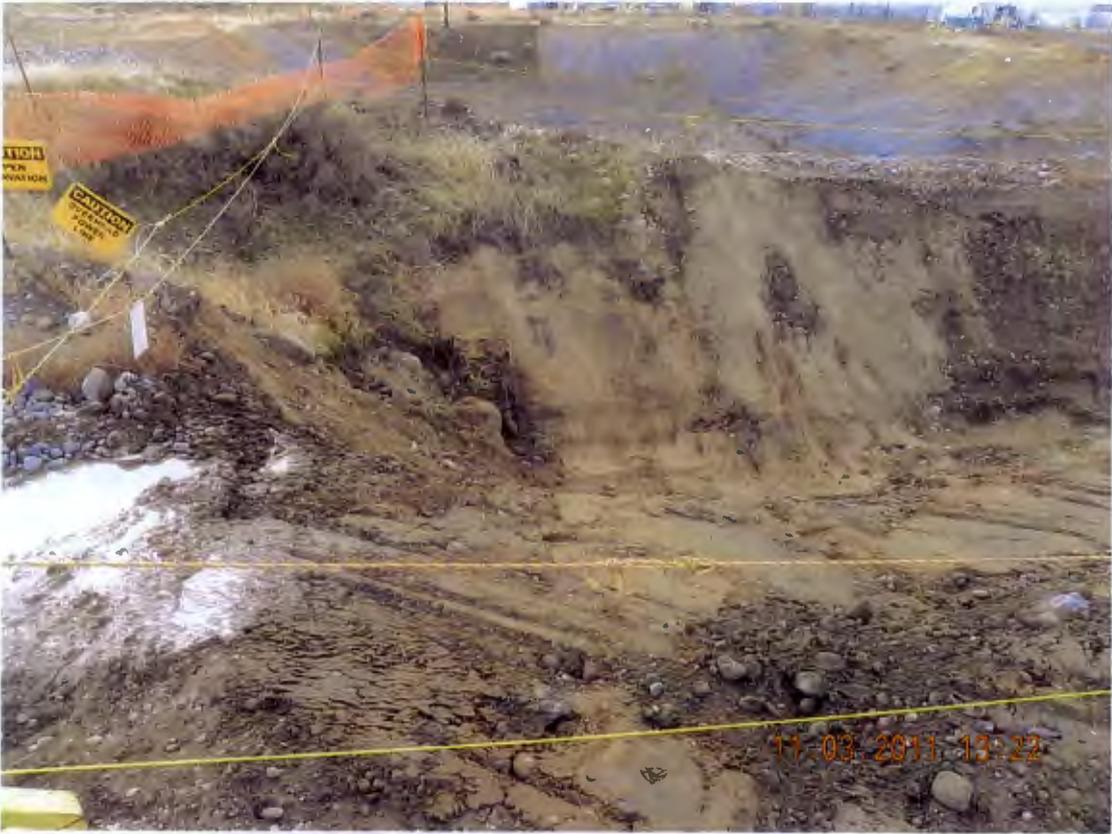
1926-N Valve Pit Post-Demolition

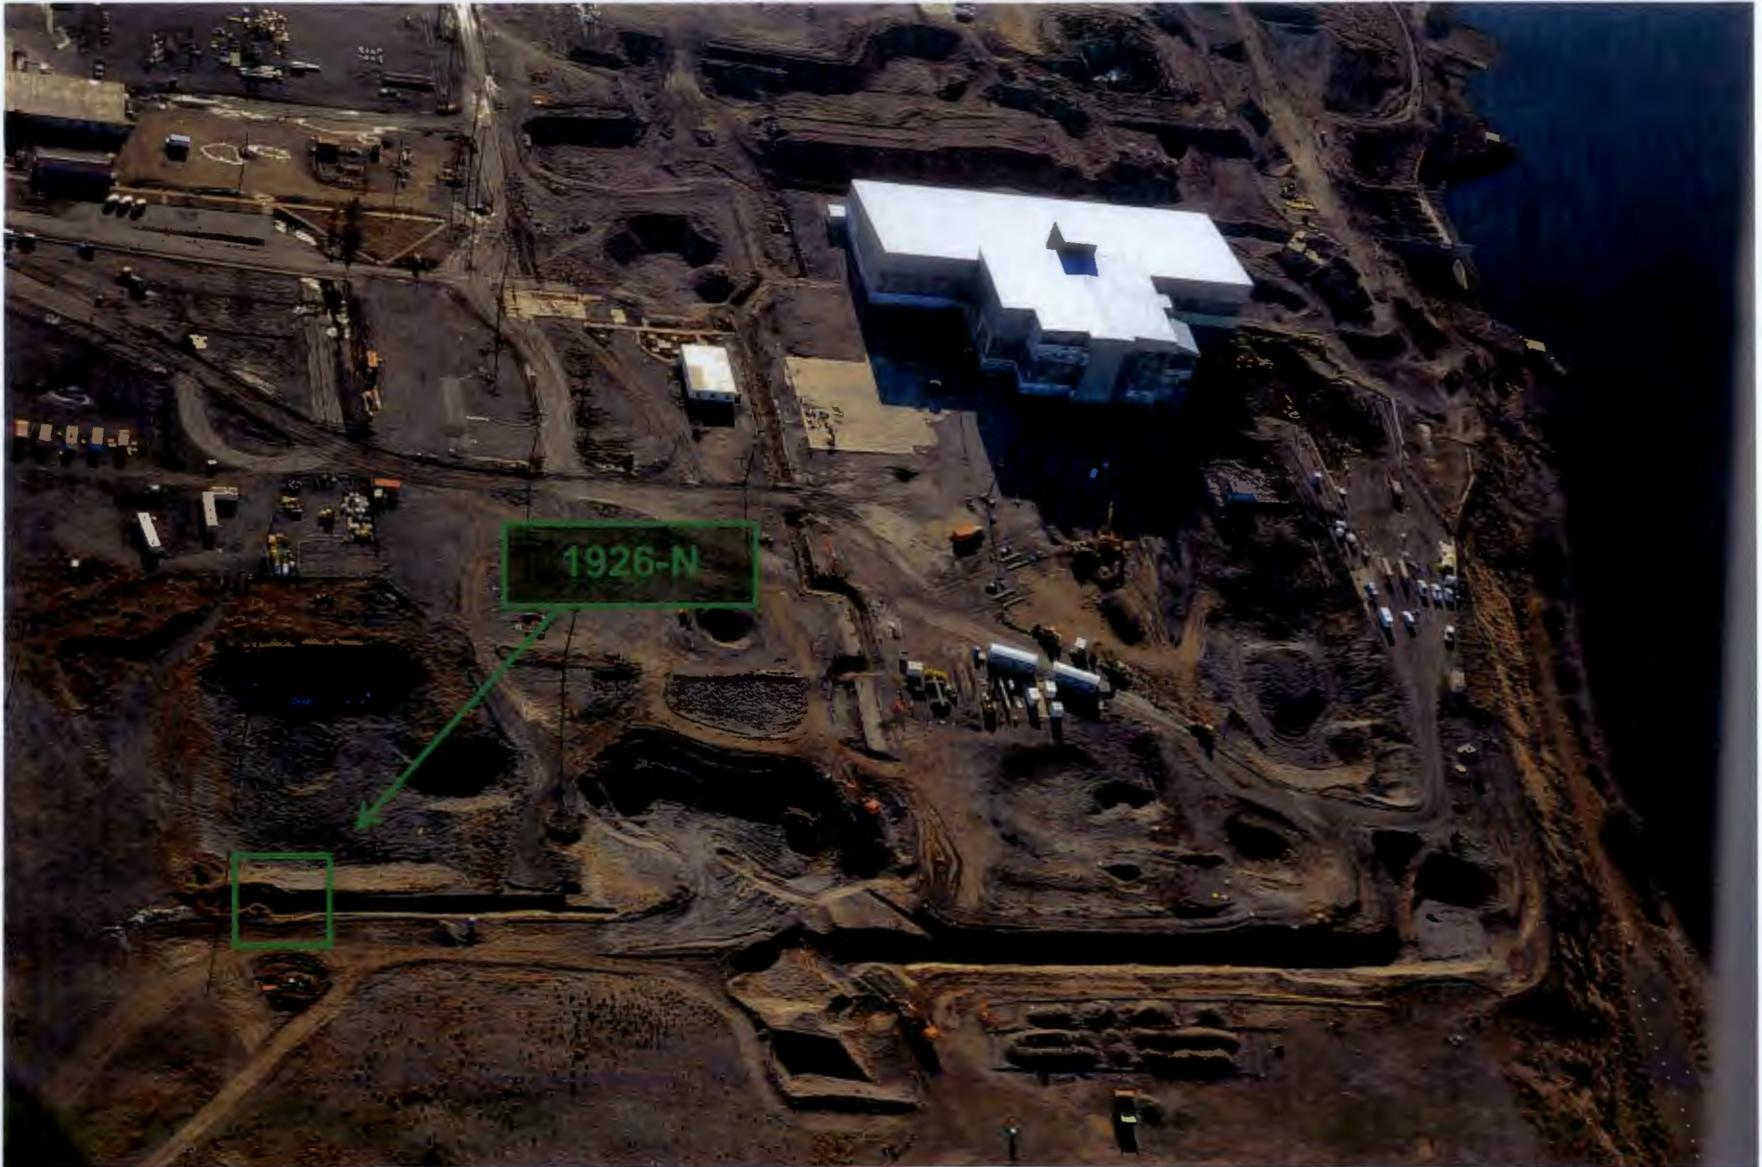
1926-N Valve Pit Post-Demolition

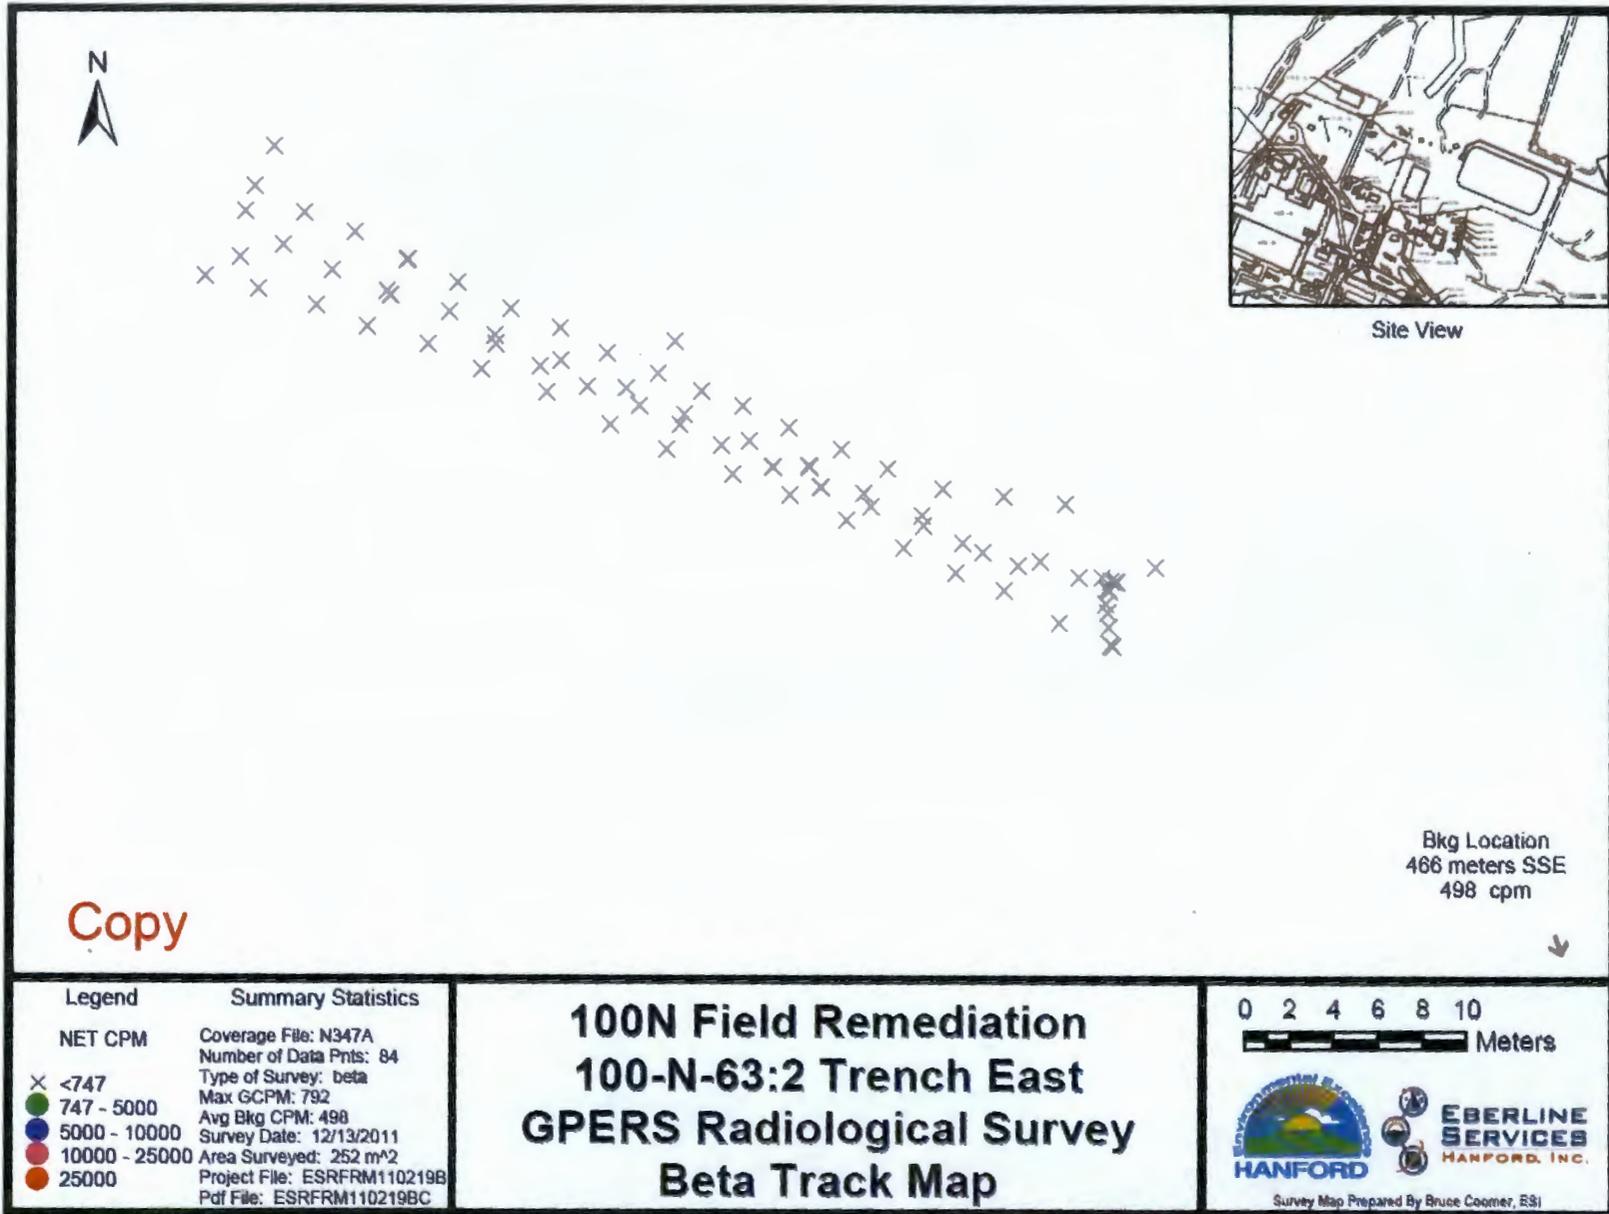
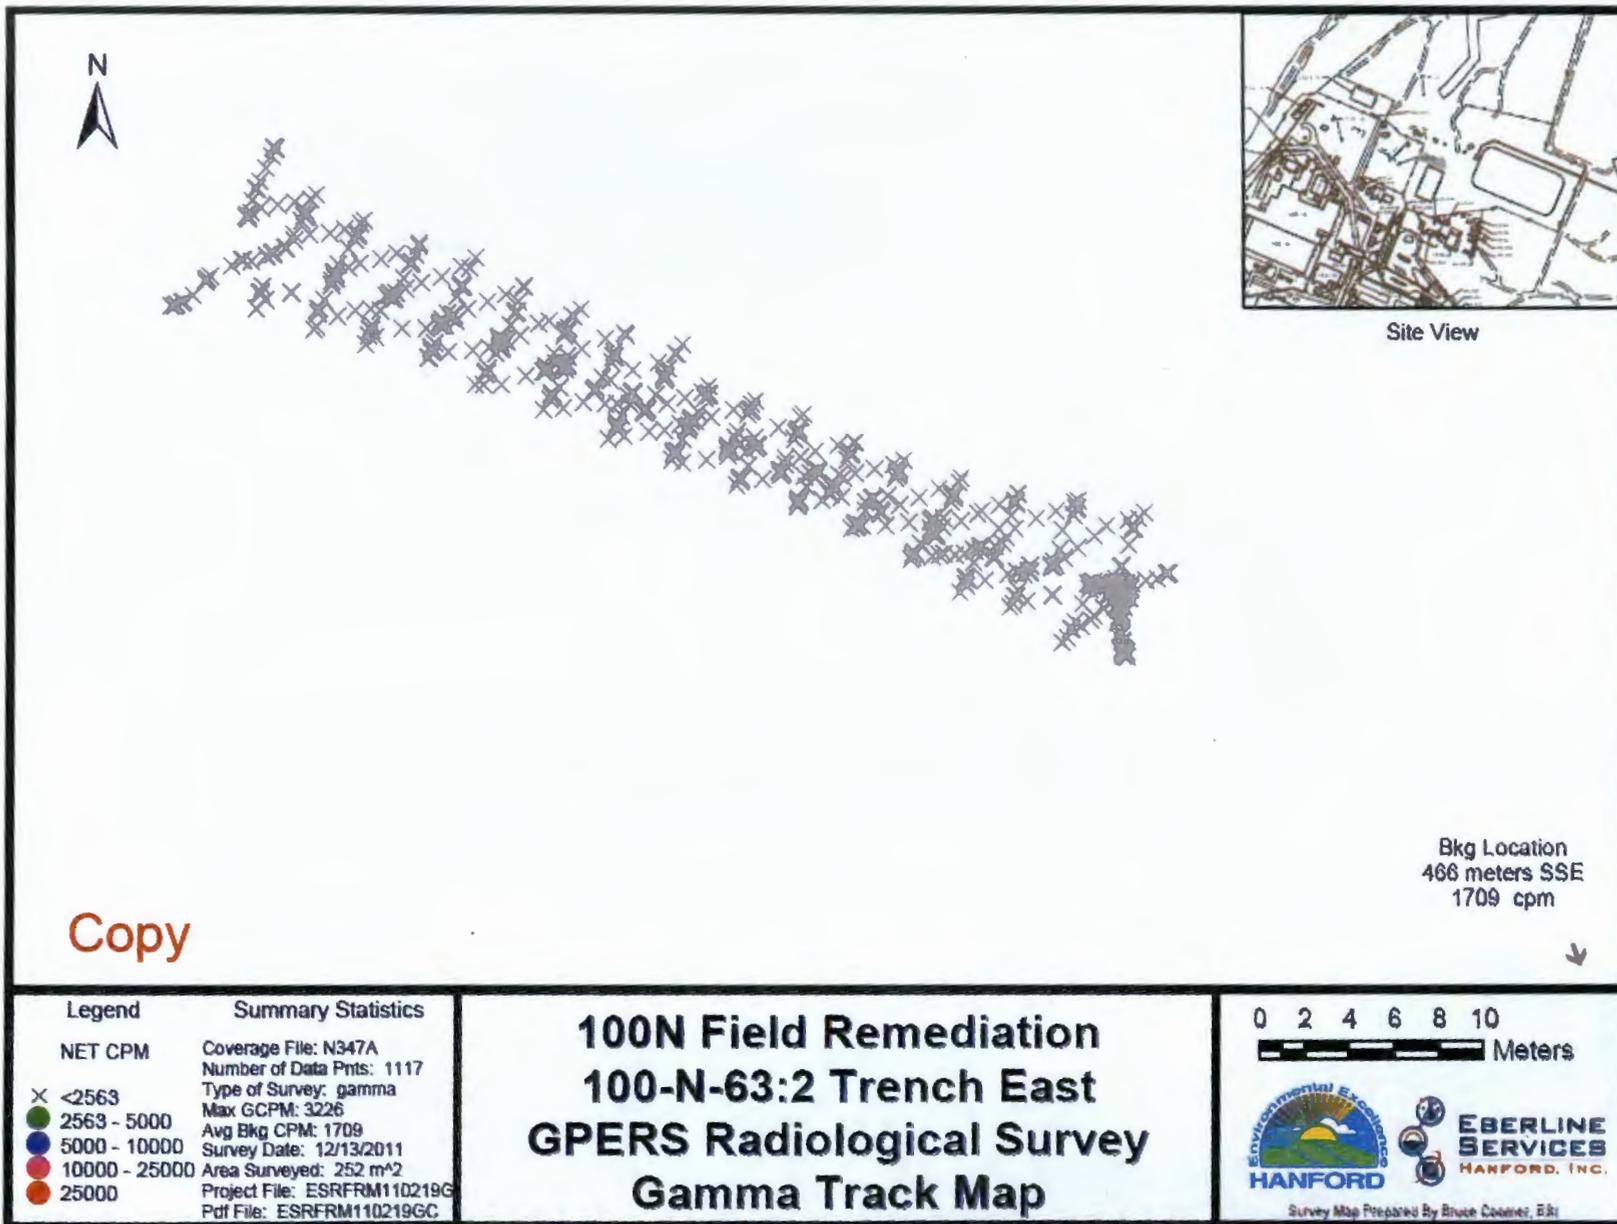
Attachment 3: GPERS Surveys (2 pages)

| Type | Quantity | Method Detection Limits | Results |
|--|---|---|--|
| Global Positioning Environmental Radiological Surveyor (GPERS) Surveys | 2 Surveys | N/A | A total of 1201 data points were taken at the 1926-N footprint. All results were less than 1.5 times background. It should be noted that readings that are under 1.5 times the background count are considered to be insignificant. The GPERS survey maps are included in Attachment 3. |

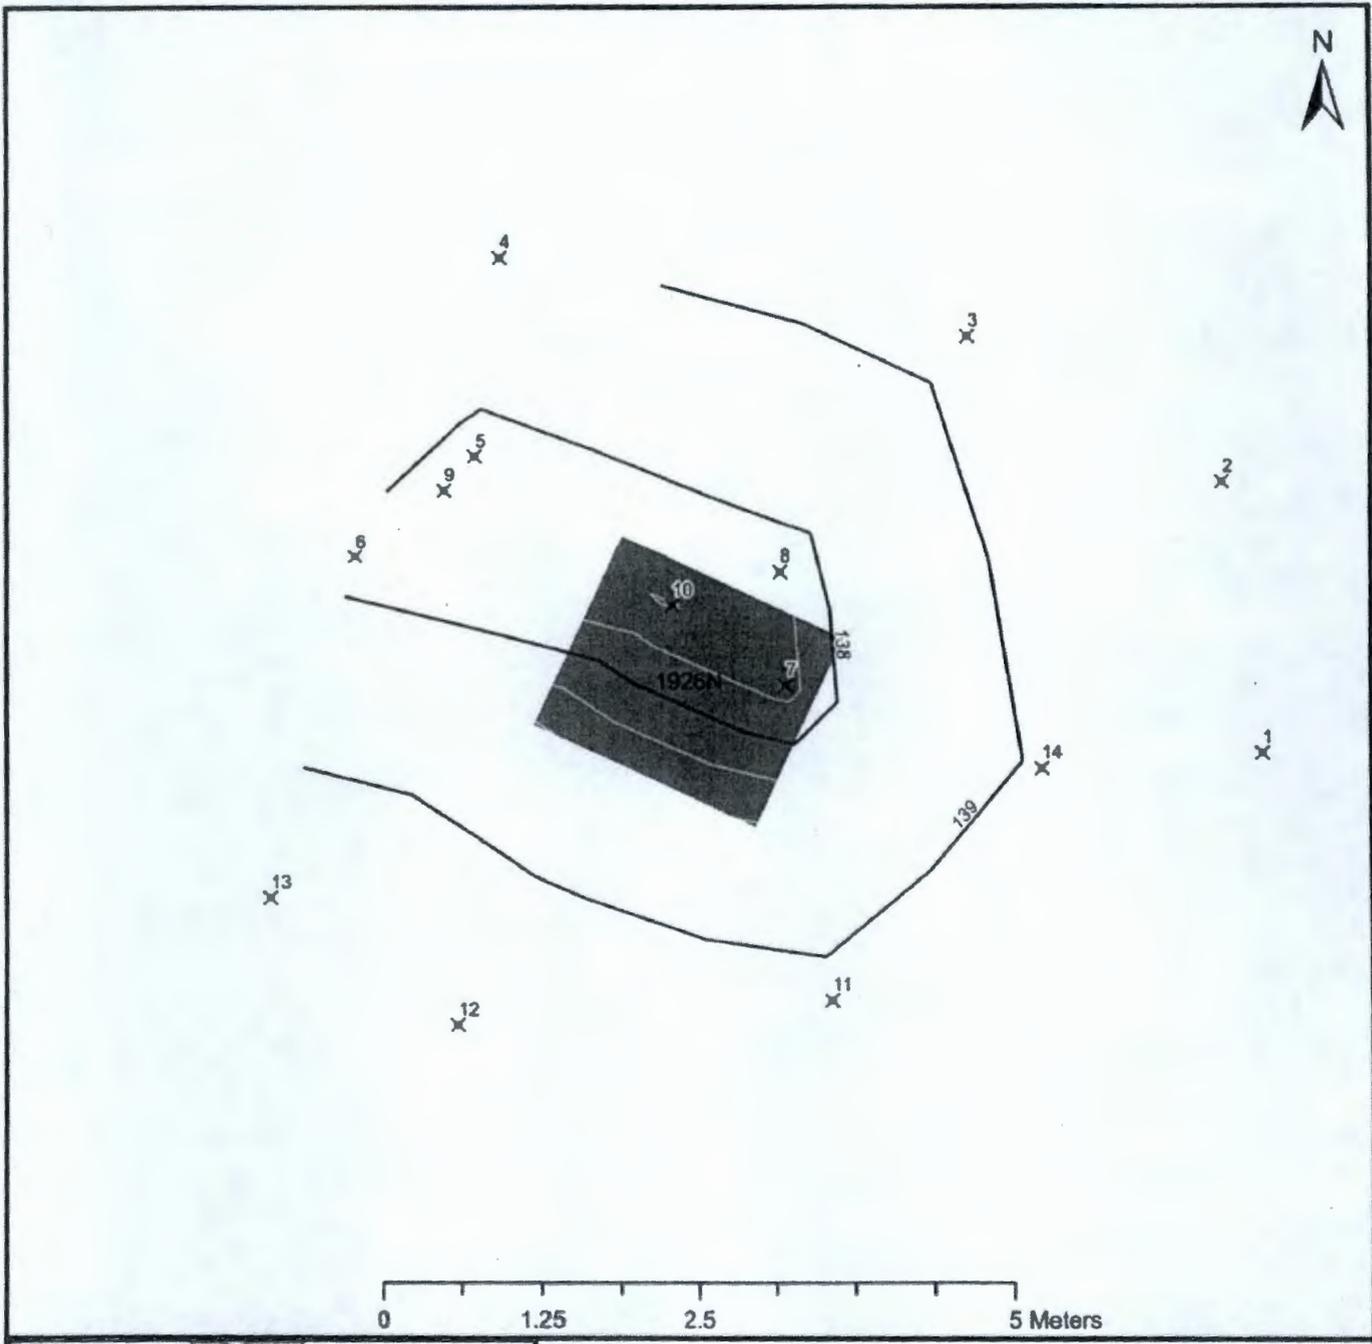
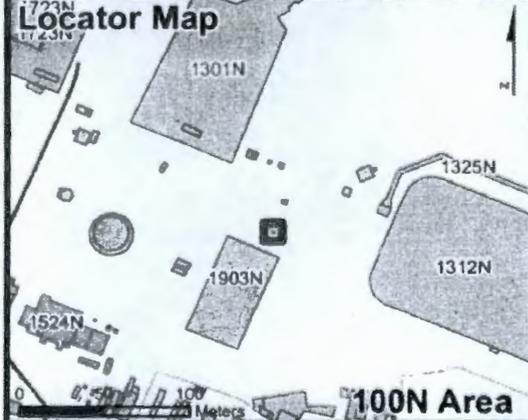
Post Demo GPS Report For 1926N

Pre and post-demolition Global Positioning System (GPS) civil surveys were performed on the 1926-N Valve Pit and its excavation. Copies of the GPS surveys are provided in Attachment 4.

- GPS Post Demolition Survey Points:**
- × See Survey Report for Point Details
 - Major Contour 1 Meter Interval
 - Minor Contour .2 Meter Interval
 - Building Location (Pre Demolition)

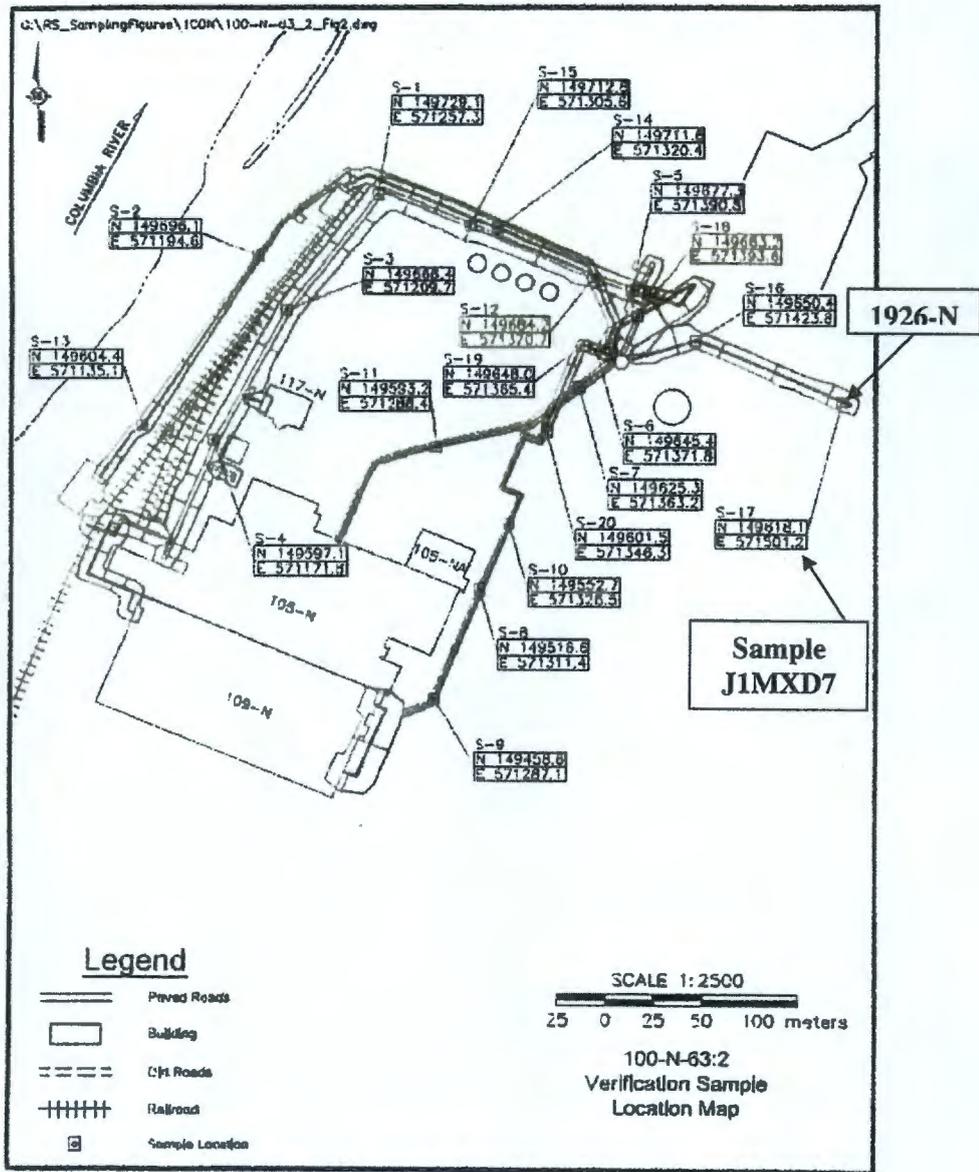
Figure 2. 100-N-63:2 Focused Sample Location Map.

| 100-N ANCILLARY FACILITIES REMOVAL ACTION SAMPLING DETERMINATION FORM | | Determination Number SDF-100N-013 |
|---|--|---|
| Comments: Verification sampling for the 100-N-63:2 WIDS site included the 1926-N facility via sampling location S-17 (0100N-WI-G0022 Figure 2-attached to this form). The sample number for this location is J1MXD7. See attached table for comparison of the sample data versus the Remedial Action Goals (RAGs). The sample locations were pre-determined as part of the RCRA TSD sampling agreement with Ecology. Pertinent design drawings for this facility are H-1-32232 & H-1-45007 Sheet 56. | | |

| 100-N ANCILLARY FACILITIES REMOVAL ACTION SAMPLING DETERMINATION FORM | | Determination Number SDF-100N-013 |
|---|--|---|
| One of the sample locations (J1MXD7) for closure of the 100-N-63:2 (Verification Sampling Work Instruction 0100N-WI-G0022) is located within the footprint of the 1926-N and will be used for verification purpose of the 1926-N soils. See attached table for comparison of the sample data versus the Remedial Action Goals (RAGs). | | |
