FACILITY STATUS CHANGE FORM

Date Submitted: April 2, 2013 Originator: Chris Strand Phone: 554-2720	Area: 300 Area Facility ID: 3718E and 3718G Action Memorandum: Action Memorandum #2	Control #: D4-300-034-1
--	---	-----------------------------------

Attachment 1: Facility Information

3718E and 3718G Storage Buildings

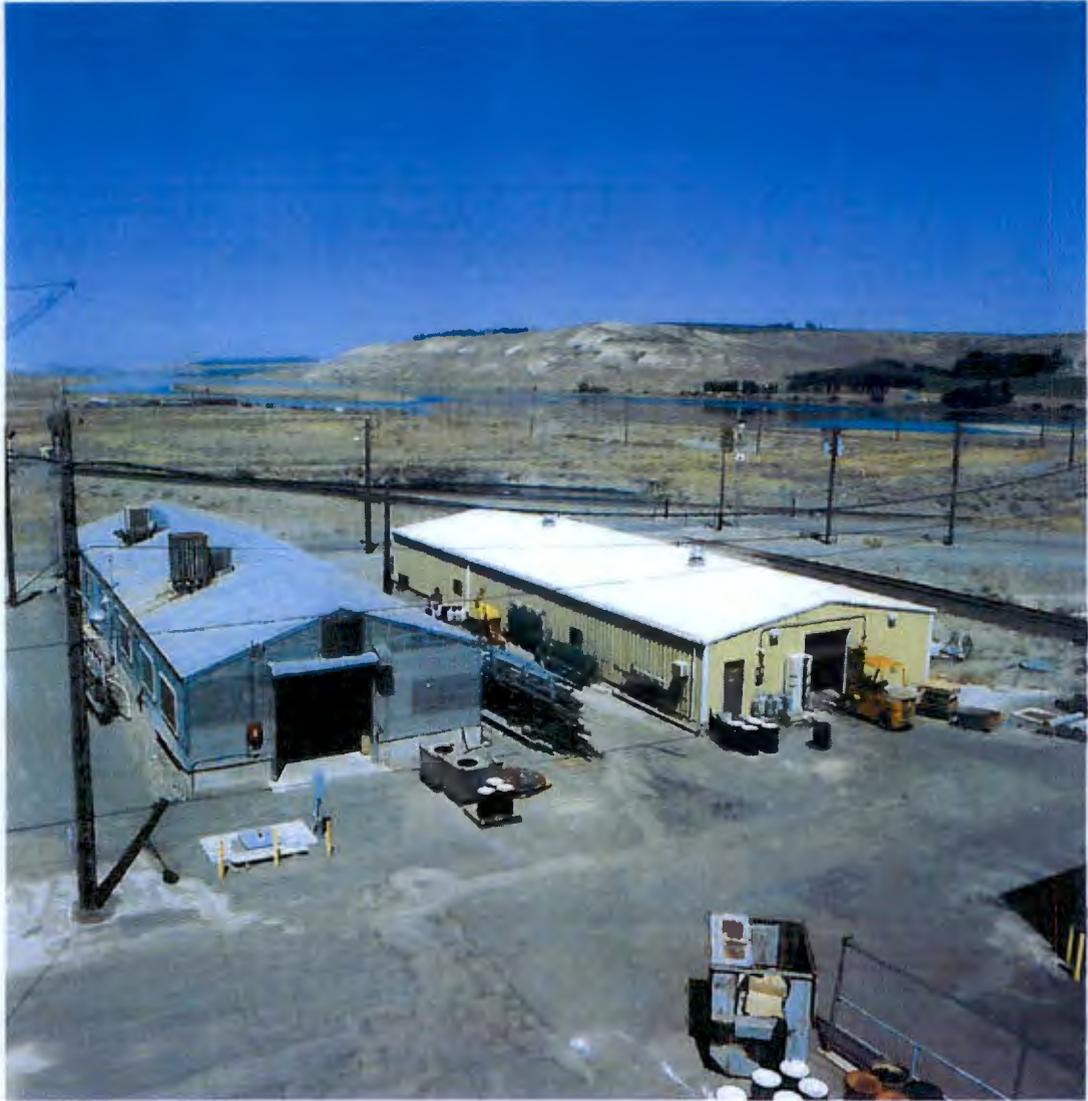
**Photograph 1: 3718E (left) and 3718G (right) Buildings,
looking north, July 26, 1985.**

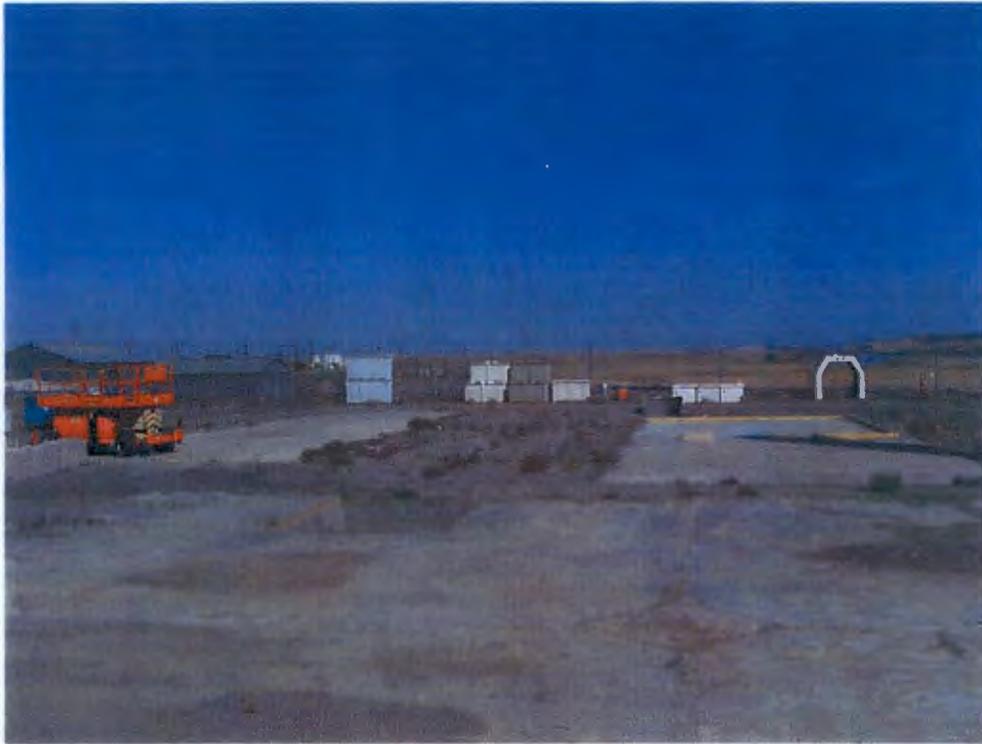
**Photograph 2. 3718E (left) and 3718G (right) slabs,
looking north on September 16, 2009.**

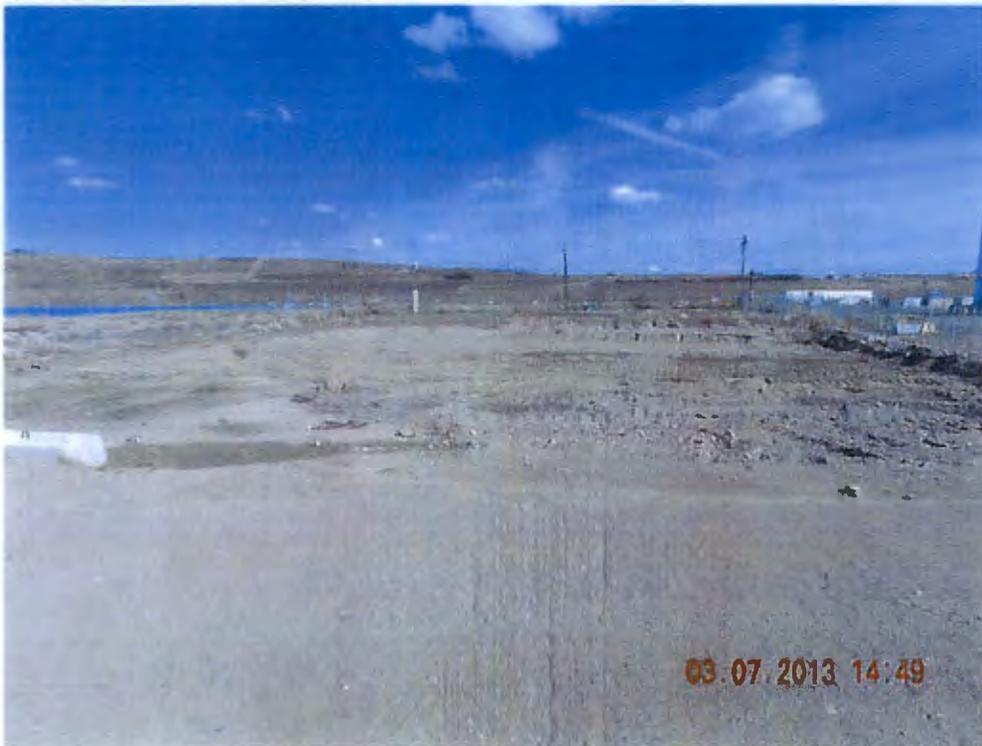
Photograph 3. 3718E and 3718G common excavation looking east, March 7, 2013.

No anomalies were discovered during slab removal. However, an asphalt apron was encountered approximately two feet below both slabs. The asphalt was left in place.

Soils beneath the slab and foundation displayed no visual evidence of staining or discoloration. A final GPERS survey of the excavation following below-grade demolition identified no radiological contamination.

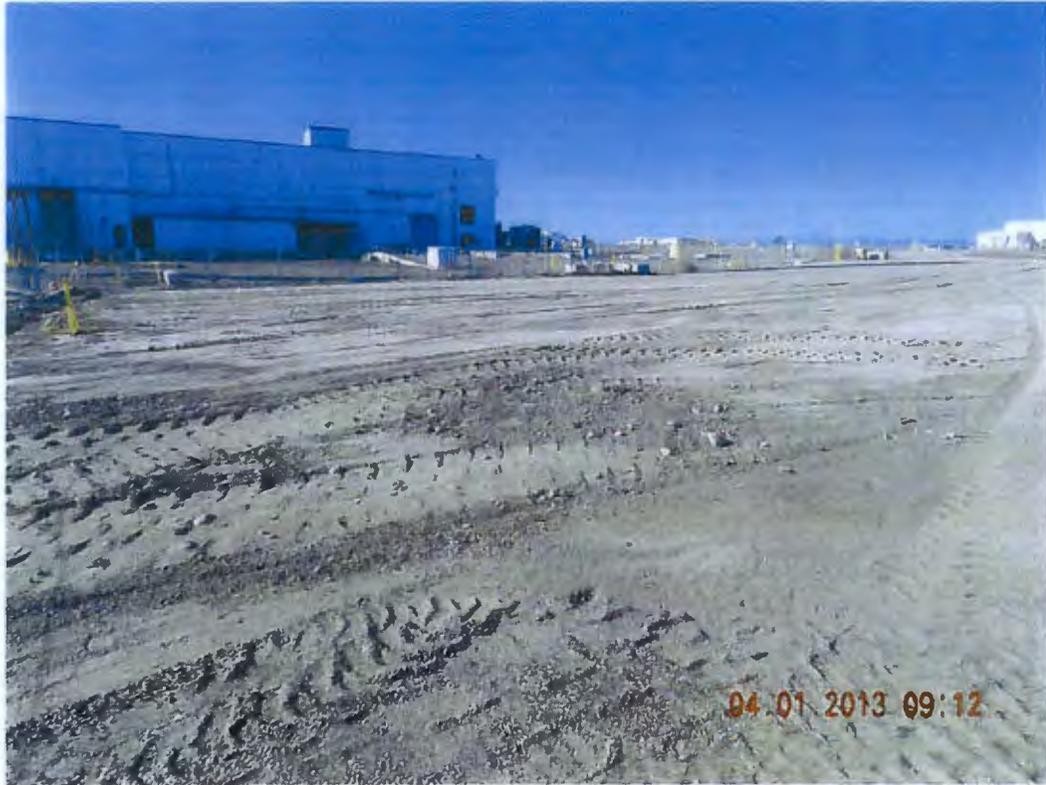
Photograph 4. 3718E and 3718G site backfilled, looking southwest on April 1, 2013.

All above-grade structures and foundations were removed. Excavations were backfilled to grade with clean fill. GPERS surveys were performed prior to backfill. No radiological or Industrial Hygiene postings remain.
