Control #: D4-300-102**FACILITY STATUS CHANGE FORM**

Demolition: Above-grade demolition of the 309 Plutonium Recycle Test Reactor was completed in 2014. Below-grade and removal of structures that included the reactor core, tanks, piping, ion exchange vaults, rupture loop annex, IEM cell, south annex and the fuel storage basis were completed January 2015. The 309 primary containment vessel was removed to -32 feet below-grade, with the rest of the structure remaining in place. All demolition debris and facility components (e.g., reactor core) were removed and disposed of at ERDF. The demolition was performed under radiological and Industrial Hygiene controls.

The lower 309 primary containment vessel remains in place at -32 feet at the bottom of the excavation. The excavation remains open with access restricted through radiological and industrial hygiene postings.

309 Plutonium Recycle Test Reactor

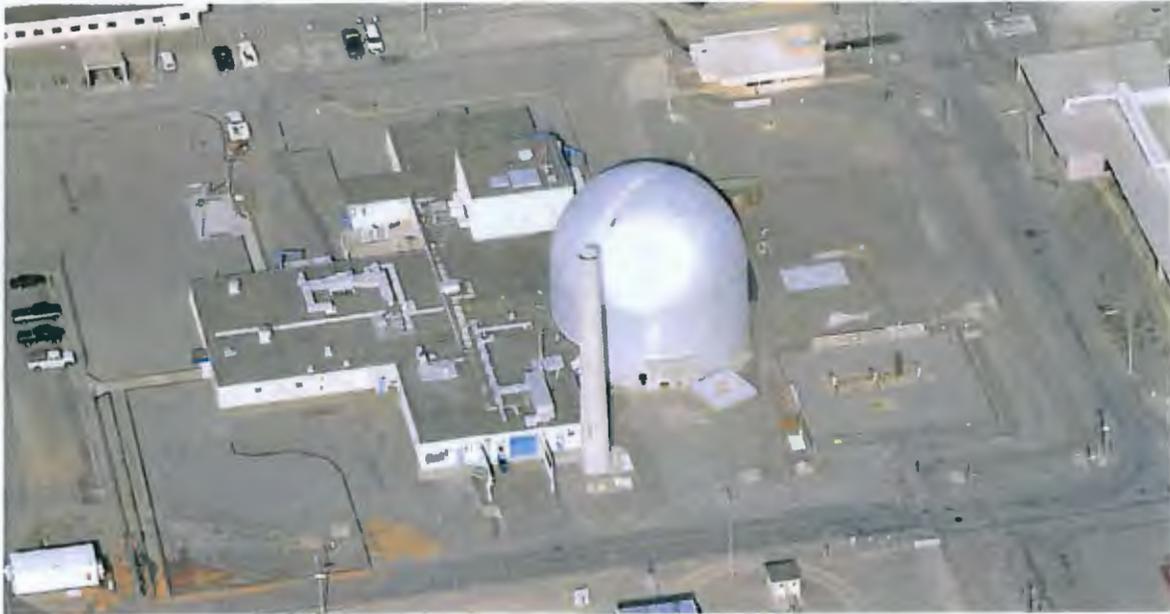
Photograph 1. Aerial photograph showing the 309 Reactor, view facing west (circa 1980s).

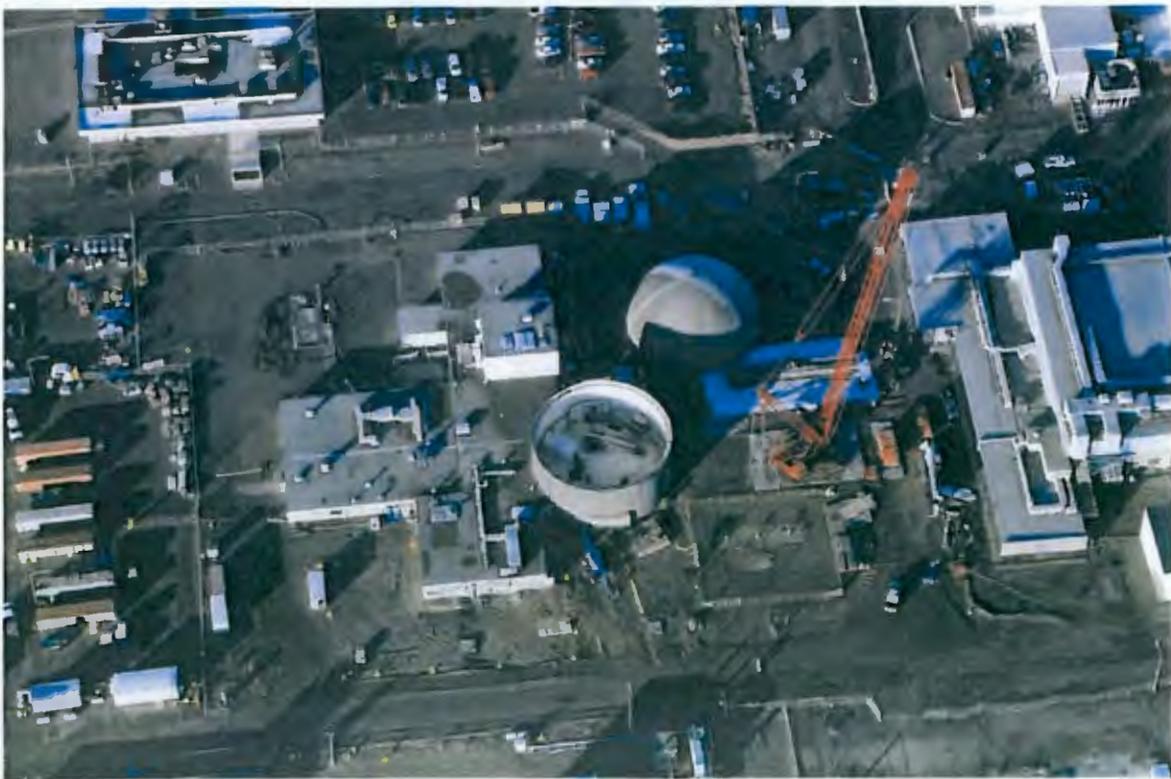
Photograph 2. Aerial photograph showing the primary containment dome removed, view facing west (1/19/11).

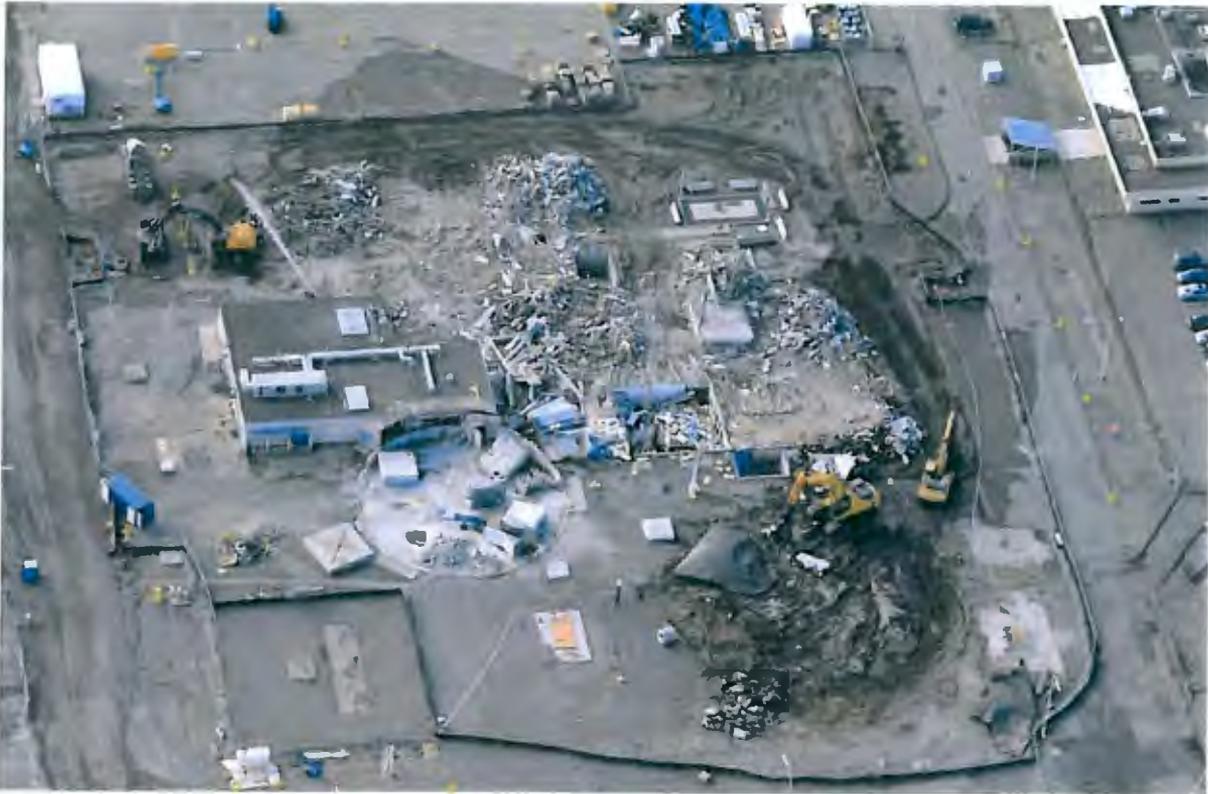
Photograph 3. Aerial photograph showing above-grade demolition progress, view facing south (10/20/11).

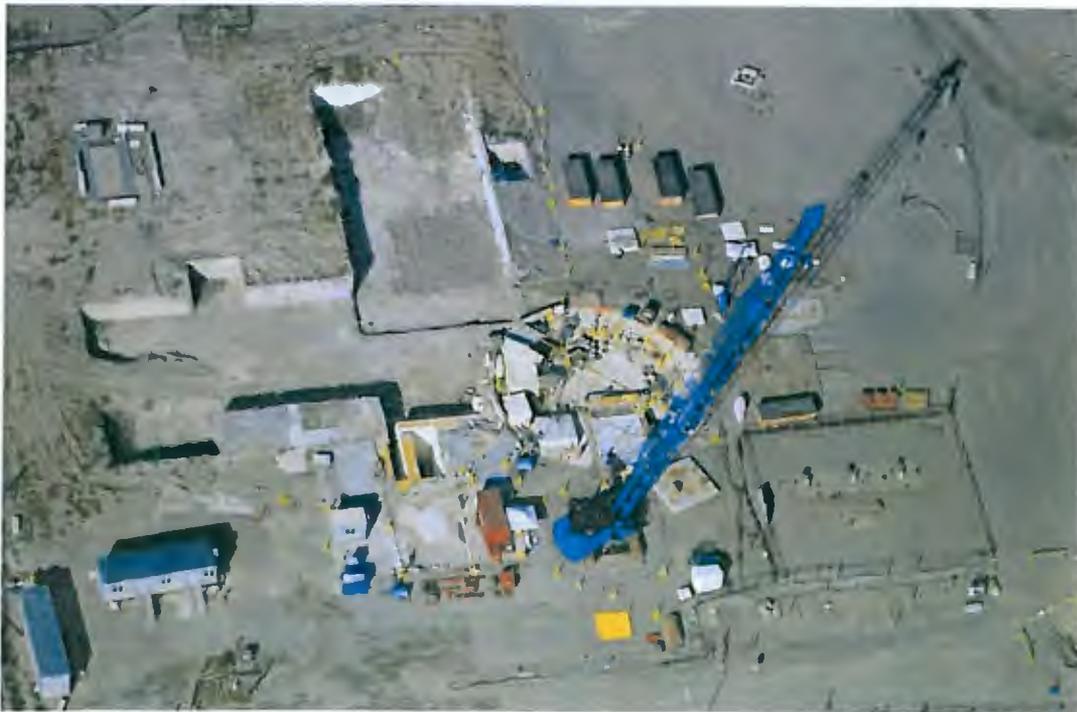
Photograph 4: Aerial photograph showing completion of above-grade demolition and preparations for reactor core removal, view facing west (9/10/13).

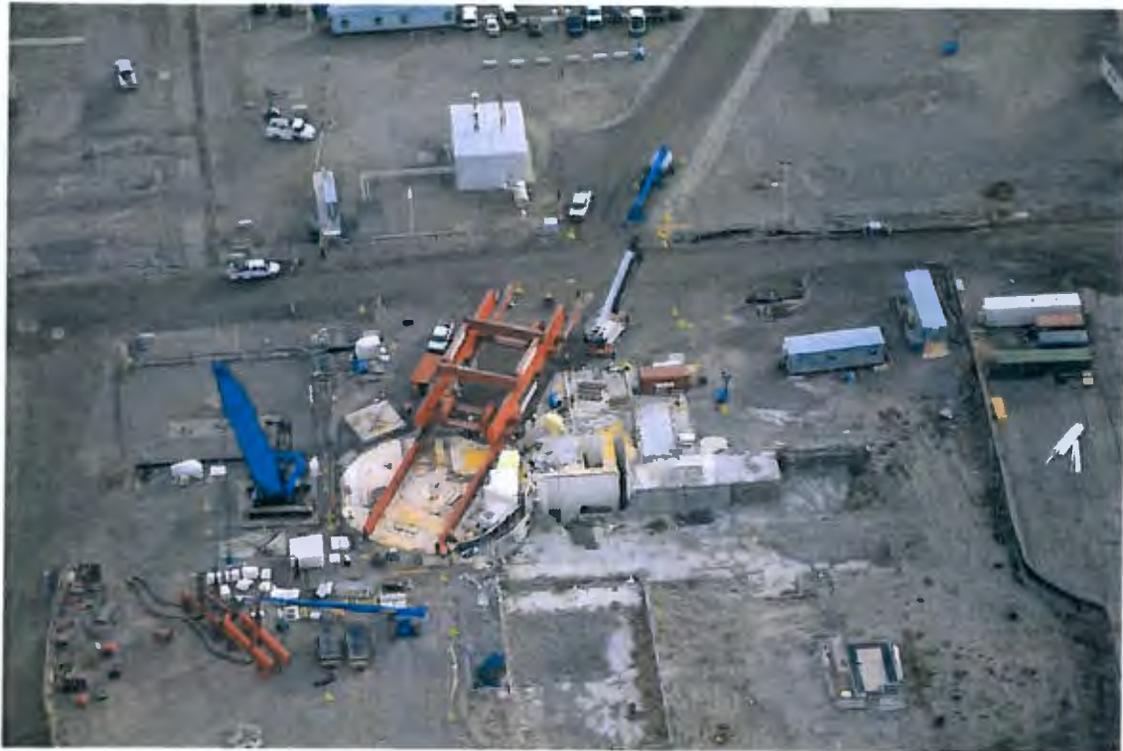
Photograph 5: Aerial photograph showing the heavy lift assembly in preparation for reactor core removal, view facing east (1/15/14).

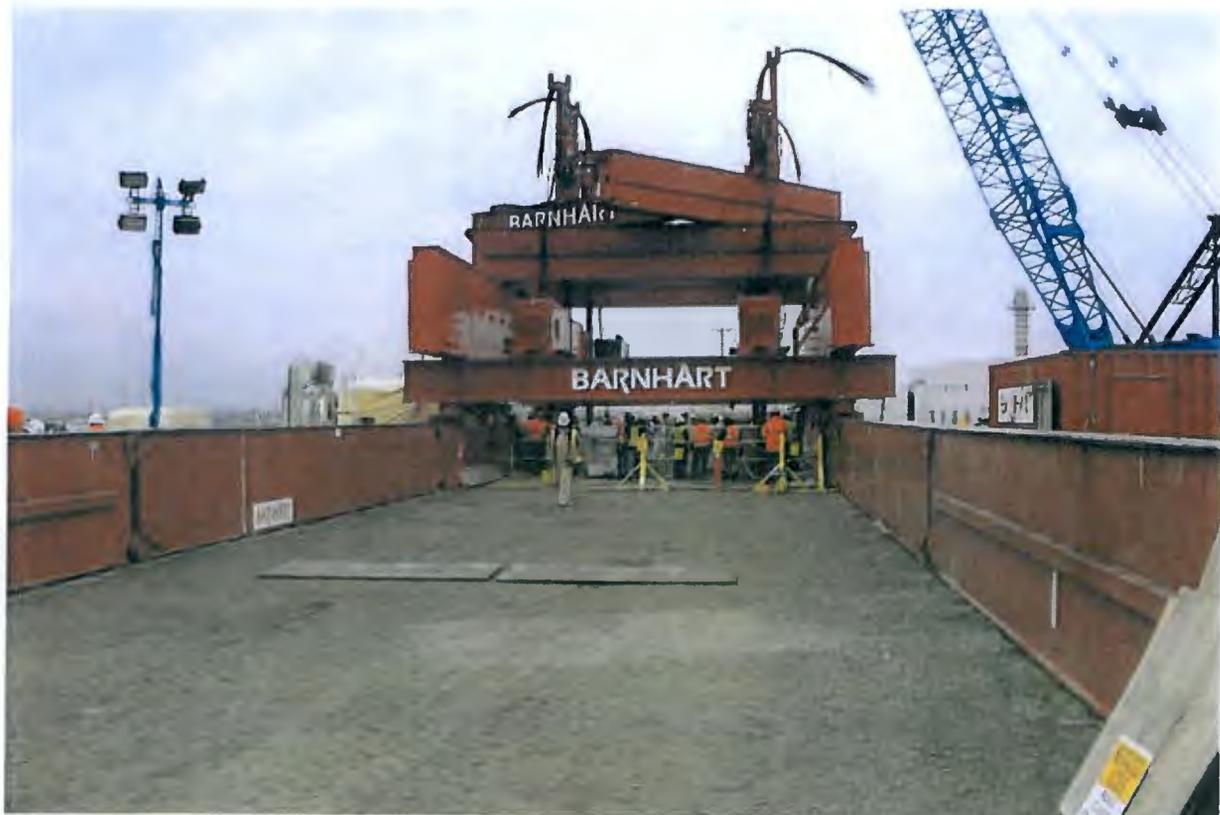
Photograph 6: Reactor core lift, view facing west (1/21/14).

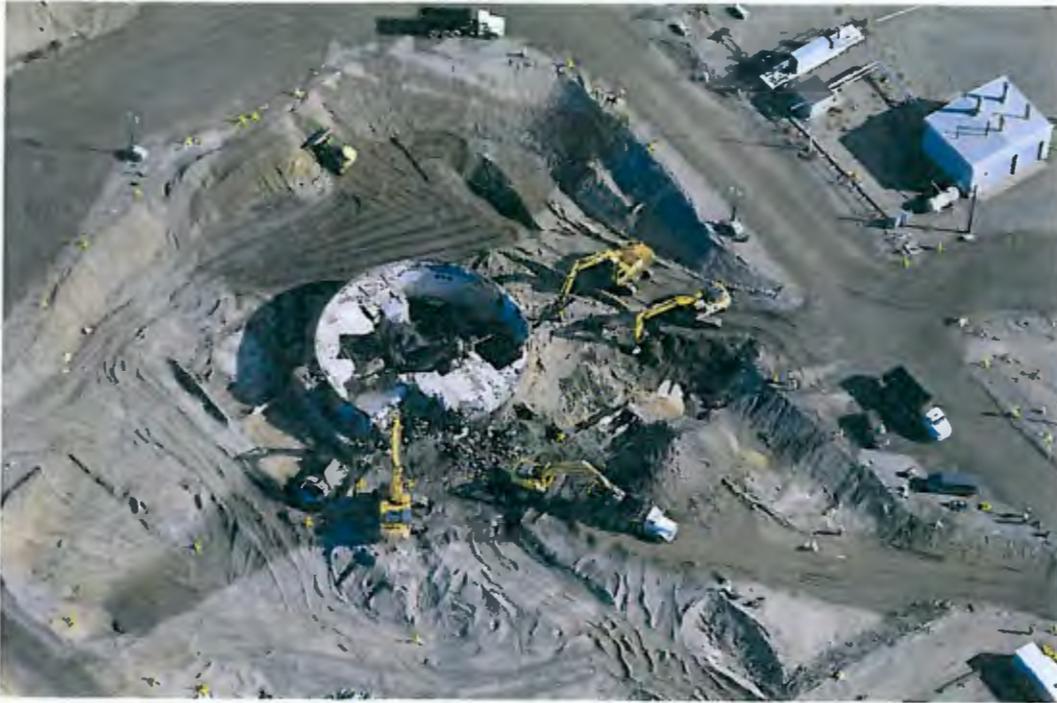
Photograph 7: 309 primary containment following explosive fracturing, view facing northeast (9/29/14).

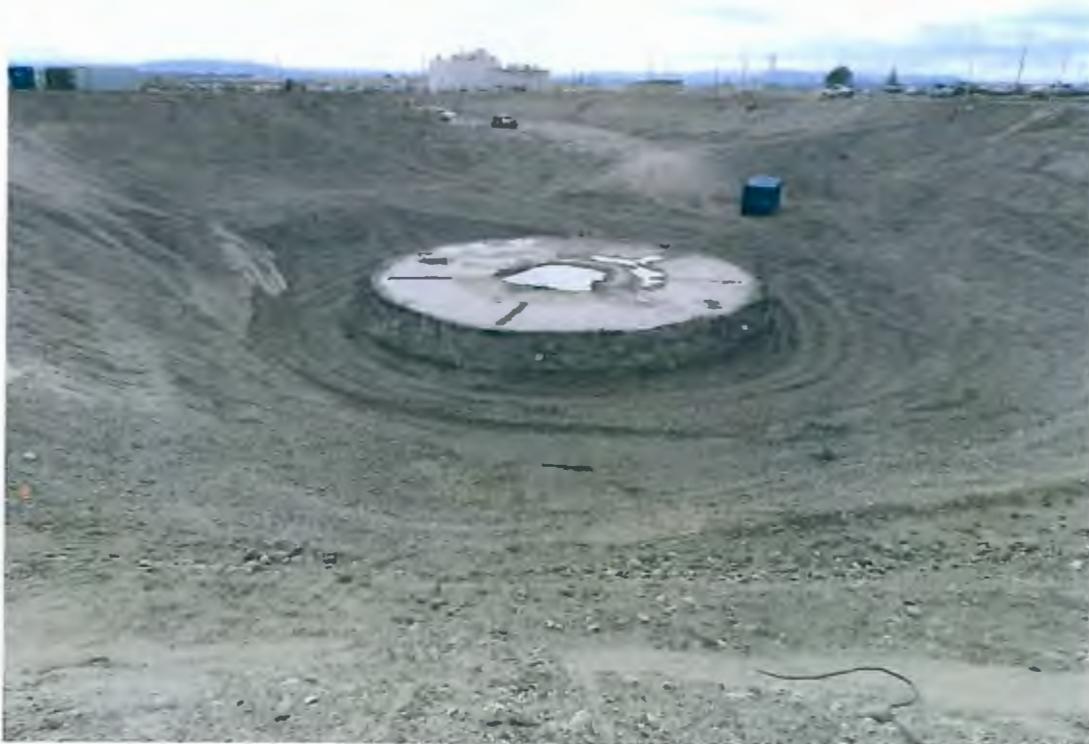
Photograph 7: -32 foot primary containment monolith, view facing south (2/24/15).

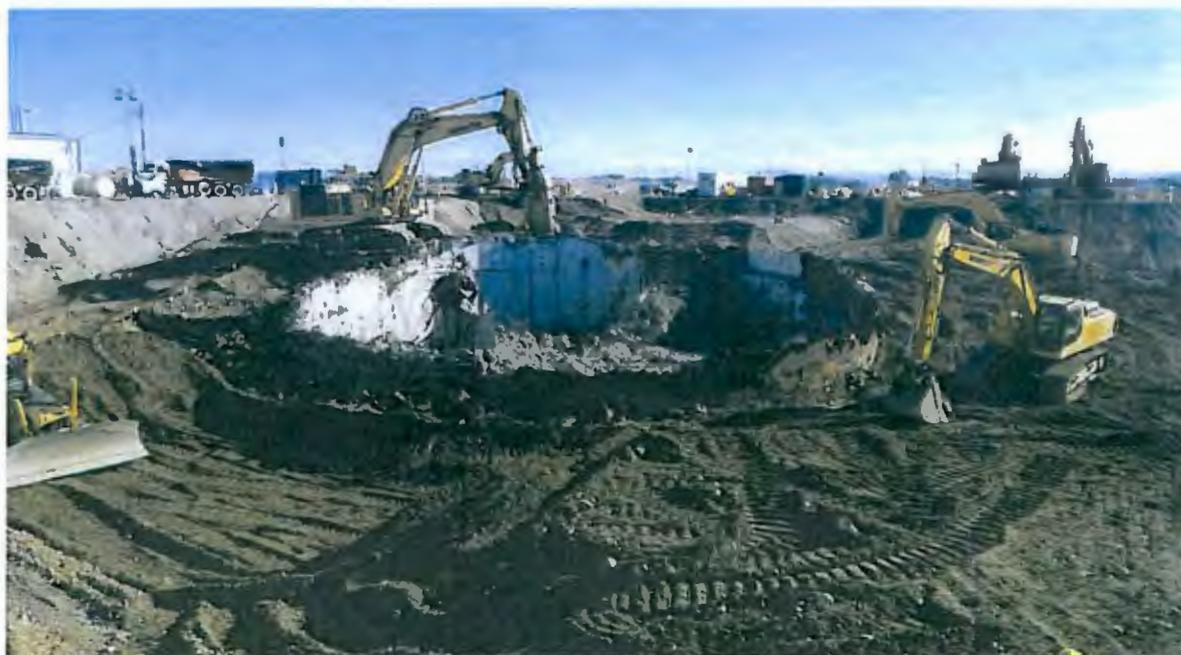
**Photograph 2. 309 Lower Containment Approaching -20 Feet Below Grade
(October 22, 2014)**

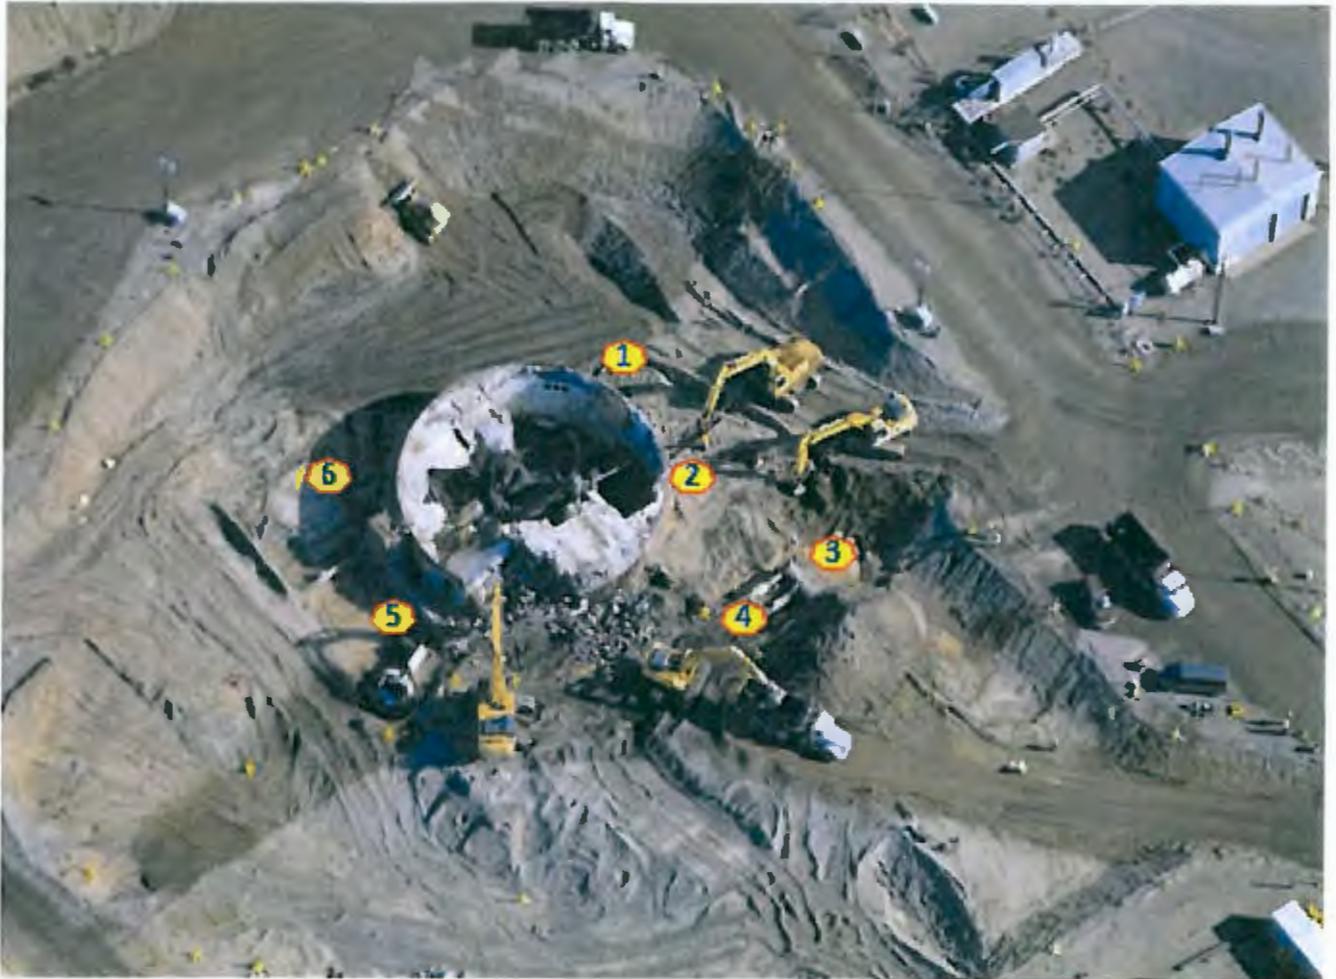
Soil characterization will consist of excavating six test pits from the -32 foot elevation to approximately an additional 18 to 20 feet (extent of excavator reach). Three samples from each test pit will be collected from the -3 foot, -12 foot, and -18 to 20 foot locations. A total of eighteen samples will be collected from the six test pit. Resultant analytical data will supplement four previous samples collected at the -17 foot elevation. Samples J1V108, J1V109, J1V110, and J1V111 were analyzed exclusively for tritium. Three of the four sample results (J1V108 through J1V110) were non-detect, the fourth sample (J1V111) result was 41.9 pCi/g, which is well below the 21,200 pCi/g deep zone CUL for tritium. Figure 3 consists of an aerial photograph and showing the soil sample locations.

Figure 3. 309 Facility Soil Sample Locations.

NOTE: This photograph shows demolition progress as of September 2014, at approximately the -15 foot elevation. Demolition as of November, 2014, has reached the -32 foot elevation. Refer to Table 3 for test pit location descriptions.

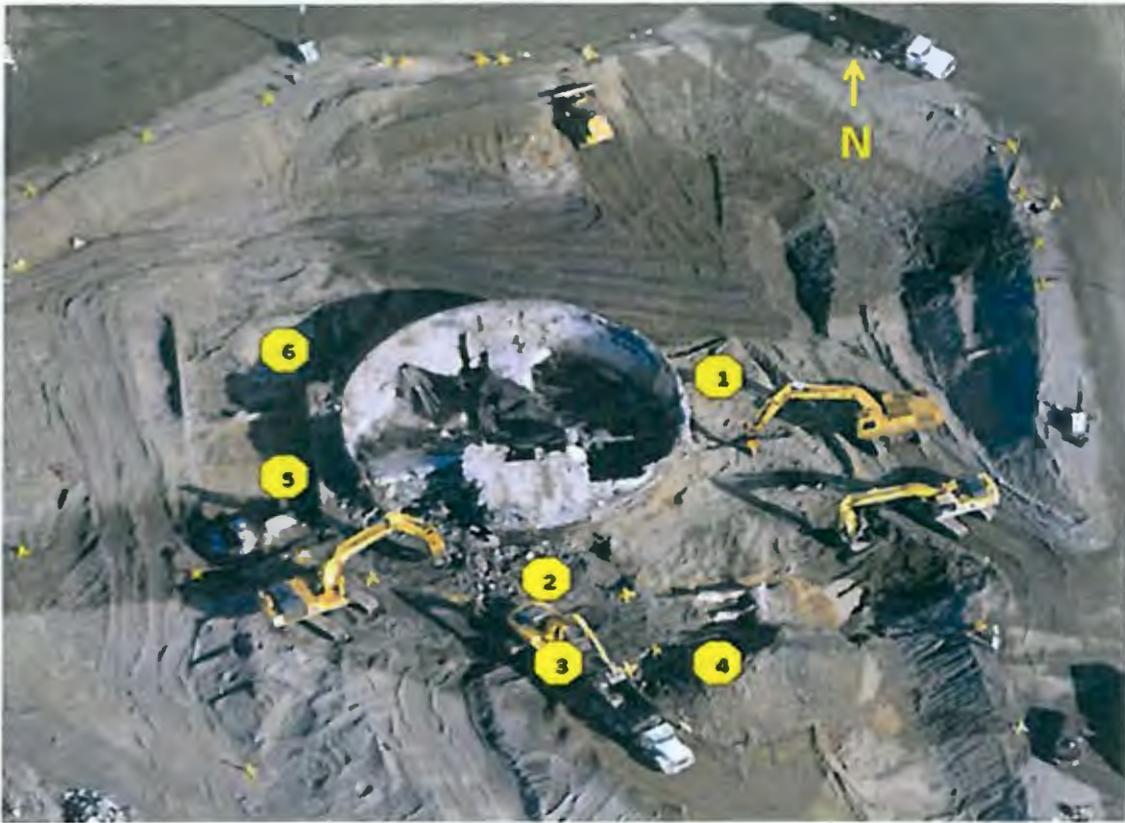
Attachment 2, Figure 1. 309 Test Pit Locations
