TS-PIC-89714
March 1989

AERIAL PHOTOGRAPHIC ANALYSIS OF ROCKWELL HANFORD OPERATIONS AREA 100H Richland, Washington

AERIAL PHOTOGRAPHIC ANALYSIS OF ROCKWELL HANFORD
OPERATIONS AREA 100H

ABSTRACT

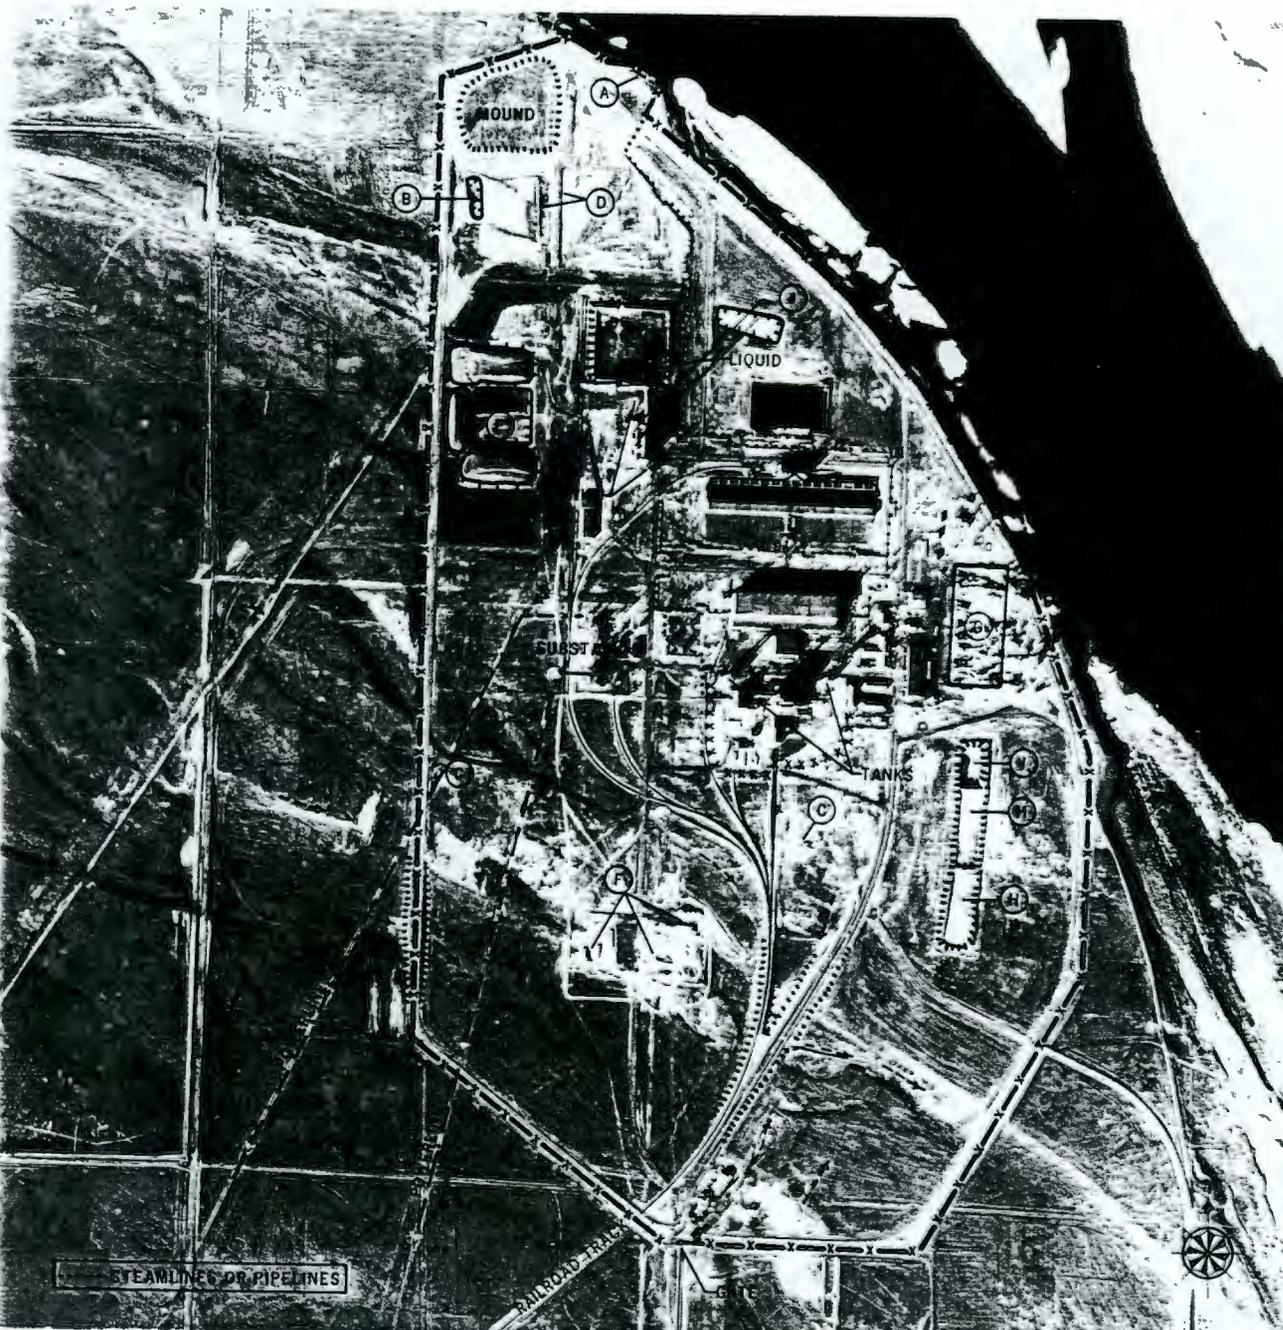
Figure 5. Rockwell Hanford Operations Area 100H, November 2, 1964. Approximate scale 1:8,900.

The 1964 photograph (Figure 5) shows the fence secured Rockwell Hanford Operations Area 100H is completed. Several vehicles are observed throughout the compound and in parking lots. Area 100H is served by road, railroad, electric power transmission lines, and a probable buried pipeline. The facility consists of several processing buildings connected by probable steam, above ground, pipelines; a steam/power plant; an electric substation; large cooling ponds/lagoons; support/administration building; and several disposal pits and/or trenches. There is a probable cooling water intake pumping station at the extreme north end of the site, on the bank of the Columbia River (Annotation A).

There are several areas at this facility where waste disposal pits or trenches are observed. Adjacent to the previously mentioned pit/trench (Annotation B) there are two long trenches (Annotation D), a very wide pit surrounded by three spoil mounds is along the site's west perimeter (Annotation E), and a group of three small pits are at the southern portion of the site (Annotation F). No vehicles are visible discharging waste at any of these locations.

The facility also has several lagoons where liquids are handled, the largest structure appears to be a cooling pond (Annotation G). There are three lagoons (Annotations H and J) and a pit (Annotation I) that appear to receive waste liquids.

The majority of disposal pits, trenches, and lagoons noted in 1964 have been covered up. The pit/trench at the north end of the site in 1964 (Figure 5, Annotation B) is absent (Annotation C). The trenches seen in the same northern area in 1964 (Figure 5, Annotation D) are also buried (Annotation D). The group of three small pits in 1964 (Figure 5, Annotation F) are covered over (Annotation F). The cooling pond is now empty (Annotation G) and the other lagoons and pit south of this cooling pond observed in 1964 (Figure 5, Annotations H and I) are absent (Annotations H and I). The other lagoons at the site are empty to suggest the facility is being shut down. Only the largest pit appears unchanged (Annotation E).

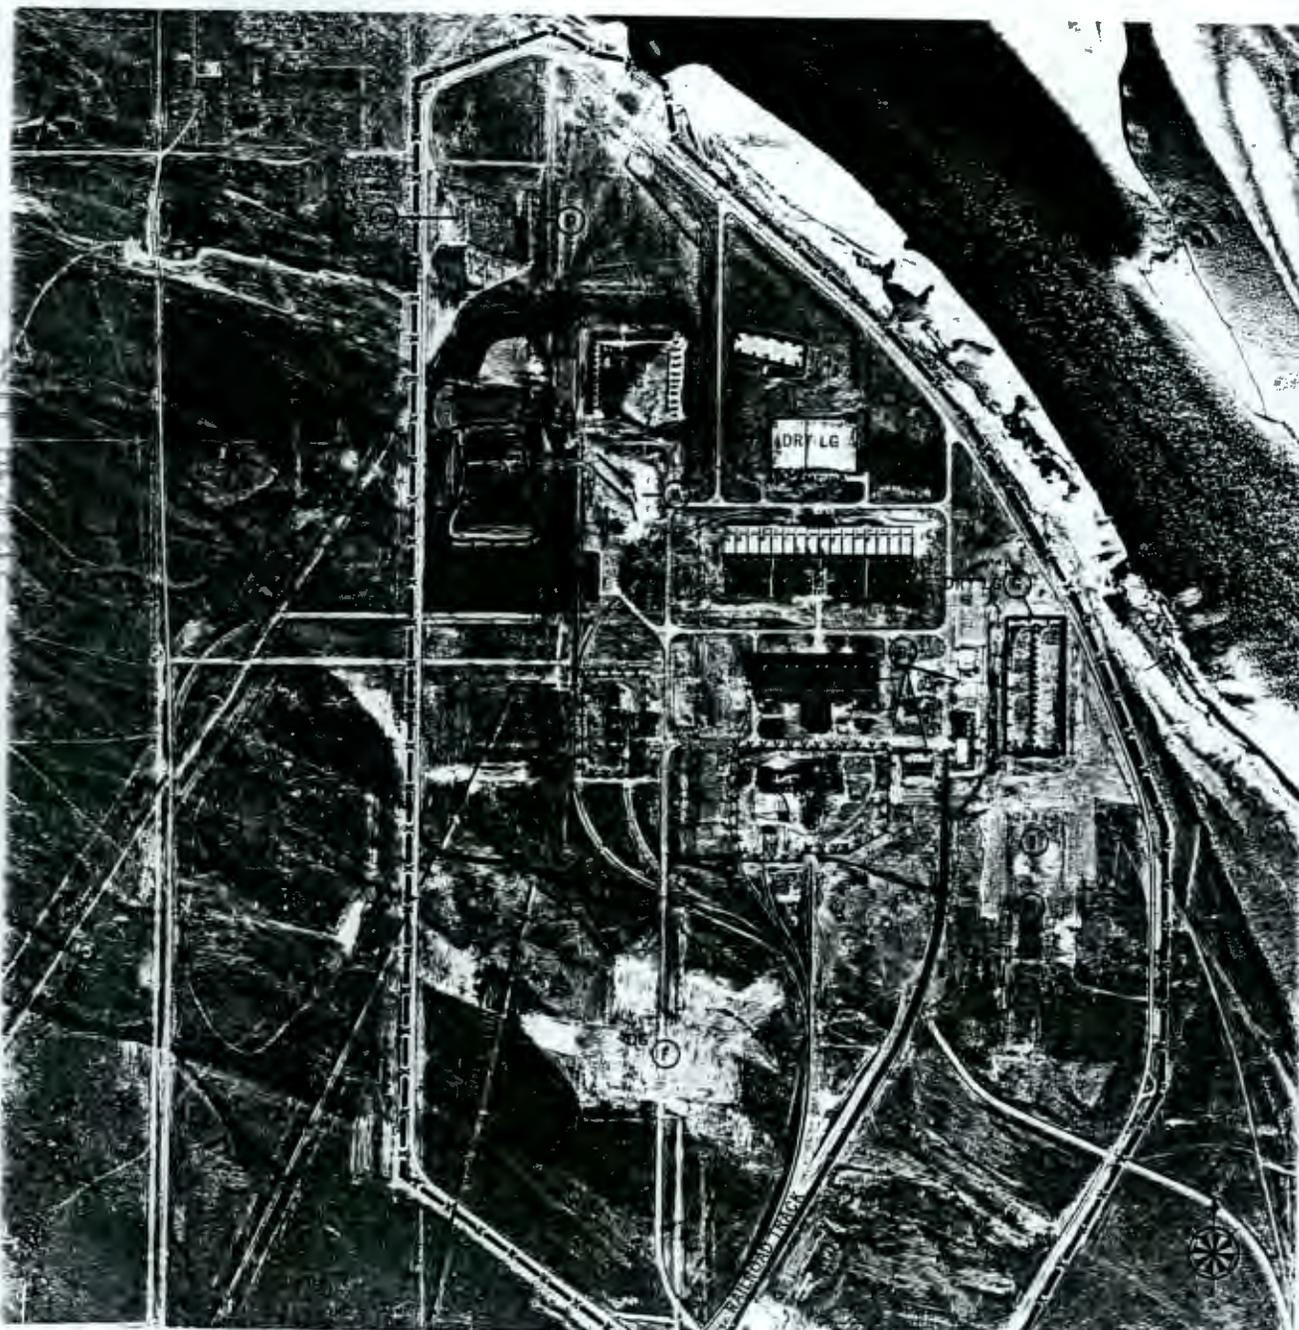
Figure 6. Rockwell Hanford Operations Area 100H, August 1973. Approximate scale 1:8,500.

The 1973 photograph (Figure 6) suggests Area 100H is no longer operational and being dismantled. The steam/power plant has been dismantled (Annotation A), the support/administration buildings are removed (Annotation B), and the steam pipelines are disconnected.

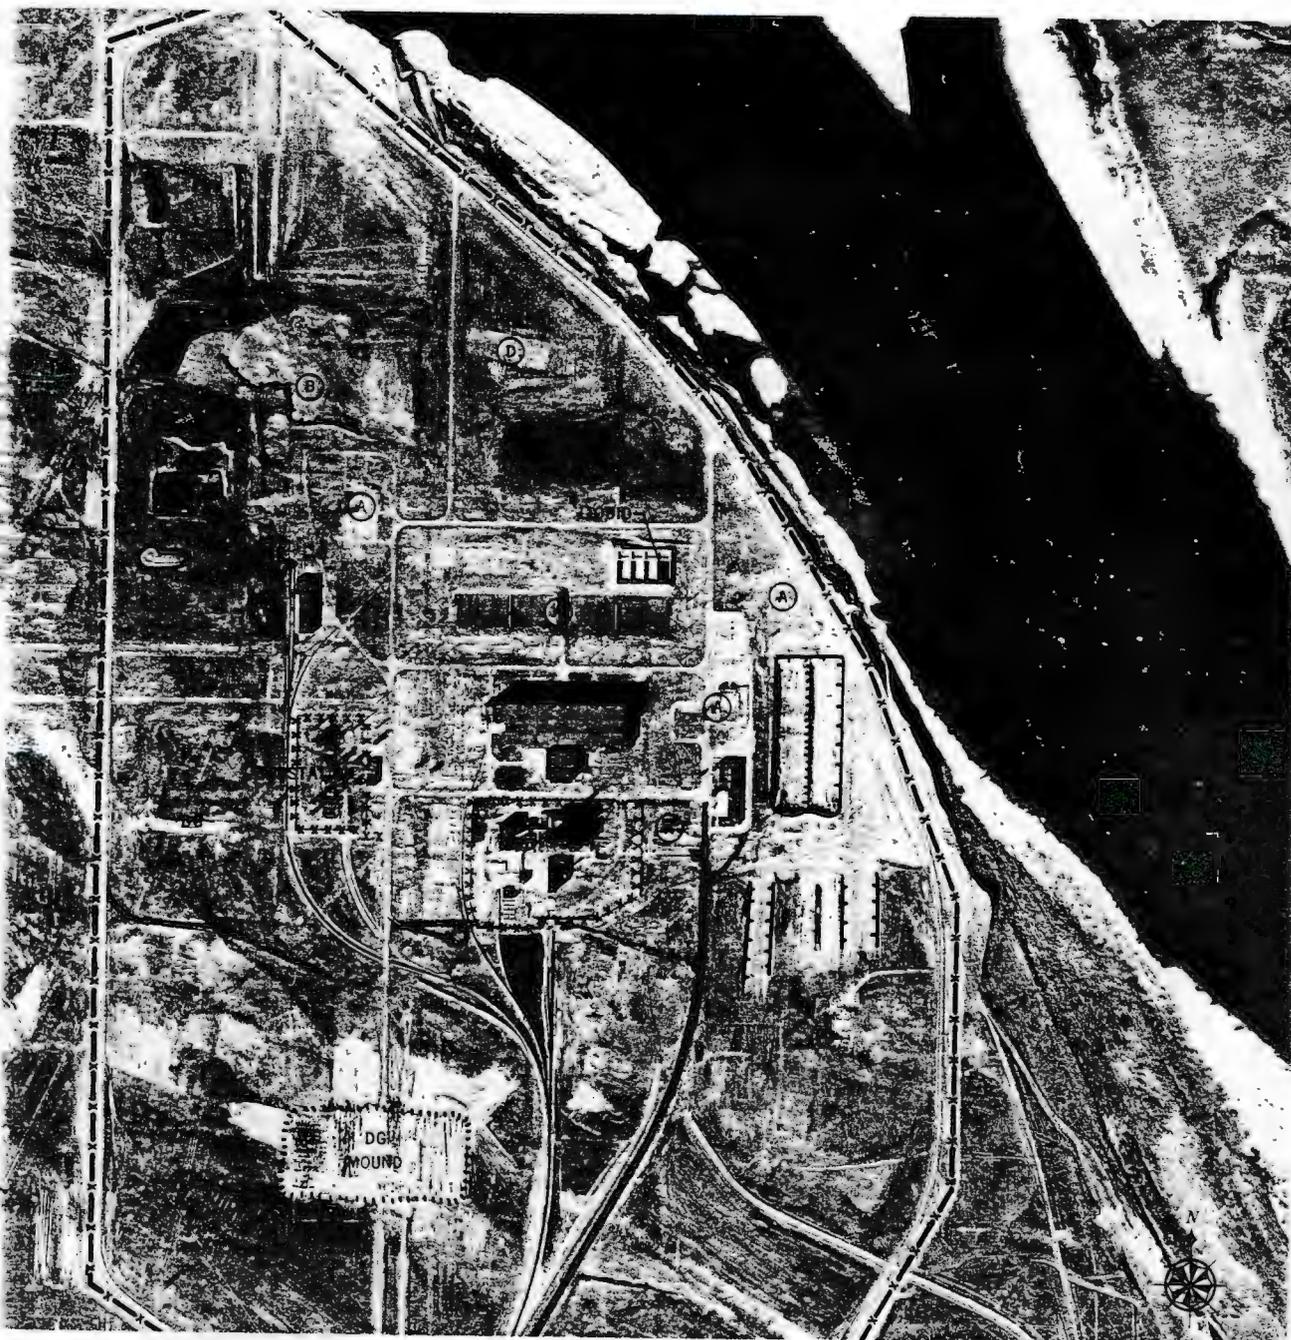
Figure 7. Rockwell Hanford Operations Area 100H, August 1976. Approximate scale 1:7,500.

The 1976 photograph (Figure 7) reveals the dismantling of buildings and closure of Area 100H has continued since 1973. Additional buildings are removed and several remains/ruins of building foundations are visible (Annotations A). The three large lagoons in the northern portion of the facility are absent, only ground scars are discernable (Annotations B, C, and D). The large pit at the west perimeter of the sit has also been filled in, a depression remains at this location (Annotation E).

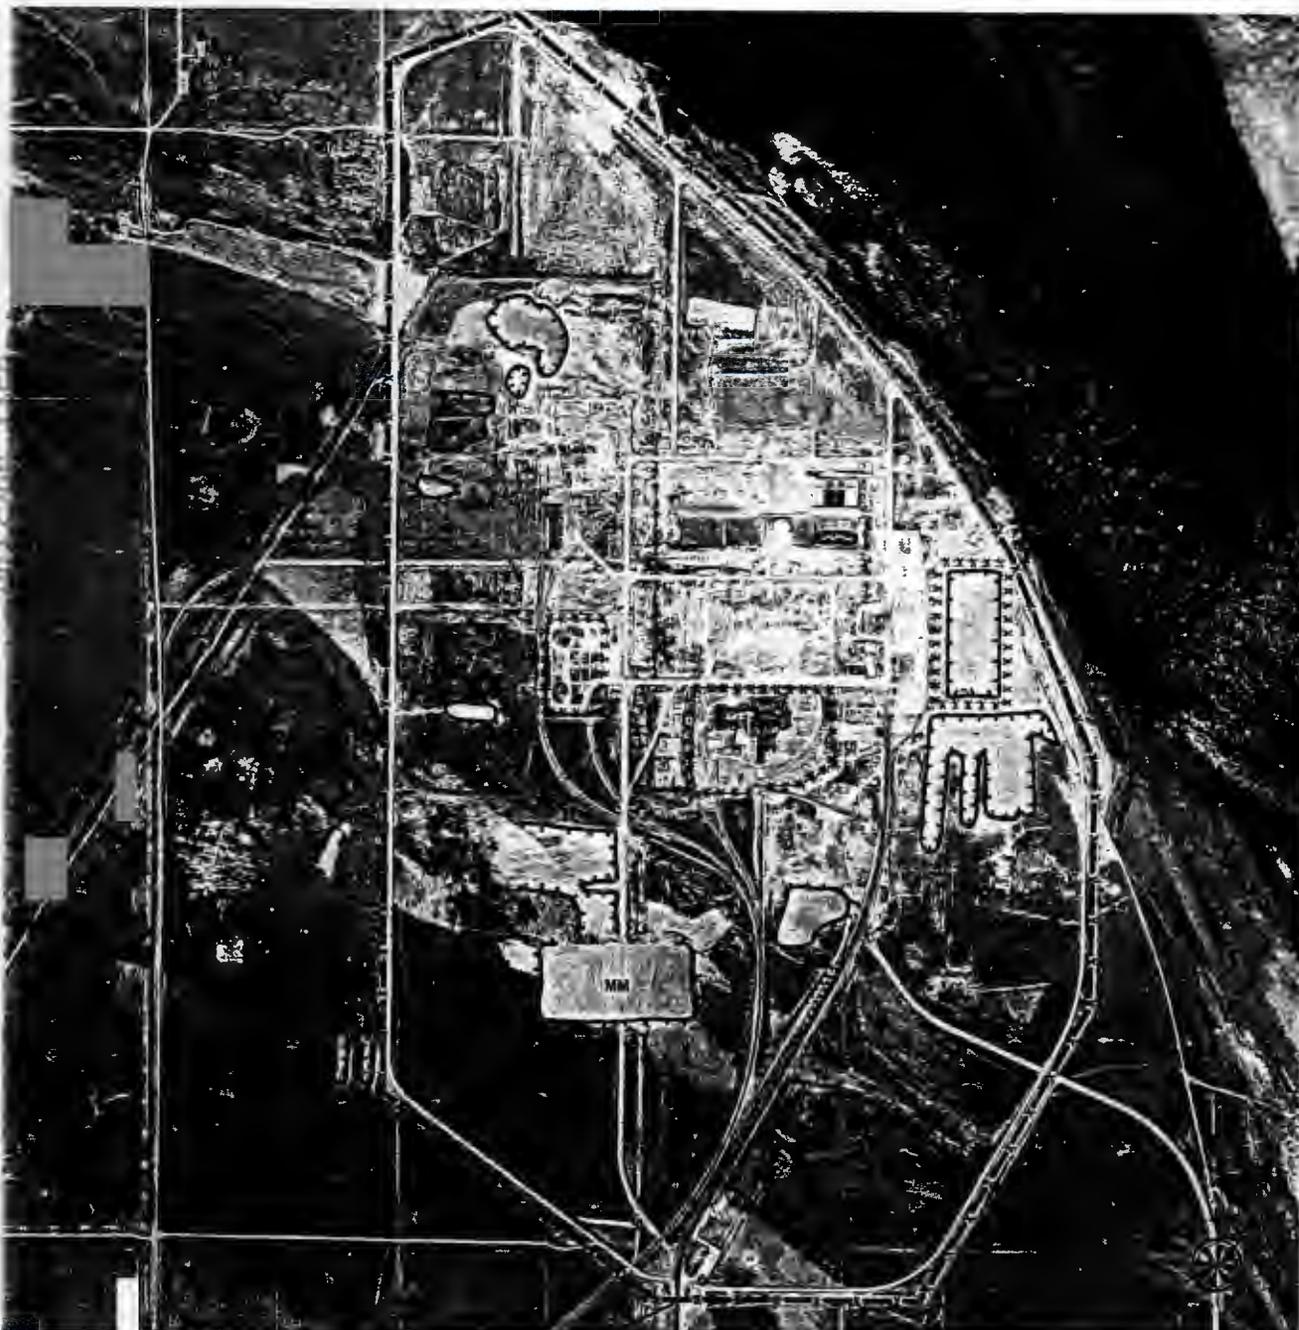
Figure 8. Rockwell Hanford Operations Area 100H, June 16, 1982. Approximate scale 1:8,500.

The 1982 photograph (Figure 8) reveals continued dismantling of the facilities and closure of Area 100H. There is no visible indication of activity at the study site which now appears deserted. There is one large building remaining (Annotation A).

No visible waste disposal activity is noted.
