FACILITY STATUS CHANGE FORM

Date Submitted: August 21, 2014 Originator: Chris Strand Phone: 554-2720	Area: 300 Area Facility ID: 342, 342A, 342B, 342C Action Memorandum: Action Memorandum #1	Control #: D4-300-098
--	---	---------------------------------

342, 342A, 342B, 342C FACILITIES COMPLETION

END-STATE PROPOSAL FOR THE 342 COLLECTION SUMP

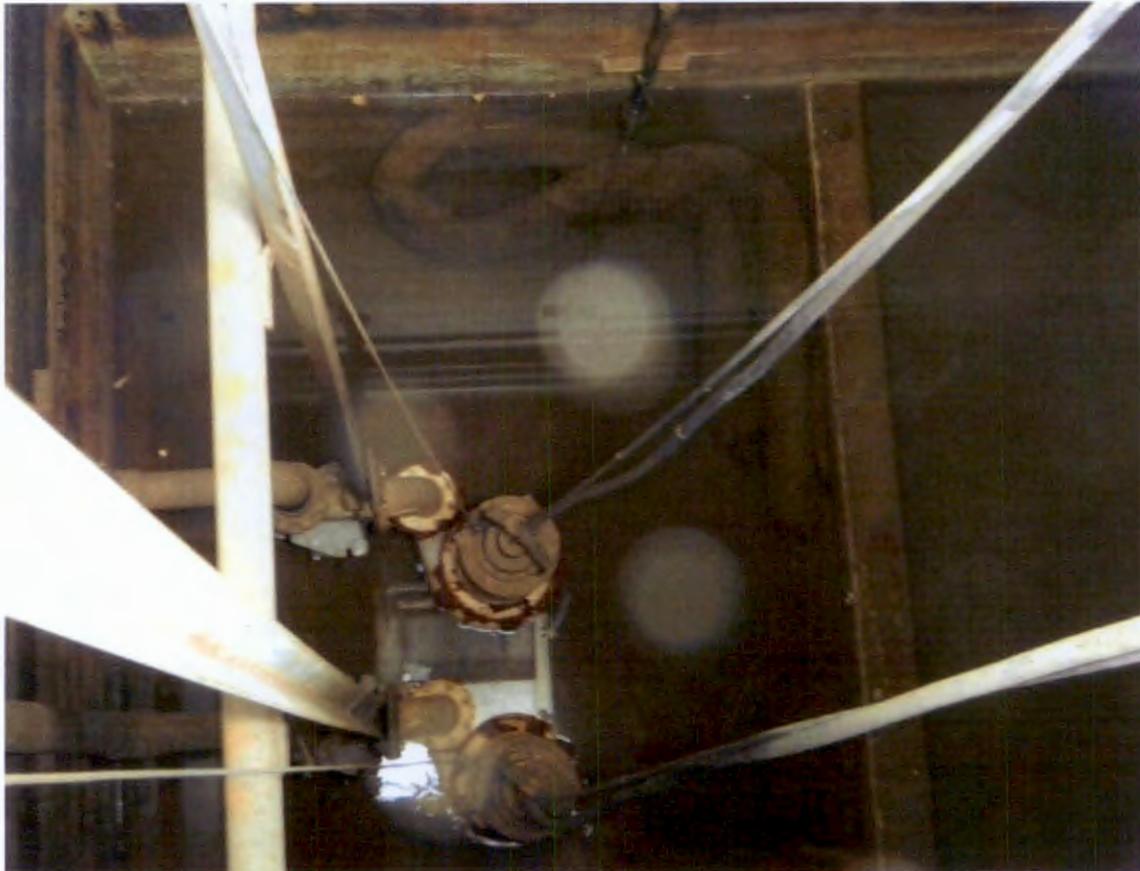
**Photograph 2. 342 Collection Sump Following Deactivation, April 2014.
(The sump is shown holding residual water and sediment
following system shut-down)**

Prior to demolition, the 342 complex deactivated and characterized. The sump was observed to be holding water and sediment supporting the history of facility operations as never having a release as shown in Figure 2. This facility has been deactivated and undergone demolition. Radiological scoping surveys performed prior to demolition identified no radiological contamination. Samples of sump sediment contained within the vault were taken during facility characterization. Analytical results did identify low levels of chemical contaminants, but all were below 300-FF-2 final Record of Decision Table 4, Cleanup Levels for industrial, shallow zone direct exposure. No asbestos containing materials were identified following inspection. A 2006 photograph showing the 342 Complex is included as Figure 1.

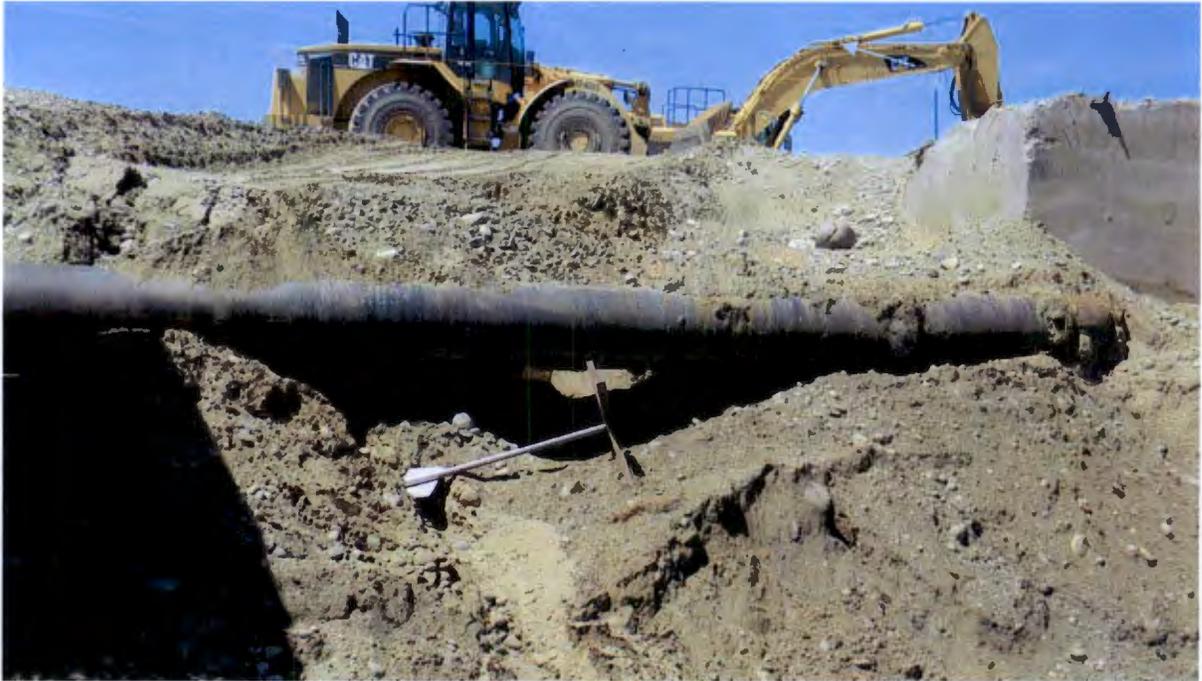
Photograph 3. 16 inch process sewer inlet piping, looking west on July 30, 2014.

300-15, Process Sewer - piping was removed to the limits of the excavation layback, but segments remain in the area.

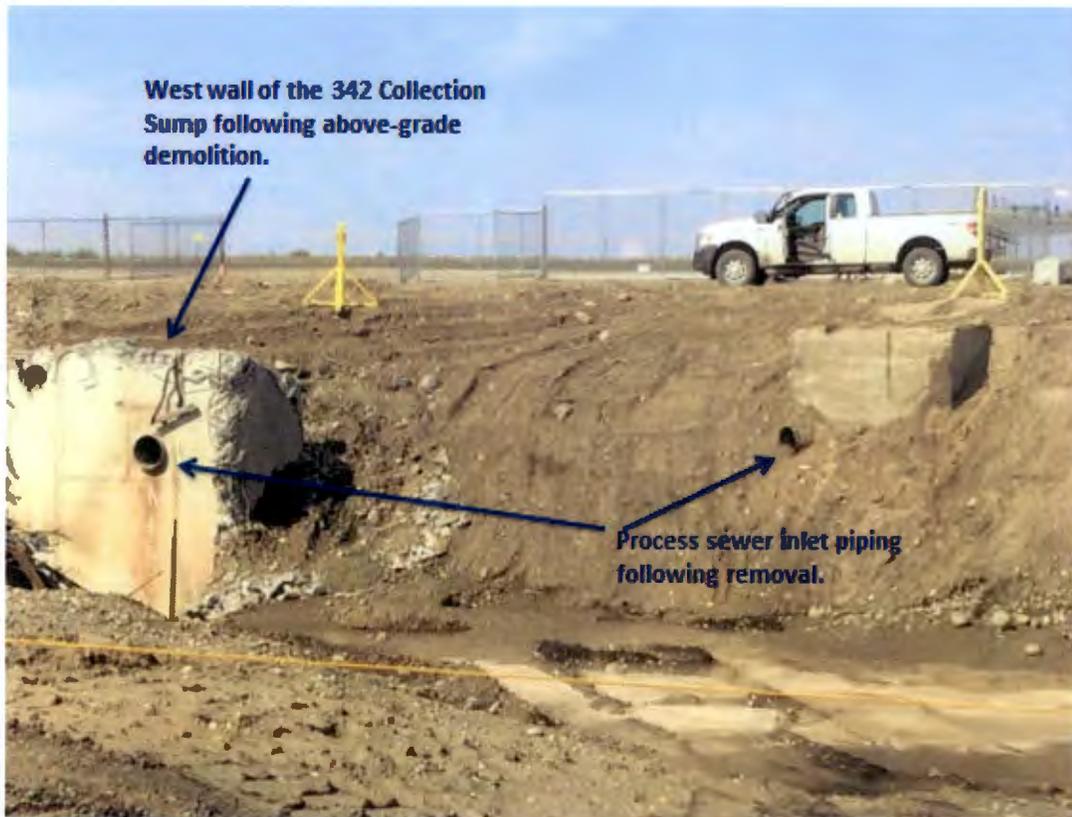
Photograph 4. 342 Below-grade demolition, looking southwest on August 12, 2014.

Demolition: Above-grade demolition of the 342 facilities were completed in August of 2014. Below-grade demolition of the 342A, 342B, and 342C foundations were completed in September 2014. The 342 Collection Sump foundation walls to 3 feet below grade was completed in September of 2014. The above-grade building debris were removed and disposed of at ERDF. The 342 Collection Sump was cleaned of remaining sediment and the basement walls and floor slab were left following EPA approval (Reference Attachment 4). Process sewer piping entering and exiting the facilities were removed to the excavation layback. The demolition was performed under Radiological and Industrial Hygiene controls.

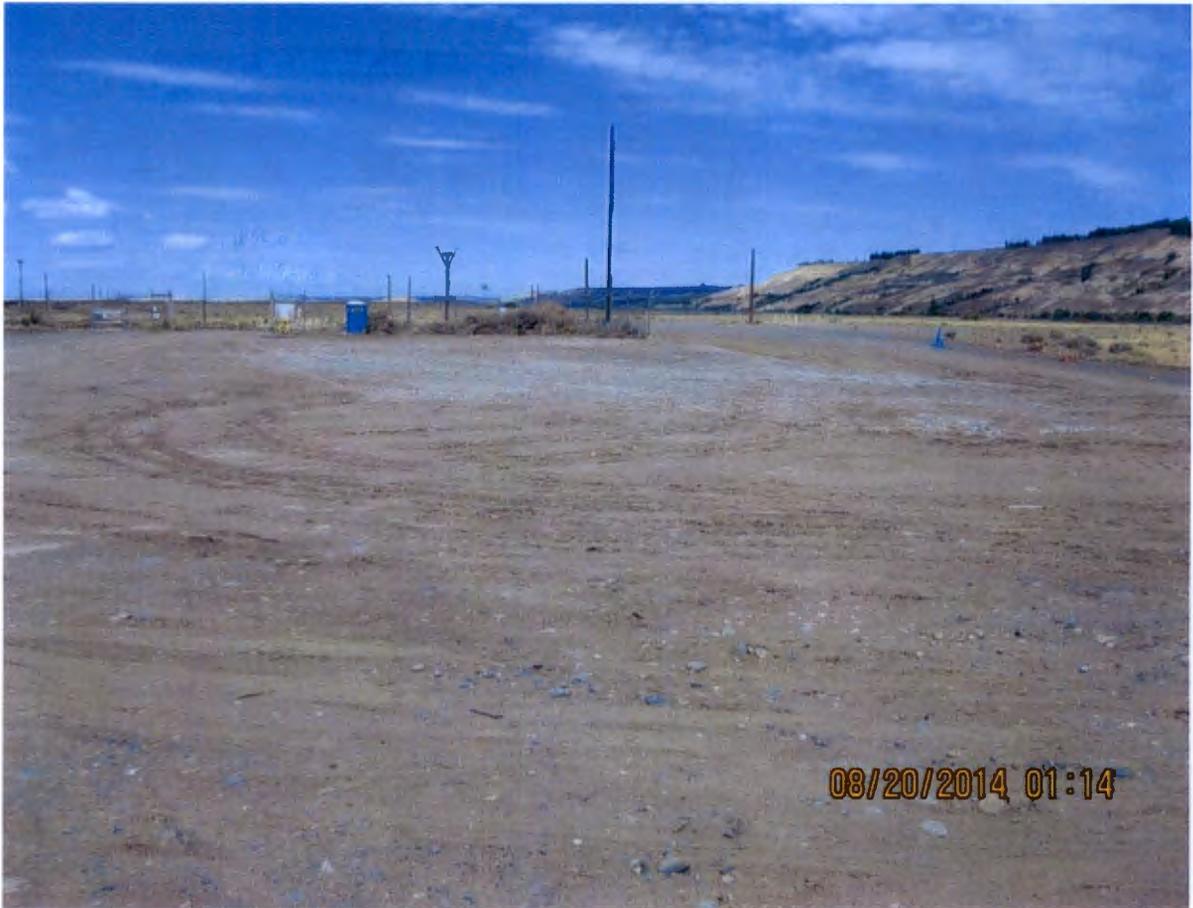
Photograph 4. 342 Complex following backfill, looking north on August 20, 2014.

The 342 Collection Sump walls were removed to 3 feet below-grade, with the remaining portion of the structure backfilled in place. GPERs surveys are included as attachment 3. The excavation was evaluated before backfill, no anomalies noted. No postings remain following backfill and site completion.

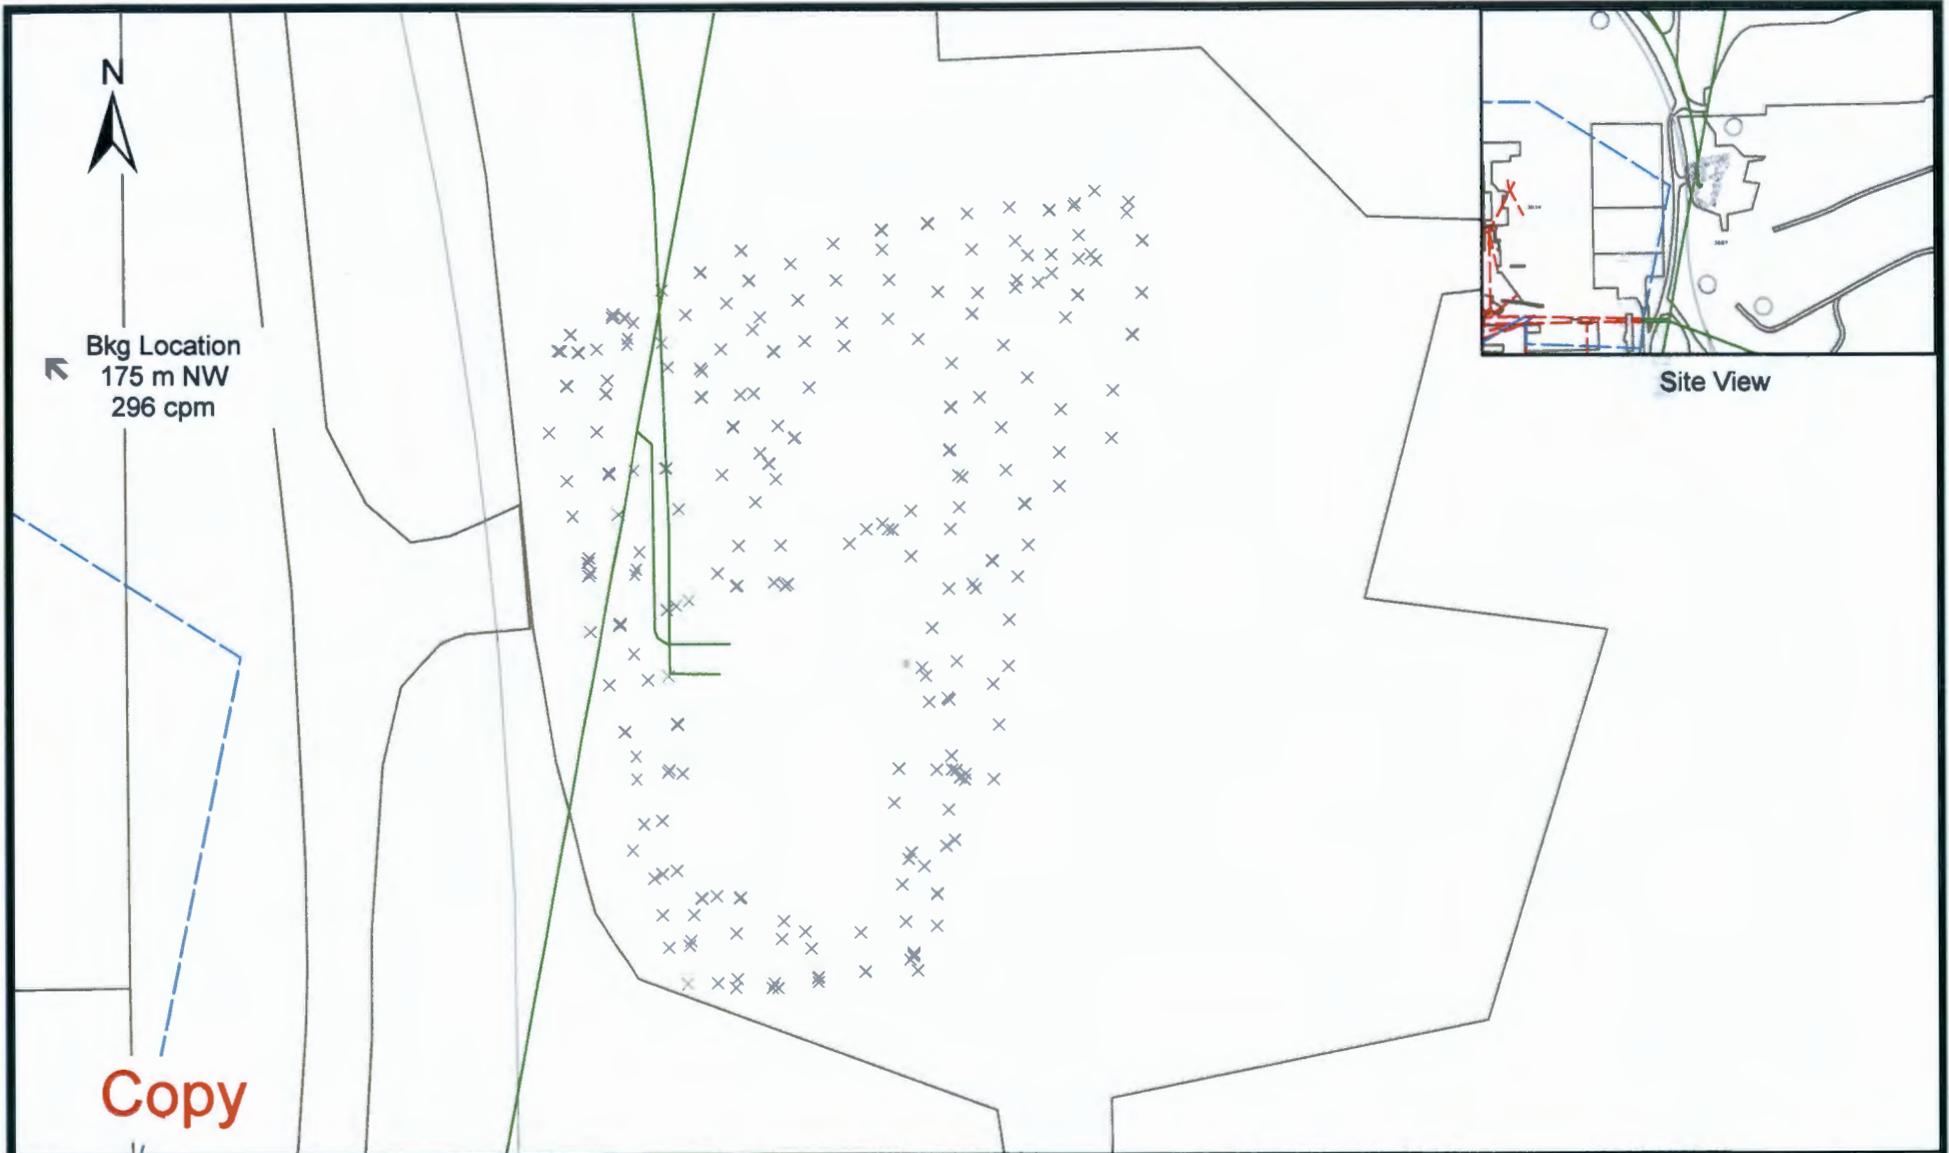
300 D4
342 Excavation
GPERS Radiological Survey
Beta Track Map

Legend	Summary Statistics
NET CPM	Coverage File: D4_226
× <444	Number of Data Pnts: 265
● 444 - 5000	Type of Survey: beta
● 5000 - 10000	Max GCPM: 524
● 10000 - 25000	Avg Bkg CPM: 296
● 25000	Survey Date: 8/14/2014
	Area Surveyed: 640 m ²
	Project File: ESRFRM140079B
	Pdf File: ESRFRM140079BC

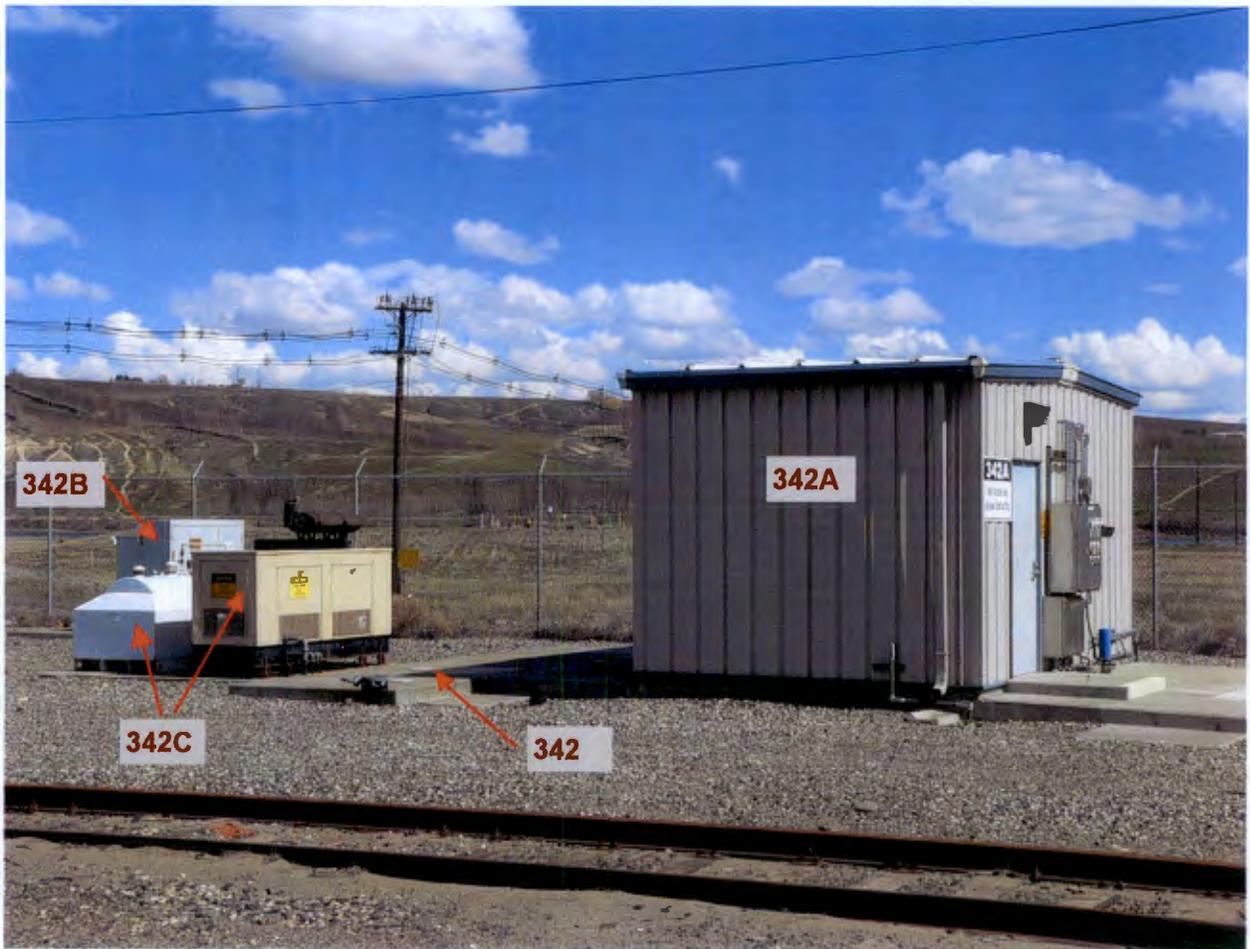
**Figure 1. 342 Complex looking north east, 2006.
(The 342 Waste Collection Sump vault lies directly beneath 342A)**

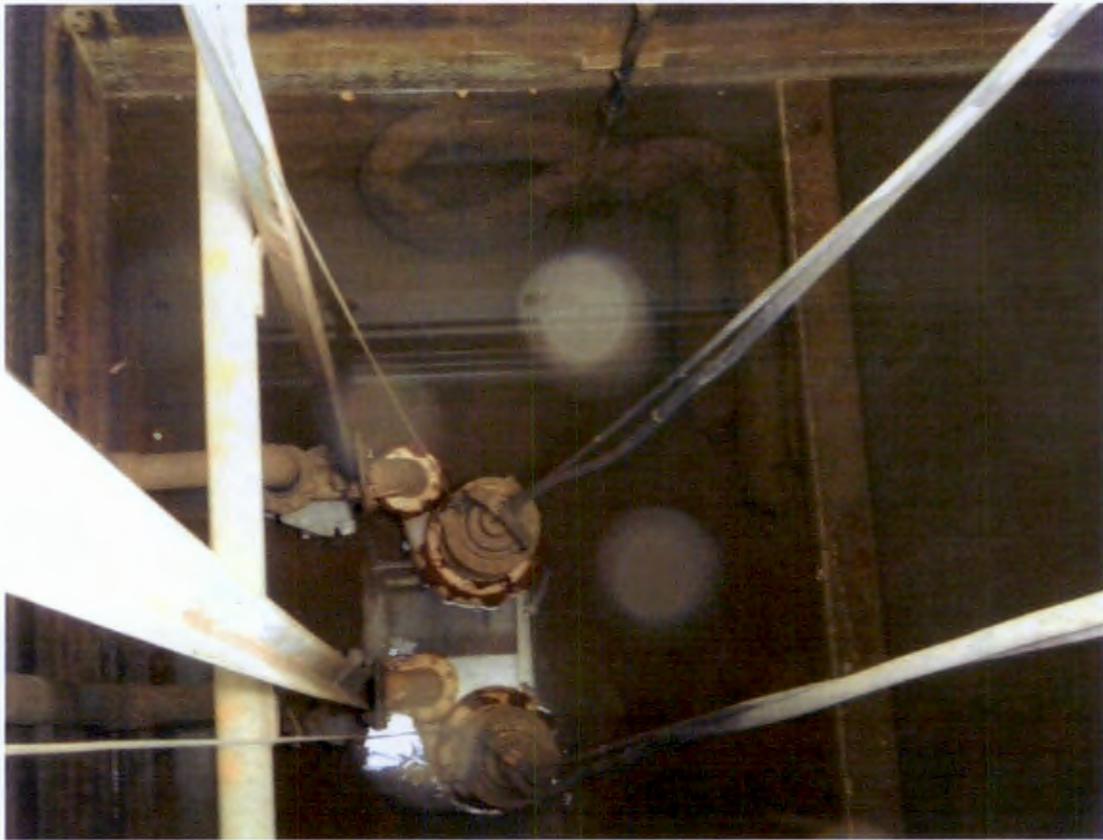
Figure 2. 342 Collection Sump Following Deactivation, April 2014.
(The sump is showing holding residual water and sediment following system shut-down)

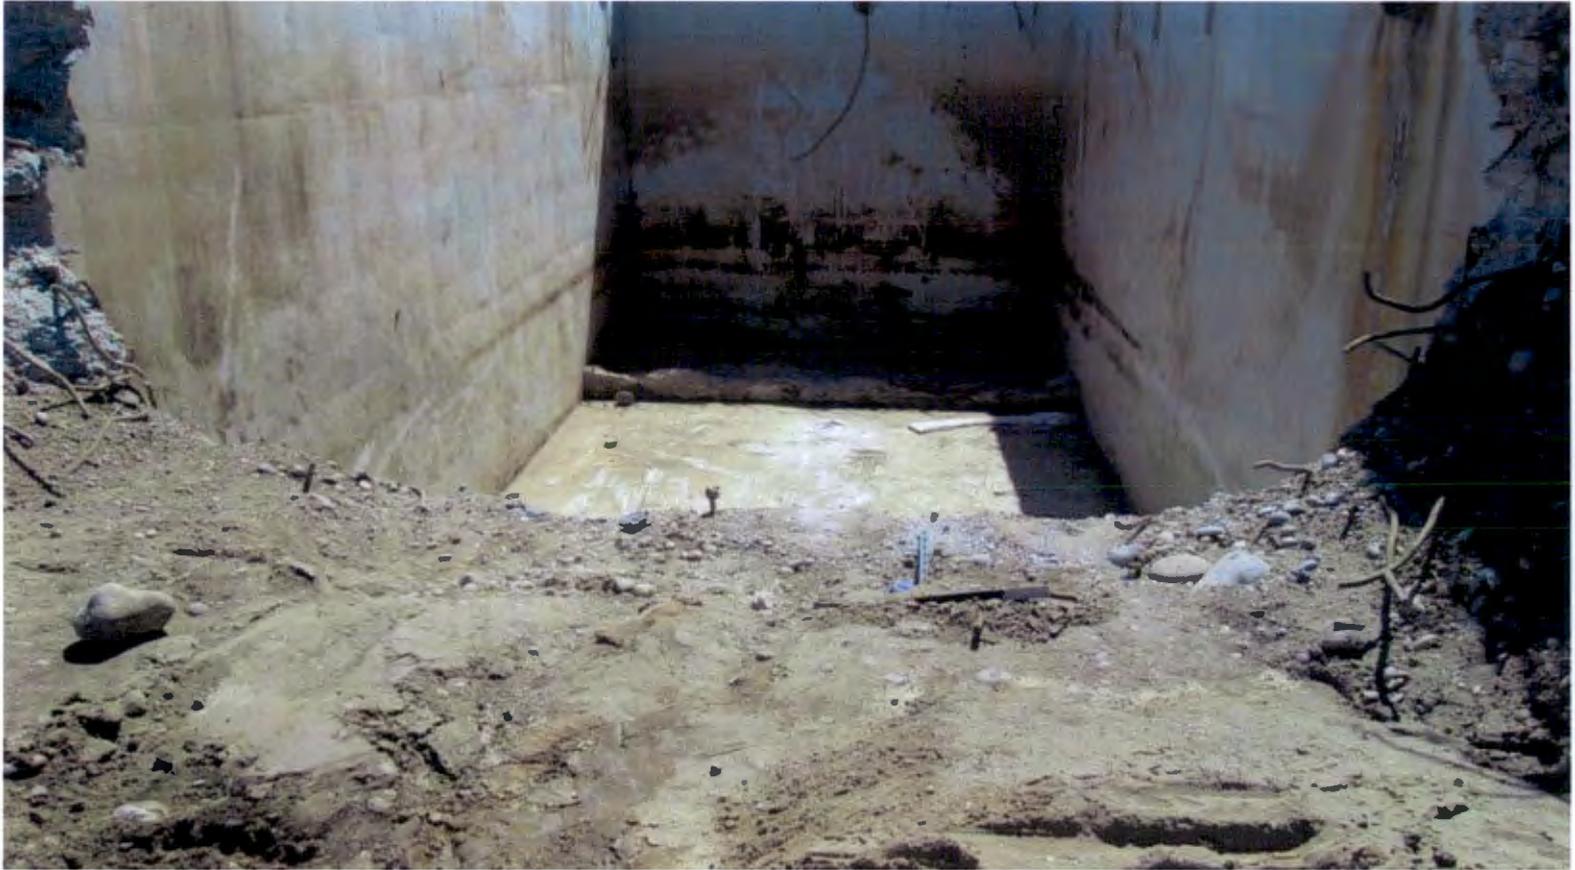
Figure 3. 342 Collection Sump vault floor, looking south, August 2014.

Following above-grade demolition, an excavator ramped down into the 342 Collection Sump vault from the northeast. The north wall of the vault was then breached and debris was removed with mechanical equipment. Following debris removal, the sediment on the vault floor was washed and pumped out into portable tanks, then solidified for disposal at the Environmental Restoration Disposal Facility. An excavator then removed residual solids as shown in Figure 3. Following cleanout of the sump, a visual inspection identified no cracks or other visible evidence structure that could have resulted in a release to the surrounding soil during operations.
