FACILITY STATUS CHANGE FORM

Date Submitted: February 7, 2013 Originator: Chris Strand Phone: 554-2720	Area: 300 Area Facility ID: 329 Action Memorandum: Action Memorandum #3	Control #: D4-300-080
---	---	---------------------------------

Attachment 2: 329 Project Photographs

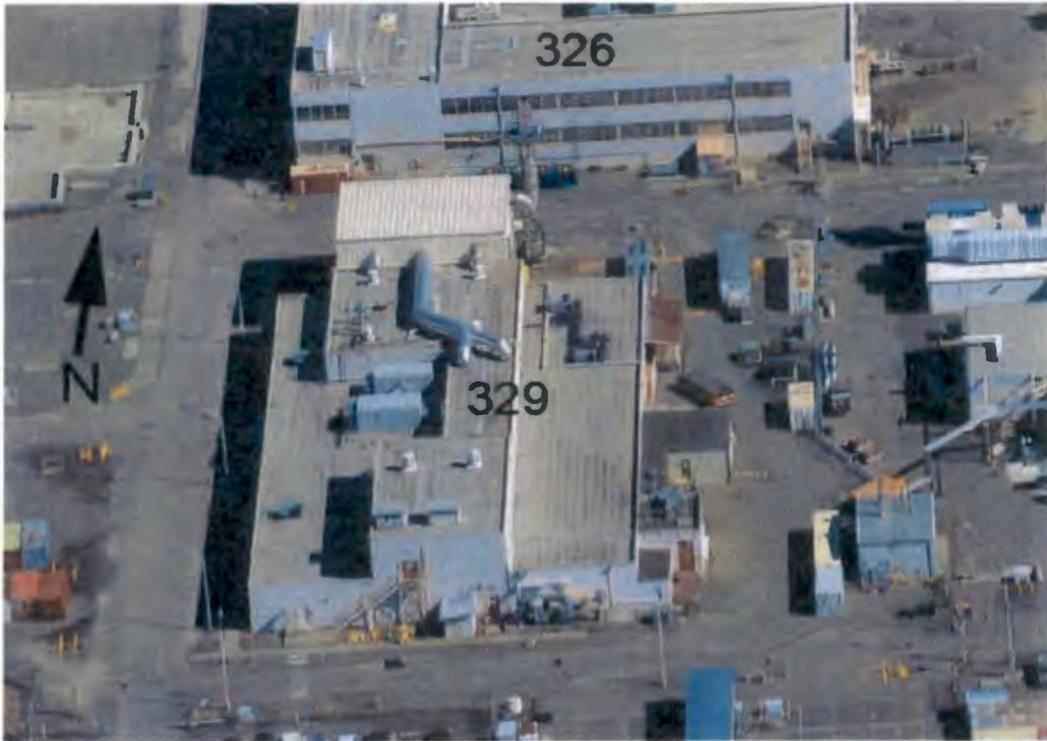
Photograph 1: Looking north at the 329 Chemical Sciences Laboratory in July 2012.

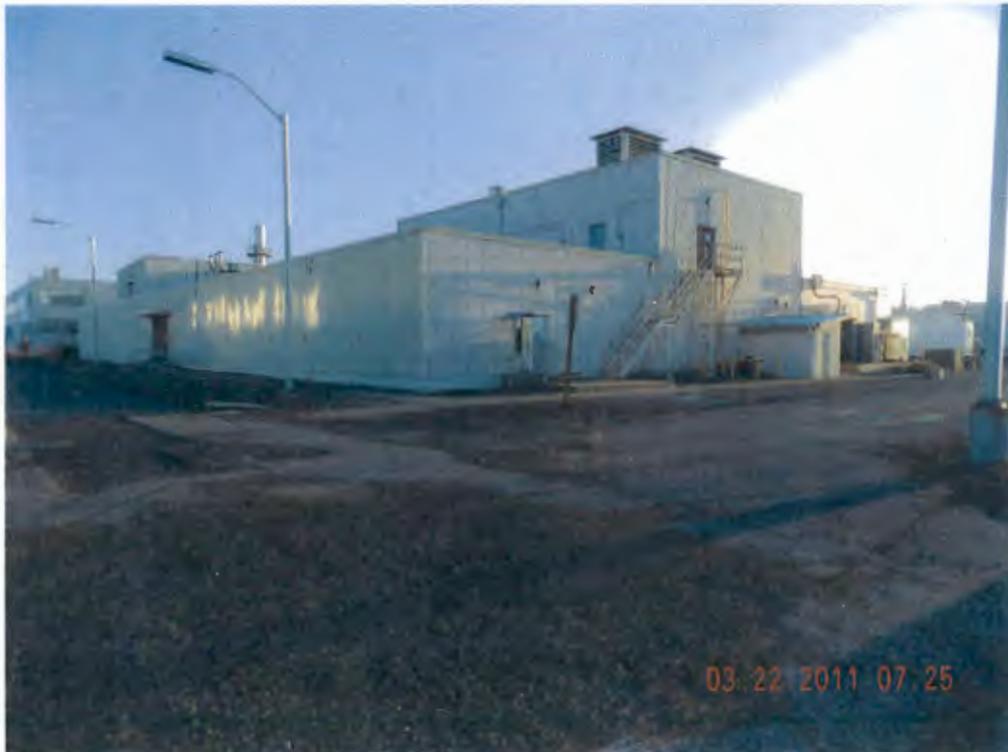
Photograph 2: 329 exterior looking northeast on March 22, 2011.

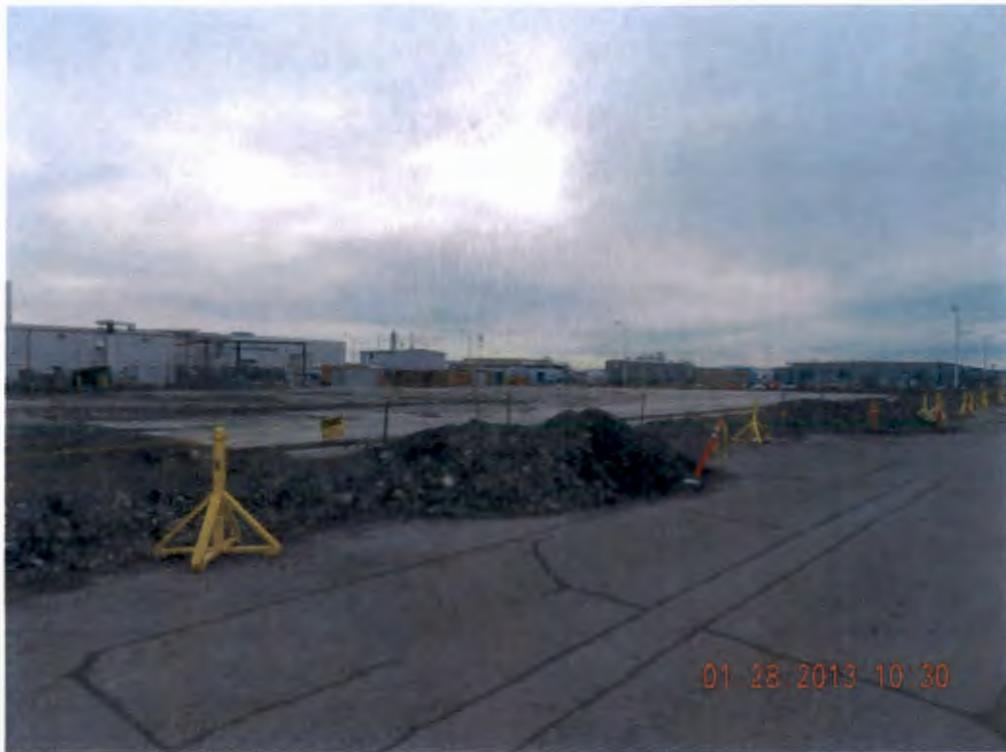
**Photograph 3: 329 slab following above-grade demolition,
looking southeast on January 28, 2013.**

Demolition: Above-grade demolition of the the 329 Building was completed in January 2013. The at-grade slab, partial basement, and neutron monitoring and ion exchange pits remain in place. Removal of these portions of the facility are interfered with by long-term retained utilities that support ongoing operation of the adjacent 325 Building. The building debris from above-grade demolition was removed and disposed of at ERDF. The demolition was performed under Radiological and Industrial Hygiene controls.

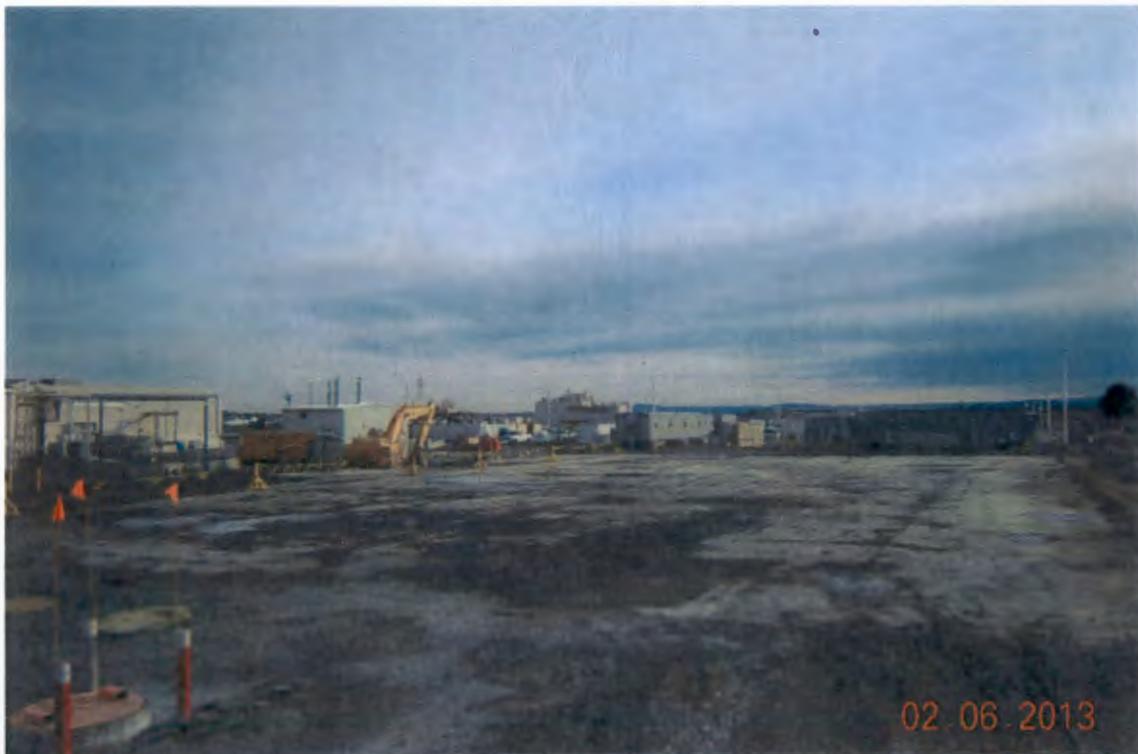
**Photograph 4: 329 slab following final grading and down-posting,
looking southeast on February 6, 2013.**

The 329 at-grade slab and grout-filled basement and pits remain. IH and radiological down-posting of the area is complete. A final GPERs survey of the slab was performed, no postings remain.

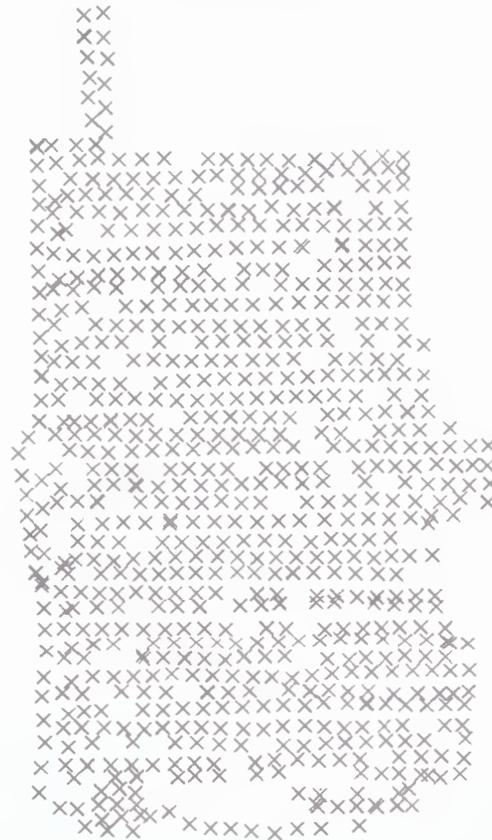
300 D4
329 Slab Area
GPERS Radiological Survey
Beta Track Map

Bkg Location
190 meters NE
353 cpm

Coverage File: D4_028,A
Number of Data Pnts: 777
Type of Survey: beta
Max GCPM: 854
Avg Bkg CPM: 353
Survey Date: 1/28/2013
Area Surveyed: 3,060 m²
Project File: ESRFRM130013B
Pdf File: ESRFRM130013BC

No anomalies were observed during the demolition of the 329 Building. GPERS surveys of the remaining slab surface identified no contamination.
