## FACILITY STATUS CHANGE FORM

<b>Date Submitted:</b> April 20, 2011	<b>Area:</b> 300 Area	<b>Control #:</b> D4-300-042
<b>Originator:</b> John Harrie	<b>Facility ID:</b> 352E East Side Switch Station	
<b>Phone:</b> 509.308.9935	<b>Action Memorandum:</b> Action Memorandum #3

**300 D4 Field Remediation  
352E Building Site  
GPERS Radiological Survey  
Beta Track Map**

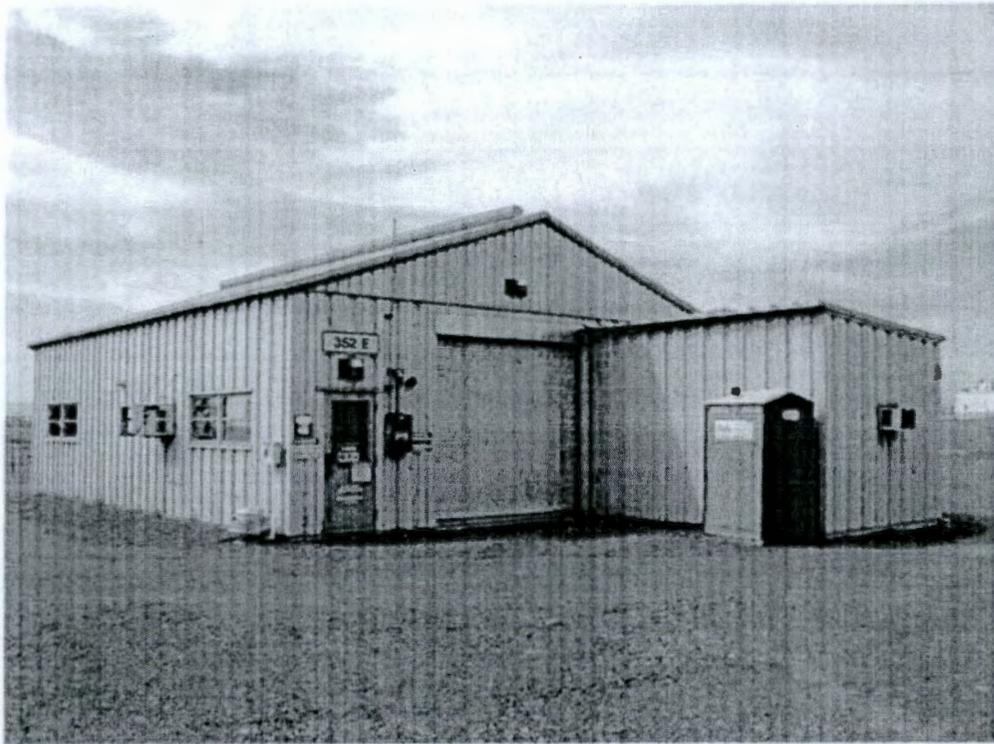
**Figure 2. 352-E Building Site, Looking Southwest, 2005**

The 352E East Side Switch Station, built in 1972, served as a breaker station for facilities in the eastern portion of the 300 Area. The building that housed the switch gear was a dust-tight prefabricated steel structure with a gable roof that measured 44-feet by 32-feet (13.4 m by 9.8 m). A rolling door was located on the north wall. An extension that measured 16-feet by 12-feet (5 m by 3.7 m) was built onto the northwest corner of 352E that was insulated and used as a battery room.

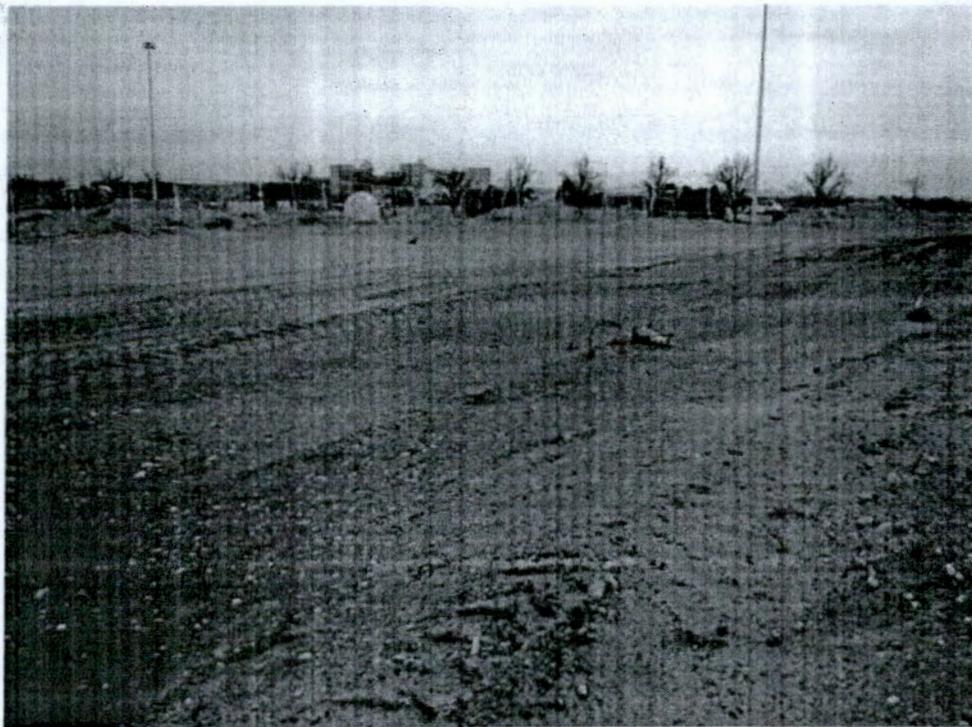
**Figure 3. 352-E Post-Demolition Site, Looking South, March 2011**

Demolition: Demolition of the entire facility, including the foundation was completed in February of 2011. The building debris were removed and disposed of at ERDF. The demolition was performed without Radiological and Industrial Hygiene controls.

All above-ground 352E building structures were removed including the foundation and the area regraded.

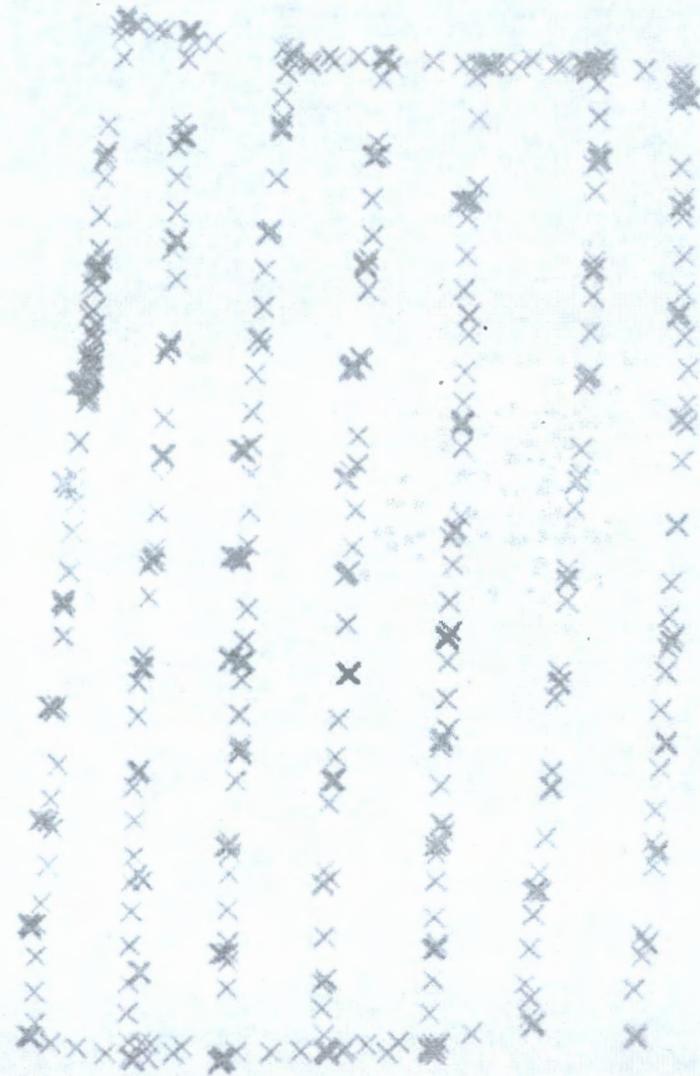
Bkg Location  
431 cpm

Coverage File: D4073  
Number of Data Pnts: 1098  
Type of Survey: beta  
Max GCPM 620  
Avg Bkg CPM: 431  
Survey Date: 3/14/2011  
Area Surveyed: 848 m<sup>2</sup>  
Project File: ESRFRM110050B  
Pdf File: ESRFRM110050BC

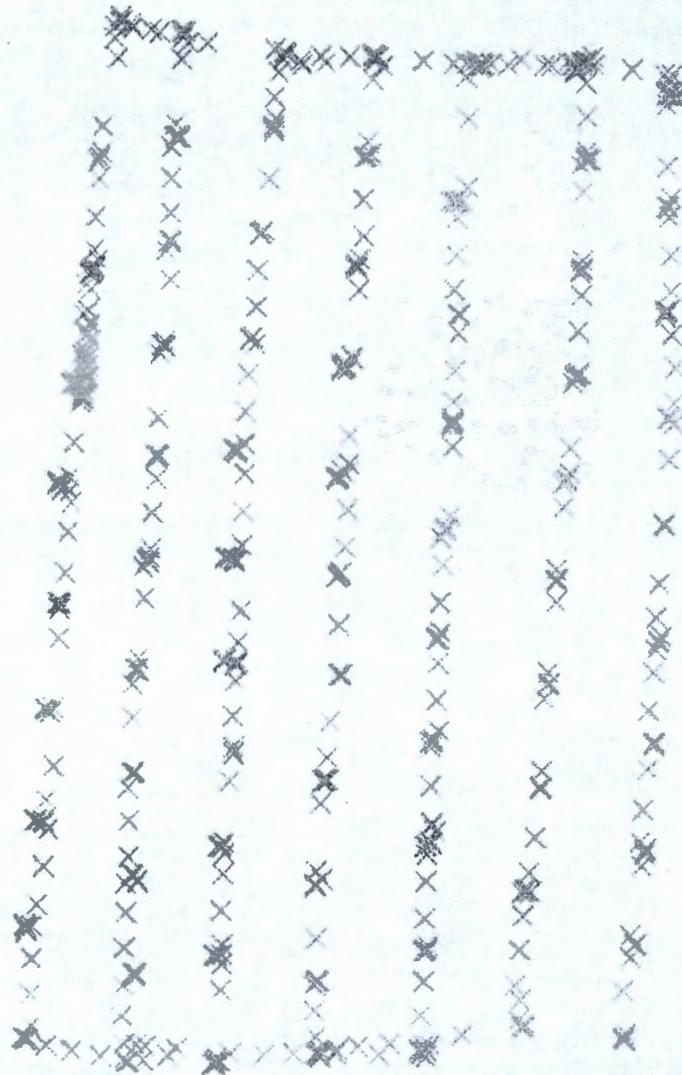
# 300 D4 Field Remediation 352E Building Site GPERS Radiological Survey Gamma Track Map

Bkg Location  
1230 cpm

Coverage File: D4073  
Number of Data Pnts: 1098  
Type of Survey: gamma  
Max GCPM 2397  
Avg Bkg CPM: 1230  
Survey Date: 3/14/2011  
Area Surveyed: 848 m<sup>2</sup>  
Project File: ESRFRM110050G  
Pdf File: ESRFRM110050GC
