SITE ASSESSMENT CHECKLIST AND REPORT FOR UNDERGROUND STORAGE TANK (UST)
3000-12 REMOVAL

UST 3000-12 SITE ASSESSMENT REPORT

UST Site Owner:	U.S. Dept of Energy, Richland Field Office
Owners Address:	825 Jadwin, P.O. Box 550, Richland, WA 99352
Site ID Number:	012763
UST ID Number:	3000-12
Date Removed:	April 2, 1993
Site Assessment Complete:	April 28, 1993

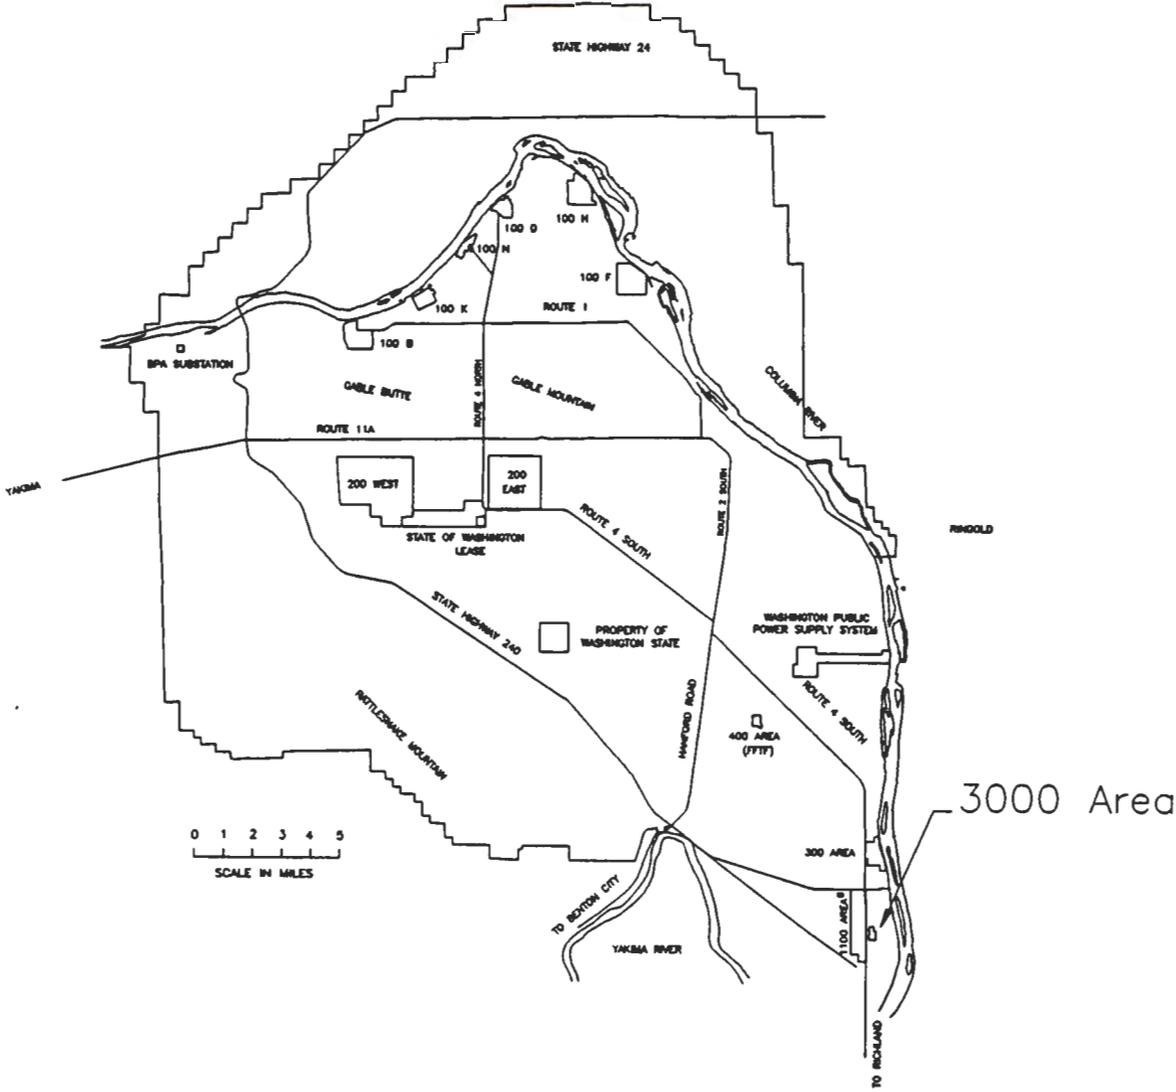
Figure 1: Hanford Site Map

The 3000-12 UST was located in the 3000 Area, within the 1100-EM-3 Operable Unit. The 3000 Area is part of the Hanford Site which is largely an industrial area. Refer to Figure 1 for details of the Hanford Site boundaries.

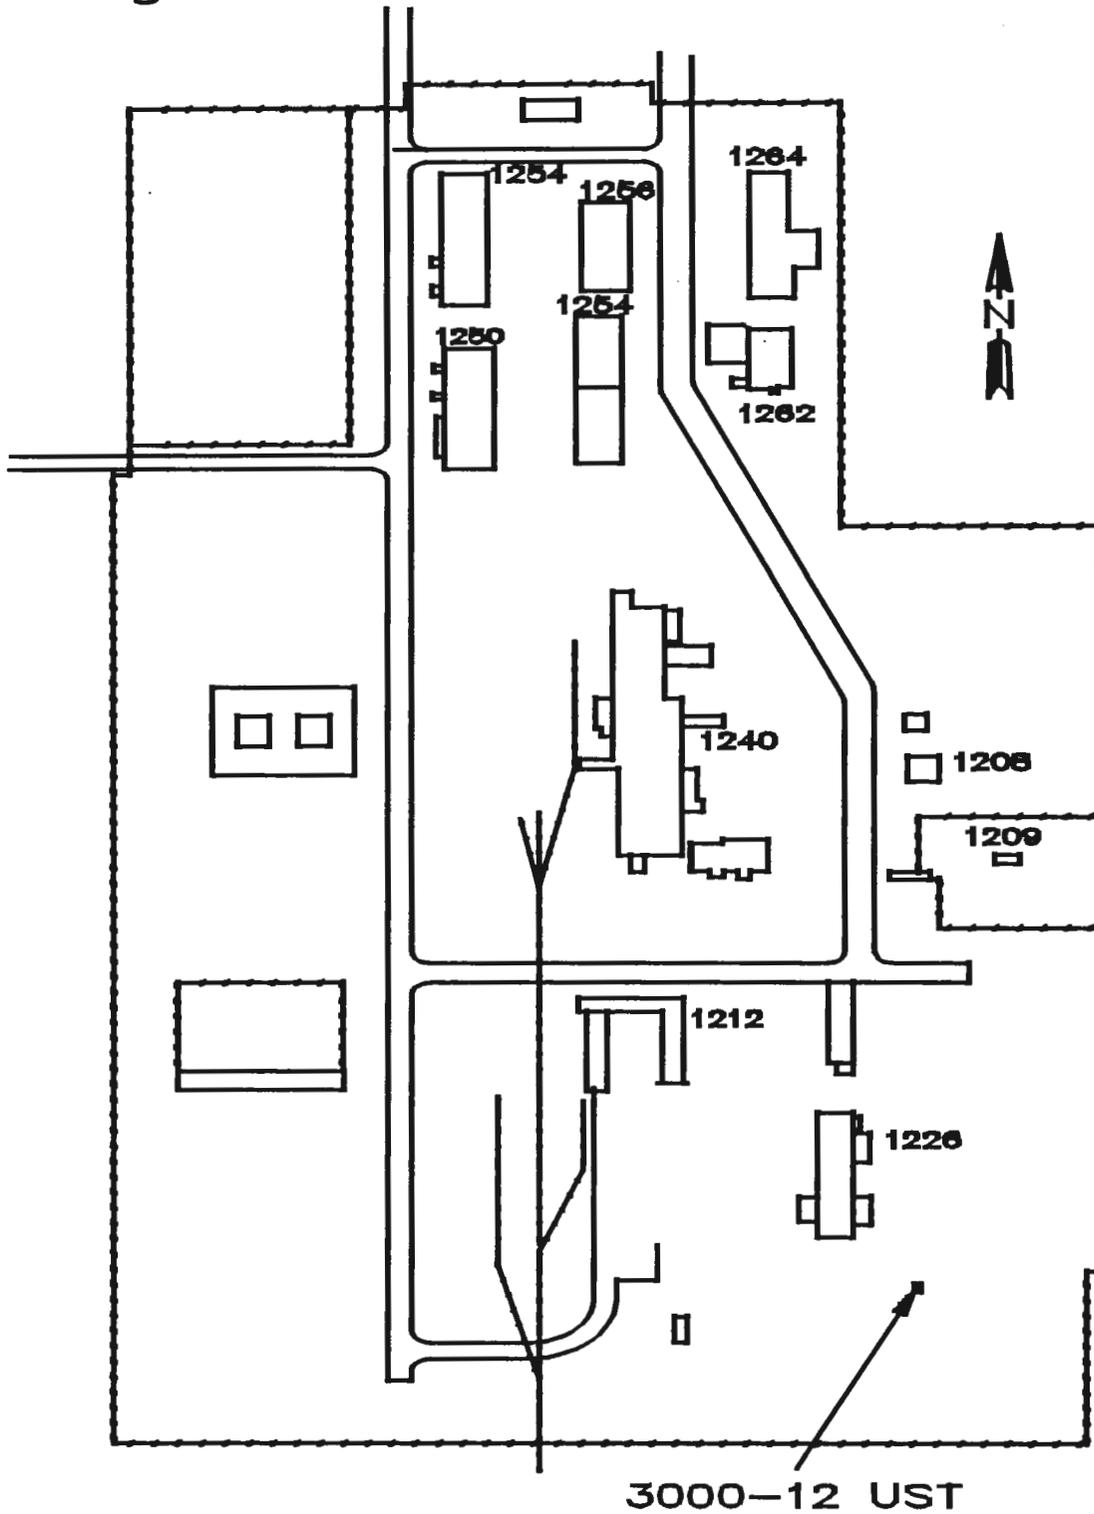
Figure 2: 3000 Area

The system was used to support operations in the 3000 Area (Operable Unit 1100-EM-3) of the Hanford Site. It was located in the southeastern portion of the 3000 Area where it supported activities of a nearby maintenance shop.

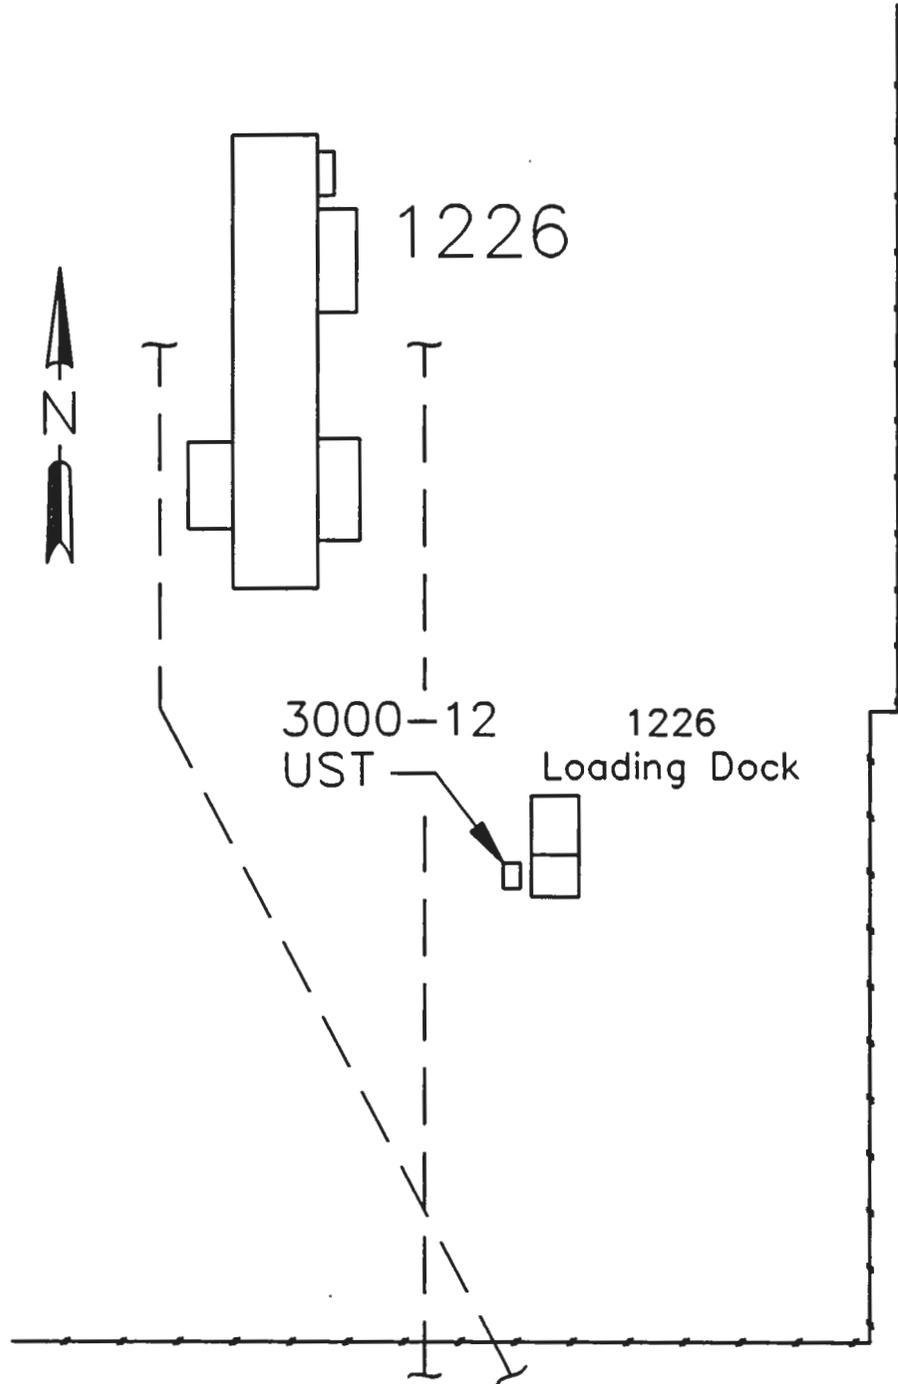
Figure 3: 1226 Building and
and 3000-12 UST Location

No above or below ground utilities were found. According to site plans and interviews, the closest underground utility (sanitary water) is more than 25 feet away as seen in Figure 3.

Several subsurface water and sewer lines exist in the 3000 area which are serviced by the City of Richland. These lines are shown leaving the 3000 Area as depicted on Figure 3 (Page SA7). These possible contamination routes are above the mounding effects of the recharge basins which eventually flow into the Columbia River, approximately 1 mile east of the site.

The UST system was located approximately 5' west of the loading dock associated with the 1226 maintenance shop. The maintenance shop is approximately 150' northwest of the loading dock as seen in Figure 3 (Page SA7).

There is a sanitary water line approximately 25' west of the UST system and a sanitary sewer line approximately 150' west of the UST system as seen on Figure 3 (Page SA7).

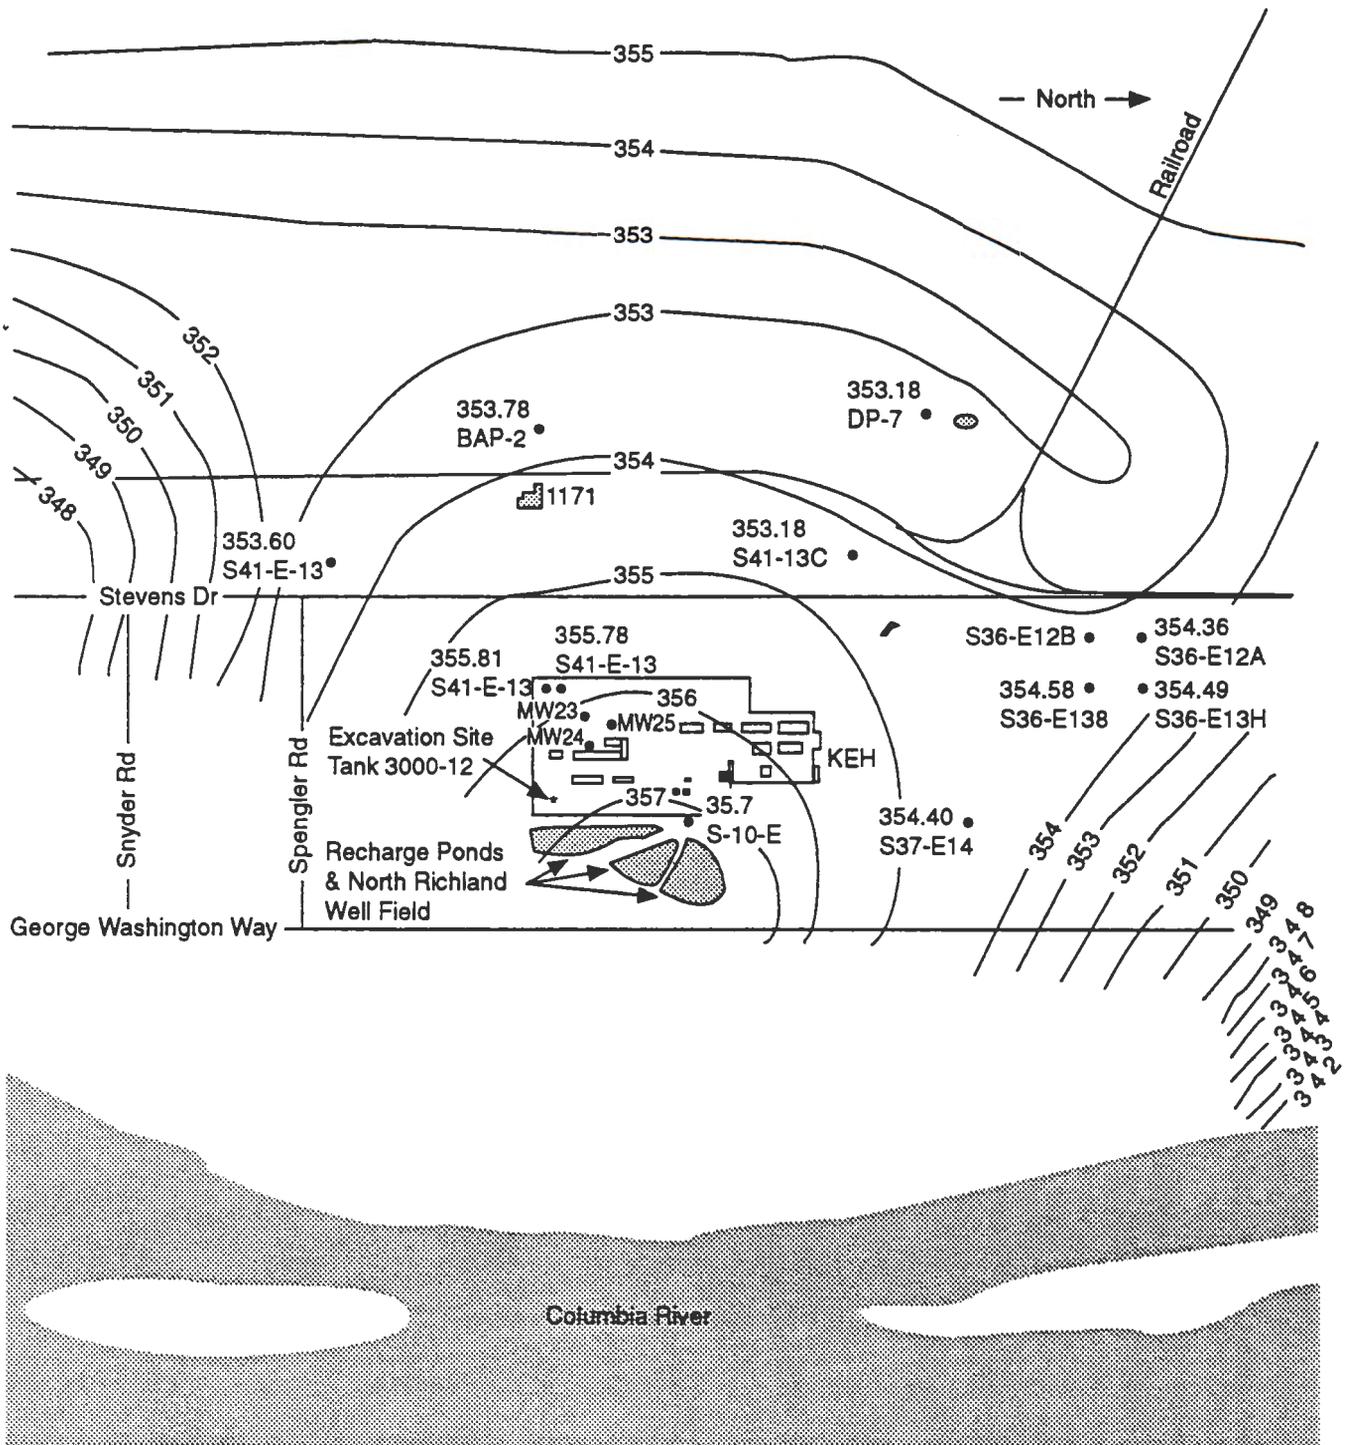
Figure 4: Water Table and Monitor Well Locations at the 3000 Area

The 3000-12 single shell UST system did not yet require leak detection (required by 12/22/93 per WAC 173-360) and did not have any systems in place. Figure 4 (Page SA10) shows monitor well locations in the immediate area. This drawing was produced in 1989 and may not reflect current groundwater levels due to the mounding effects of the recharge basins located nearby. The recharge basins and other groundwater related items are discussed on page SA12.

Groundwater in the 3000 Area occurs in an unconfined aquifer approximately 50 to 60 feet below ground surface. The unconfined aquifer exhibits high permeability, particularly in the Pasco gravels (WHC 1992). Studies conducted at the 3000 Area estimate maximum groundwater flow velocity at 170 feet/year (RL 1989).

The groundwater flow direction is complicated by the groundwater mounding resulting from the city of Richland's well field and recharge basins. When the basins are active and mounding occurs, this introduces a reversing or stalling westward component to the natural west to east flow direction. Normal groundwater flow is also effected by spacial differences in the hydraulic conductivity of the unconfined aquifer and variations in river stage (WHC 1992).

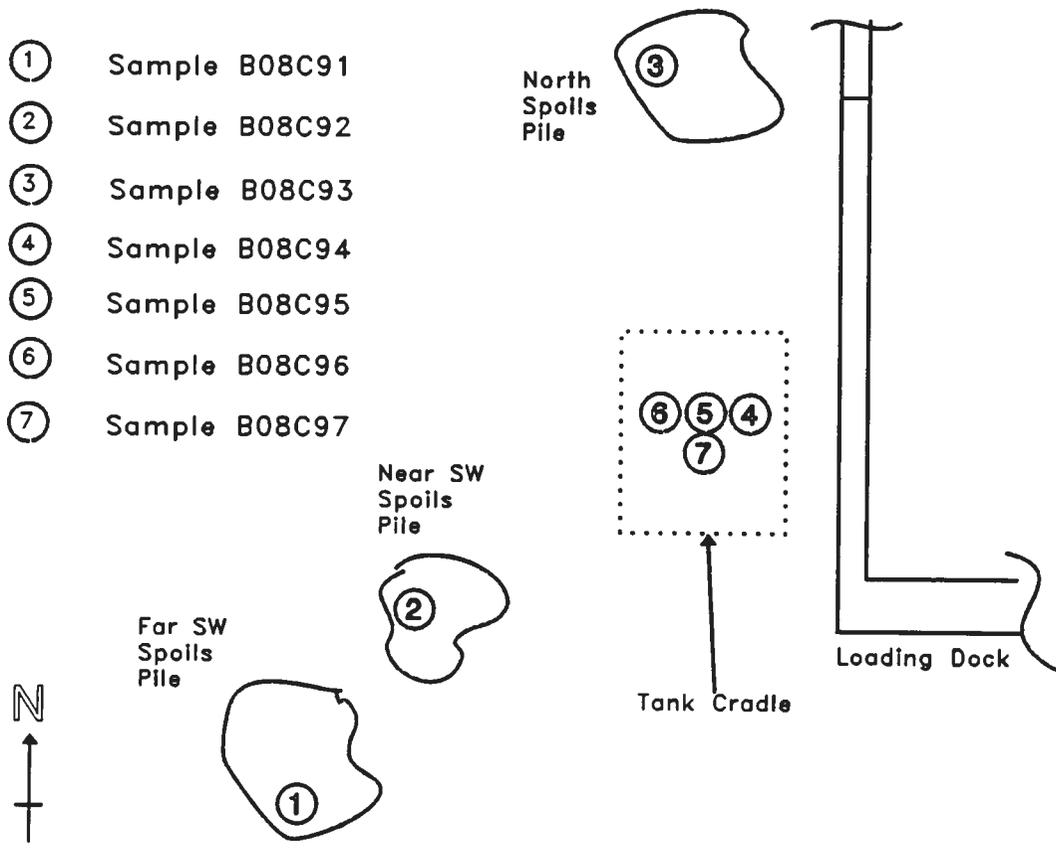
Figure 5: 3000-12 Spoils and Samples

A visual inspection of the surface soils under the fill funnel indicated the existence of petroleum contamination. The soil under the funnel was lightly stained from probable spills and overfills during waste oil insertion into the tank.

Sample ID	Sample Location
B08C91	Far Spoils Pile, SW of Tank
B08C92	Near Spoils Pile, SW of Tank
B08C93	Spoils Pile, N of Tank
B08C94	East Side of Tank Cradle
B08C95	Center of Tank Cradle
B08C96	West Side of Tank Cradle
B08C97	Center of Tank Cradle, Duplicate of B08C95

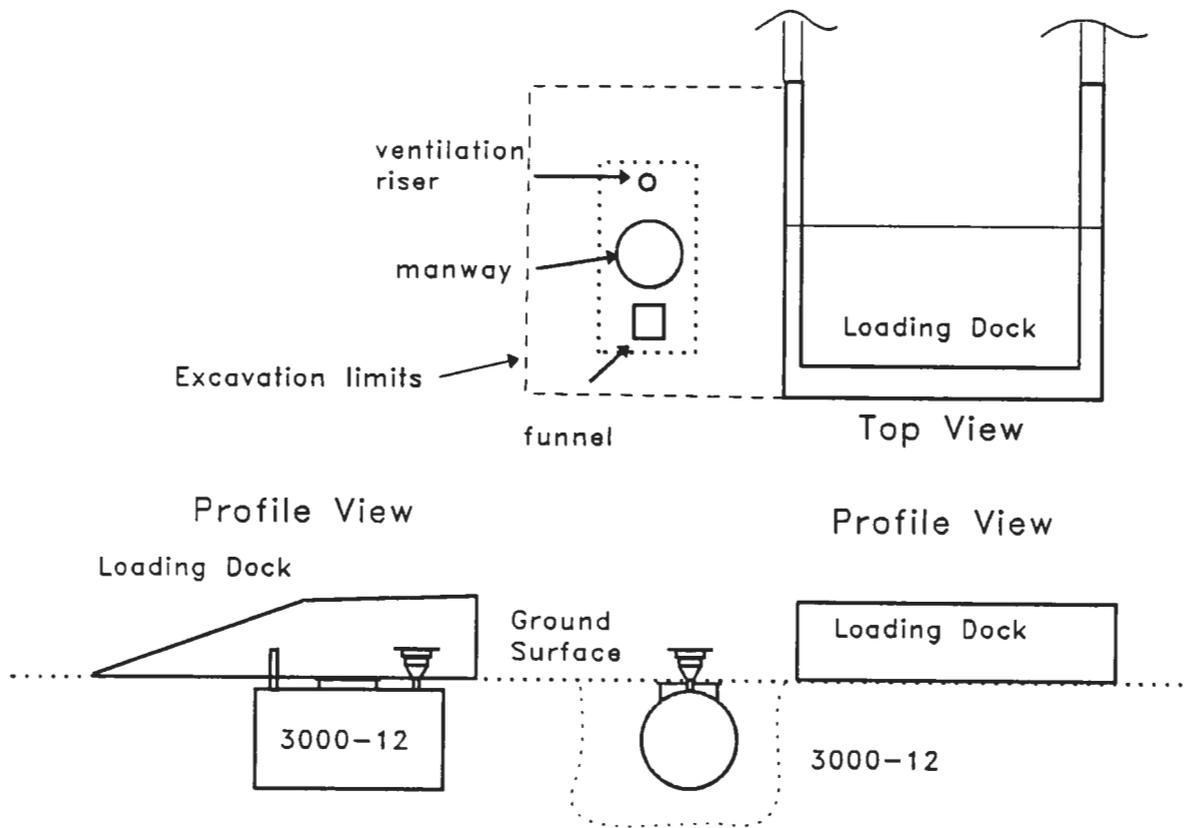
Figure 6: 3000-12 Excavation

Underground storage tank plans or drawings were not available for this tank. Information presented here was obtained during operator interviews and the site assessment. The 3000-12 UST system consisted of one STI_{p3} (™) cathodically protected steel tank and no piping. The top of the tank was at grade with a 12" square funnel permanently attached to a 4" diameter fill opening for oil insertion, a 24" diameter manway and a vent line. The tank inlet funnel was capped and locked. The manway had a ½ inch thick bolted steel plate cover. The location of the tank can be seen in Figures 5 and 6 (Pages SA16 and SA18, respectively).

The field conditions and near perfect condition of the tank (installation instructions were easily read) indicate that overfills and spills of used oil have occurred during the operating life of this tank. Discolored soil was found in the tank cradle leading down from the funnel. The sample of this segregated soil (B08C94) had a 2400ppm concentration of heavy petroleum oils (C24+). This soil failed the TCLP test as defined in the dangerous waste regulations (WAC 173-303) and was designated as a "problem waste". Further investigations did not locate the extent of the contamination plume so a 90 day report will be prepared describing these efforts.
