FACILITY STATUS CHANGE FORM

Date Submitted: 03/20/2019 Area: 200W Control Number: D4-PFP-041

The 2712Z Stack Sampling and Monitoring Station was deactivated and demolished to slab-on-grade in July 2017.

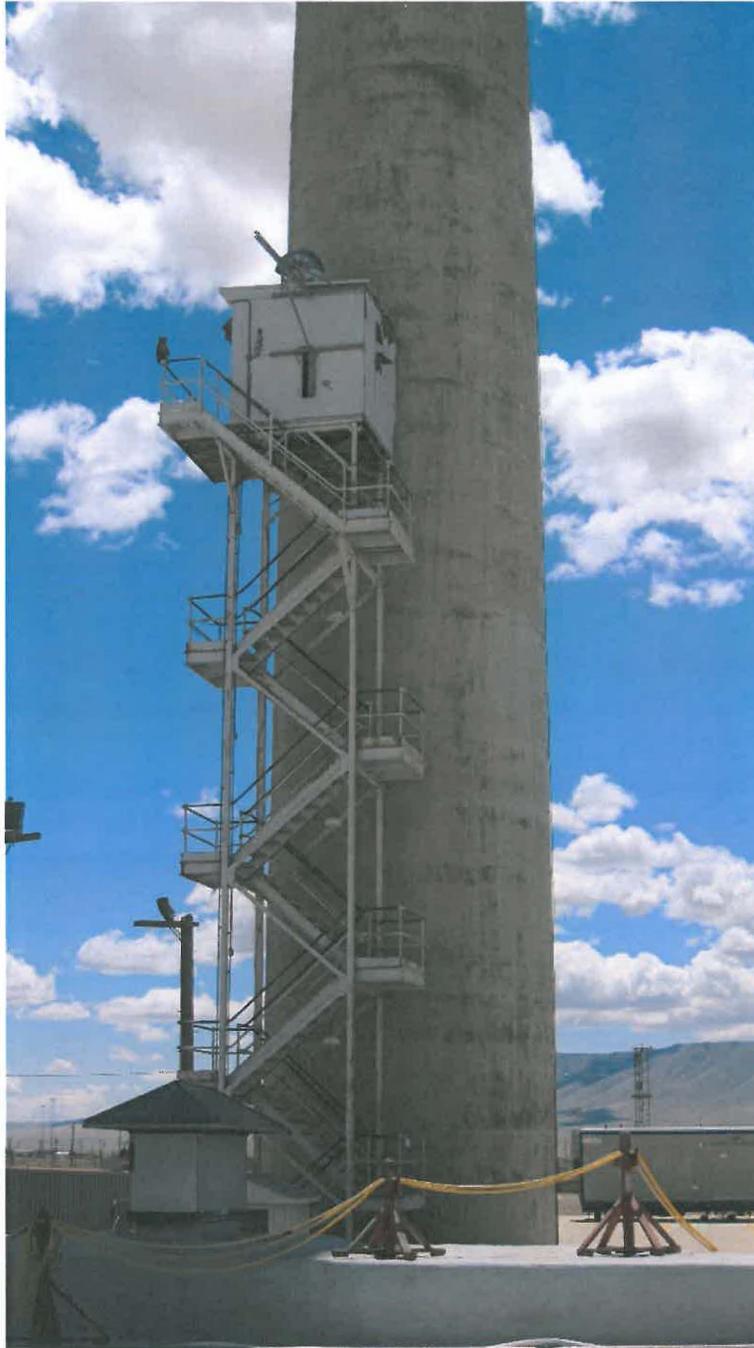
Figure 1. 2712Z Monitoring Station Pre-Demolition

The 2712Z Stack Sampling and Monitoring Station consisted of two small buildings designed to house air monitoring equipment and was constructed and began operation in March 1979:

- Building 1 is unnamed and is a simple, approximately 6 by 6 by 8 ft (36 ft²) plywood shell housing TV monitoring equipment and is located at the base of the stack.
- Building 2, 2712-Z is an 8 by 8 ft monitoring shack built on a lightweight concrete base 50 ft above the ground level on a steel staircase. This building is used to house the air monitoring samplers for the stack.

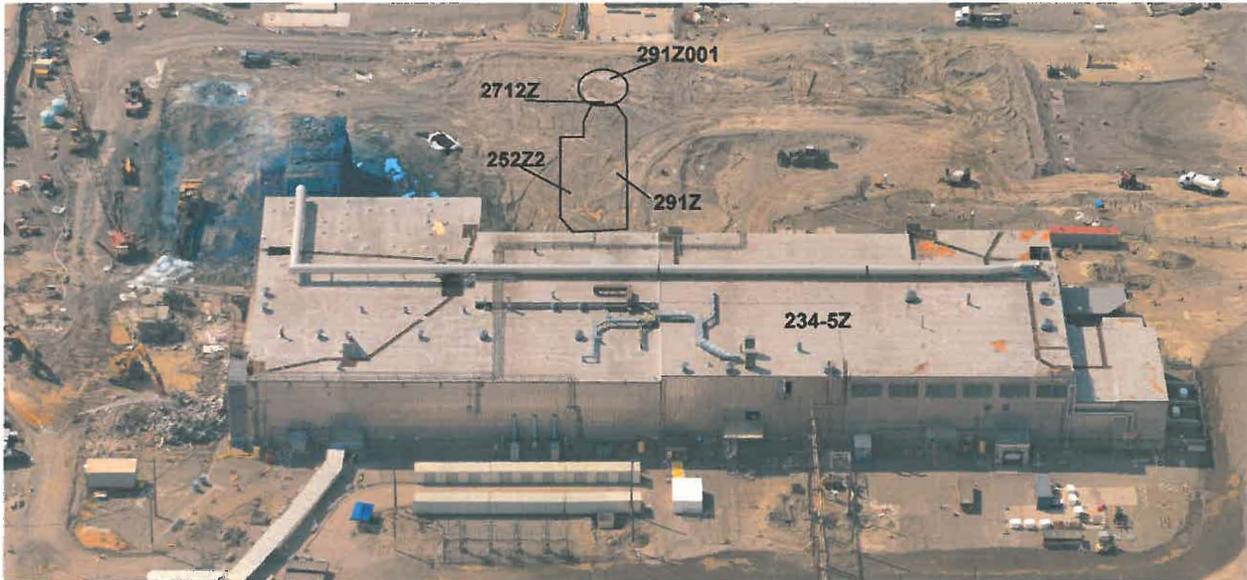
Figure 2. 2712Z Monitoring Station Post-Demolition

The 2712Z Stack Sampling and Monitoring Station was removed to grade. The 291Z001 and 2712Z slab has been left in place, and a layer of gravel placed on top and contoured to provide a stabilized condition suitable for D4 activities to proceed in adjacent areas.

No anomalies were discovered during demolition. Soils around the slab displayed no visual evidence of staining or discoloration.
