WCH-573
Rev. 0

River Corridor Closure Contract

100 Area D4 Project Building Completion Report

January 1, 2013, to
December 31, 2013

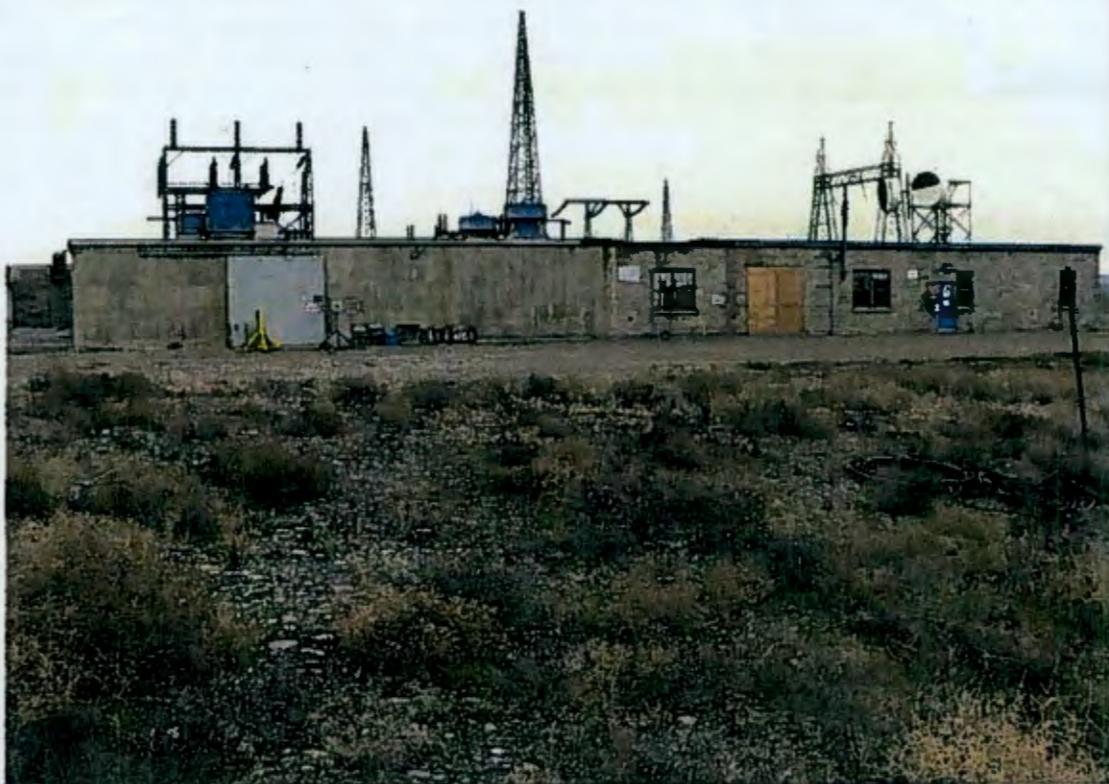
Figure 2. 151-B Switch House Building.

The original 151-B Switch House was the primary source of electrical power for all facilities in the 100-B Area and later expanded to support the 100-C Area. The 151-B Switch House, constructed in 1944, consisted of a 30- by 85-ft one-story reinforced concrete and cinderblock building on the north side of the 151-B switching yard. The roof consisted of lightweight concrete panels covered with roofing felt, tar, and gravel. The 151-B Switch House had a sub-level cable pit that consisted of a completely enclosed reinforced concrete pit 12-ft below-grade. The main floor comprised a switch room, a fan room, a battery room, and a restroom at the west end. Partitions within the building were constructed of concrete block. Switchgear equipment was located on the main floor directly above the cable pit (Figure 2).

In 1952, a 30- by 60-ft concrete building was added to the east end of the original Switch House to support the "C" Reactor. The top of the concrete slab roof was 12.3-ft above the first floor level, and the structure included an 11-ft deep basement level. The cable pit in the original portion of the building connected directly into the basement of the addition. The first floor of the addition was used primarily to house switchgear equipment, while the basement level provided access to the electrical ducts.

The 151-B Switch House Building was demolished by WCH D4 to 1-m below grade in May 2013. Portions of the below-grade structure greater than 1-m below-grade were left in place. No backfill of the excavation was performed as that scope of work will be performed following remediation of adjacent Waste Information Data System site 100-B-35. A GPS survey was performed at the site following D4 activities to delineate the extent of removal and identify below grade structures left in place. There are no radiological or Industrial Hygiene postings. The area is currently posted with an open-excavation boundary for the open basement/excavation.

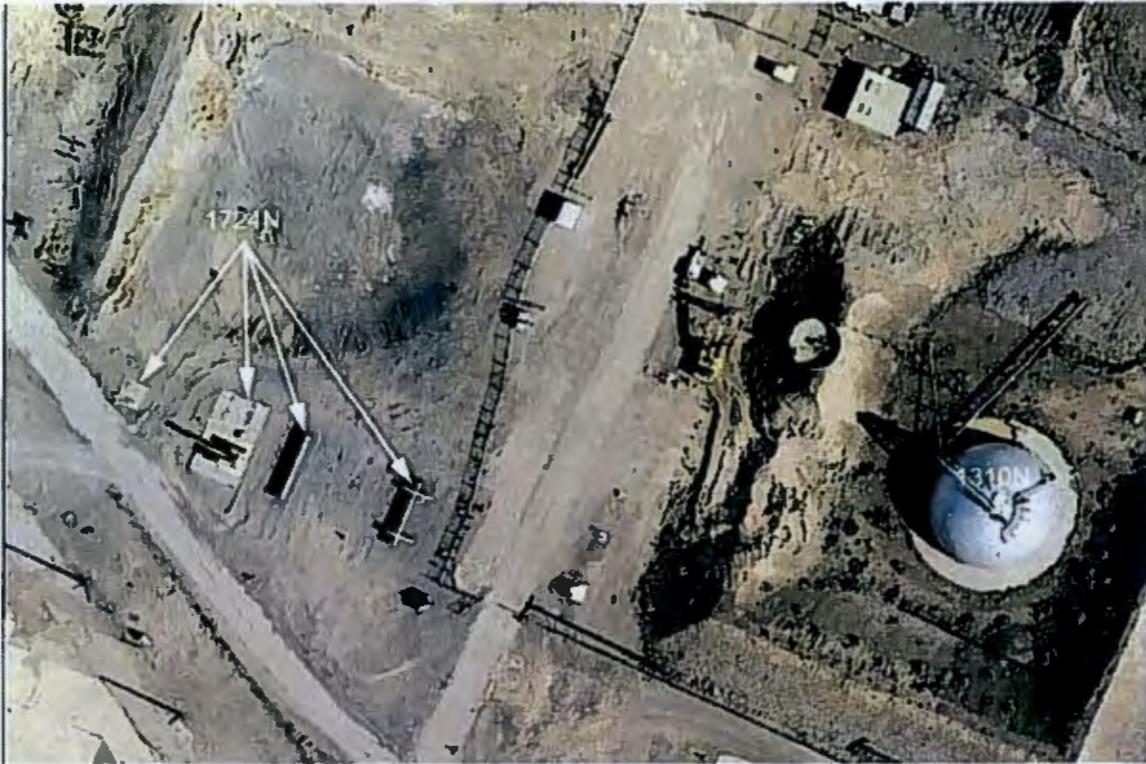
Figure 5. 1724-N Nitrogen Electrical Controls Facility.

The 1724-N consisted of two reinforced concrete structures and a below grade electrical vault. The eastern most structure (Nitrogen Tank Foundation) was a 36- by 42-ft reinforced concrete slab with a pedestal to support the east end of two nitrogen tanks. The western structure was a reinforced concrete slab that had a pedestal to support the west end of the nitrogen tanks, and an at-grade 25- by 42-ft vaporizer pad. The entire western structure was 42- by 58-ft and varied in thickness from 1.8- to 3.8-ft. Only the tank pedestals and vaporizer pad were above grade.

The 1724-N Nitrogen Electrical Controls Facility was demolished by WCH D4. Debris was loaded out and disposed at ERDF. Work was completed in January 2013.

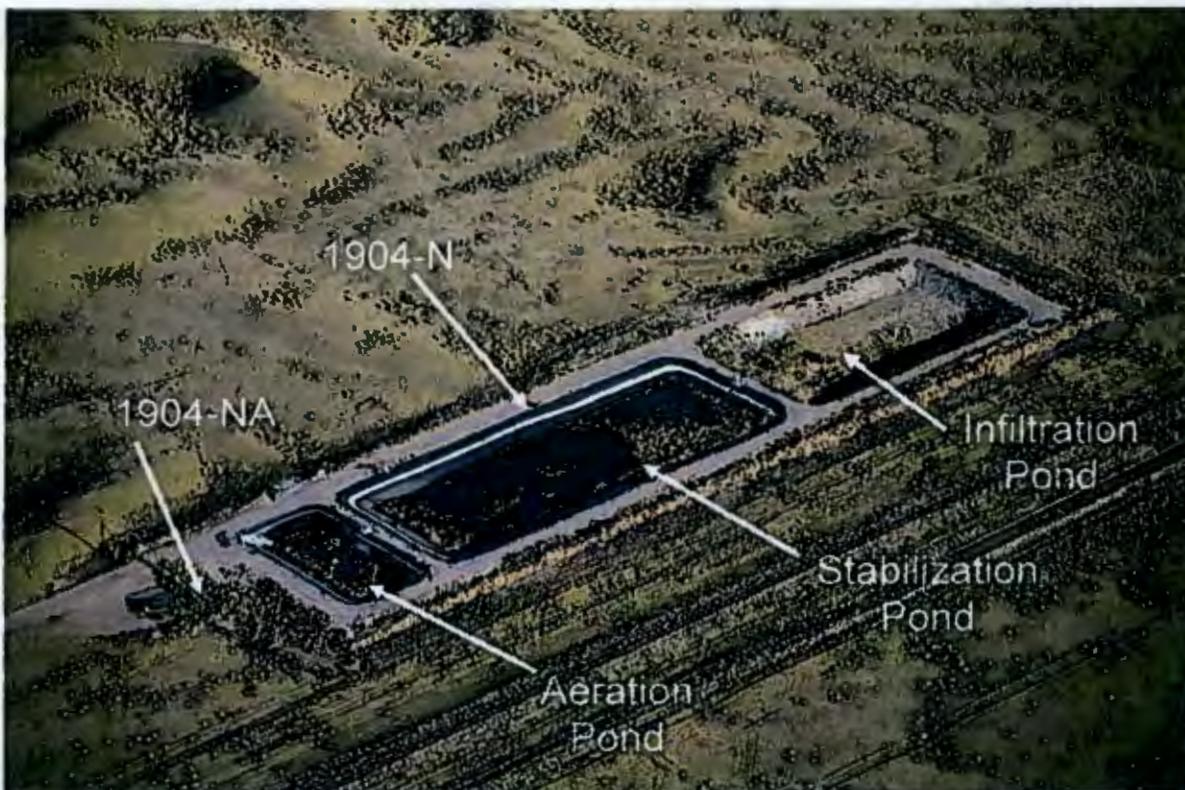
Figure 6. 1904-N and NA Sewage Lagoon and Lift Station #1.

The 1904-N Sewage Lagoon consisted of three separate, interconnected ponds: the aeration pond, the stabilization pond, and the infiltration pond (Figure 6). Waste was introduced into the aeration pond, flowed via a weir to the stabilization pond, and from there over another weir to the infiltration pond where it percolated into the soil. The aeration pond and stabilization pond were lined with a geo-synthetic liner. There were two aerators in the aeration pond and one aerator in the stabilization pond. The overall dimensions of the lagoon were 220- by 825-ft.

The 1904-NA Sewage Lagoon Lift Station #1 was used as part of the piping system that transferred wastewater from the various facilities in the 100-N Area to the 1904-N Sewage Lagoon. The 1904-NA Lift Station consisted of two below-grade concrete structures - a wet well and a valve pit.

The 1904-N Sewage Lagoon and 1904-NA Sewage Lagoon Lift Station #1 were demolished by WCH D4 and load out was completed in April 2013.
