Appendix D

Conceptual Site Models

Figure D-1.	Waste Type Area Maps.....	D-5
Figure D-2.	Landfill Types Descriptions & Locations	D-7
Figure D-3.	CSM for the 218-C-9 Landfill	D-9
Figure D-4.	CSM for the 218-E-1 Landfill	D-11
Figure D-5.	CSM for the 218-E-2 Landfill	D-13
Figure D-6.	CSM for the 218-E-2A Landfill	D-15
Figure D-7.	CSM for the 218-E-4 Landfill	D-17
Figure D-8.	CSM for the 218-E-5 Landfill	D-19
Figure D-9.	CSM for the 218-E-5A Landfill	D-21
Figure D-10.	CSM for the 218-E-8 Landfill	D-23
Figure D-11.	CSM for the 218-E-9 Landfill	D-25
Figure D-12.	CSM for the 218-E-10 Landfill	D-27
Figure D-13.	CSM for the 218-E-12A Landfill	D-30
Figure D-14.	CSM for the 218-E-12B Landfill	D-32
Figure D-15.	CSM for the 218-W-1 Landfill	D-34
Figure D-16.	CSM for the 218-W-1A Landfill	D-36
Figure D-17.	CSM for the 218-W-2 Landfill	D-38
Figure D-18.	CSM for the 218-W-2A Landfill	D-40
Figure D-19.	CSM for the 218-W-3 Landfill	D-43
Figure D-20.	CSM for the 218-W-3A Landfill	D-45

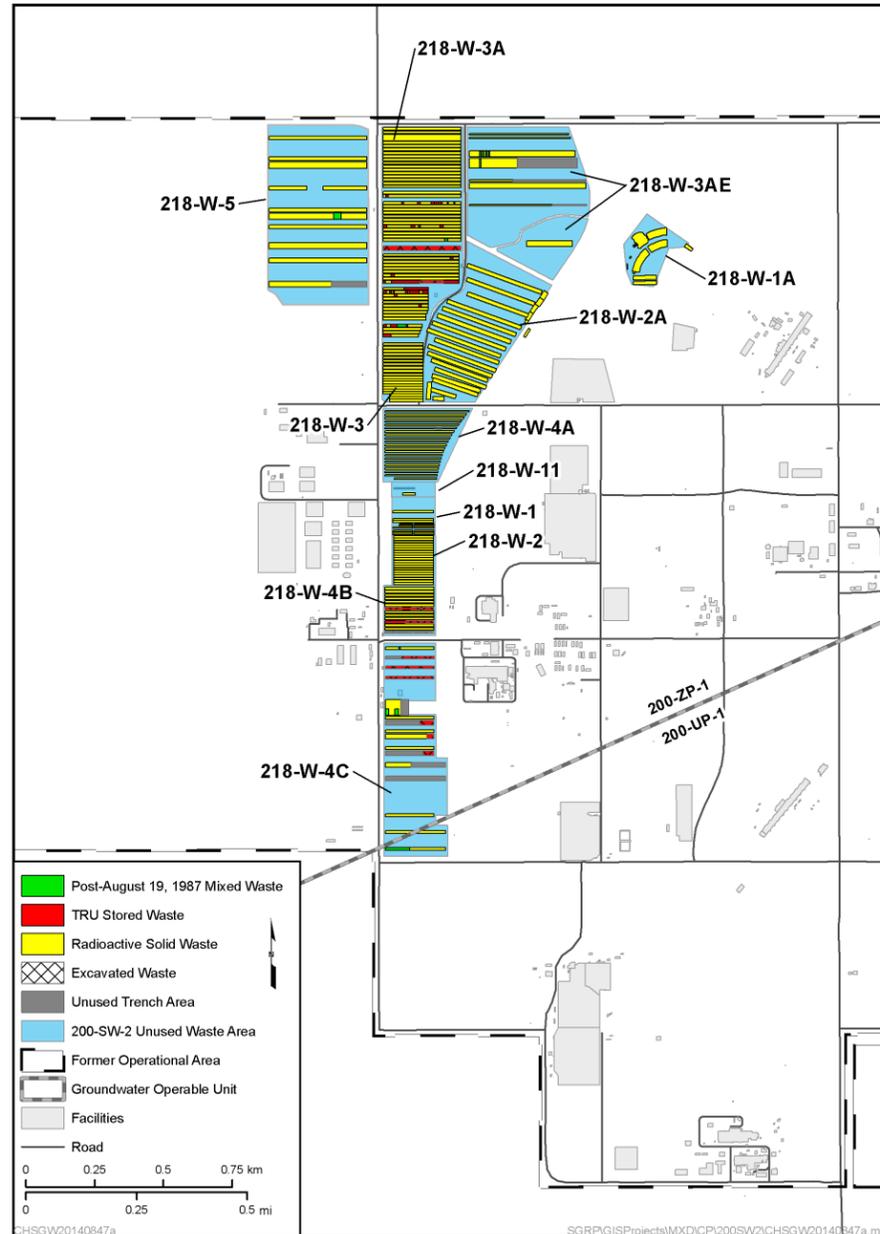
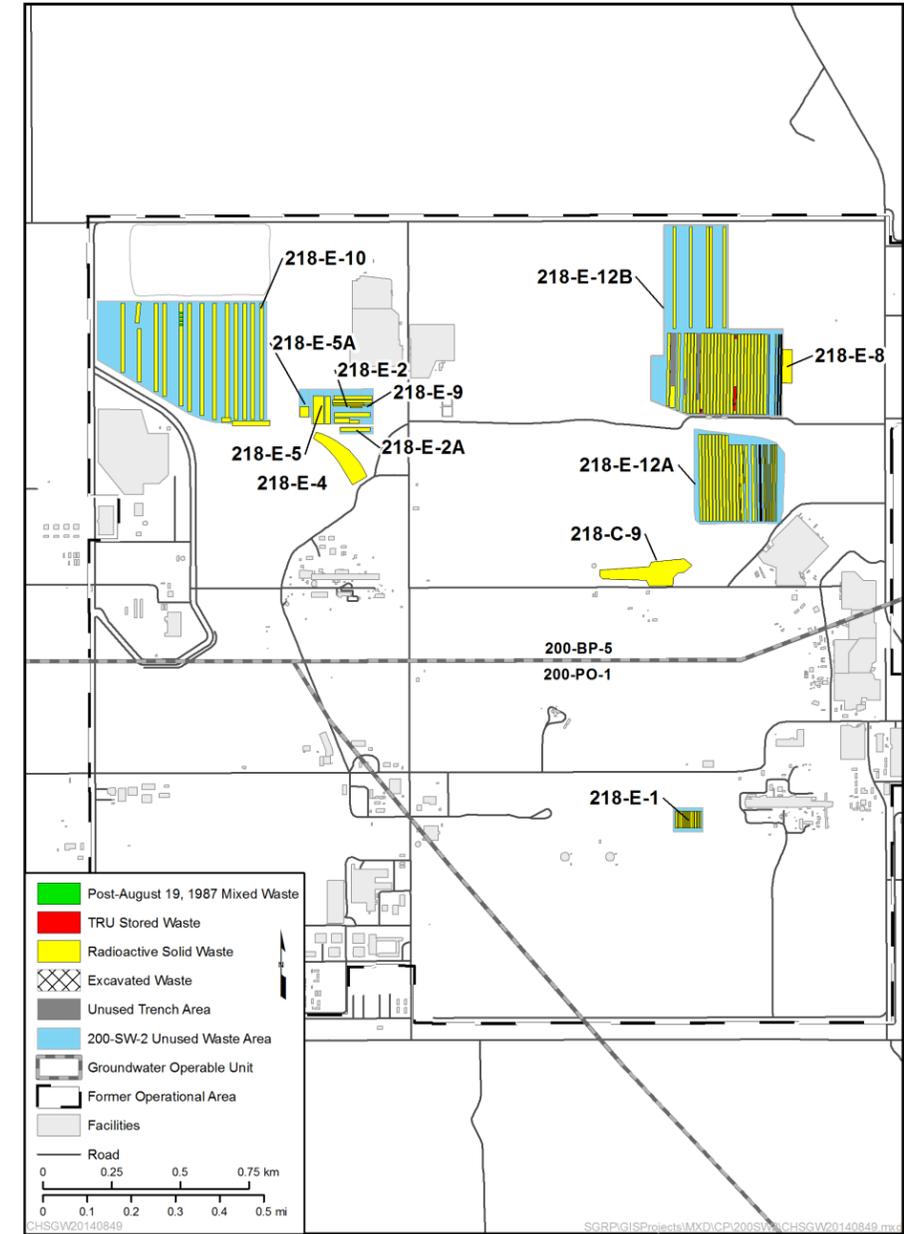
Each landfill trench is color coded based on known waste type. More detailed information on landfill characterization is provided in the Conceptual Site Models for the individual landfills.

The West Inner Area and East Inner Area Waste Type Area Maps are provided as reference material for the landfill Conceptual Site Models contained in Appendix D.

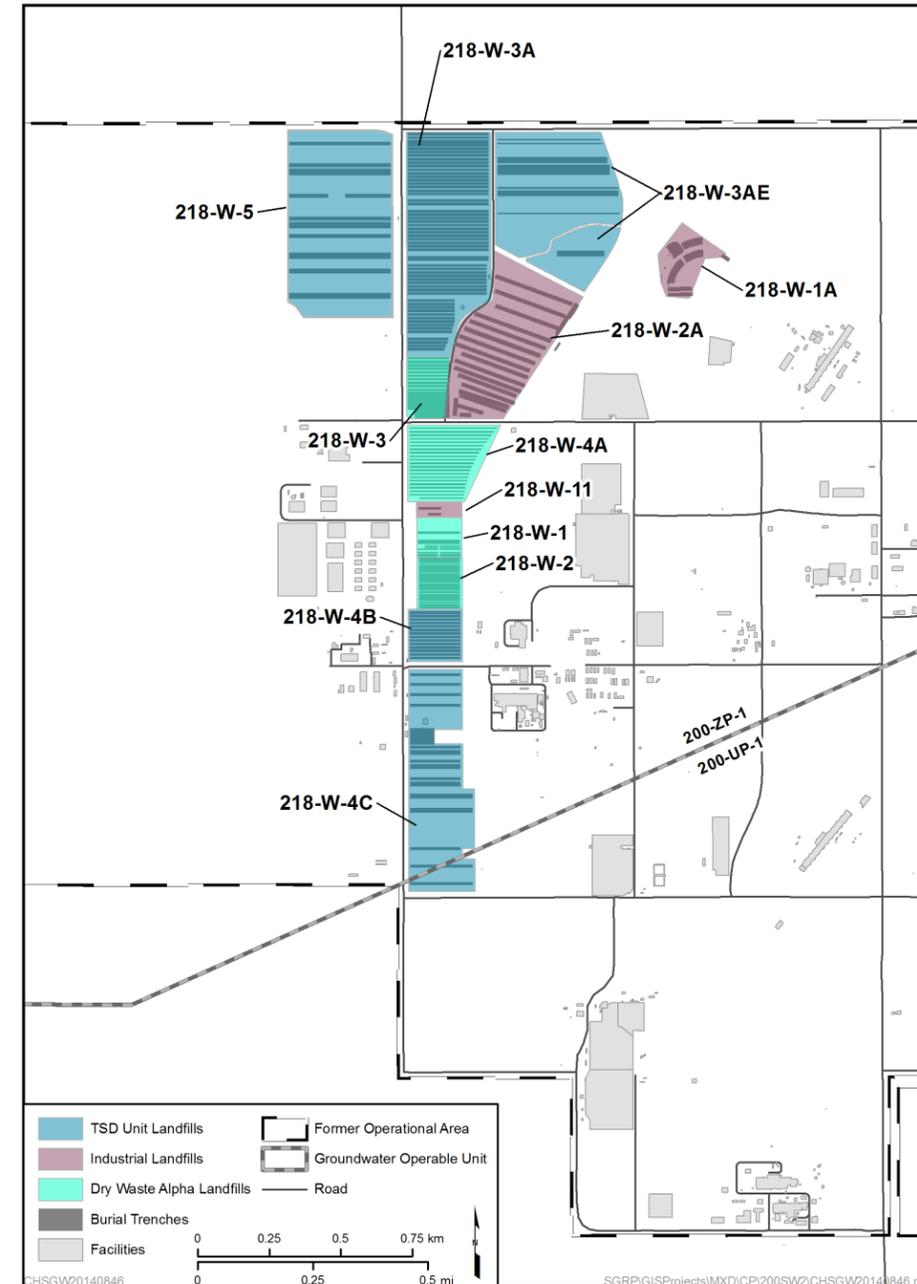
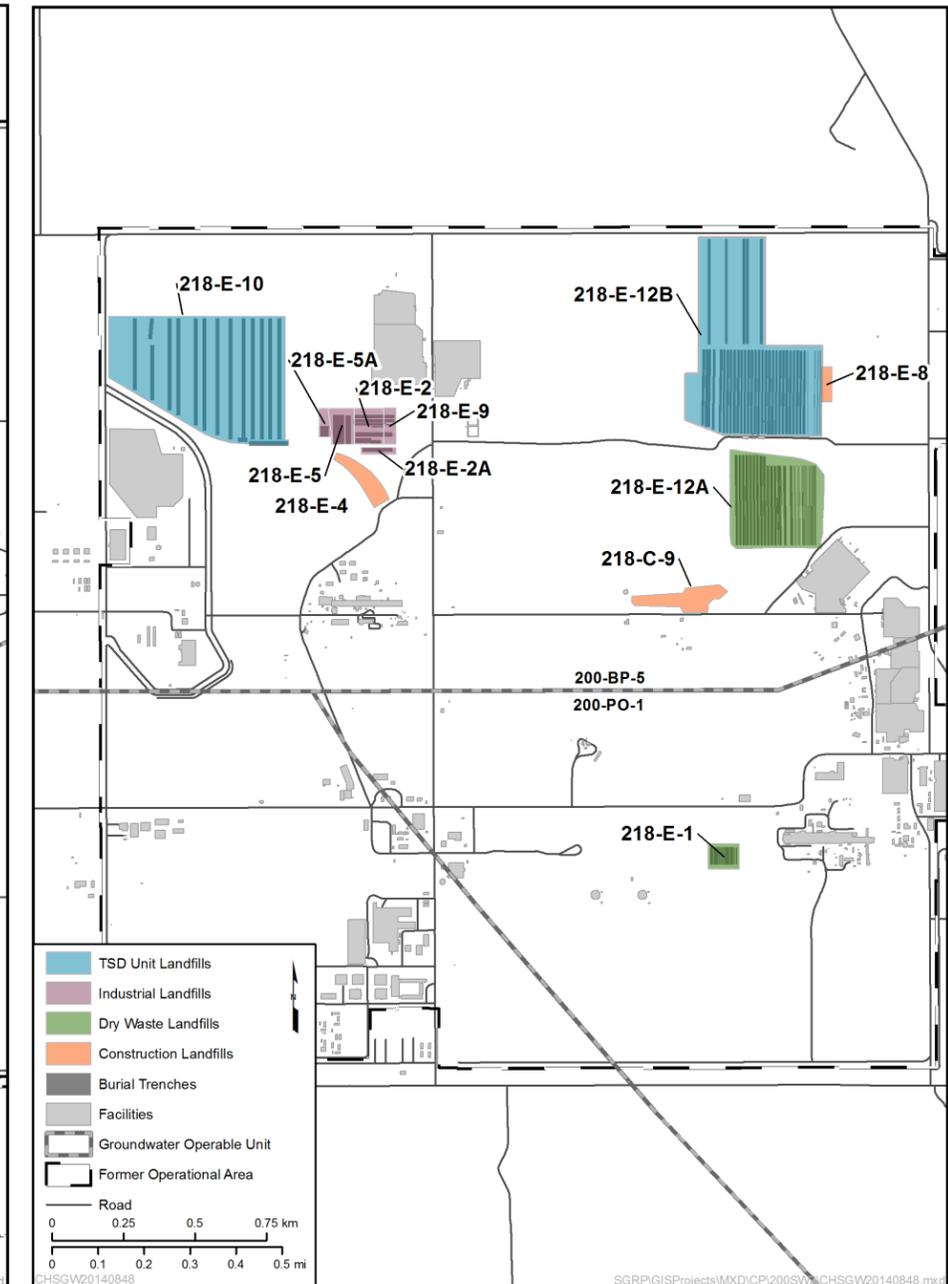
Each landfill is color coded based on type. Descriptions of each type and associated landfills is provided on page D-4. More detailed information on landfill characterization is presented in the Conceptual Site Models for the individual landfills.

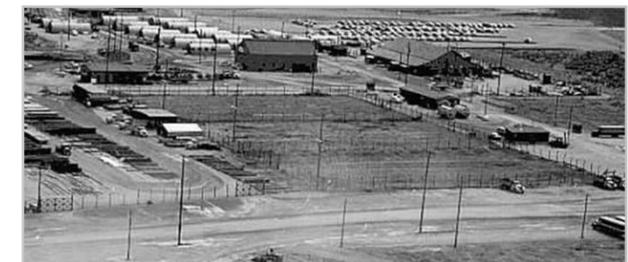
1987 photo shows the 218-E-1 landfill. Trench locations are still visible.

No photos of the 218-E-1 trench contents have been found. This photo of the completely backfilled and fenced site, dated June 8, 1954, corroborates the WIDS and SWITS descriptions of operating dates of 1945-1953.

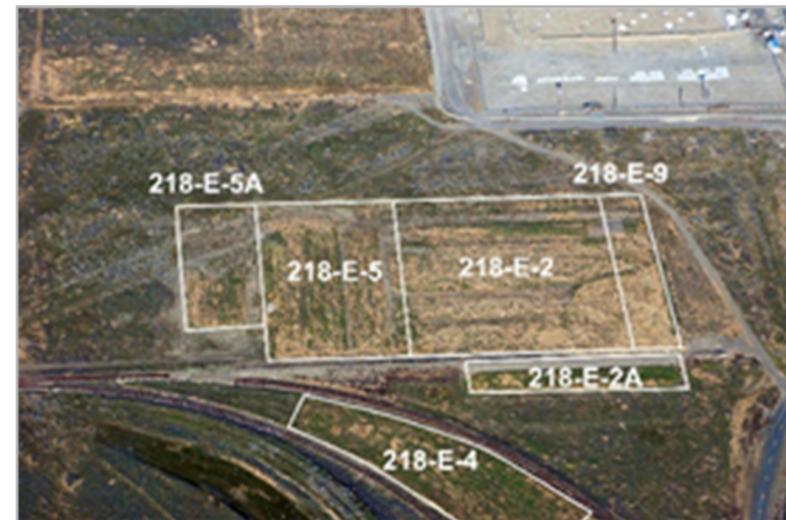
A 2007 photo shows the landfills' recent appearance.

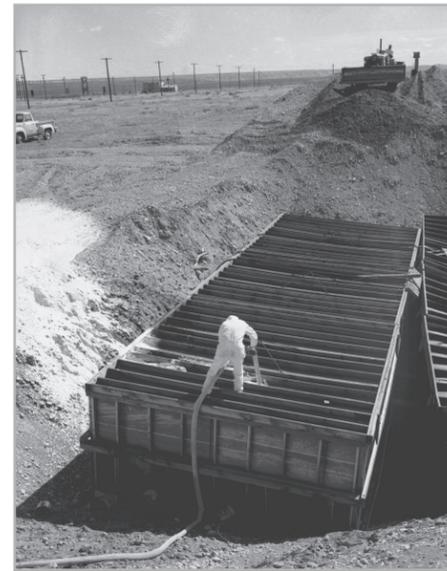
In a 1961 photo, worker is backfilling the stabilized and foamed box.

April 19, 1961 photos of 218-E-5A correlate well with the WIDS description of the backfilling operation for deteriorating wooden boxes, which occurred that date and which used foam as contamination control. Operator is foaming pit and interior of box.

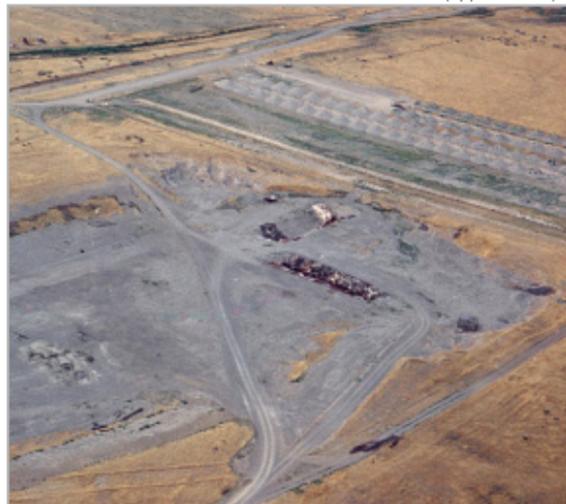
June 1969: aerial photo looking southwest shows waste in the 200-E Burn Pit (non-radioactive) adjacent to 218-E-8. The photo suggests some overlap between the locations of the landfill and burn pit. The photo shows open trenches in 218-E-12B (top right), the 216-B-2 ditches (top), the 200-E Burn Pit (center), and the 218-E-8 landfill (upper center).

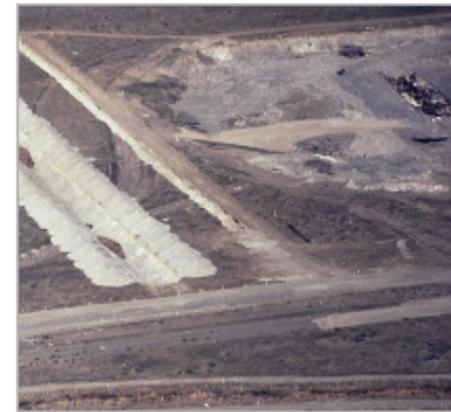
Undated aerial photo, probably about 1970, looking northeast. Shows open trench in 218-E-12B, 200 East Burn Pit, and possibly waste stored on surface of 218-E-8.

Photos from the late 1960s through late 1980s show the non-radioactive 200 East Burn Pit adjacent to the radioactive 218-E-8 landfill. The burn pit was still in use during that period but the landfill was backfilled. The landfill footprints of the two waste sites appear to overlap in places. Geophysical investigations of 218-E-8 have been difficult to interpret because of the close proximity of the two waste sites.

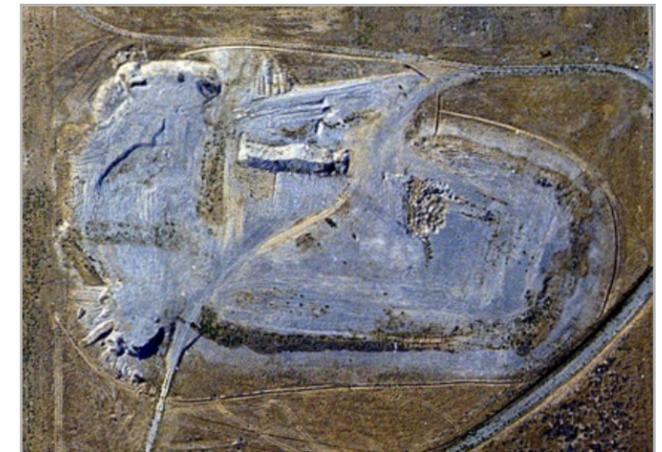
1975 photo (top is north) shows backfilled trenches in the 200 East Burn Pit (center) adjacent to the 218-E-8 landfill (left).

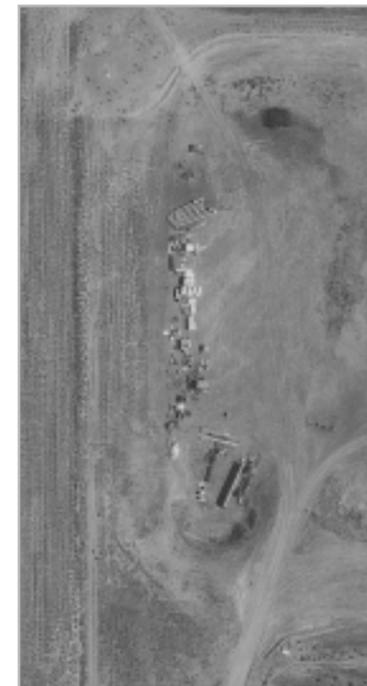
1988 photo (top of photo is north) shows waste stored on surface of 200 East Burn Pit adjacent to 218-E-8

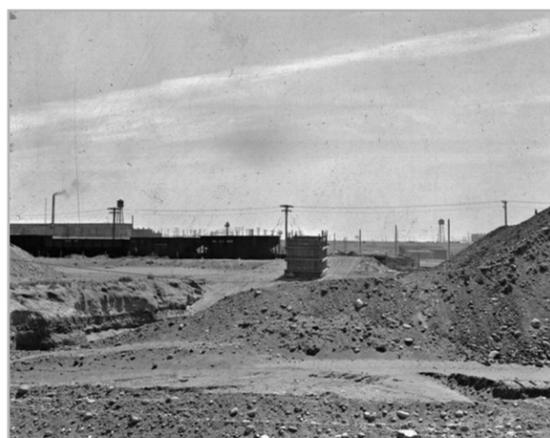
1954 photo of large wooden dragoff box placed in 218-W-2A industrial landfill.

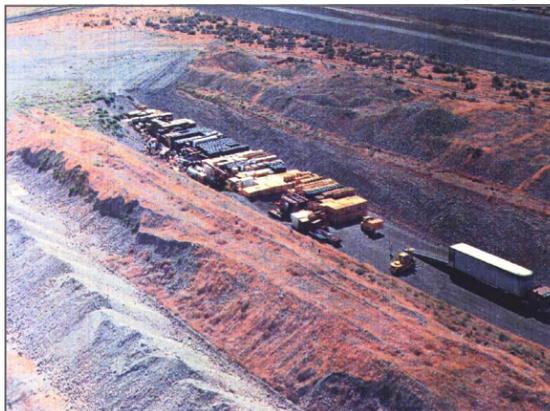
Undated photo showing workers placing waste in a trench in 218-W-3AE.

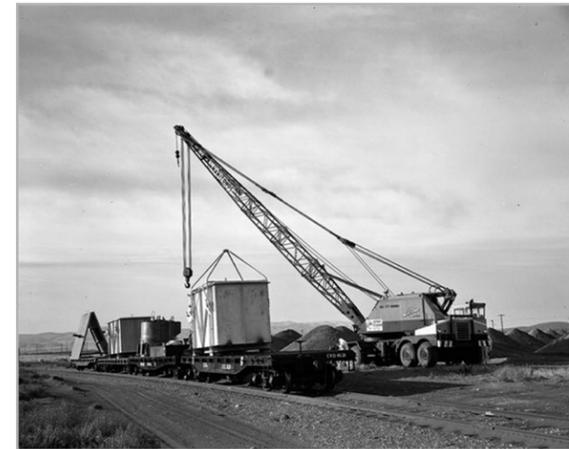
Photo (January 30, 1964) of waste destined for burial in Trench 10 of 218-W-4A landfill.

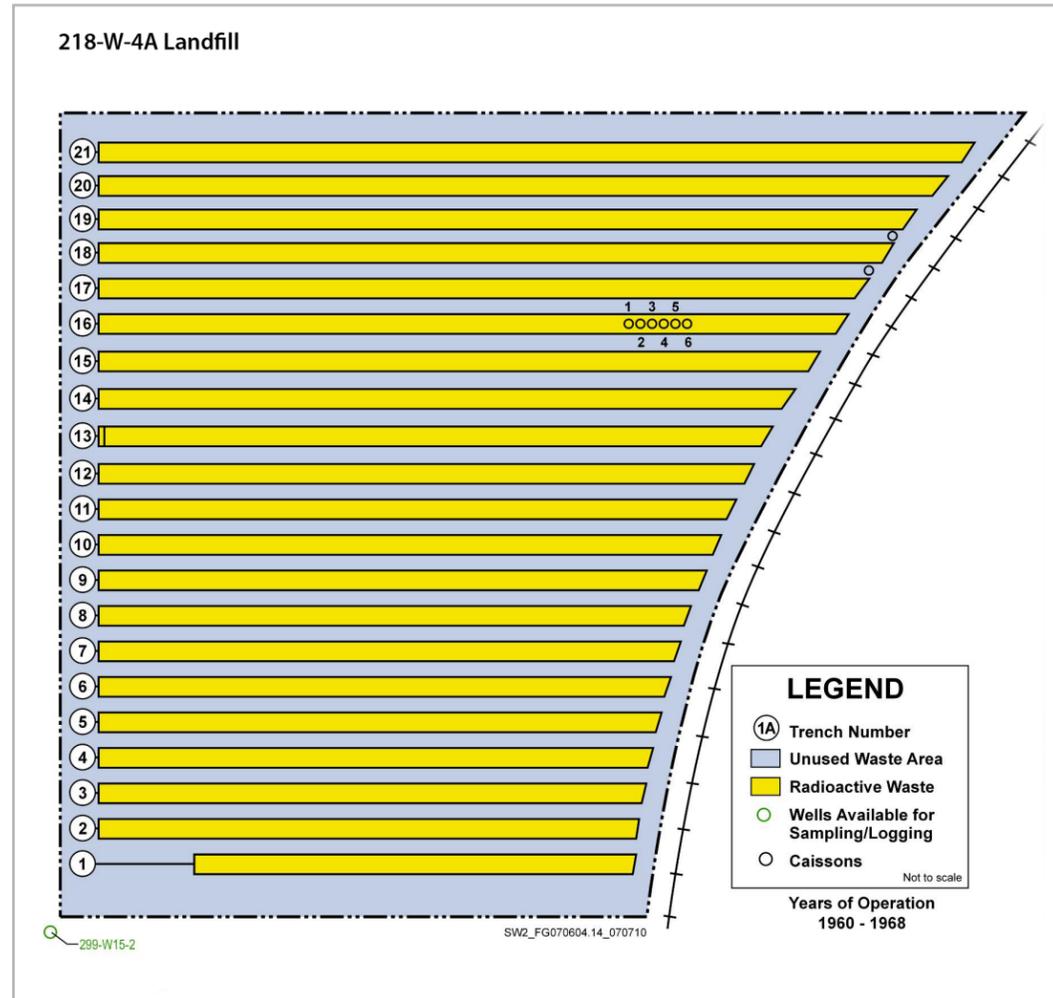
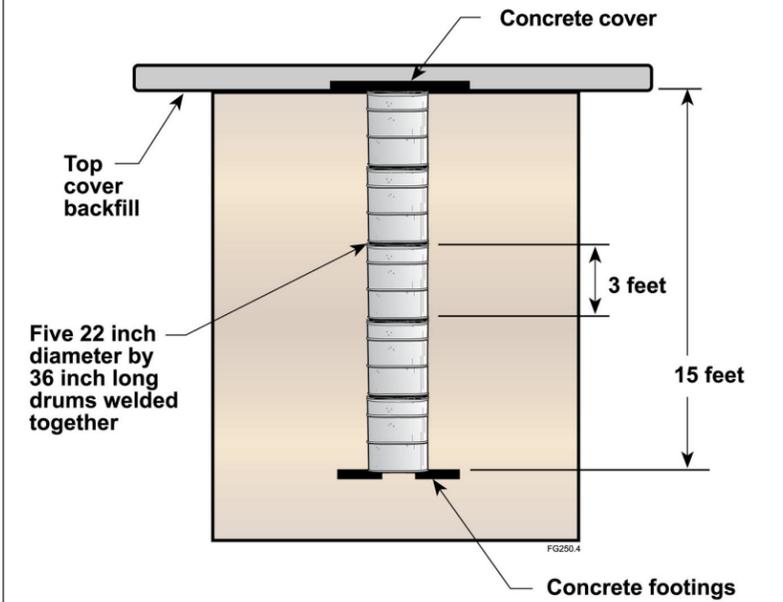
- High dose rate (up to 10,000 mR/hr)
- Typically remote handled waste
- Small containers (1-5 gallons)
- High beta-gamma radiation
- Potential for small volumes of sorbed organics (lab packs)
- 4 caissons believed unused

The 218-W-4A landfill contains 21 miscellaneous dry waste trenches oriented east to west and 6 or 8 vertical pipe units or drywells, also known as caissons. The vertical pipe units were installed near the east end of Trench 16 and consist of two to five 55-gal drums welded together with the lids and bottoms removed. They were placed 4.6 m (15 ft) below ground surface. Two deeper caissons may be located between Trenches 17, 18, and 19.

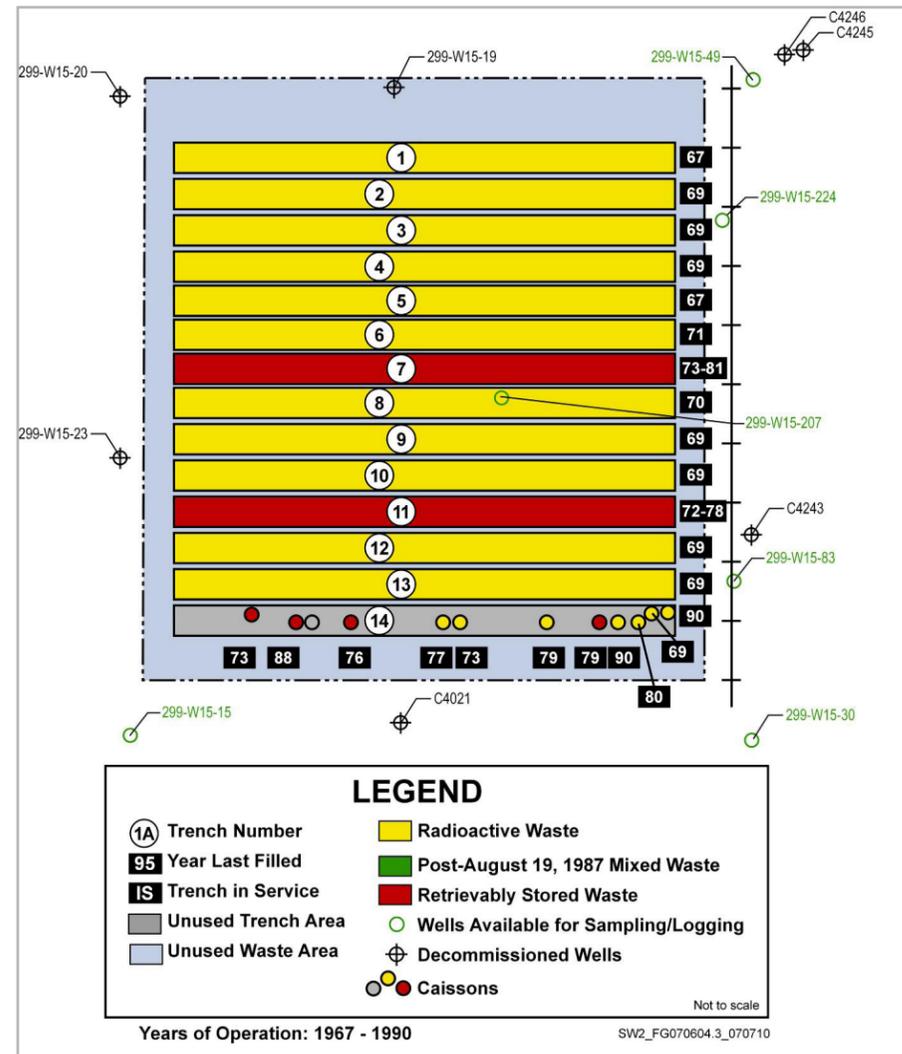
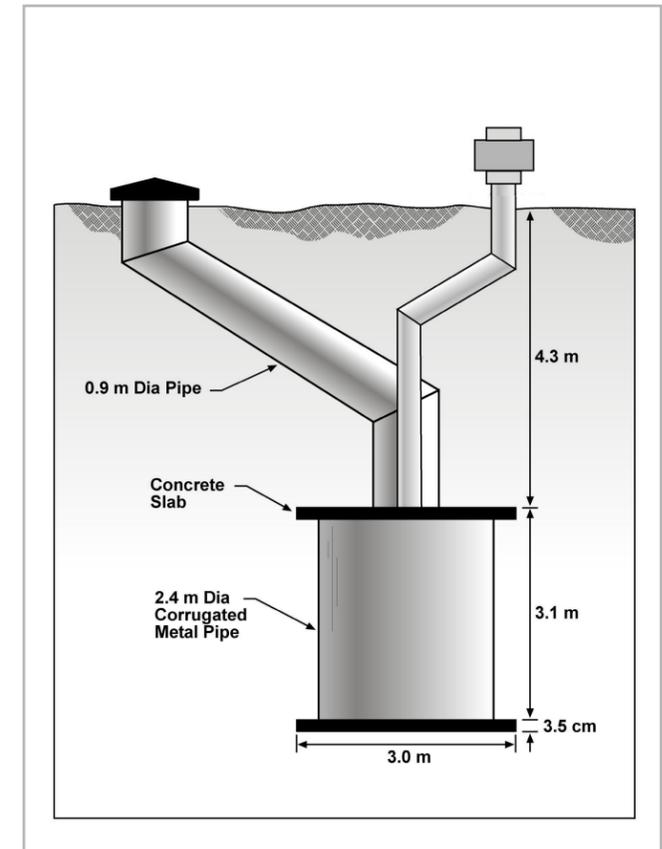
- High dose rate (up to 10,000 mR/hr)
- Typically remote handled waste
- Small containers (1-5 gallons)
- High beta-gamma radiation
- Potential for small volumes of sorbed organics (lab packs)
- 5 caissons in M-91 project scope
- 1 alpha caisson believed unused, two MFP caissons believed to contain fewer than 10 waste packages each.

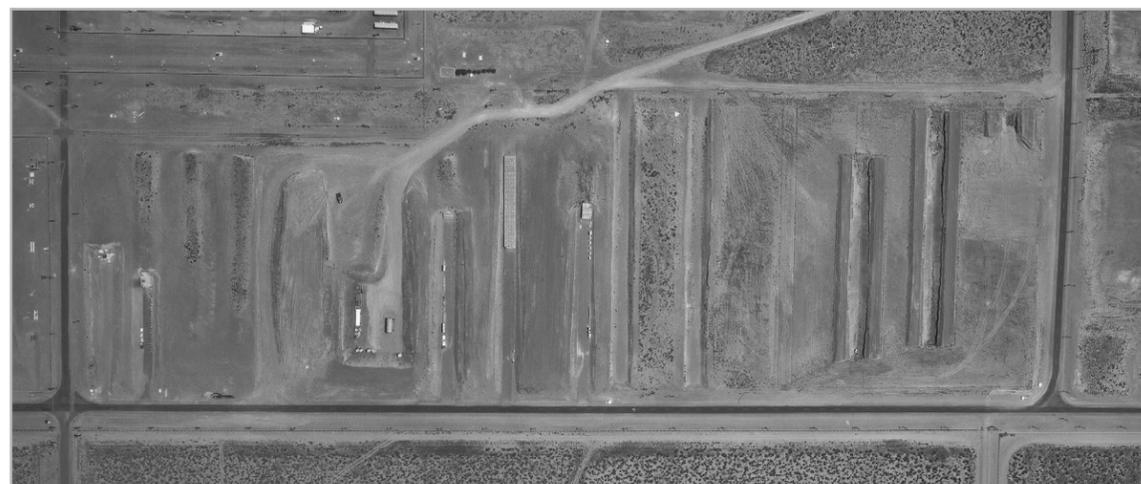
This June 1989 photo of 218-W-4C shows the layout of the landfill.

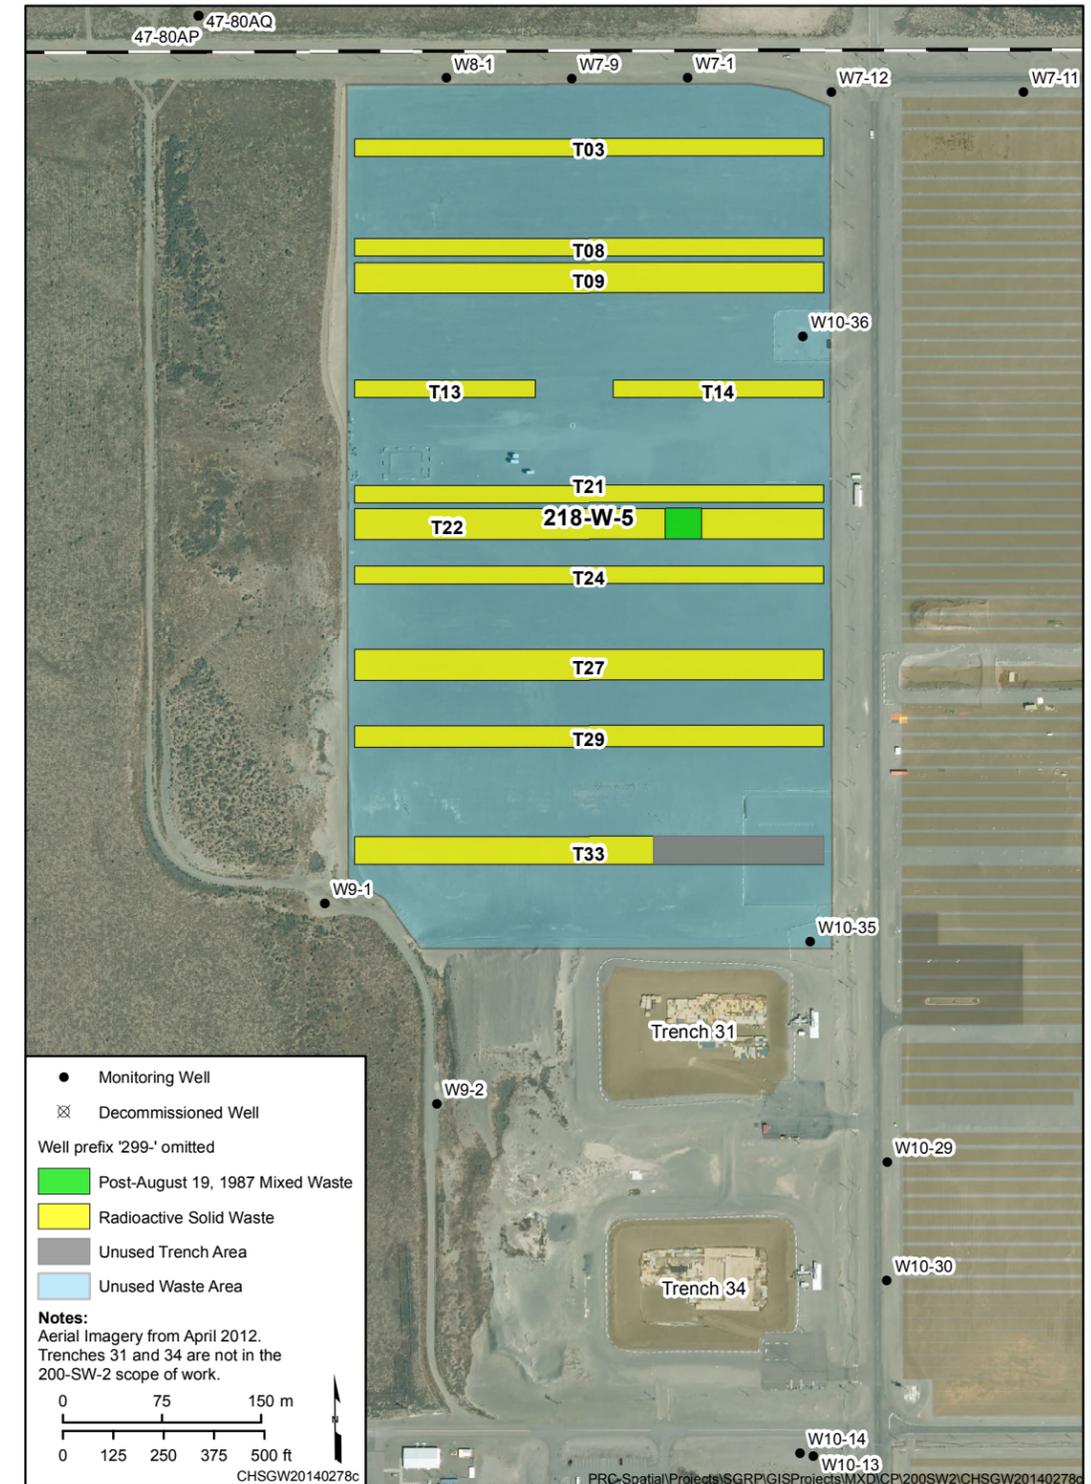
This undated photo of waste emplaced in 218-W-5 shows stacked wooden and plastic boxes.
