Document No.  
UNI-2627

Title  
108-F BIOLOGICAL LABORATORY  
HANFORD SITE  
INTERIM DECOMMISSIONING REPORT

108-F BIOLOGICAL LABORATORY  
HANFORD SITE  
INTERIM DECOMMISSIONING REPORT

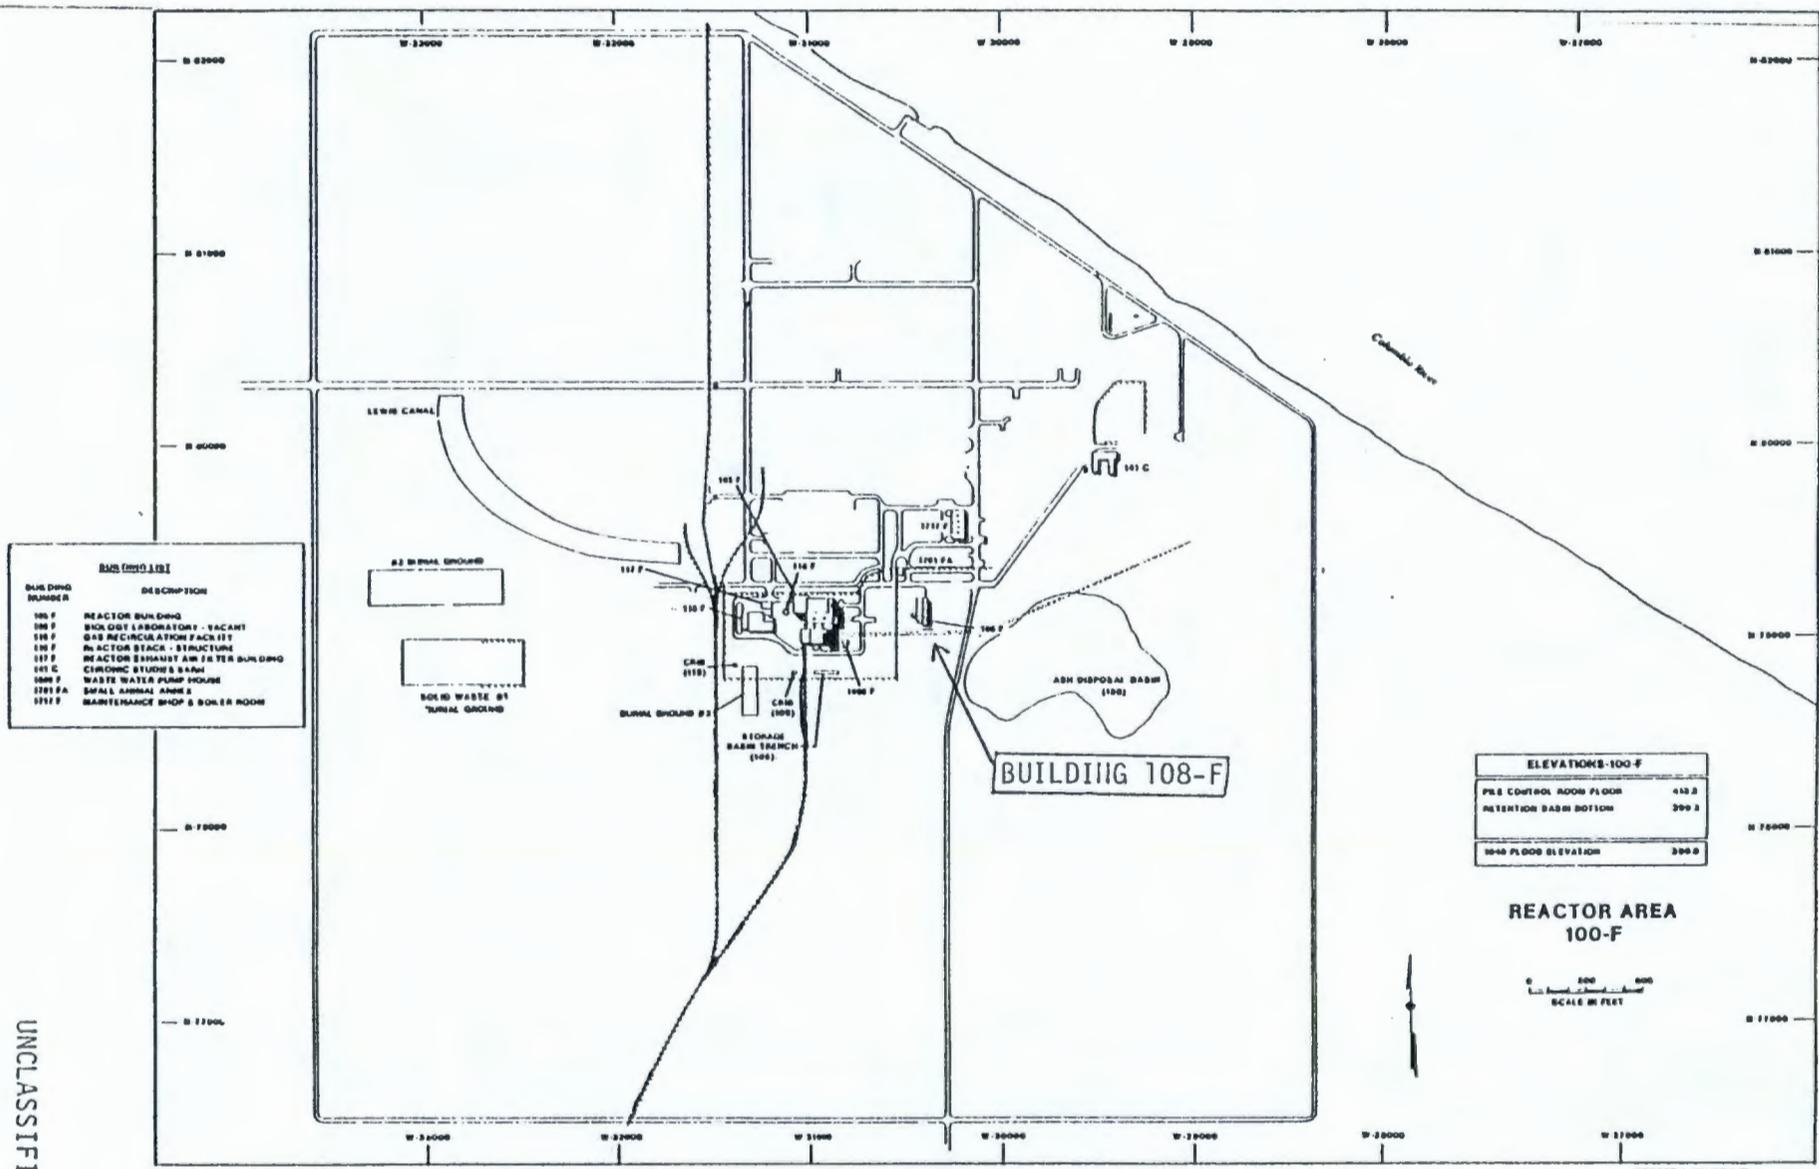
Figure 2.1

site boundaries of the 100-F Area, and the location of the 108-F Biological Laboratory within the site, are shown on the map in Figure 2.1, 100-F Reactor Area .

100-F REACTOR AREA

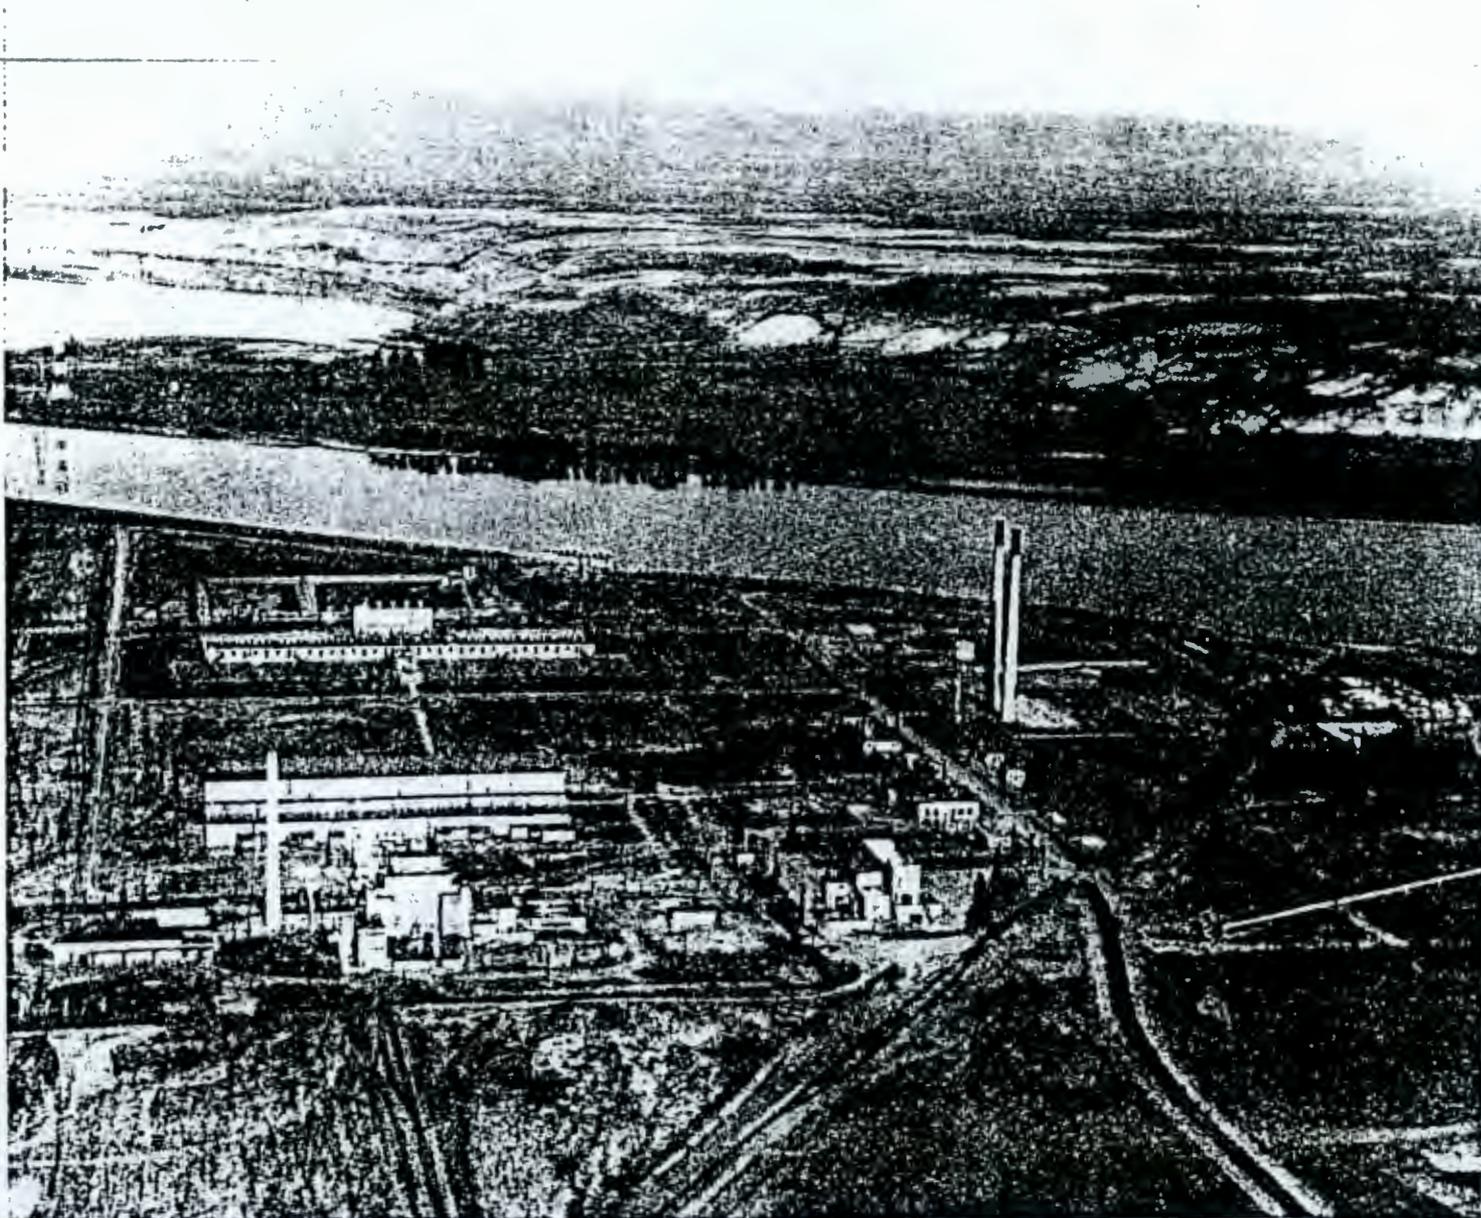
FIGURE 2.2.  
100-F AREA MAY 5, 1976

The aerial photo shown in Figure 2.2 shows the status of the 100-F Area facilities on May 5, 1976, before the contaminated facility decommissioning program was begun. Since this photo was taken, most of the uncontaminated facilities have been removed leaving only the 105 reactor building and its ancillaries (in the left foreground) and the 108-F laboratory building (in right-center foreground) as the only remaining major structures. The reactor exhaust stack, adjacent to the reactor building, was demolished in September 1983.

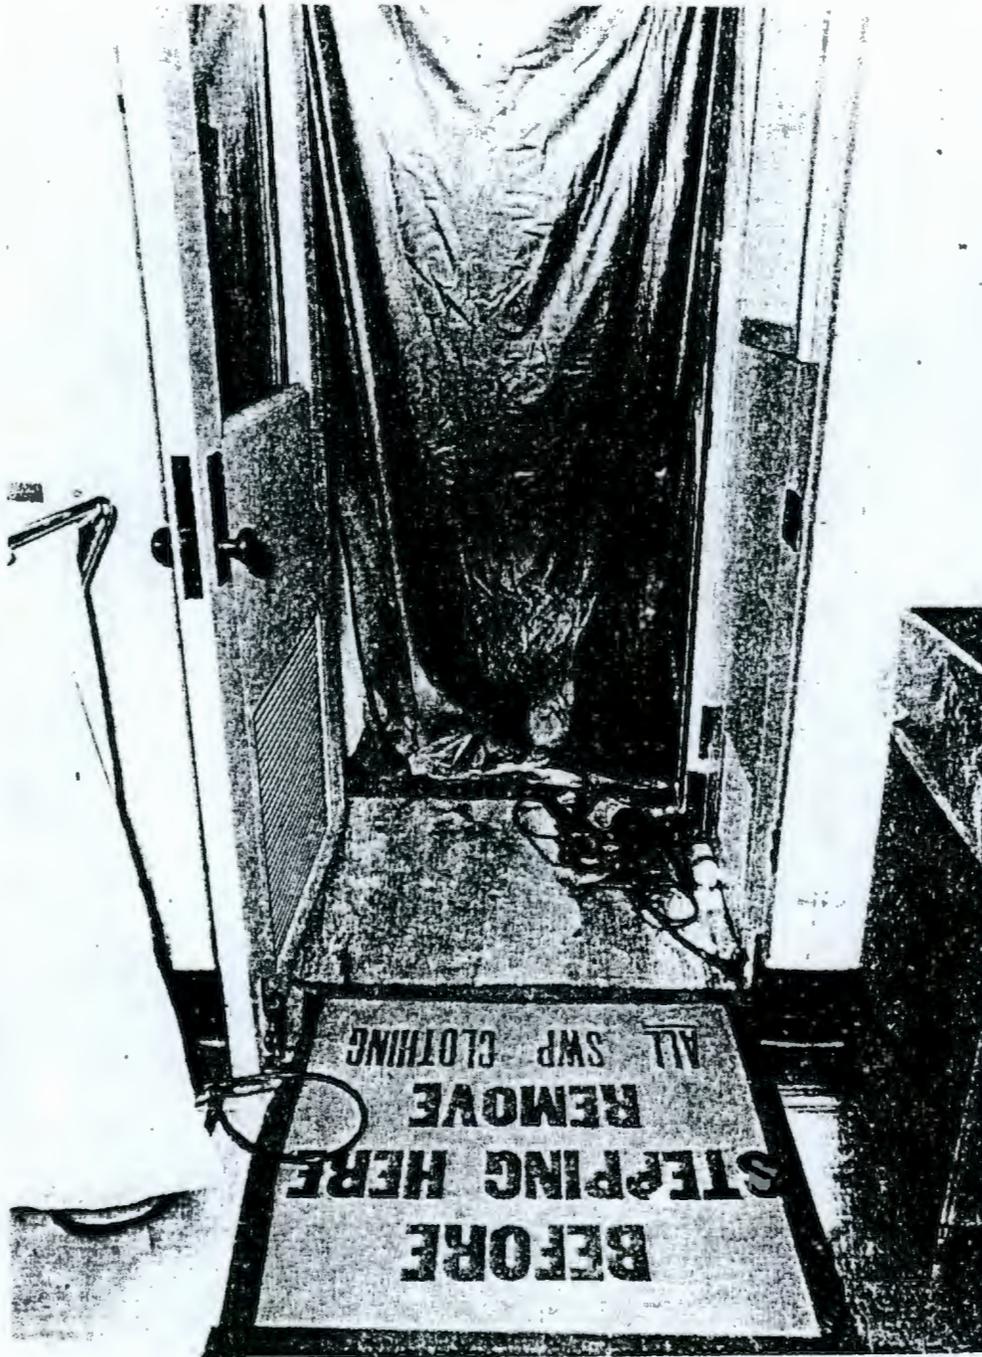
To control contamination, the laboratories were sealed with plastic sheets and tape. A vacuum unit was attached to the sealed lab with an exhaust through a HEPA filter. This provided a negative pressure on the laboratory and thereby minimized the chance for any contamination spread. Only five of the forty-four laboratories warranted this type of control, i.e., rooms 107, 205, 207, 303 and 308. (Figure 5.2.1-A, B, C, and D depict the typical techniques used.)

FIGURE 5.2.1-A  
TYPICAL LABORATORY CONFINEMENT - ROOM 308  
108-F BUILDING

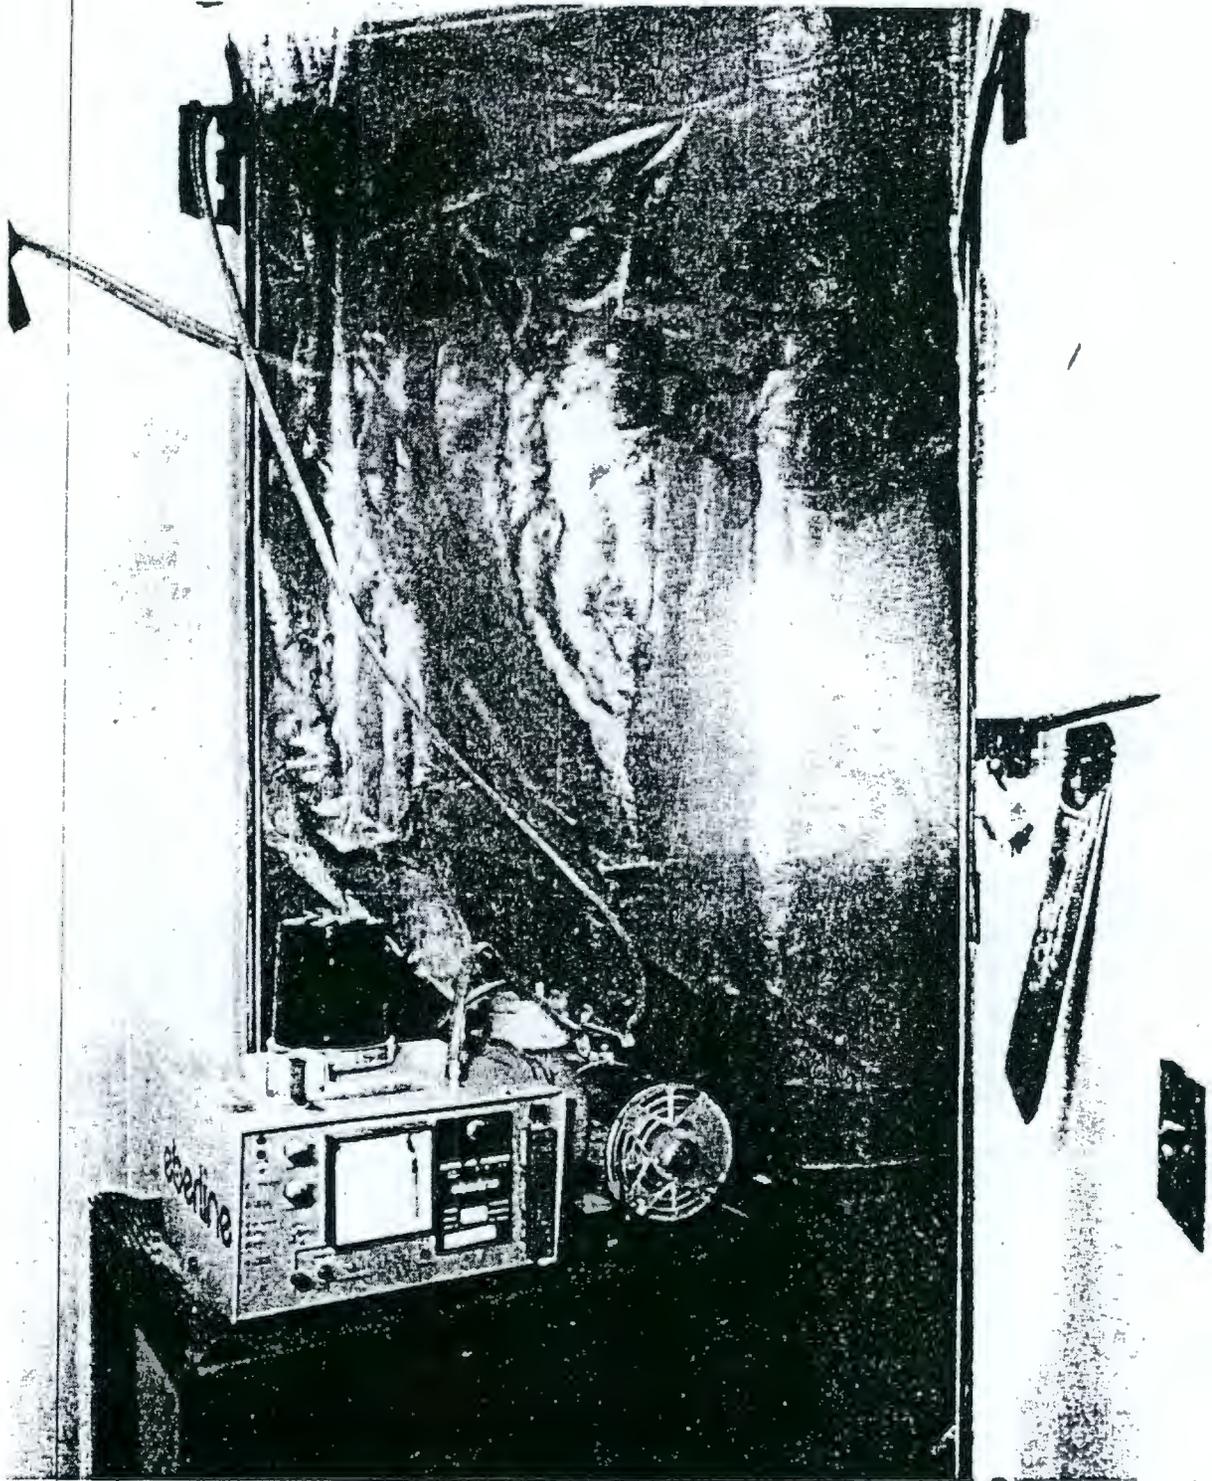
FIGURE 5.2.1-B

TYPICAL LABORATORY CONFINEMENT - ROOM 308

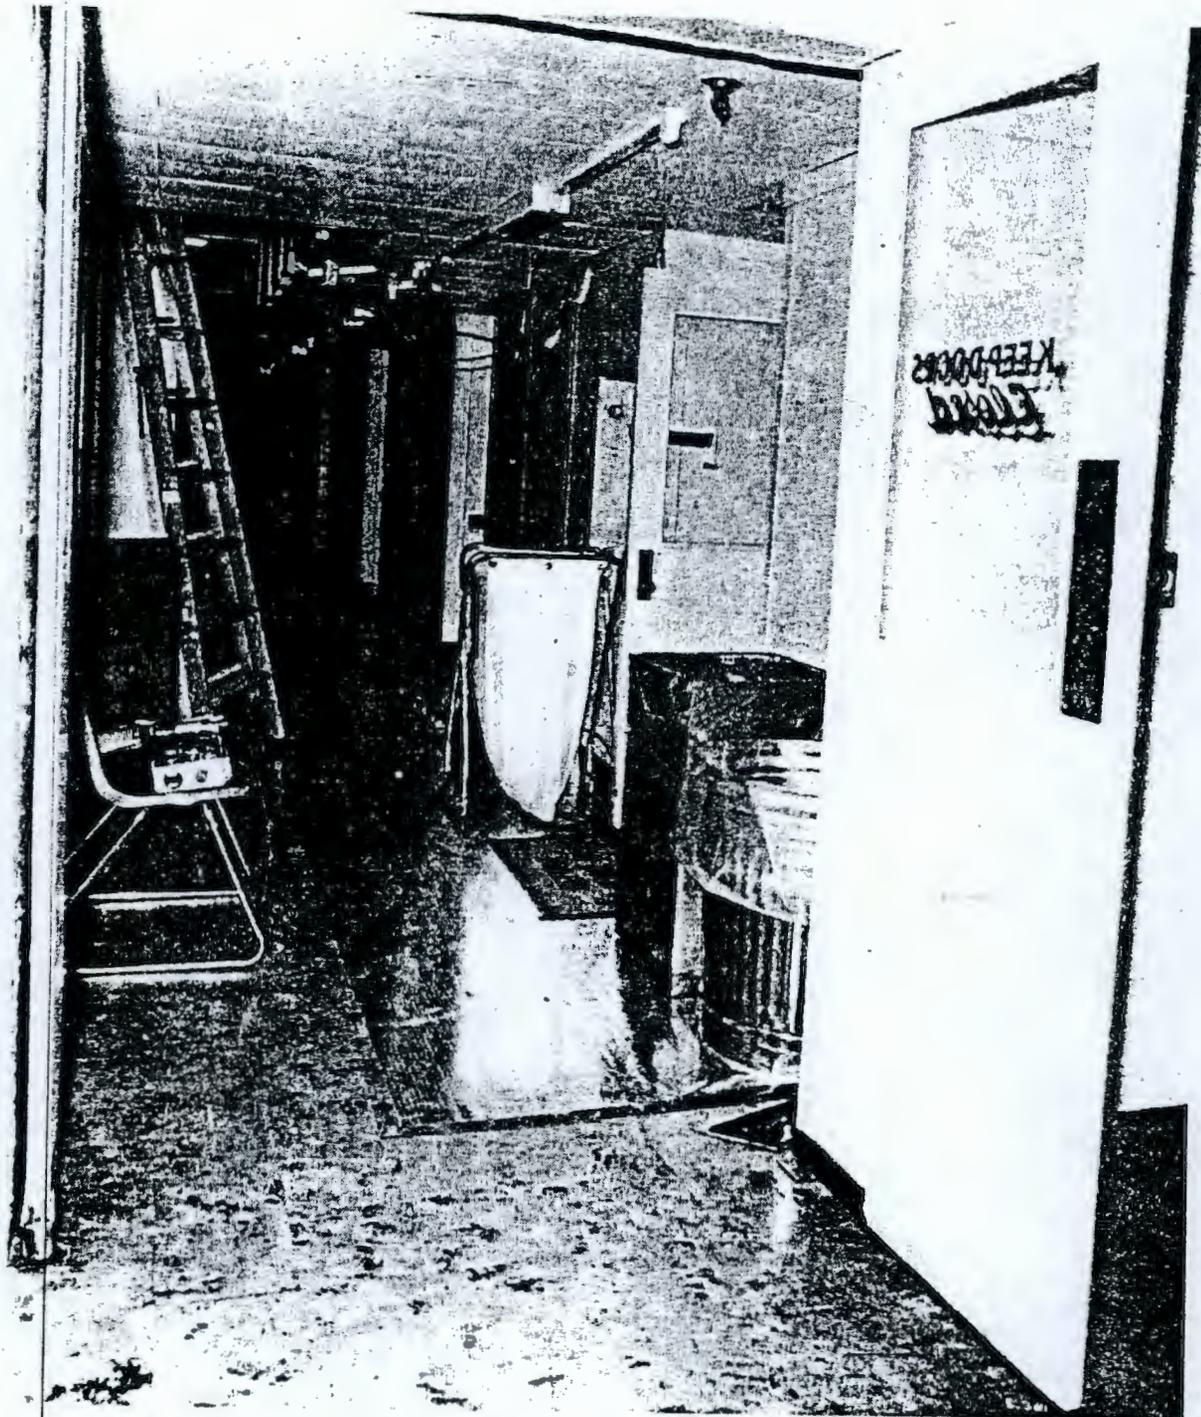
FIGURE 5.2.1-C  
TYPICAL CORRIDOR - 3rd FLOOR RADIATION ZONE  
108-F BUILDING

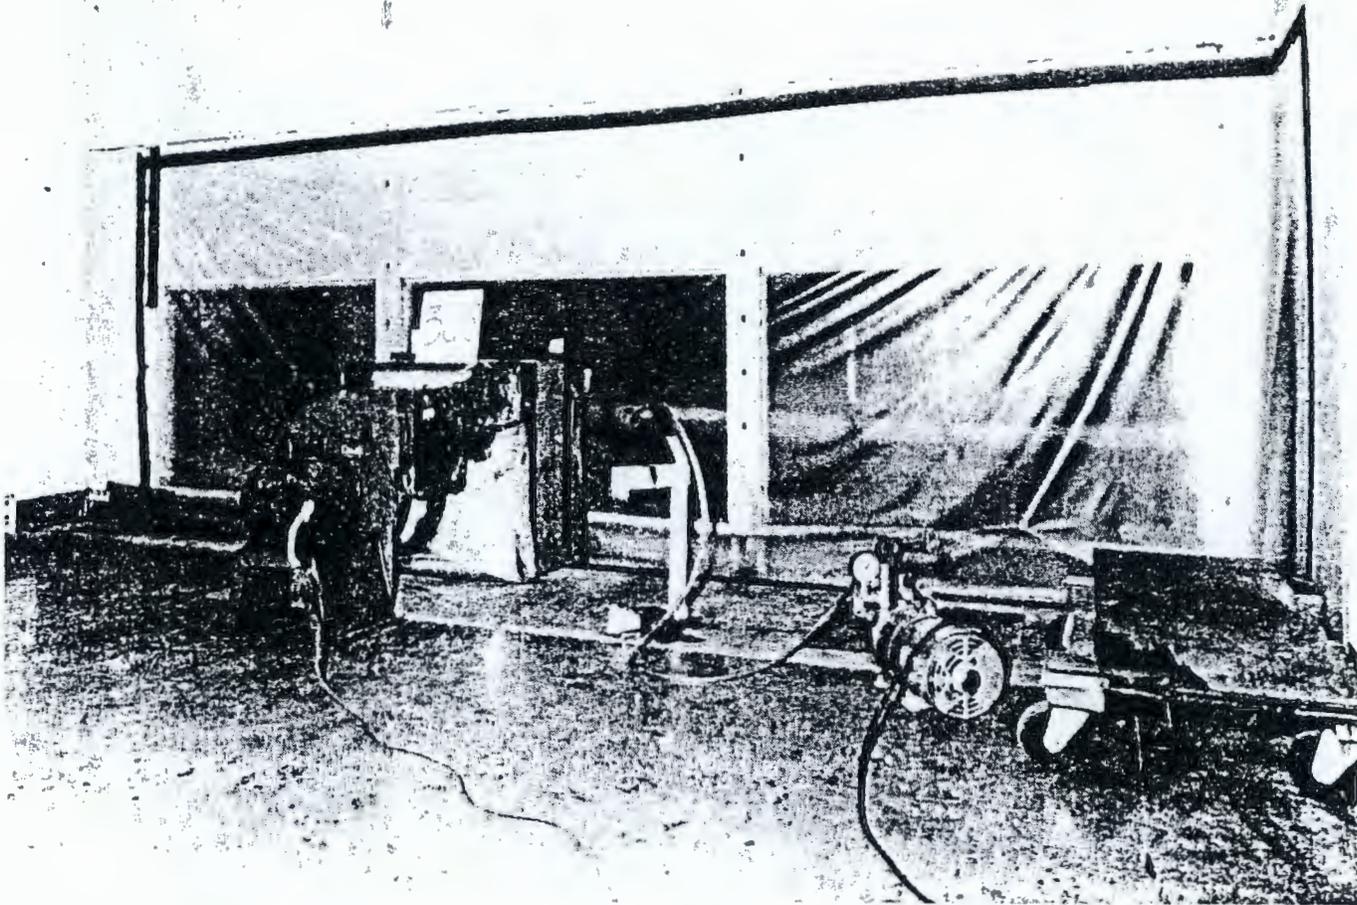
FIGURE 5.2.1-D

TYPICAL HEPA FILTER EXHAUST AND AIR SAMPLING UNIT  
ROOM 108 - 108-F BUILDING

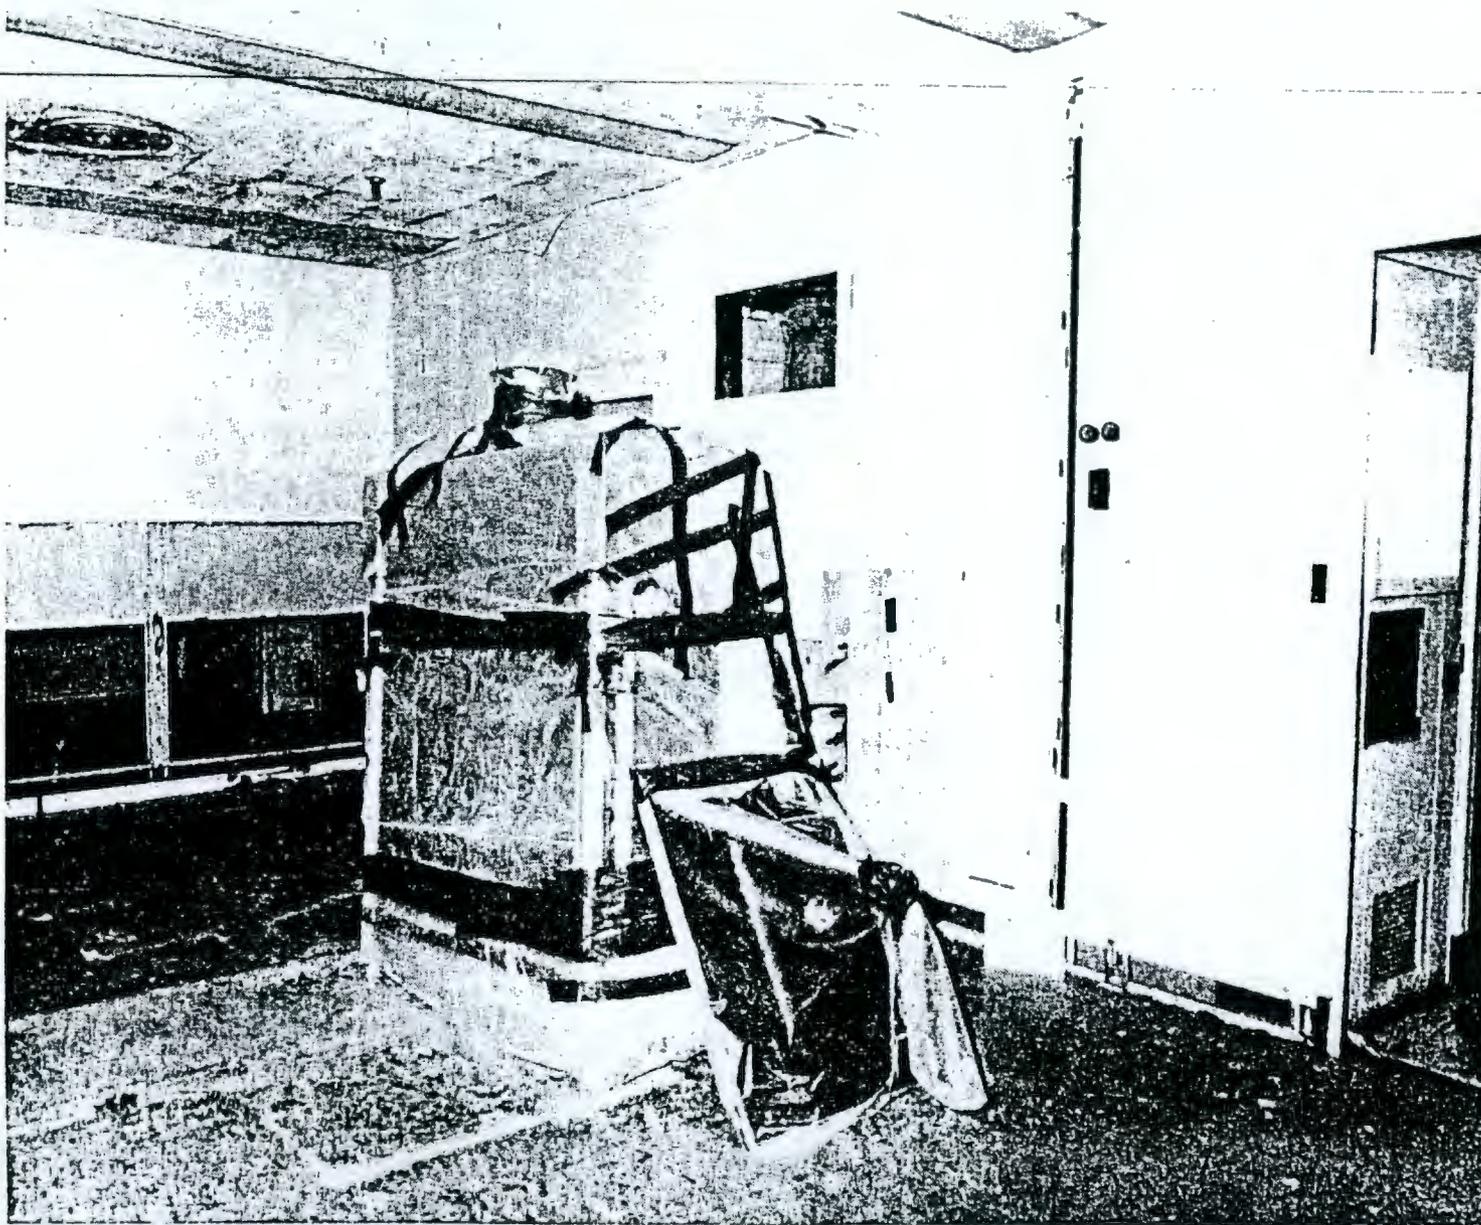
FIGURE 5.2.2

Fixture removal involved the foaming, disassembly, wrapping and handling of contaminated fixtures and equipment. Hoods contaminated with plutonium were coated with paint to fix the contamination. The hoods were then partially disassembled as required. The hood, sink and cabinet components were removed from a laboratory after being completely wrapped in plastic and sealed with tape. The contaminated components were loaded into shipping containers in preparation for burial at the 200-W burial site. (See Figure 5.2.2 )

TYPICAL METHOD OF WRAPPING AND TAPING COMPONENTS IN PREPARING FOR BURIAL

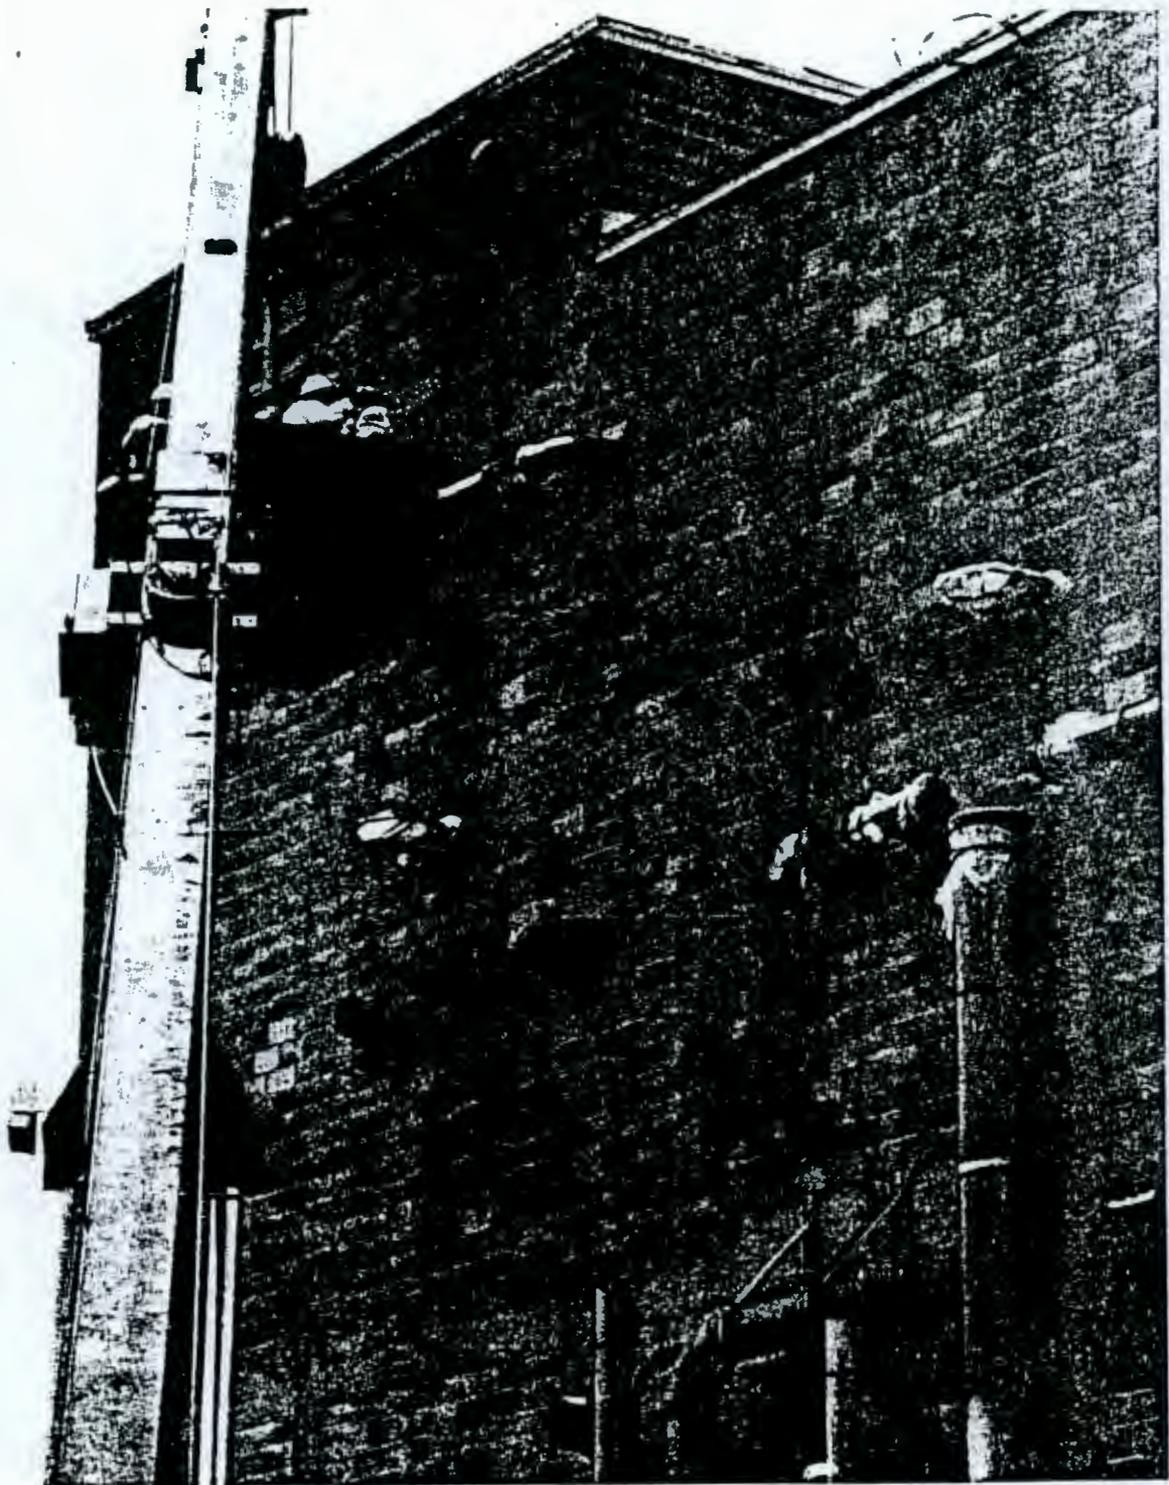
The interior of the duct work on the roof of the 103-F Building was painted, then cut into manageable sections. The duct work on the outer east wall was disconnected from the hoods inside the building and sealed. After disconnection from all anchor points, the duct work was removed from the side of the building and lowered to the ground intact. If the duct work was contaminated, it was coated with paint prior to cutting up for disposal. Whenever any duct work was opened, it was surveyed and immediately

FIGURE 5.2.4-A  
EXTERIOR DUCT REMOVAL - EAST SIDE  
108-F BUILDING

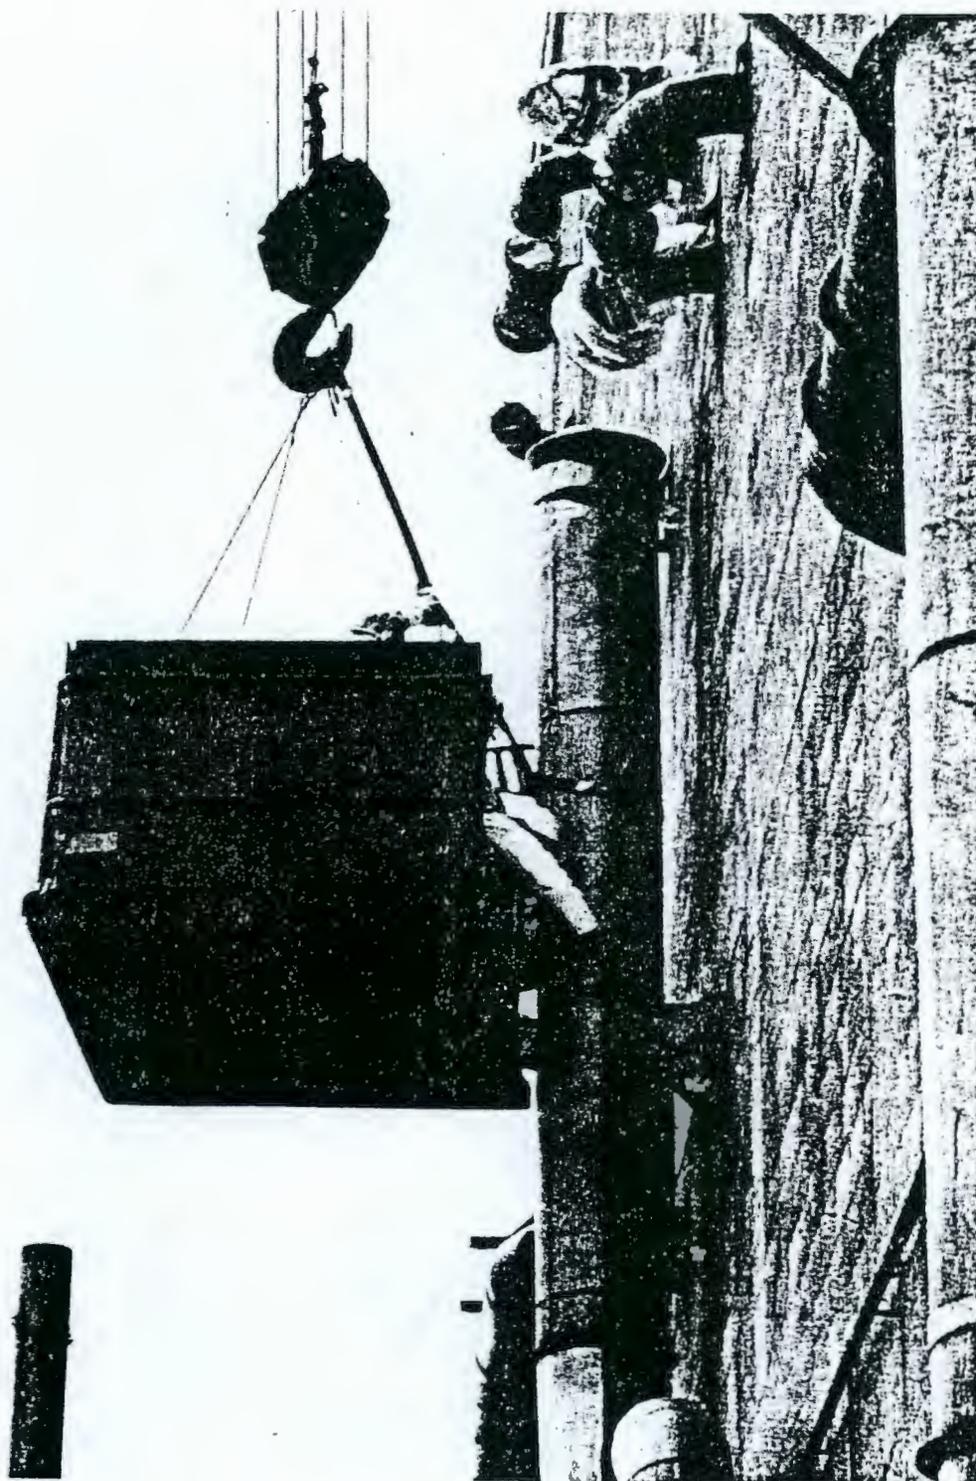
FIGURE 5.2.4-B

RIGGING EXTERNAL DUCT - EAST SIDE

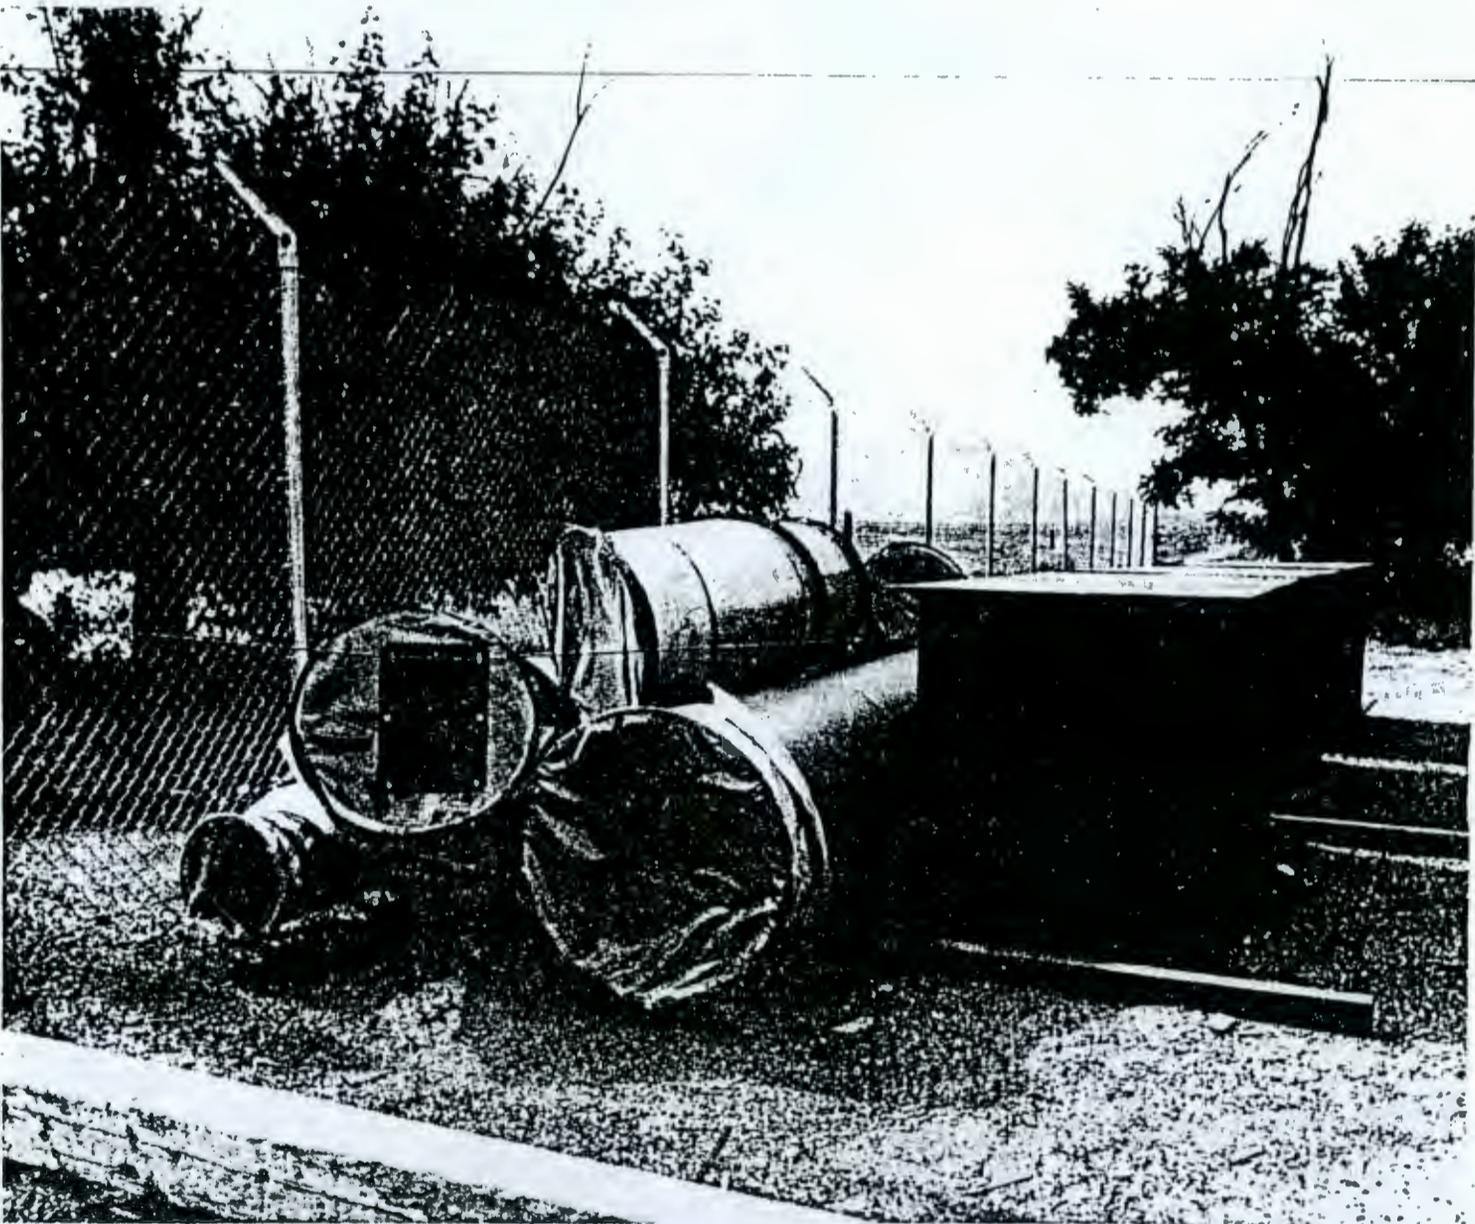
Duct removal involved the fixing, dismantling or cutting and sealing of the duct work each time it was opened. Disposal involved the removal through third-floor double doors, requiring the use of hoisting and rigging equipment, and the eventual sectioning, nesting\*, wrapping, handling and storing in a controlled zone until shipment to the burial site.

FIGURE 5.2.4-C  
CONTROLLED STORAGE

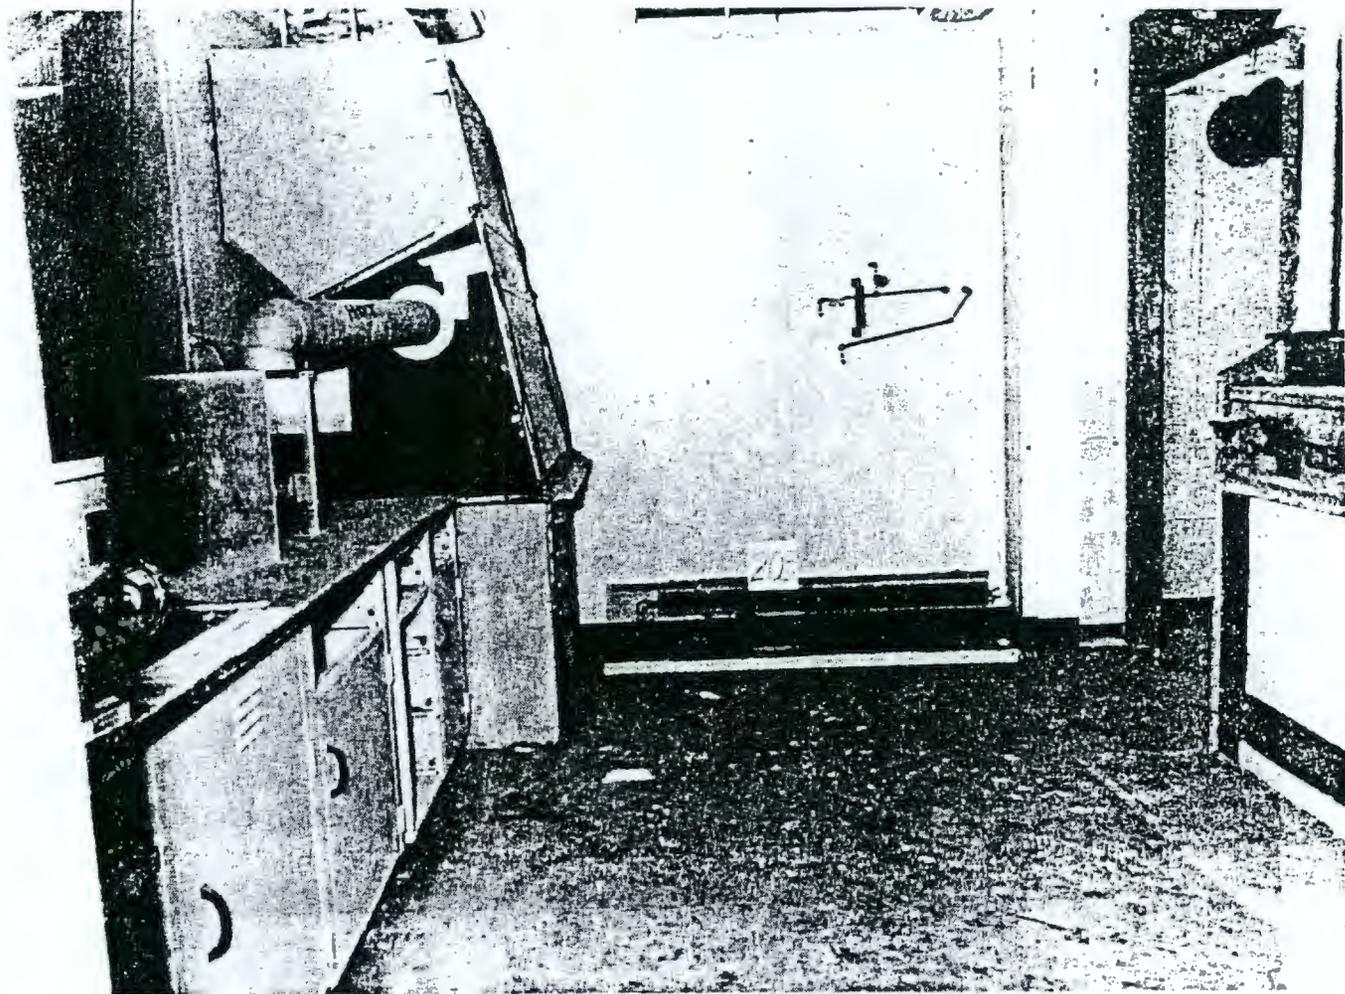
FIGURE 5.2.6-A

Contamination was removed from the structures by various techniques. Some of the techniques included: (See Figures 5.2.6-A & B)

- Removal of wall partitions.
- Surface spalling concrete floors with rock-jack, grinding wheel, chipping hammers and scabbler.
- Use of strippable coating.
- Where necessary, as with chipping and grinding, a contamination control envelope was set up requiring the use of proper respiratory equipment.

TYPICAL LABORATORY BEFORE DECONTAMINATION - ROOM 203

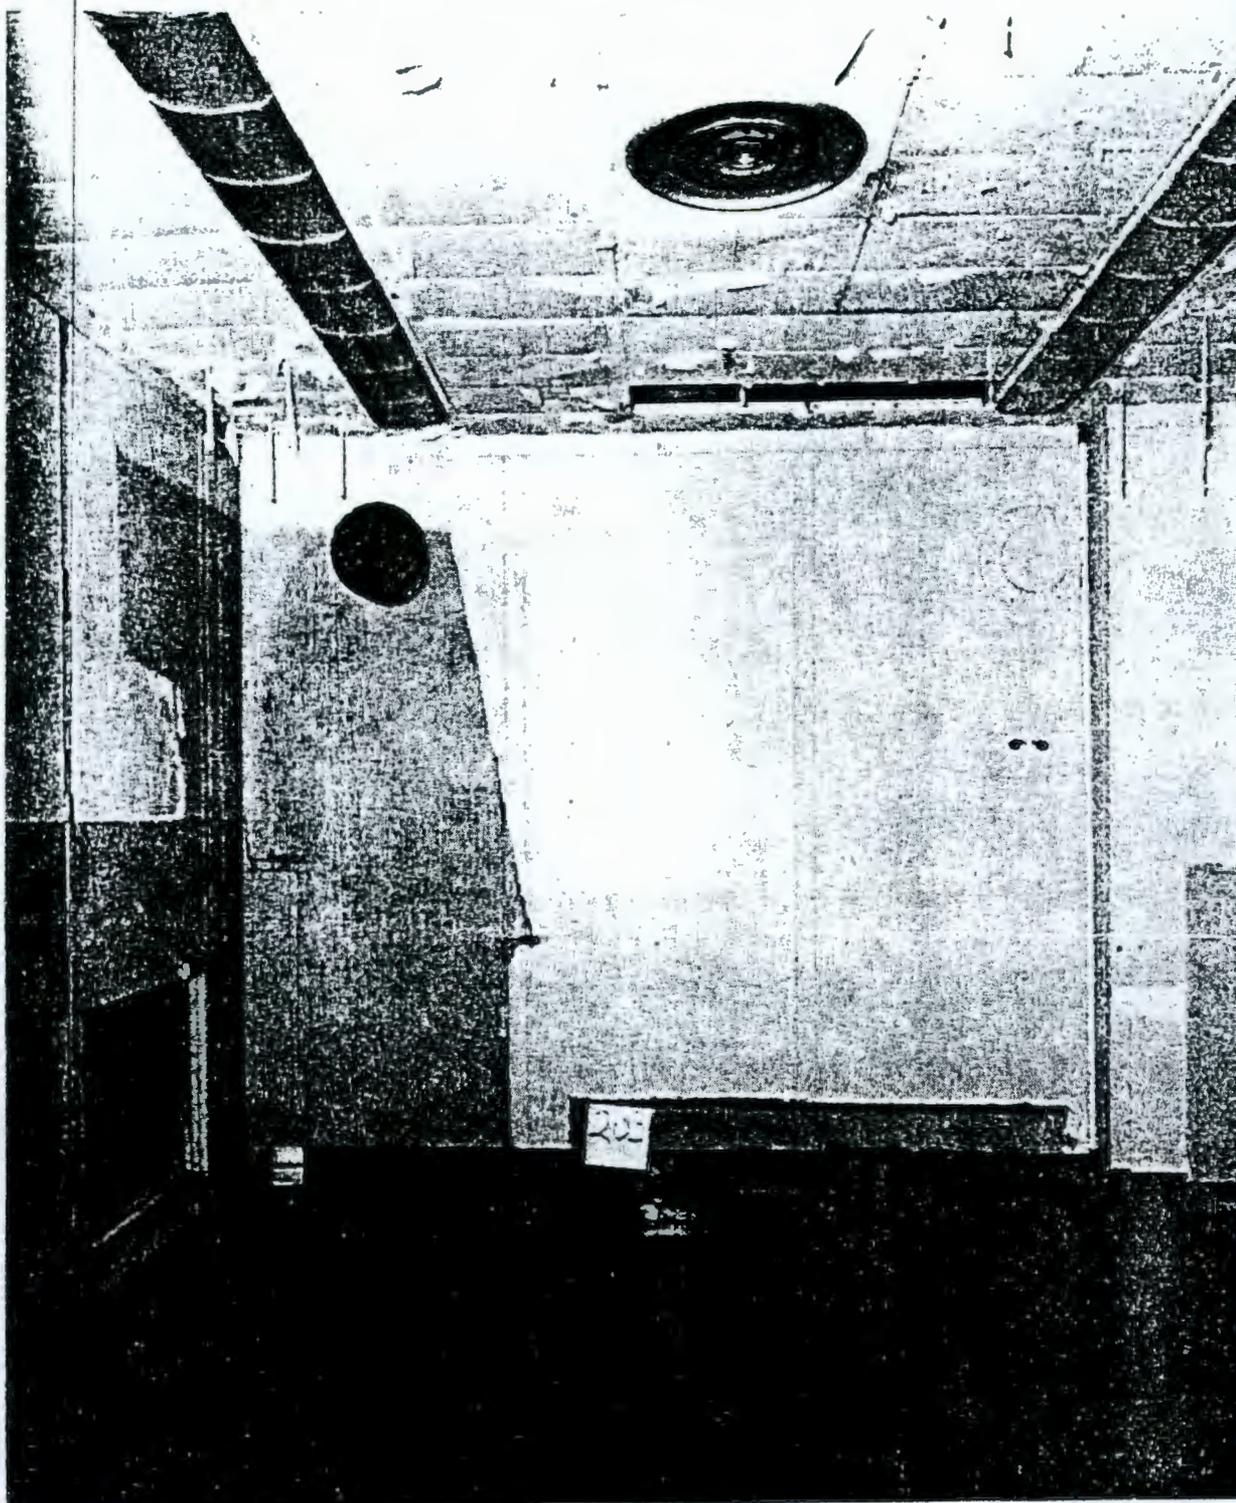
FIGURE 5.2.6-B

TYPICAL LABORATORY AFTER DECONTAMINATION - ROOM 203

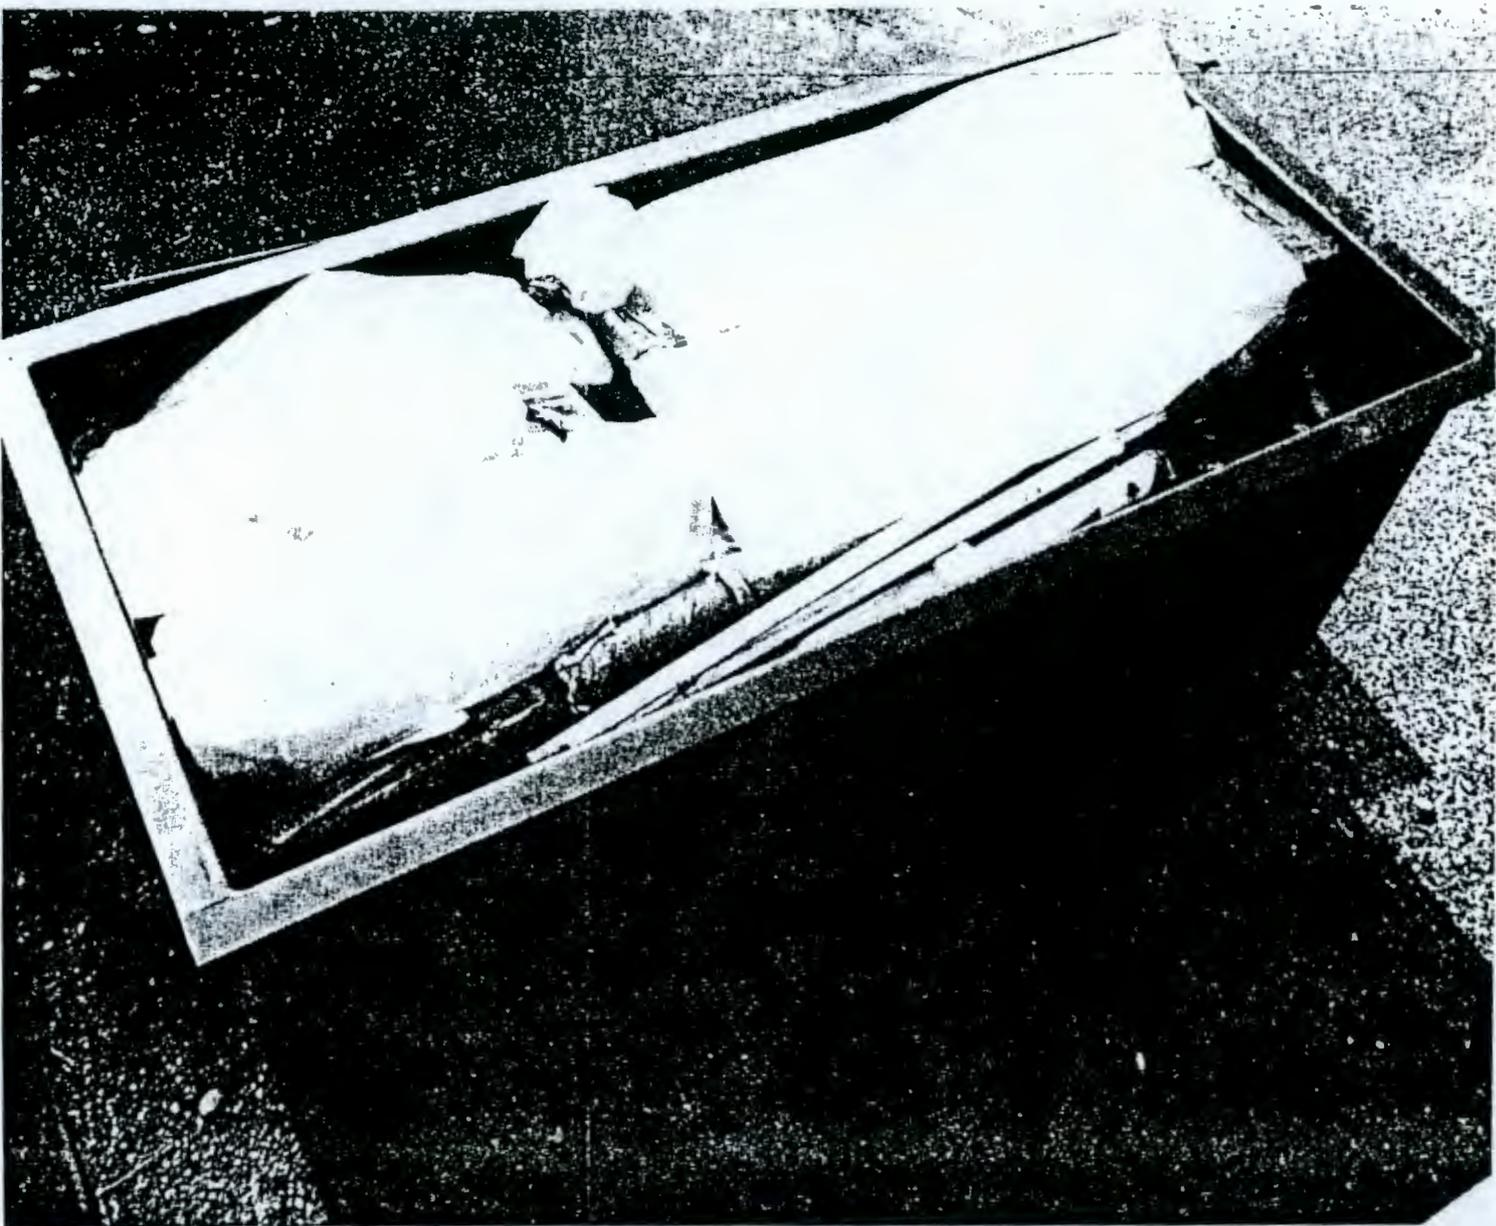
A lightweight steel container was designed for packaging waste material. This container met the DOT-7A criteria and Rockwell Hanford Operations (RHO) waste disposal requirements. (See Figure 5.2.7-A)

FIGURE 5.2.7-A  
OPEN - METAL WASTE CONTAINER  
108-F BUILDING
