Document No.  
UNI-2627

Title  
108-F BIOLOGICAL LABORATORY  
HANFORD SITE  
INTERIM DECOMMISSIONING REPORT

108-F BIOLOGICAL LABORATORY  
HANFORD SITE  
INTERIM DECOMMISSIONING REPORT

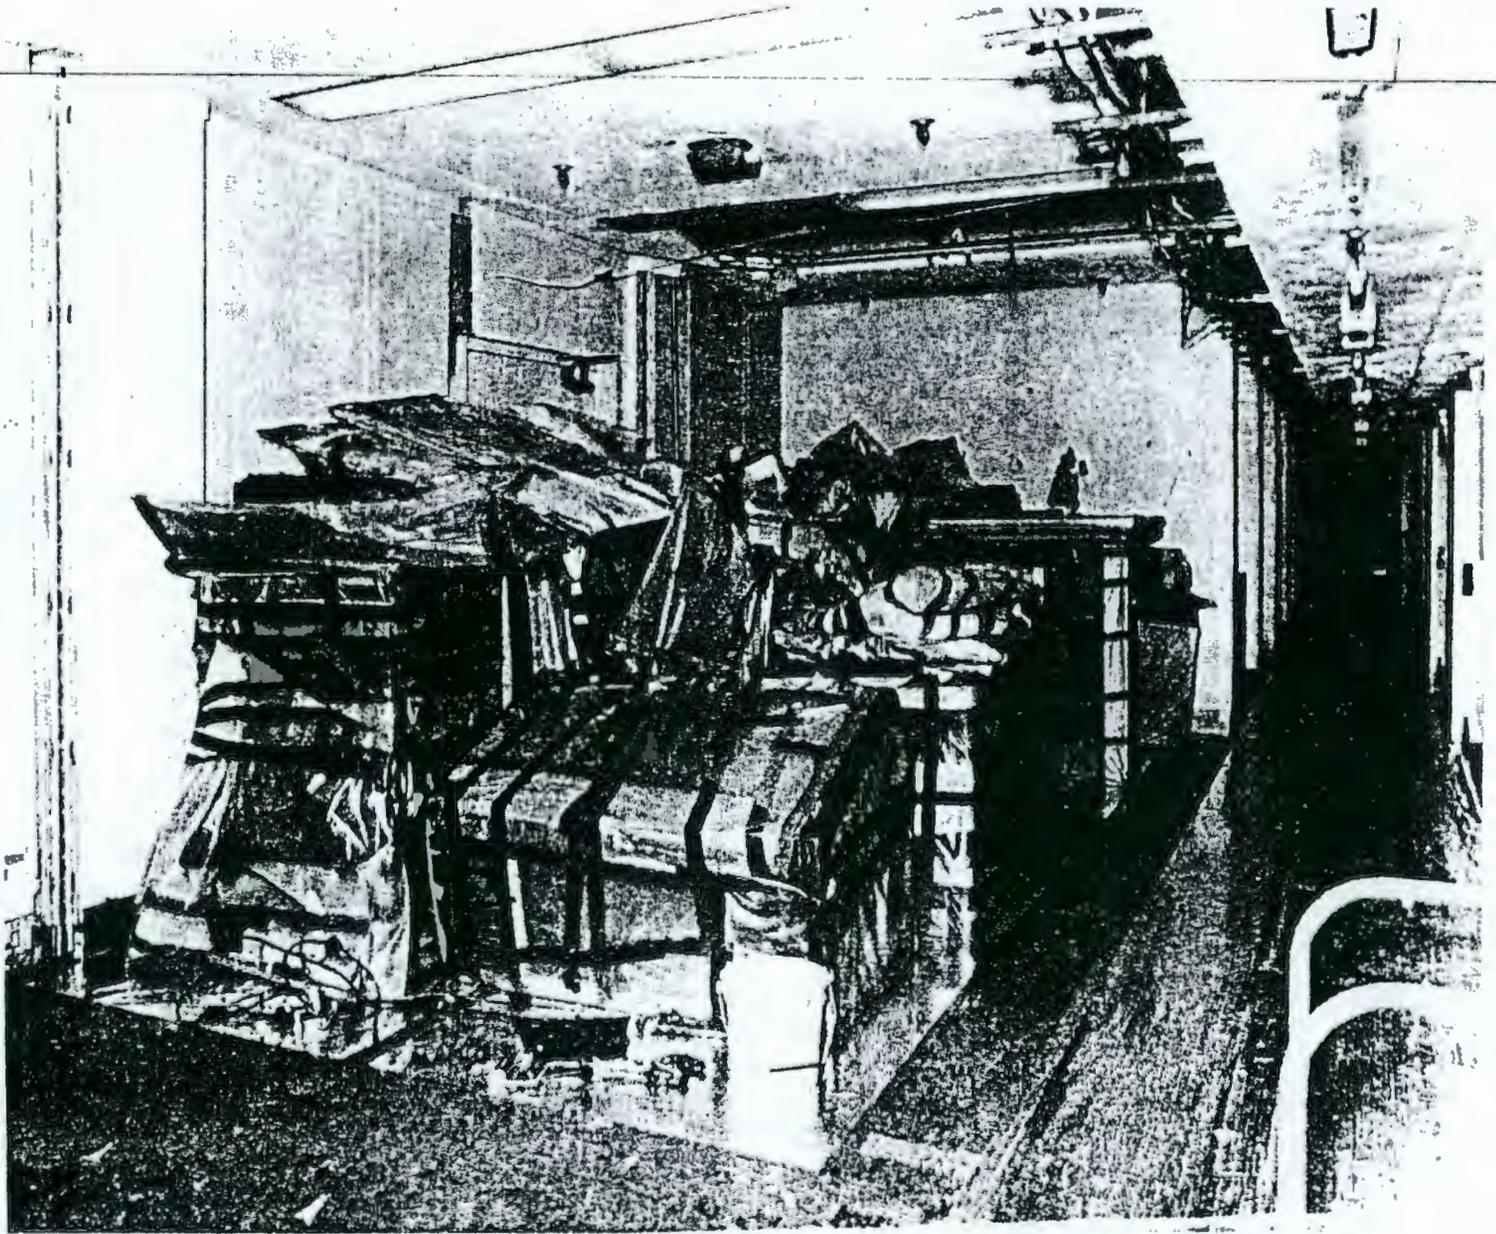
All radioactive waste from the 108-F decommissioning project was packaged and transported in compliance with the regulations and requirements described in UNI-M-29 "Shipment of Radioactive and Other Hazardous Materials". (See Figure 5.2.7-B & C)

FIGURE 5.2.7-B  
CONTAMINATED WASTE READY FOR LOAD-OUT  
108-F BUILDING

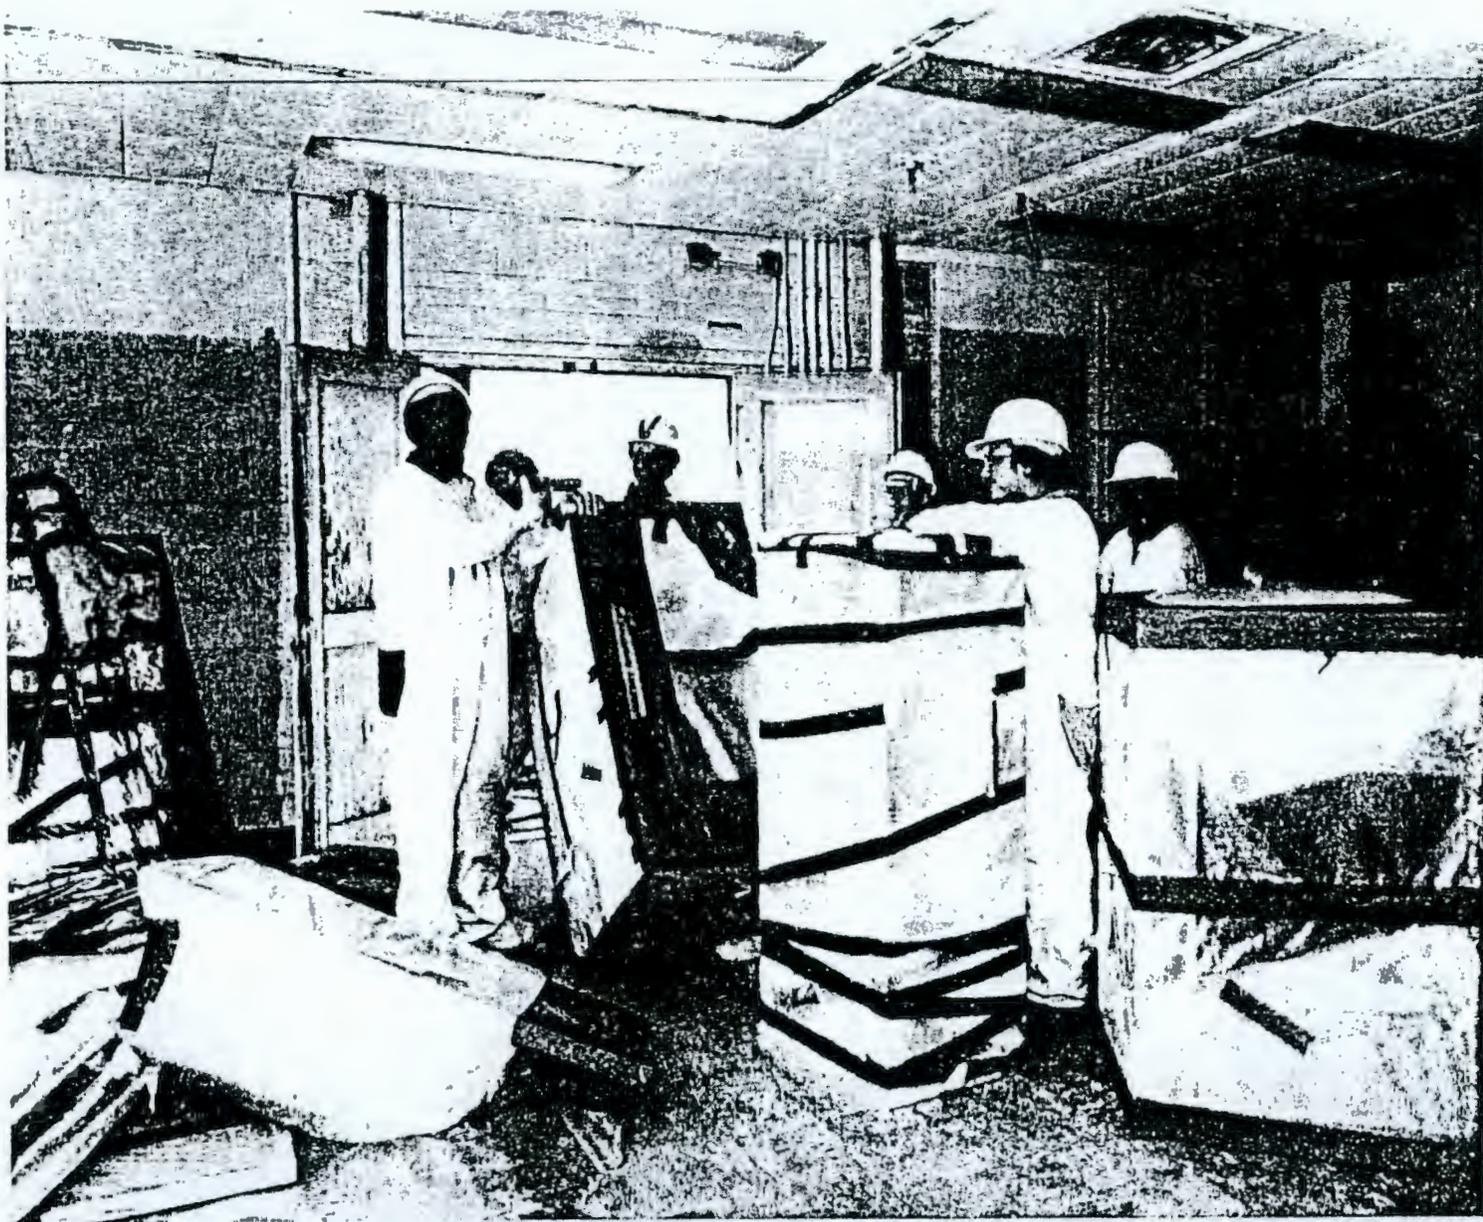
FIGURE 5.2.7-C  
WASTE REMOVAL  
108-F BUILDING

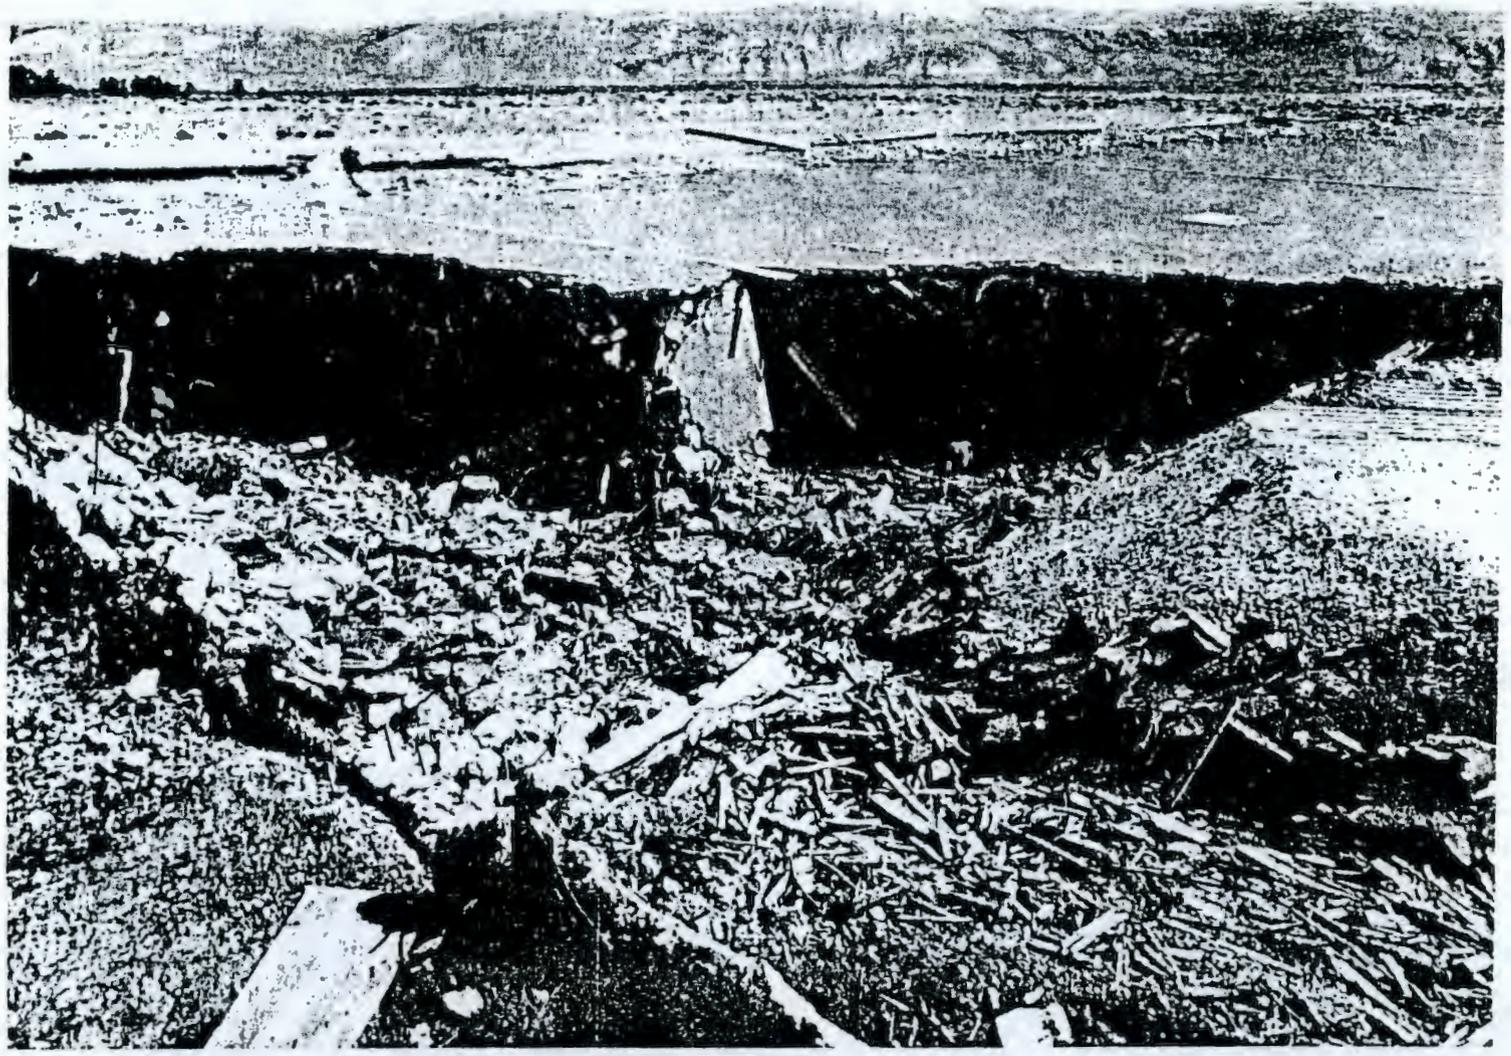
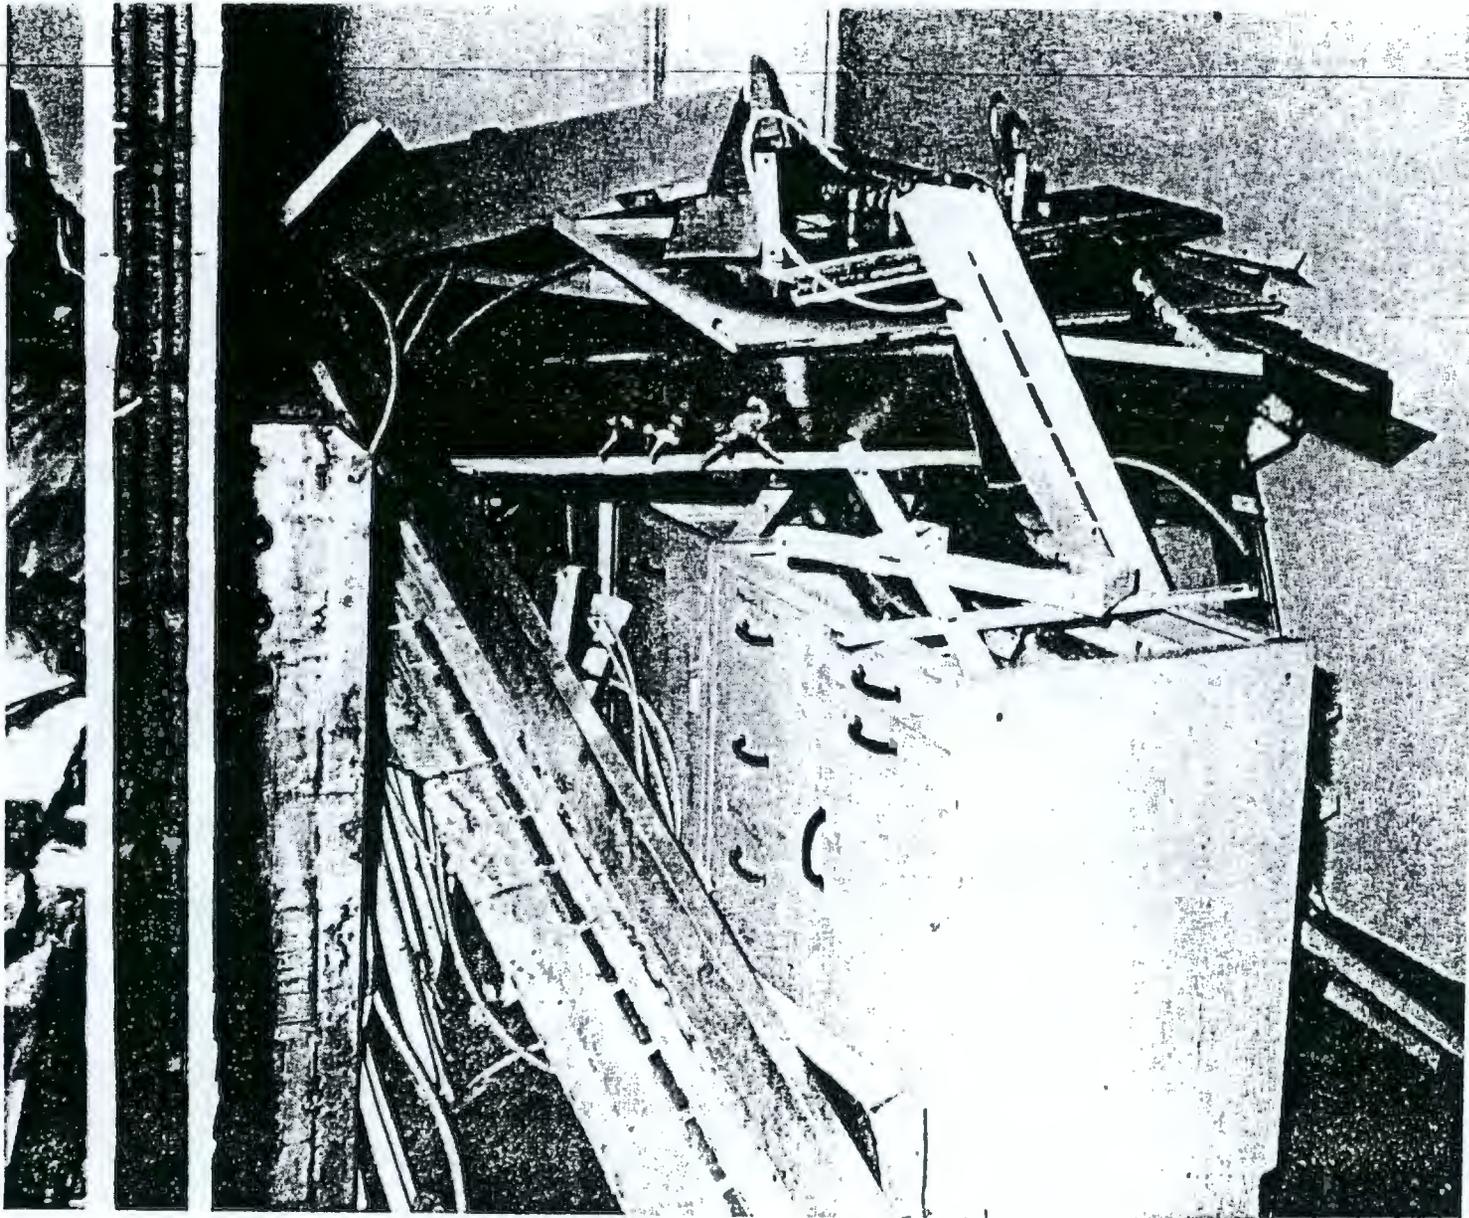
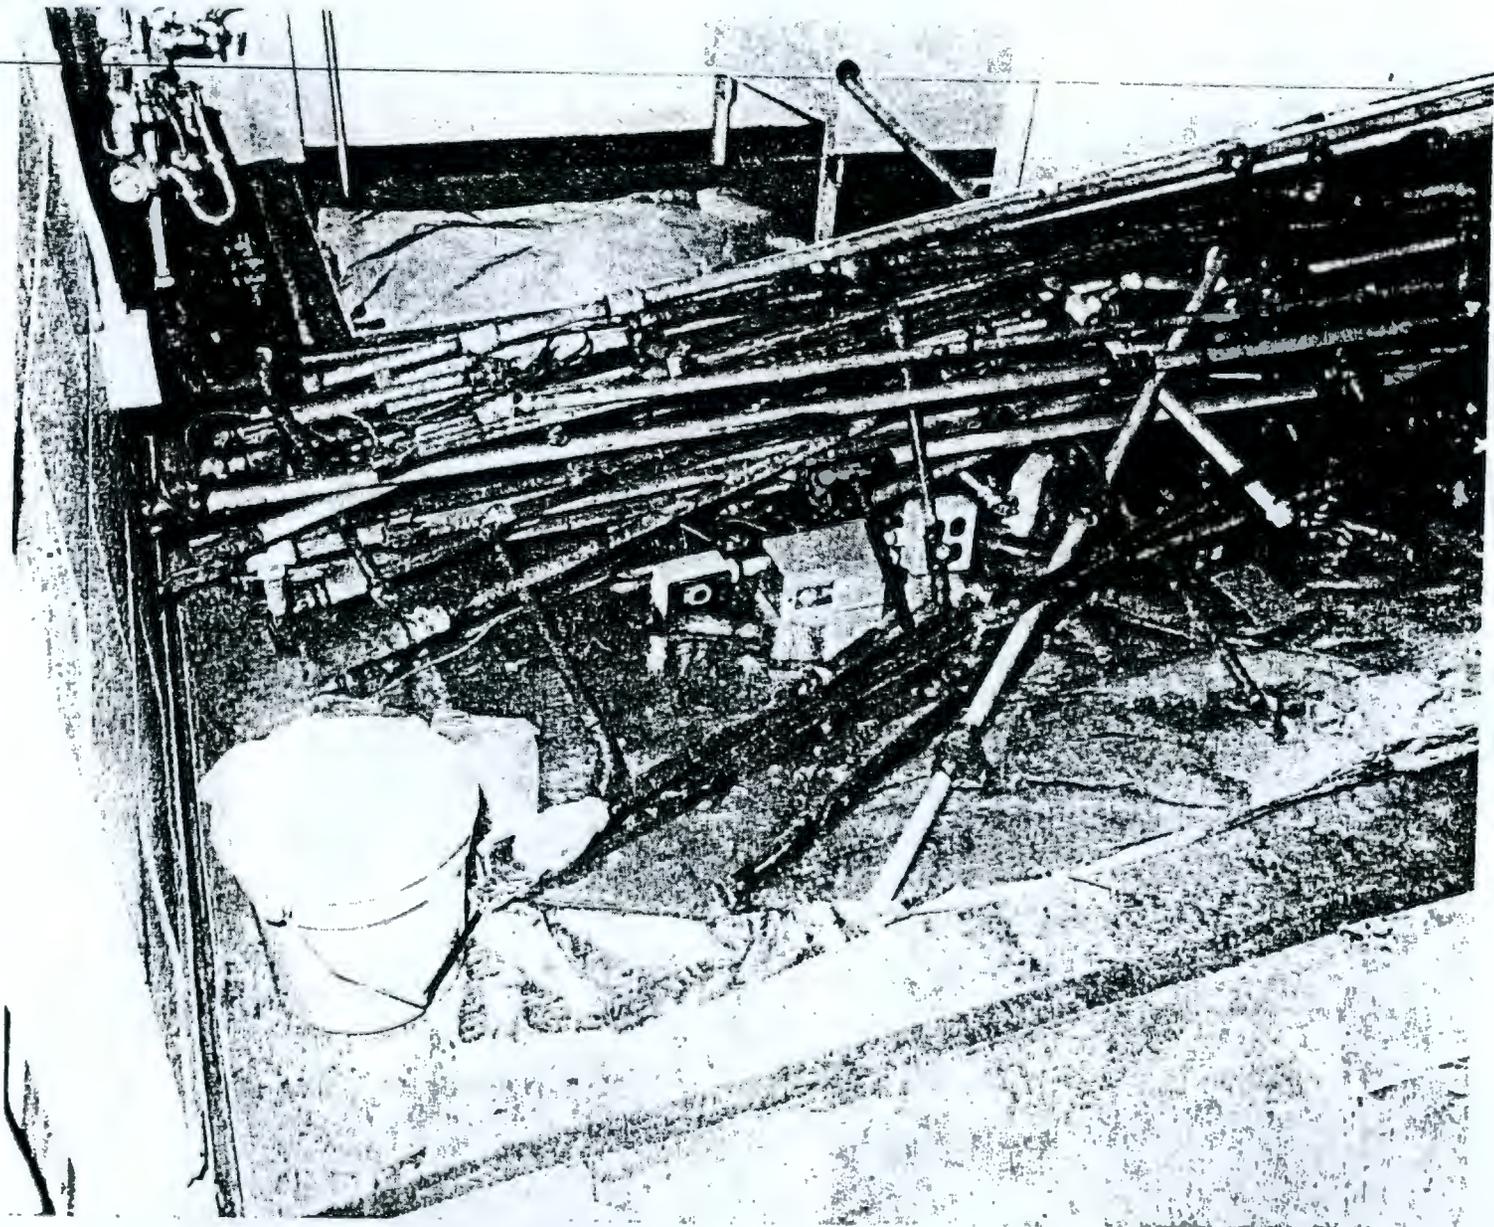
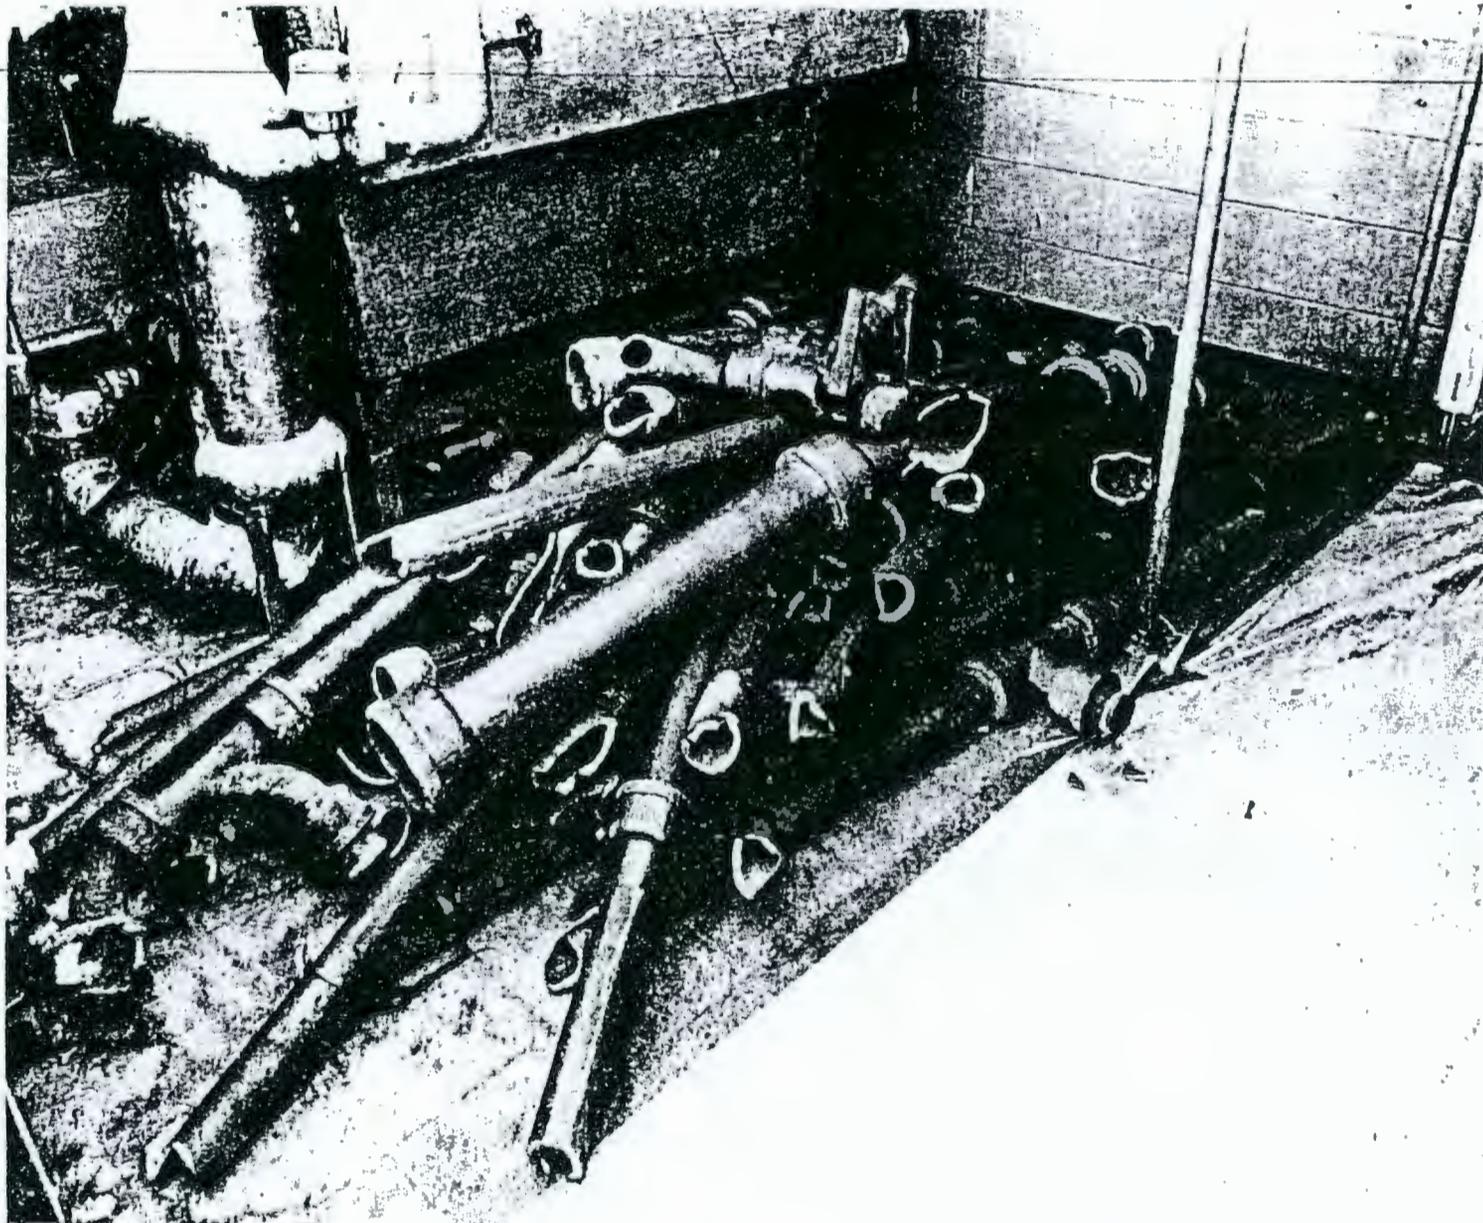
The volume amount of noncontaminated waste as of September 1983 exceeds that of the contaminated waste by 227%. Non-contaminated waste is any item which is examined by radiation monitoring and found not to be detectable with PAM probe for Alpha and not detectable with the P-11 probe for Beta-Gamma. No special packaging or transportation requirements are needed to ship or bury this material. Truck loads amounting to 10,840 cu. ft. were hauled and dumped into the 183-F clearwells and backfilled with excavated dirt. (See Figures 5.2.8-A, B, C, D & E) (For volume, see Table 5-2, page 30)

FIGURE 5.2.8-A  
NONCONTAMINATED - NONHAZARDOUS WASTE SITE

FIGURE 5.2.8-B  
CLEARWELL - 100-F AREA - WASTE SITE

FIGURE 5.2.8-C  
NONCONTAMINATED WASTE  
108-F BUILDING

FIGURE 5.2.8-D  
NONCONTAMINATED WASTE  
108-F BUILDING

FIGURE 5.2.8-E  
NONCONTAMINATED WASTE  
108-F BUILDING DRAIN PIPE

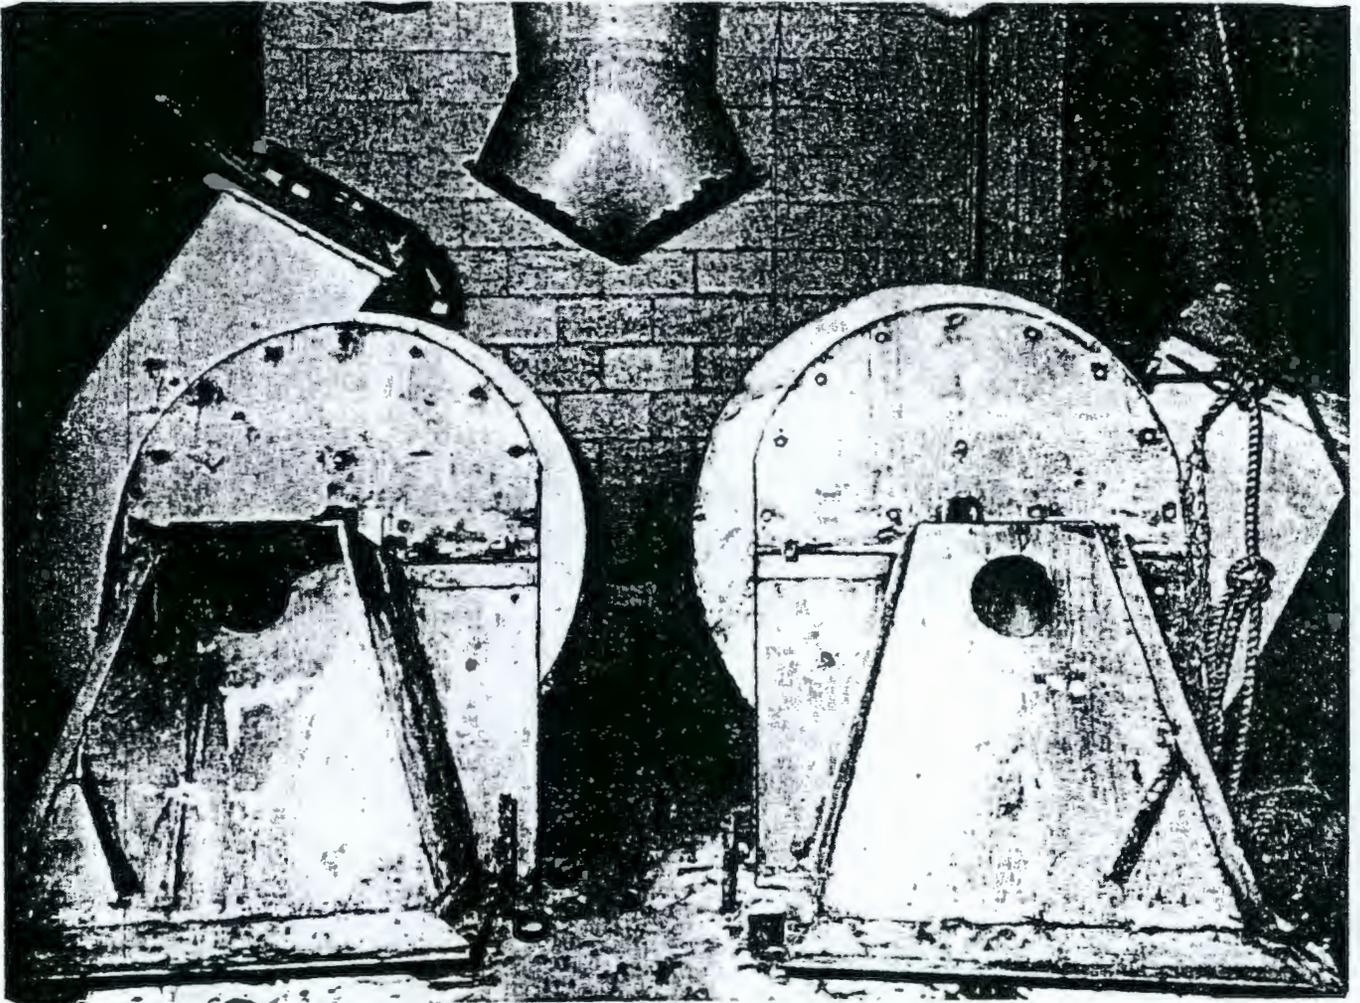
FIGURE 6.1.12-B

An accident investigation was conducted on Thursday, June 30, 1983 to determine the cause of a fire in the 108-F building on Wednesday, June 29, 1983. The purpose of this investigation was to determine primarily what happened, the response, and lessons to be learned from that incident. Results of that investigation are recorded in the UNC Type D Accident Investigation Report Number 8307. Briefly, an oxyacetylene torch was being used in room 404 to cut a 2½" drive shaft to a ventilation blower and debris fire was started. After the fire was extinguished, work continued in room 404 to remove the 108-F primary ventilation system. (Figure 6.1.12-B, Room 404 after fire.)

PRIMARY VENTILATION FANS  
POST FIRE PHOTO  
ROOM 404 - 108-F BUILDING
