FACILITY STATUS CHANGE FORM

Date Submitted: 4-30-2012	Area: 100-N	Control #: D4-100N-0033
Originator: David Warren	Facility ID: 1310-N "Golf Ball and Silo"

D4 Project Facility Completion Form

Attachment 1: Facility Information (7 pages)

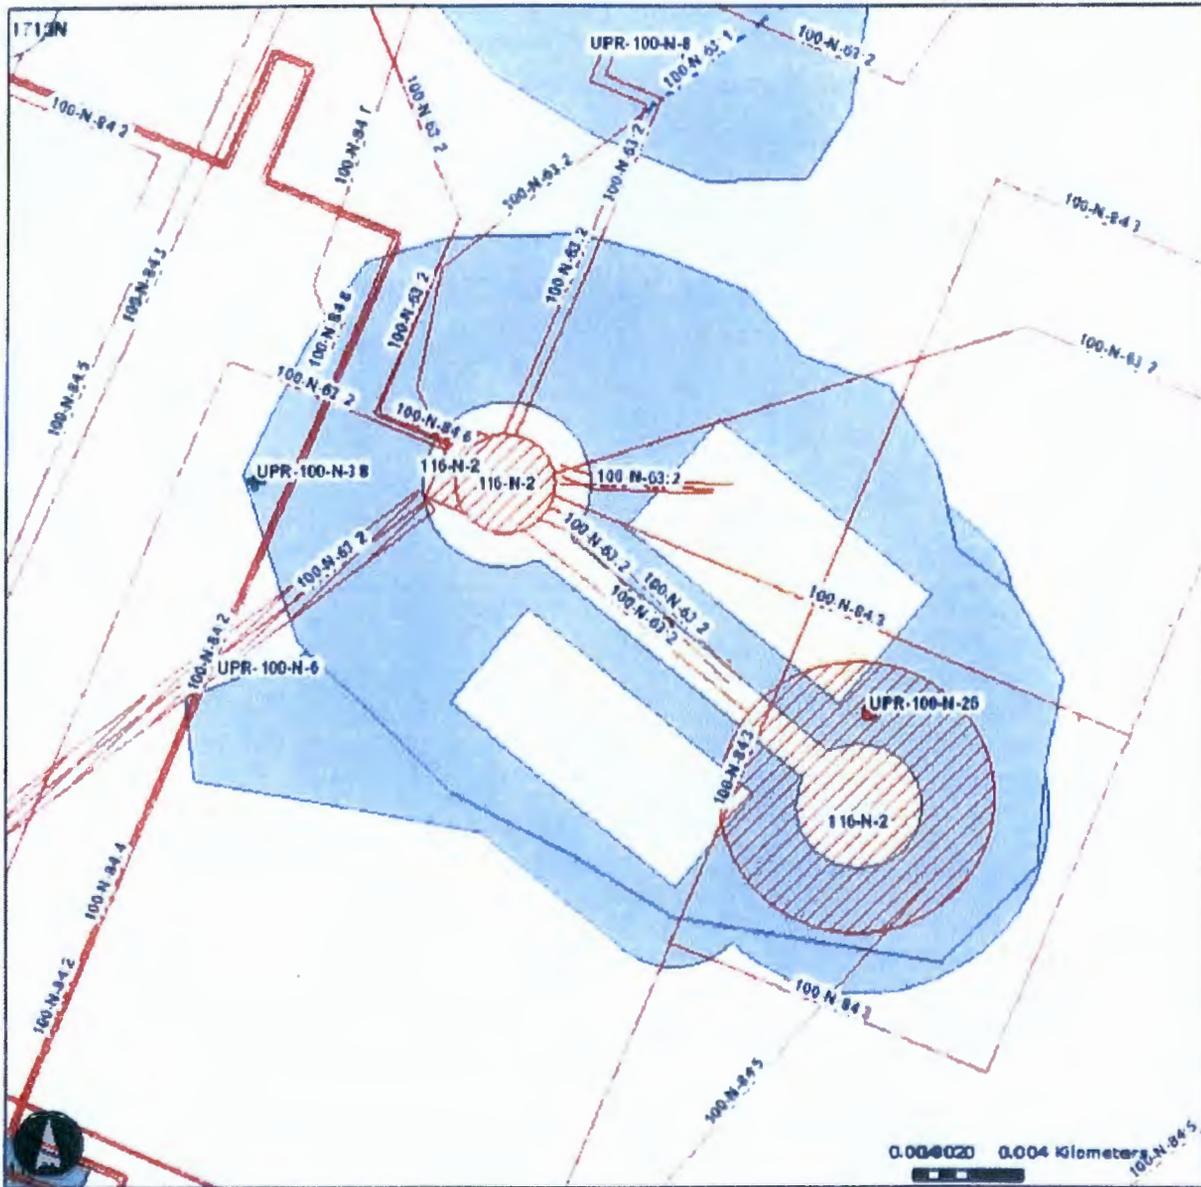
Figure 1. Map of 1310-N

Table-4 below lists each waste site and an abbreviated description. Figure-1 (below) shows the excavation layback in light blue and the excavation toe in tan. The wastes sites can be seen in

red with black type with the exception of UPR- 100-N-5 which is located along the length of 100-N-63:2 pipeline between the two 116-N-2 polygons.

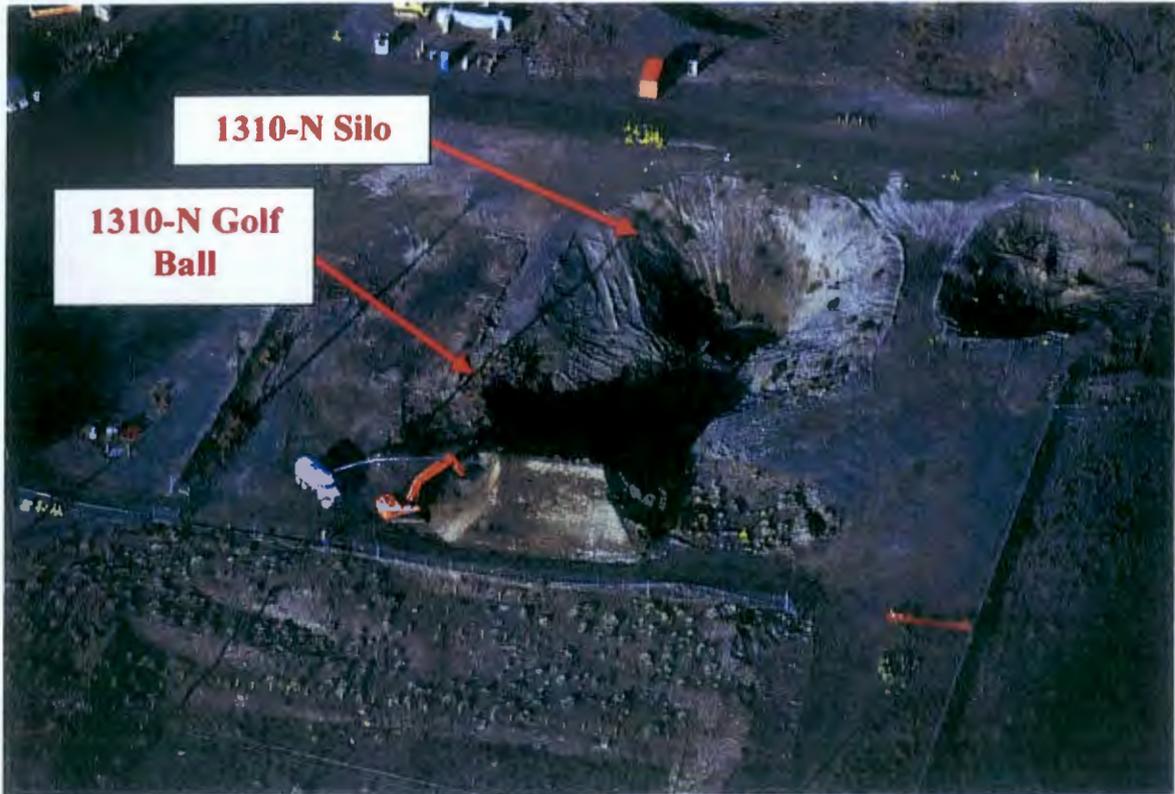
Photo 2. Aerial Photo of 1310-N following demolition

At the time of this report, all that remains of the 1310-N Facility is a portion of the earthen berm and an excavation approximately 148-feet by 220-feet and about 20-feet deep. Piping was exposed in the northwest and north sides of the excavation. The December 2, 2010 Civil GPS Survey depict the final condition of the project when it was handed over to the FR project for

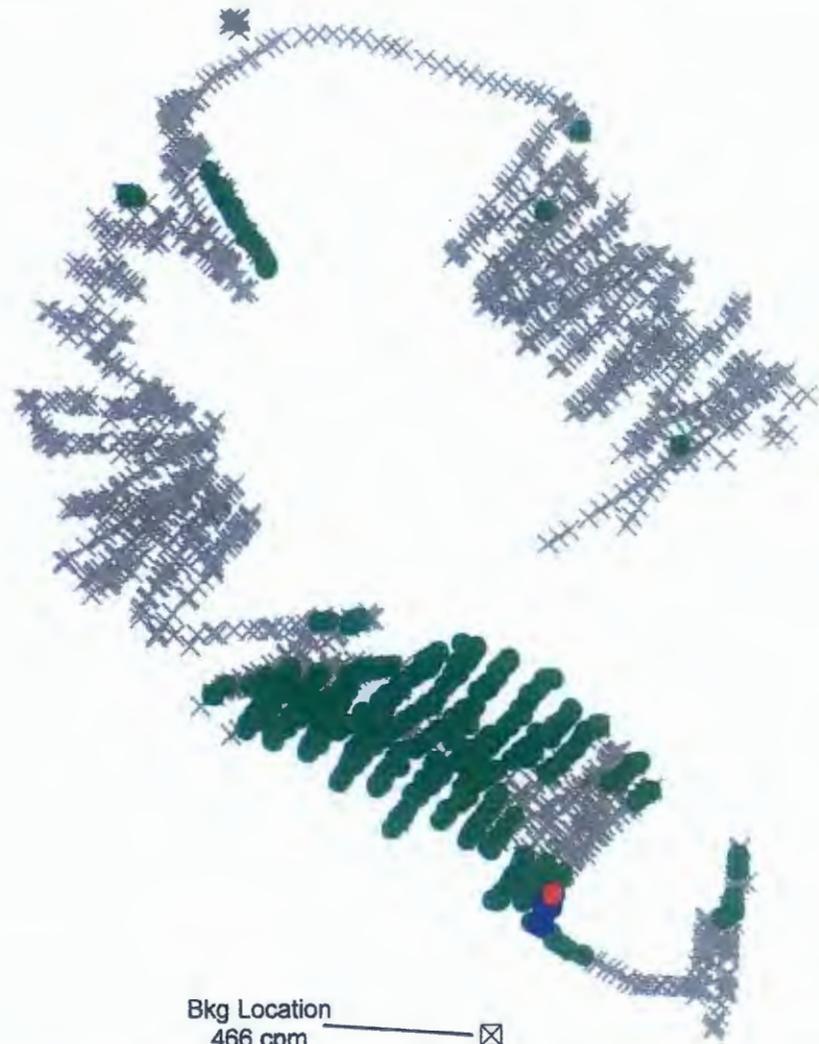
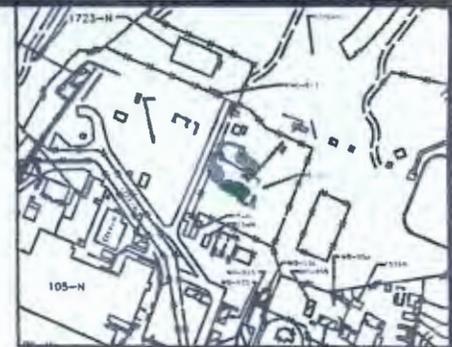
100N D4 1310N Golfball GPERS Radiological Survey Beta Track Map

Bkg Location
466 cpm

Summary Statistics
Coverage File: N321_
Number of Data Pnts: 4863
Type of Survey: 'Beta'
Max GCPM: 16841
Avg Bkg CPM: 466
Survey Date: 11/17/2010
Area Surveyed: 1224 m²
Project File: N321_
Pdf File: ESRFRM100144BC

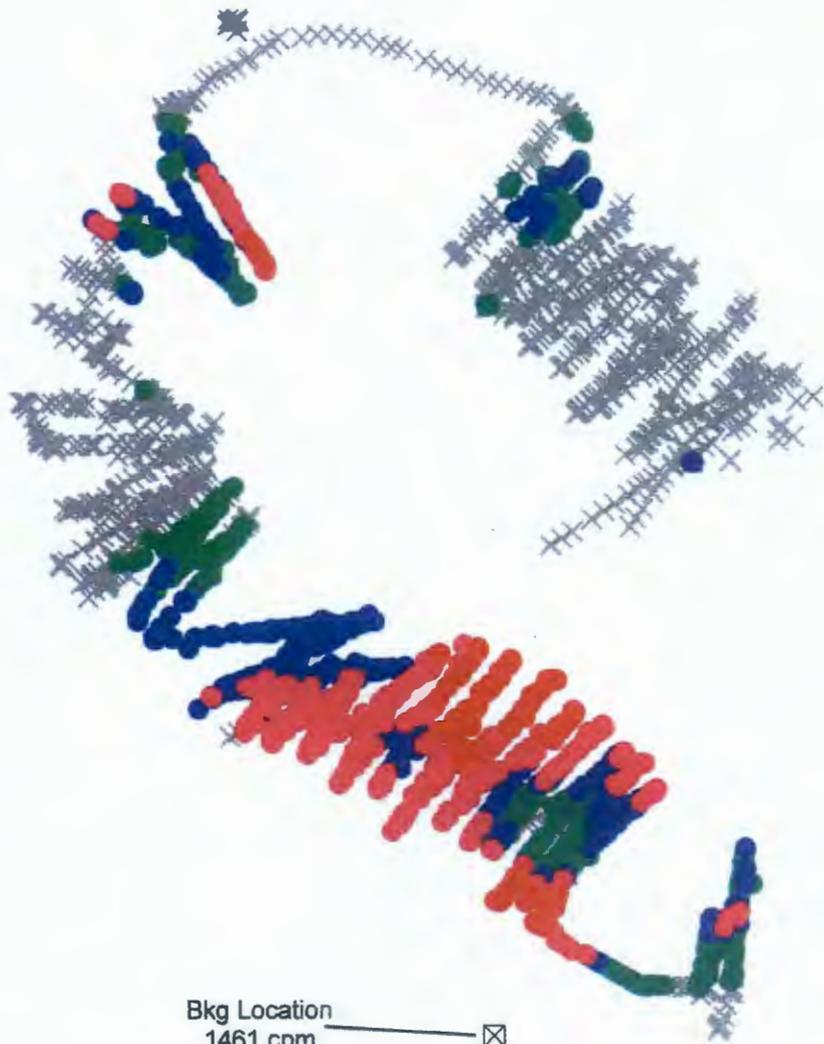
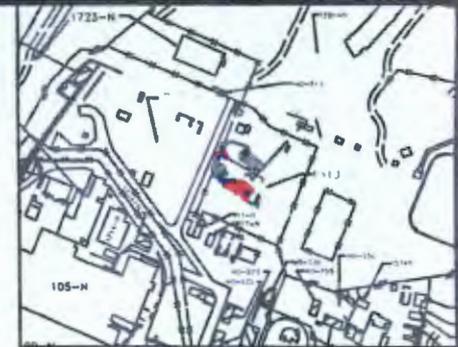
100N D4 1310N Golfball GPERS Radiological Survey Gamma Track Map

Bkg Location
1461 cpm

Coverage File: N321
Number of Data Pnts: 4863
Type of Survey: 'Gamma'
Max GCPM: 94812
Avg Bkg CPM: 1461
Survey Date: 11/17/2010
Area Surveyed: 1224 m²
Project File: N321
Pdf File: ESRFRM100144GC

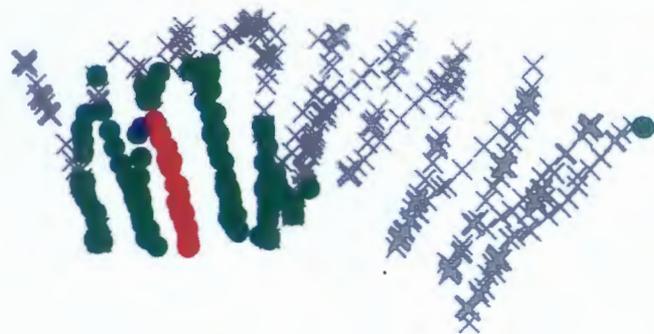
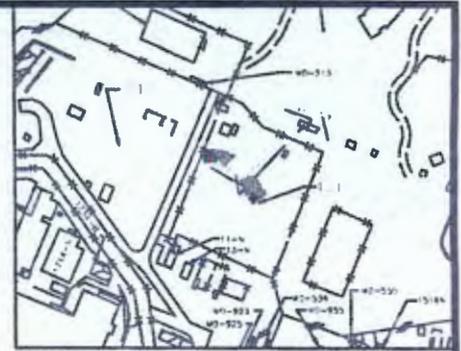
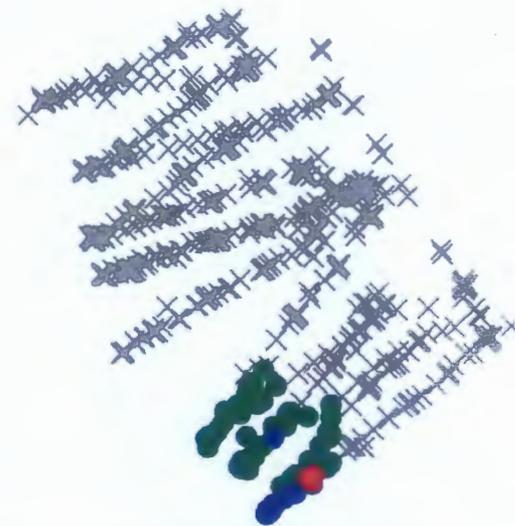
100N D4
1310N Golfball
GPERS Radiological Survey
BetaTrack Map

Bkg Location
484 cpm

Coverage File: N322B
 Number of Data Pnts: 2125
 Type of Survey: 'Beta'
 Max GCPM: 19172
 Avg Bkg CPM: 484
 Survey Date: 11/18/2010
 Area Surveyed: 443 m²
 Project File: N322B
 Pdf File: ESRFRM100145BC

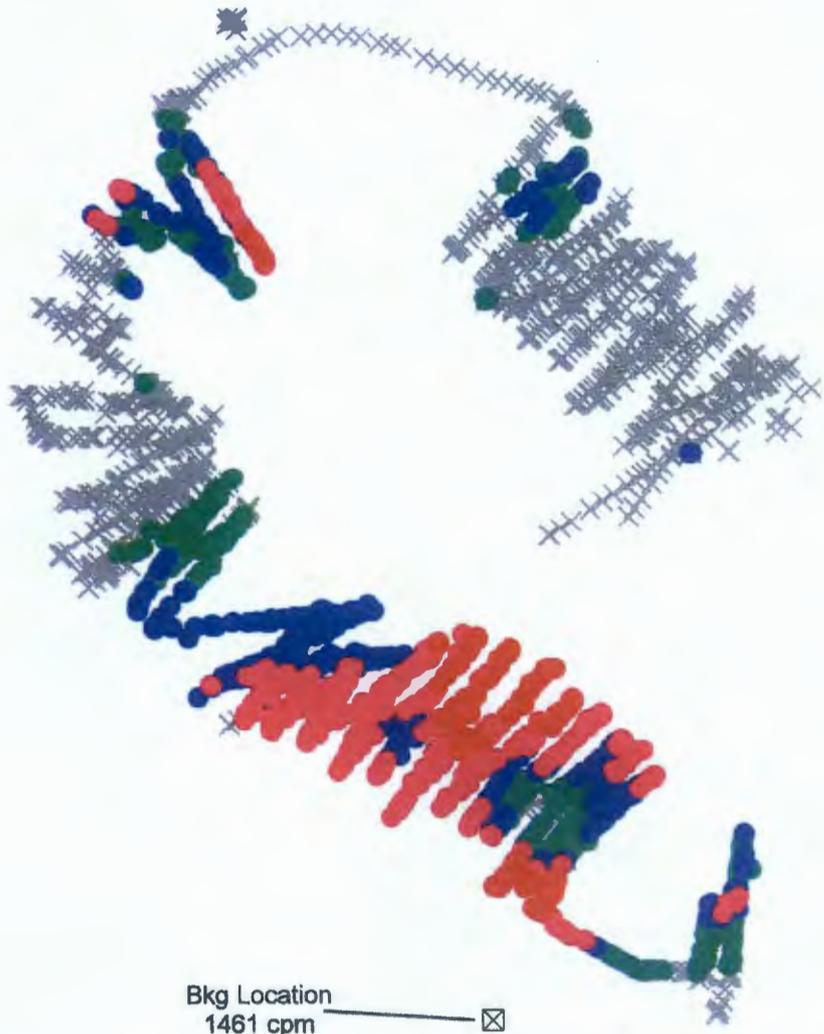
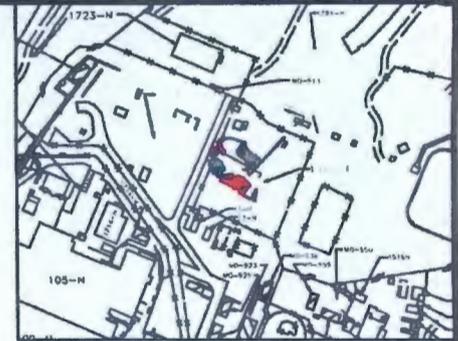
**100N D4
 1310N Golfball
 GPERS Radiological Survey
 Gamma Track Map**

Bkg Location
1461 cpm

Coverage File: N321
 Number of Data Pnts: 4863
 Type of Survey: 'Gamma'
 Max GCPM: 94812
 Avg Bkg CPM: 1461
 Survey Date: 11/17/2010
 Area Surveyed: 1224 m²
 Project File: N321
 Pdf File: ESRFRM100144GC
