Control #: D4-300-100**FACILITY STATUS CHANGE FORM**

Date Submitted: September 19, 2014	Area: 300 Area	Control #: D4-300-100
Originator: Chris Strand	Facility ID: 352F	
Phone: 554-2720	Action Memorandum: Action Memorandum #1

352F FACILITY COMPLETION

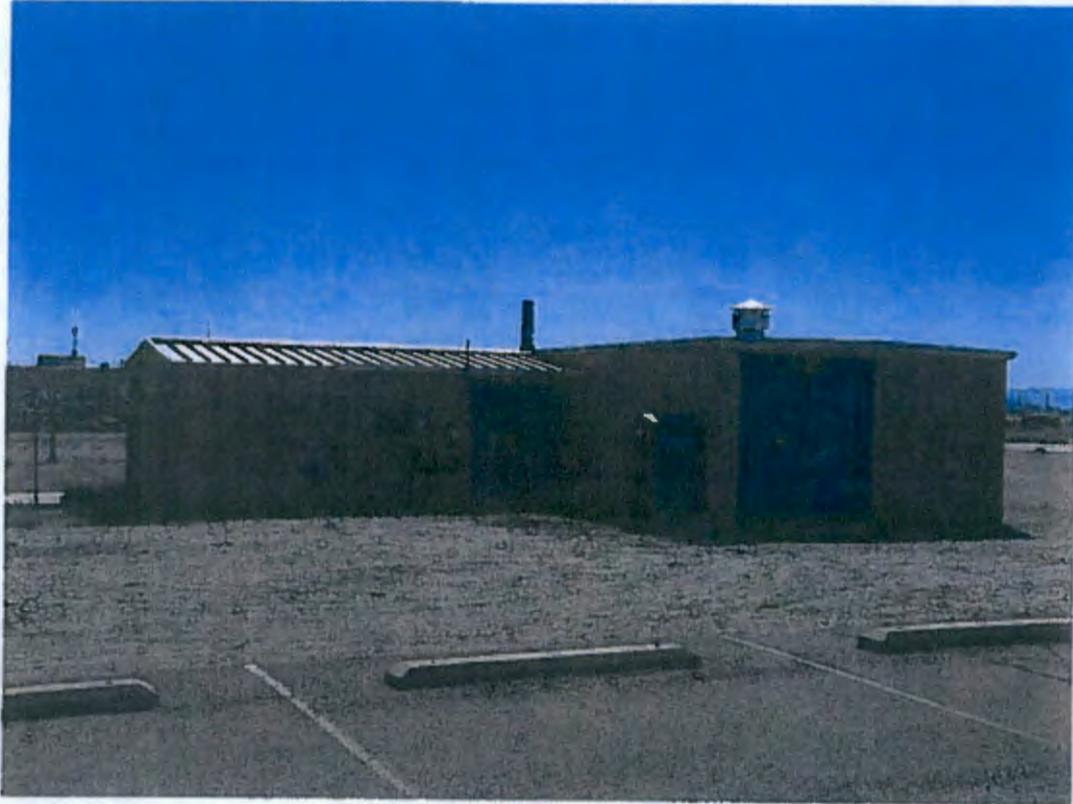
**Photograph 1: 352F Substation looking east, 2008.
(The cable vault lies directly beneath)**

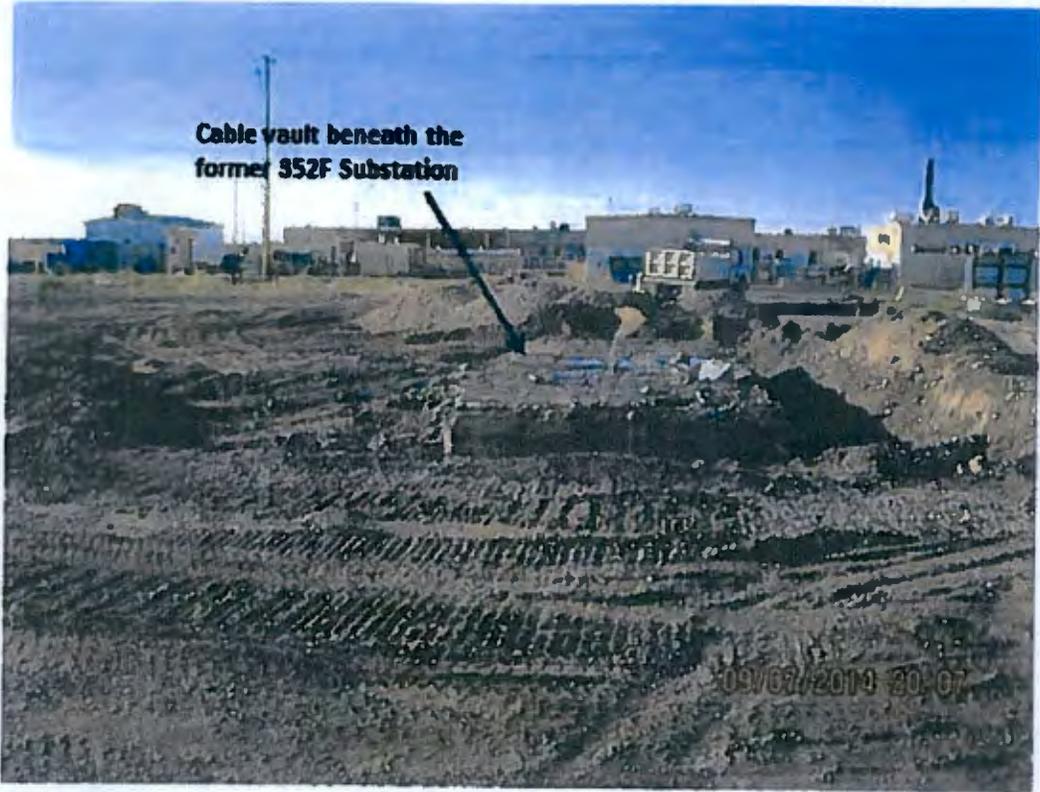
**Photograph 2. 352F Cable Vault following above-grade demolition,
looking south, September 8, 2014.**

Demolition: Above-grade demolition of the 352F Substation was completed in August of 2014. Below-grade demolition of the 352F foundation was completed in September 2014. A cable vault underlying 352F was demolished to 3 feet below grade and left in place in September of 2014. The above and below-grade building debris were removed and disposed of at ERDF. The demolition was performed under standard demolition controls.

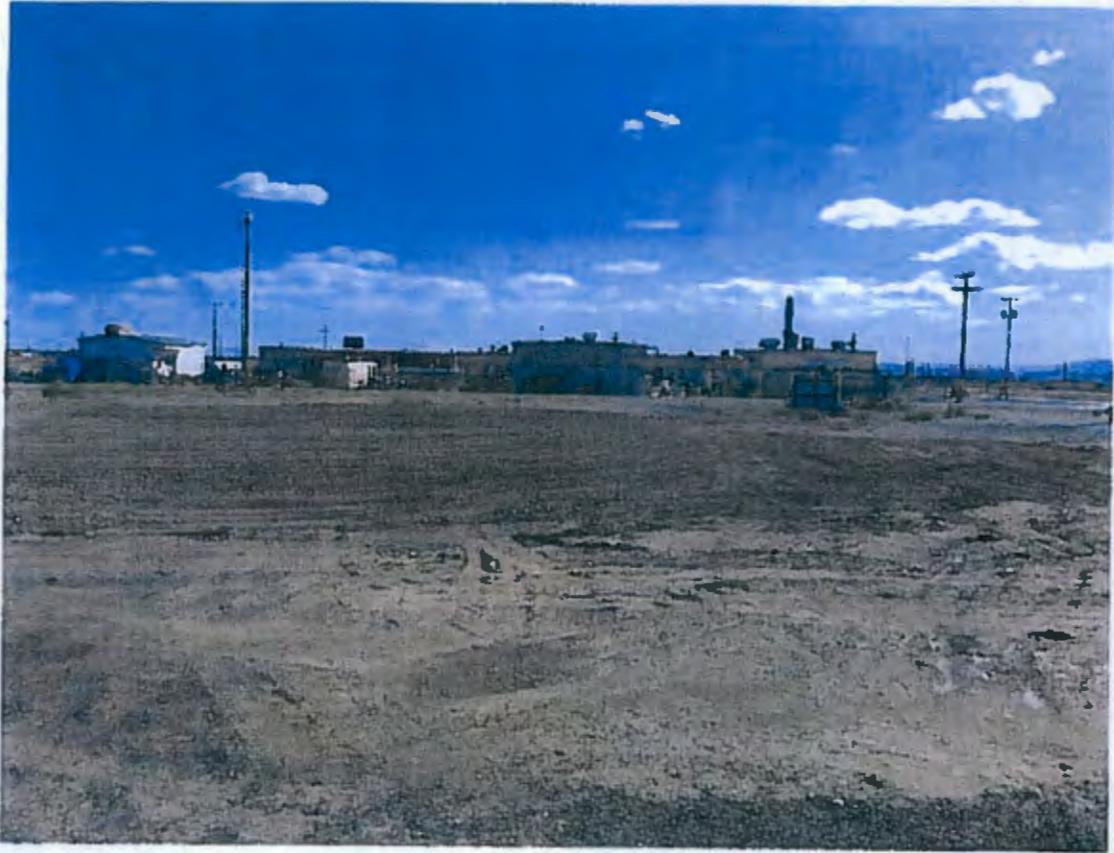
**Photograph 3. 352F Site Completion following backfill,
looking south, September 11, 2014.**

The 352F cable vault walls were removed to 3 feet below-grade, with the remaining portion of the structure backfilled in place. No GPERS surveys were conducted as the facility was not radiologically contaminated and it was located outside of the 300 Area Underground Radioactive Material Area. The excavation was evaluated before backfill, no anomalies noted. No postings remain following backfill and site completion.

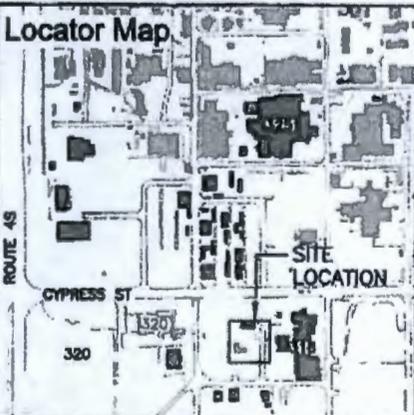
300 Area GPS Survey for 352F Cable Vault

POINT NO.	EASTING	NORTHING
1	593924.36	115469.07
2	593924.26	115459.03
3	593929.38	115459.13
4	593929.17	115469.17

Estimated Horizontal Precision: 0.10m
 US State Plane 1983
 Zone: Washington South 4802;
 NAD83; Units are in Meters

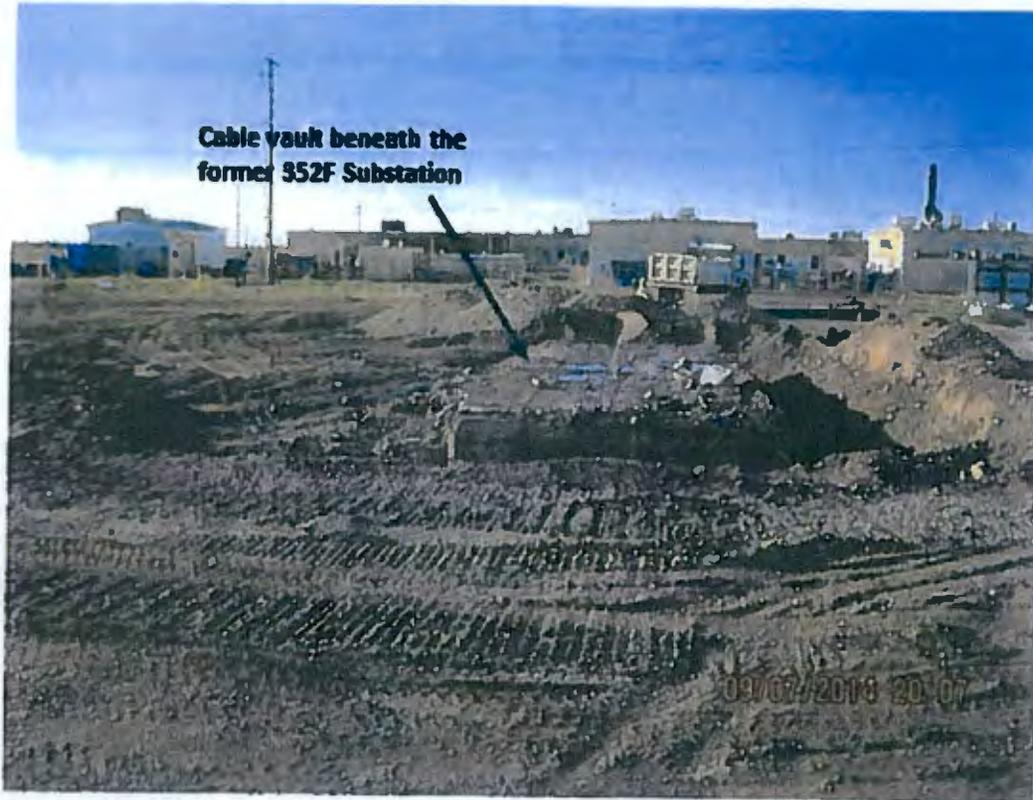
**Figure 2. 352F Cable Vault following above-grade demolition,
looking south, September 8 2014.**

Following above-grade demolition, the 352F cable vault will be demolished to 1 to 3 feet below grade with the balance of structure being left in place. The vault contained no hazardous materials (to include PCB containing items) nor is it associated with, or in the proximity of, a waste site. Two transformers located outside the facility did contain PCB oils, but below 50 parts per million. The transformers were drained in 2006 and were subsequently recycle. The transformers showed no signs of leaking upon removal. In addition, there were no process operations that resulted in a release to the environment from facility operations (e.g., electrical distribution). Only electrical cable remains in the vault. No process sewer piping serviced the building as well and the former facility was located outside of the 300 Area Underground Radioactive Material Area. An inspection of adjoining soils following above-grade demolition identified no anomalous conditions or soil staining.

The final configuration of the 352F cable vault will consist of walls and floor. The vault walls will be removed 2 to 3 feet below grade to facilitate backfill and meet Site Completion standards in Section 2.5 of the *Removal Action Work Plan for 300 Area Facilities*, DOE/RL-2004-77, Rev. 2. This configuration will be documented on a Facility Status Change Form provided to EPA and DOE for approval.
