FACILITY STATUS CHANGE FORM

Date Submitted: Aug 7, 2012 Originator: David Warren Phone: 539-6040	Area: 100-N Facility ID: 105-ND Remote and Local Air Intakes Action Memorandum: General Hanford Decommissioning Activities	Control #: D4-100N-0040
--	--	-----------------------------------

D4 Project Facility Completion Form

105-ND Local Air Intake and Remote Air Intake Facility Completion

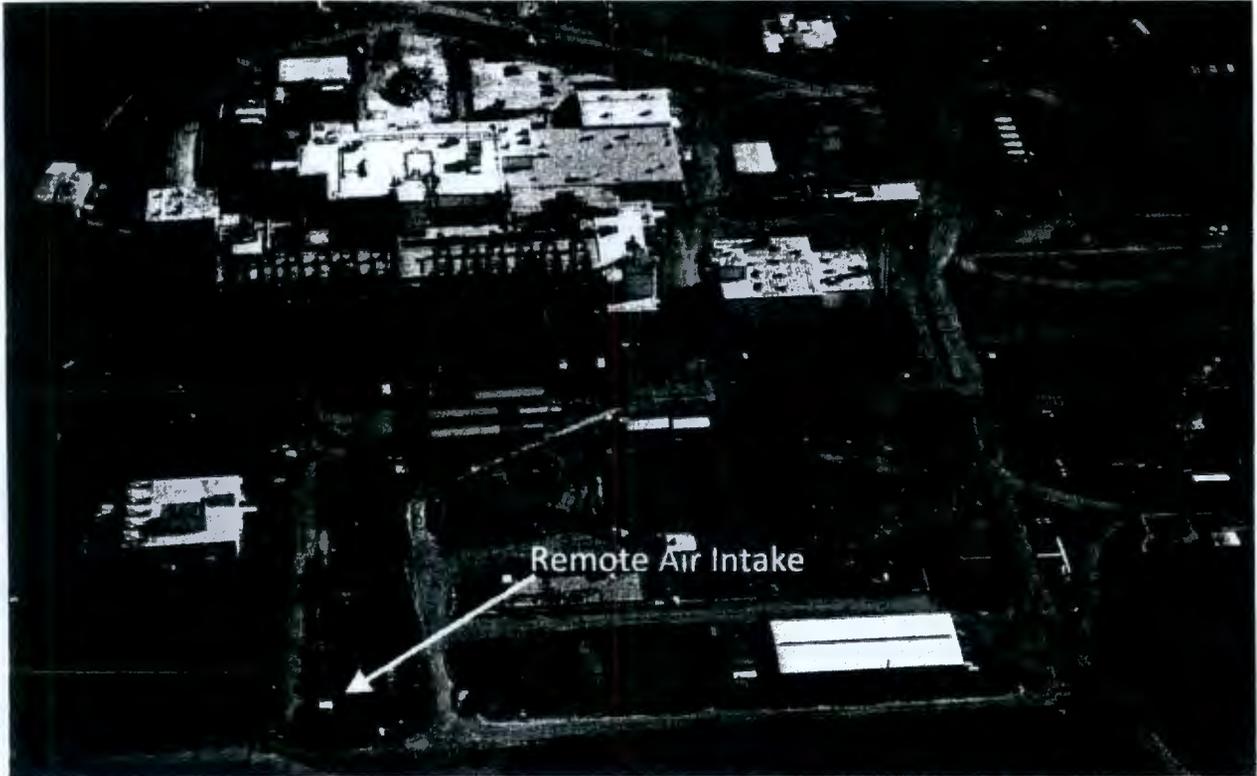
105-ND Remote Air Intake Pre-Demolition

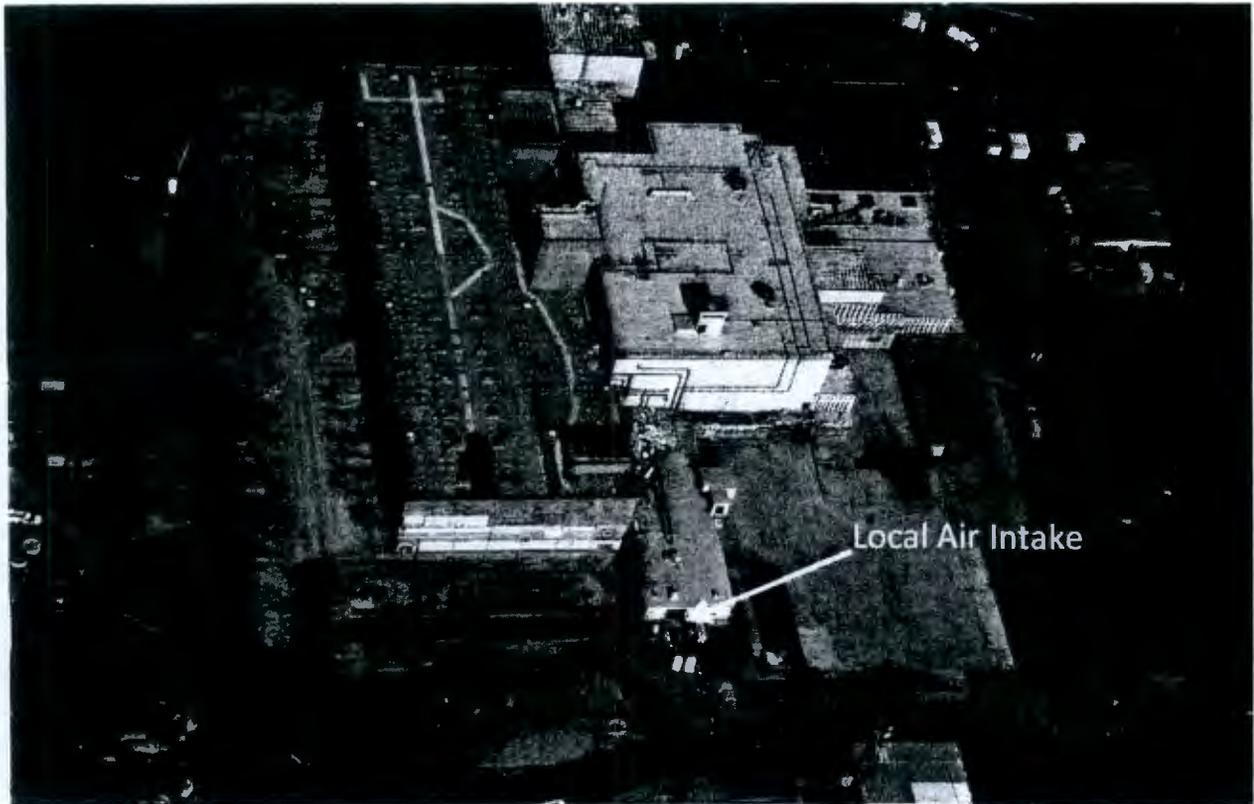
105-ND Local Air Intake Pre-Demolition

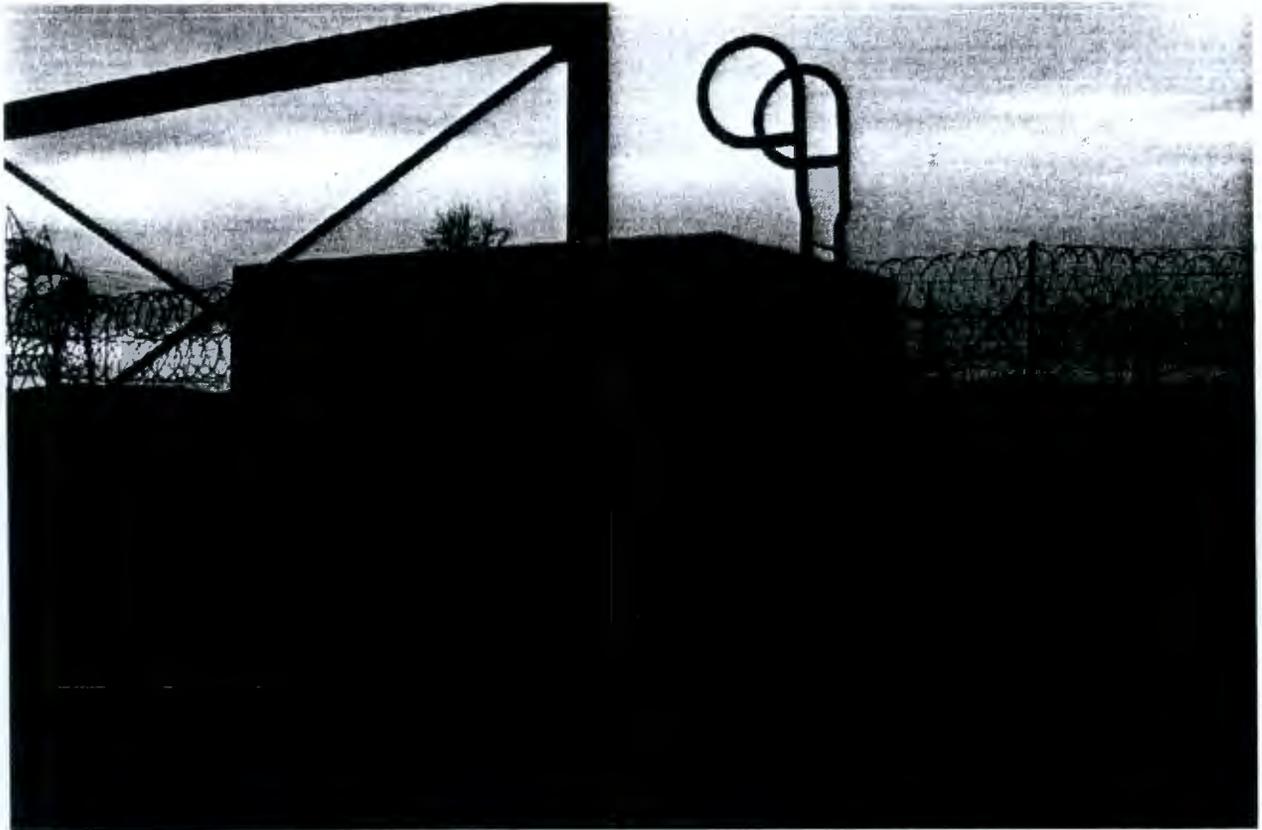
105-ND Remote Air Intake Pre-Demolition

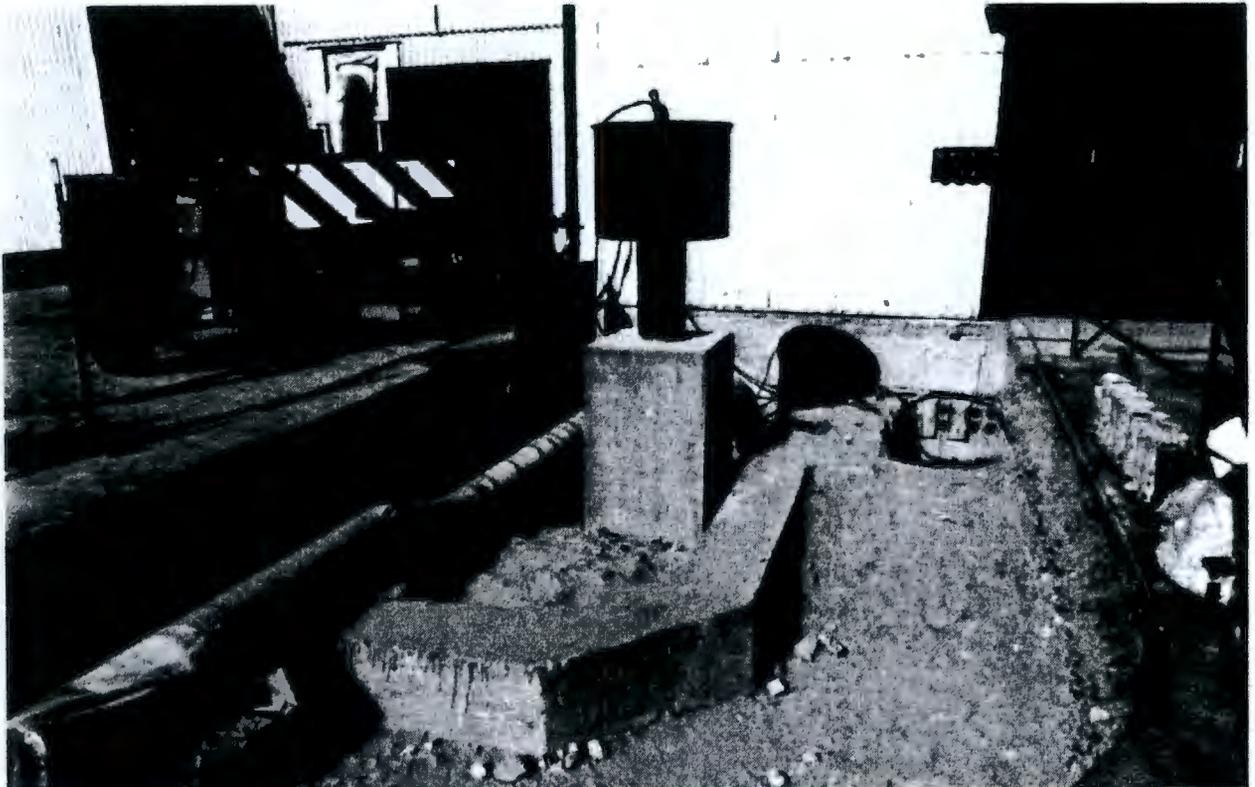
105-ND Local Air Intake Pre-Demolition

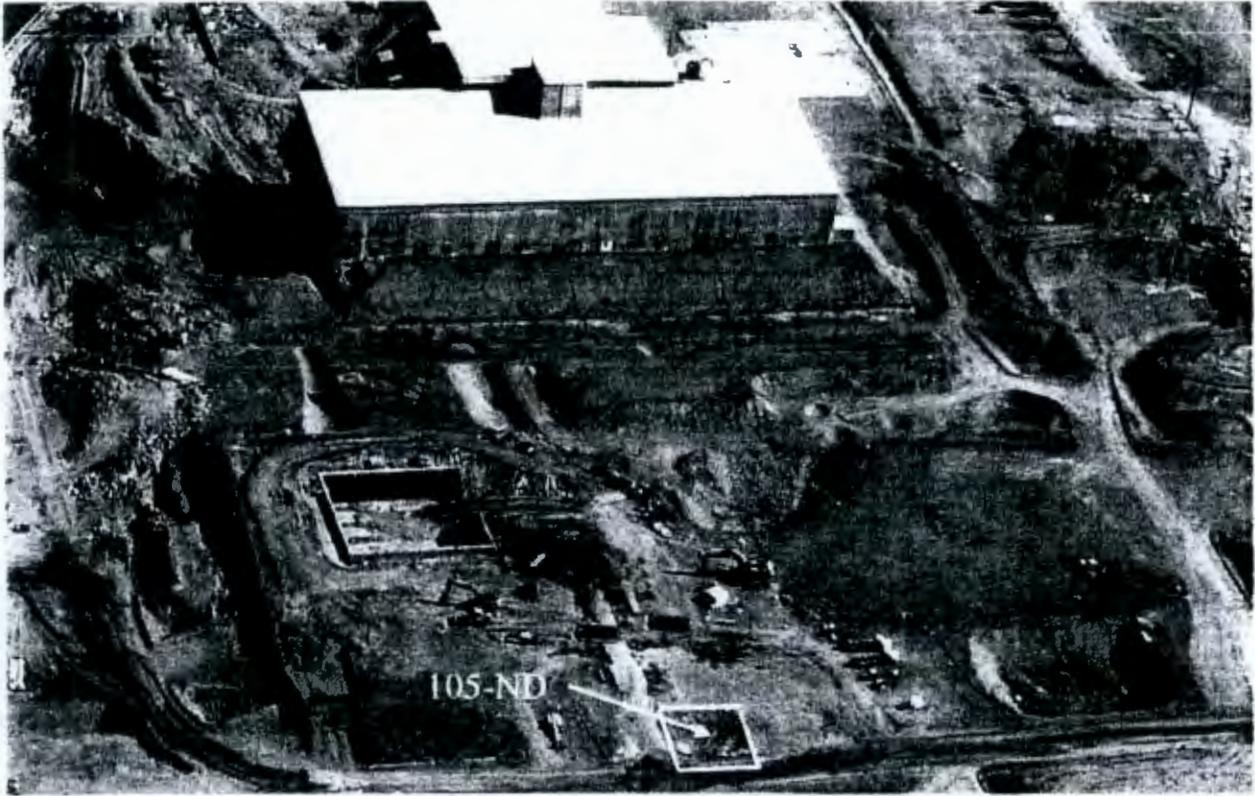
105-ND Remote Air Intake Post-Demolition

The 105-ND Remote Air Intake was excavated, demolished, and disposed of at the ERDF. A visual inspection of the excavation was made to identify any soil staining and Global Positioning Environmental Radiological Surveyor surveys were performed to document that no radiological contamination was present in the resulting excavations. A global positioning system (GPS) civil survey was performed to document the extent of the depression prior to the sites being backfilled and graded to match the surrounding terrain.

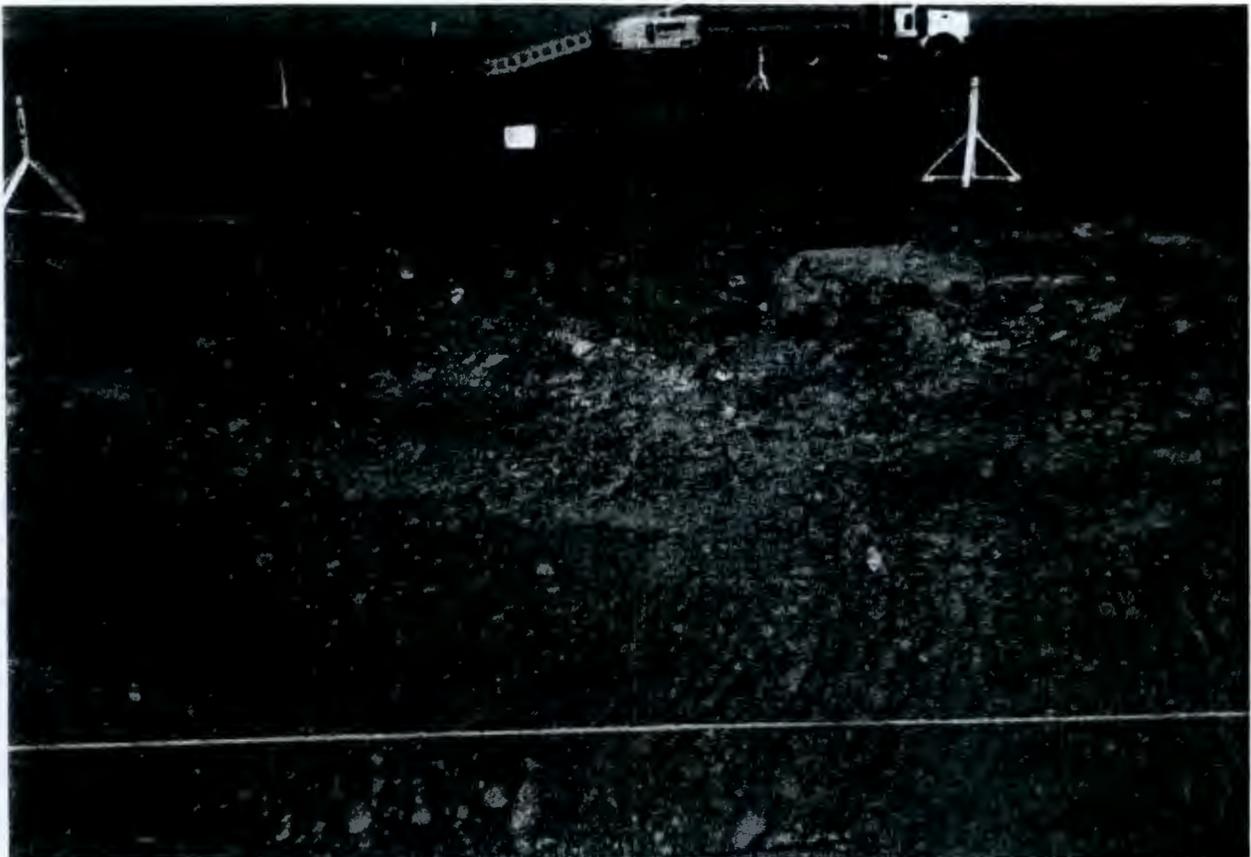
105-ND Remote Air Intake Post-Demolition (Looking West)

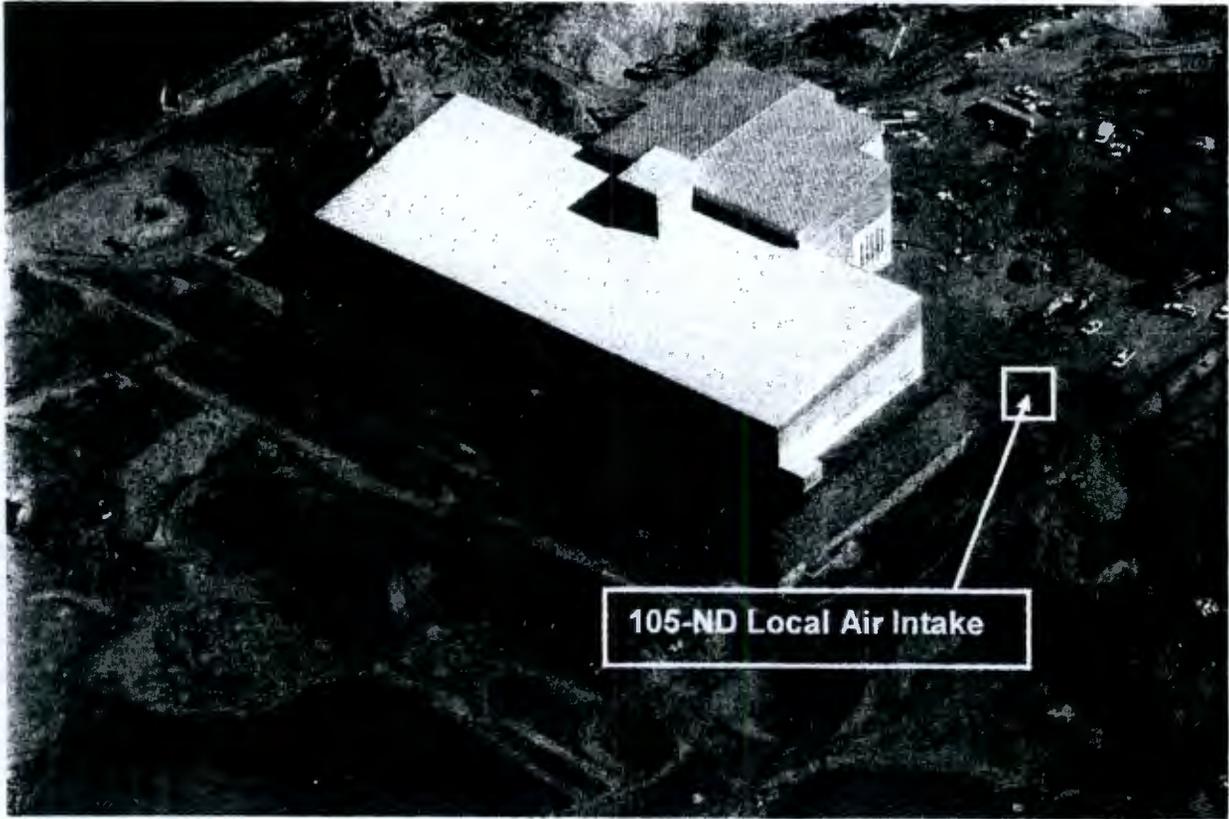
105-ND Local Air Intake Post-Demolition

The 105-ND Local Air Intake was excavated, demolished, and disposed of at the ERDF. A visual inspection of the excavation was made to identify any soil staining. A GPS civil survey was performed to document the extent of the depression prior to the site being backfilled and graded to match the surrounding terrain.

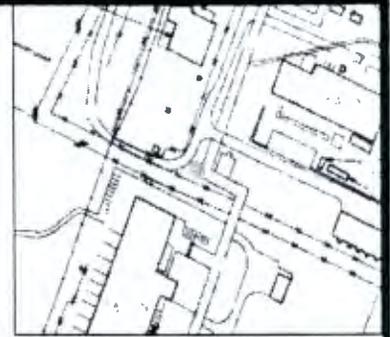
**100N D4
105-ND Intake
GPERS Radiological Survey
Gamma Track Map**

Legend	Summary Statistics
NET CPM	Coverage File: N109
	Number of Data Pnts: 244
	Type of Survey: gamma
● <2440	Max GCPM: 2012
● 2440 - 5000	Avg Bkg CPM: 1627
● 5000 - 10000	Survey Date: 4/18/2012
● 10000 - 25000	Area Surveyed: 45 m ²
● 25000	Project File: ESRFRM120053G
	Pdf File: ESRFRM120053GC

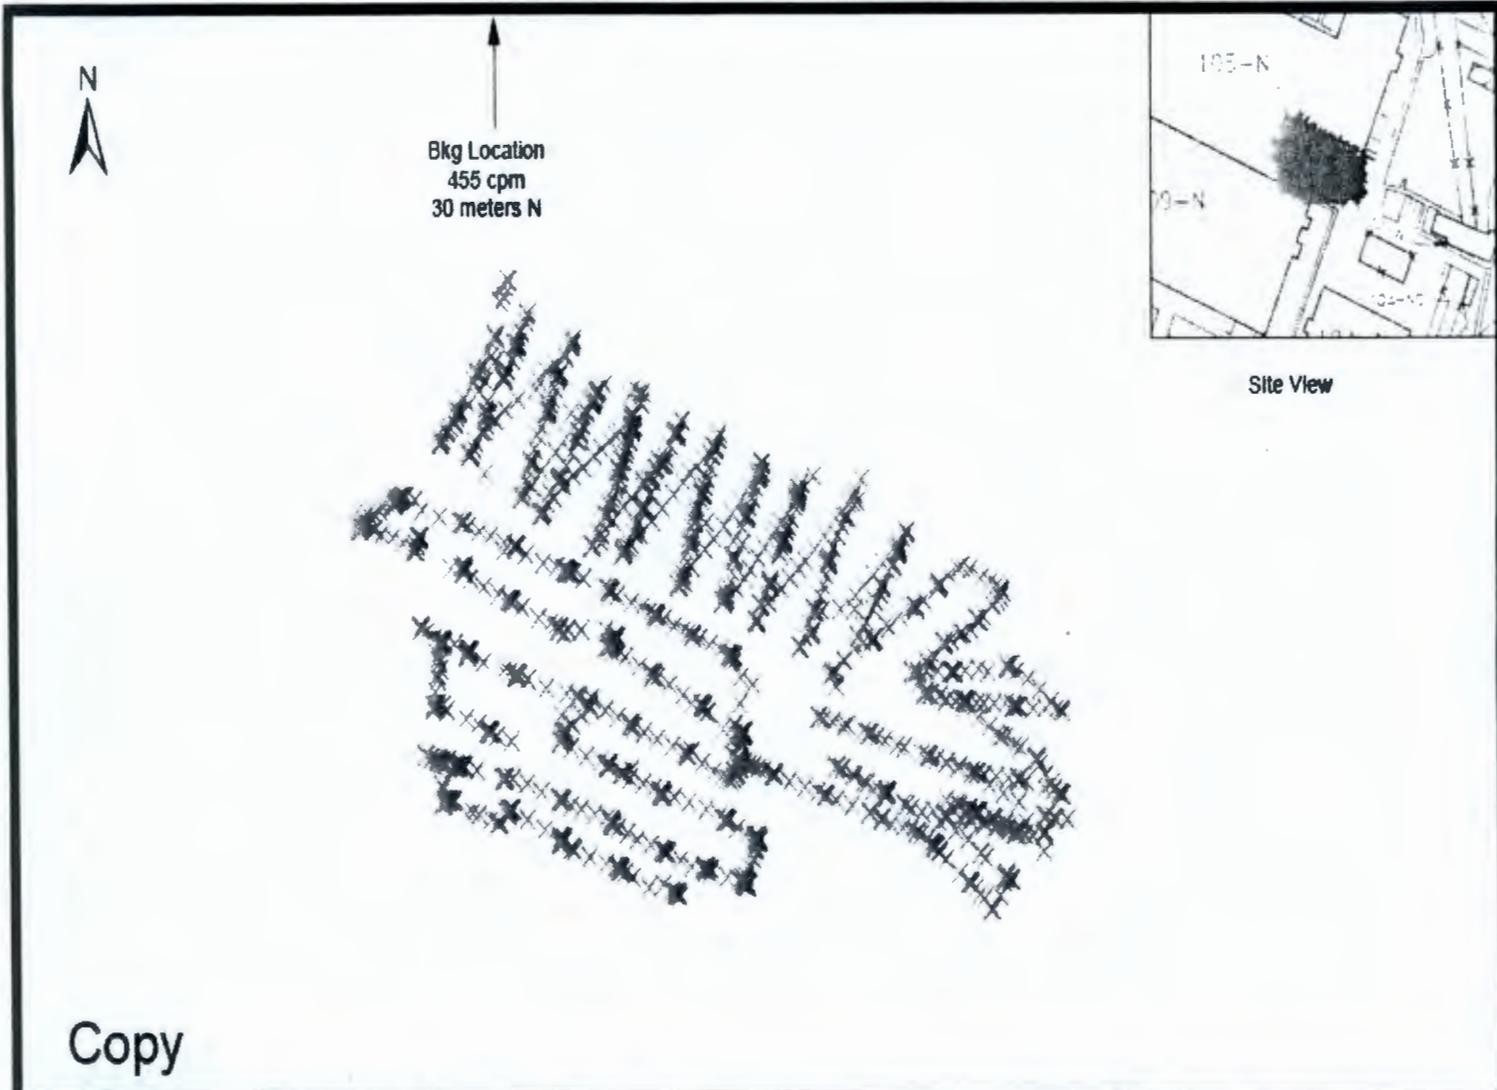
100N Field Remediation
105-N Control Room
GPERS Radiological Survey
Beta Track Map

Legend	Summary Statistics
NET CPM	Coverage File: N322A
	Number of Data Pnts: 2139
	Type of Survey: Beta
X < 910	Max GCPM: 1133
● 910 - 5000	Avg Bkg CPM: 455
● 5000 - 10000	Survey Date: 11/18/2009
● 10000 - 25000	Area Surveyed: 134 m ²
● > 25000	Project File: N322A
	Pdf File: ESRFRM0901738C

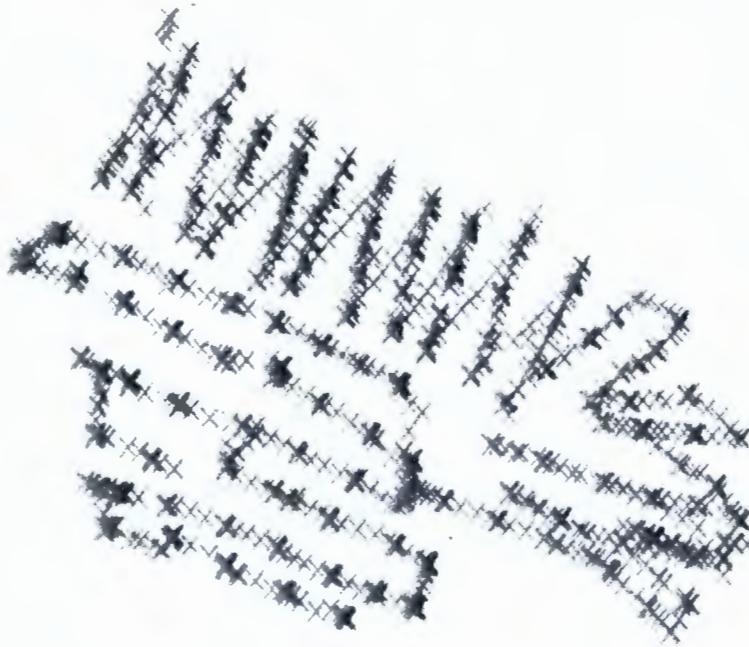
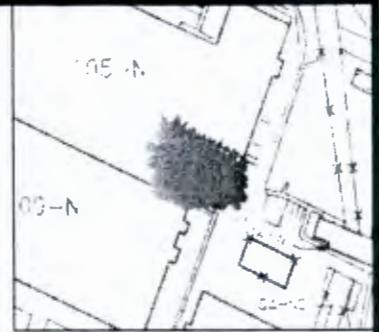
**100N Field Remediation
105-N Control Room
GPERS Radiological Survey
Gamma Track Map**

Summary Statistics
Coverage File: N322A
Number of Data Pnts: 2139
Type of Survey: 'Gamma'
Max GCPM: 2289
Avg Bkg CPM: 1236
Survey Date: 11/18/2009
Area Surveyed: 134 m²
Project File: N322A
Pdf File: ESRFRM090173GC

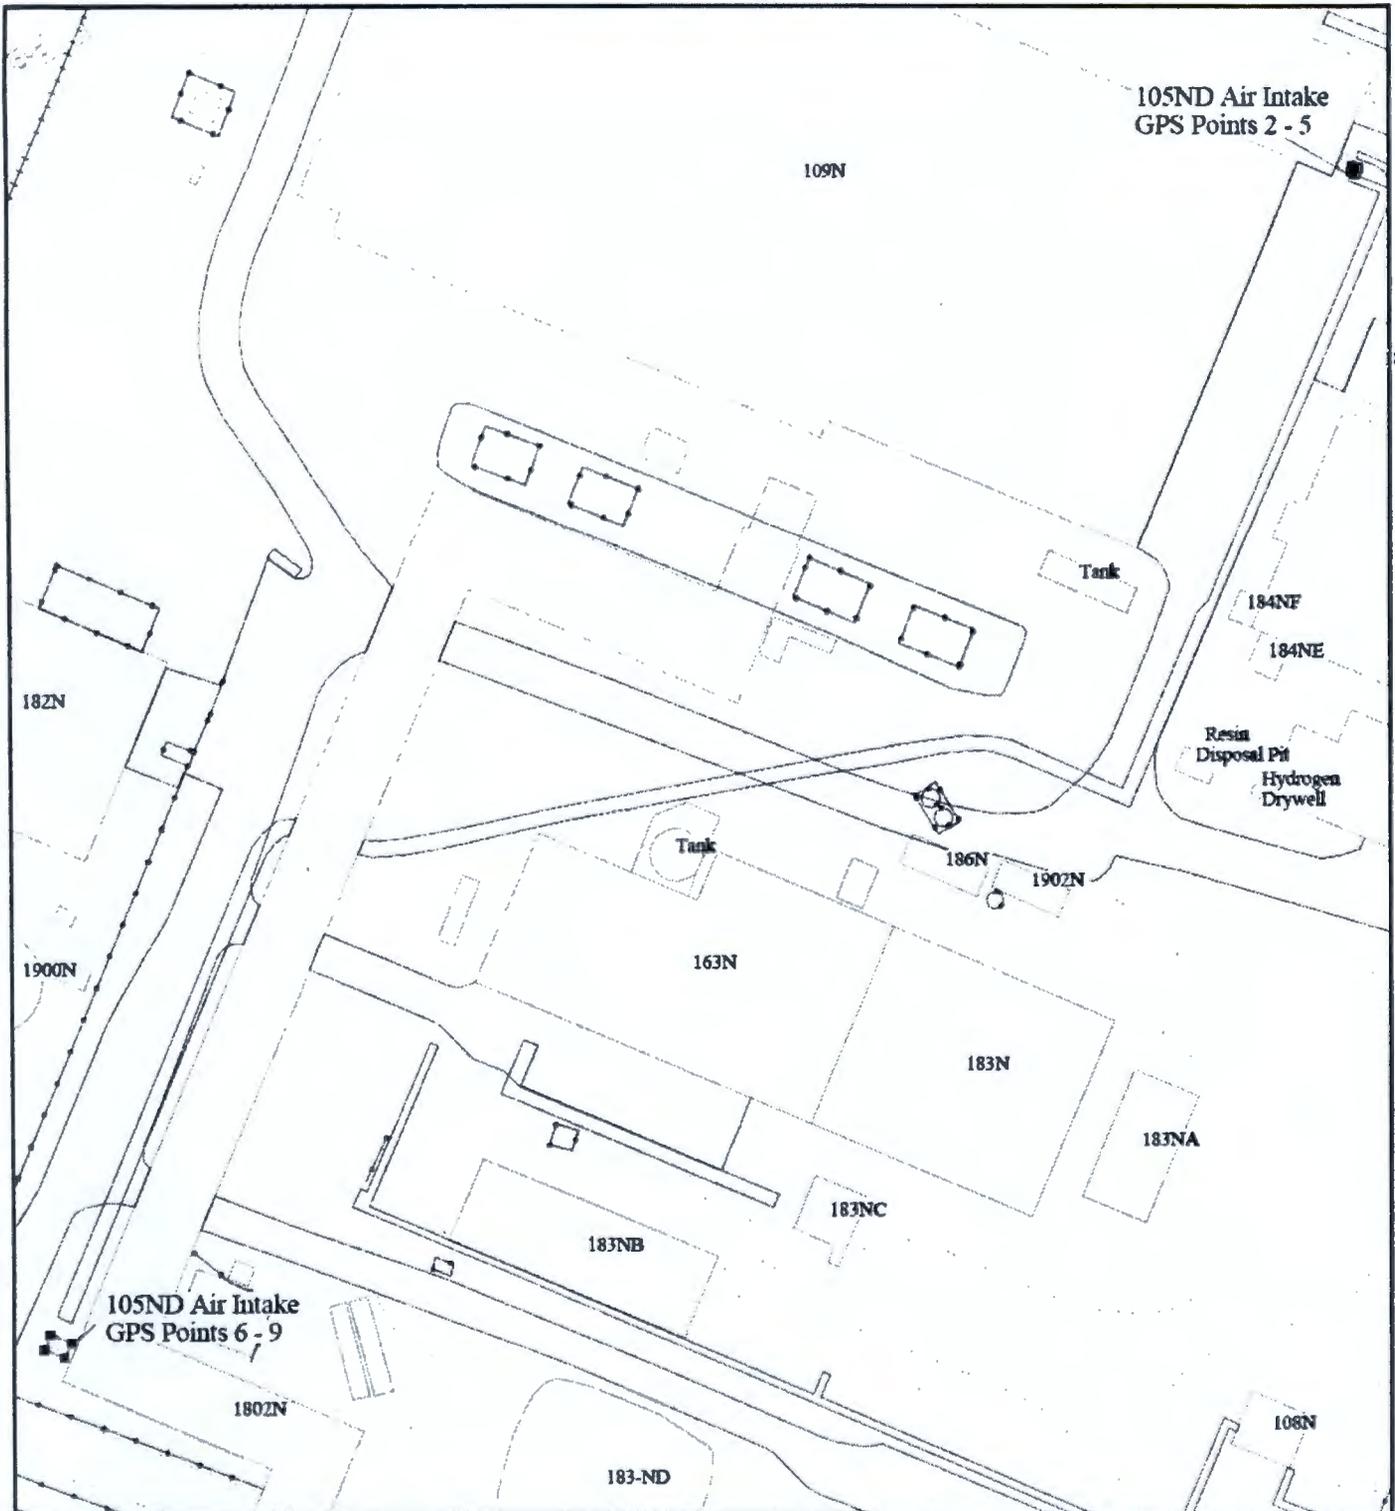
Pre- Demolition Survey of The 105ND Air Intake

GPS Locations for 105ND
- See GPS Survey Report for Coordinate Information

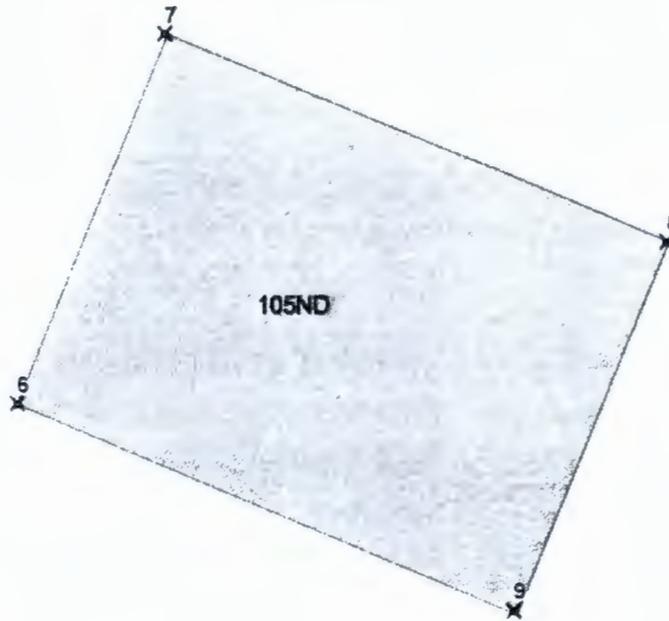
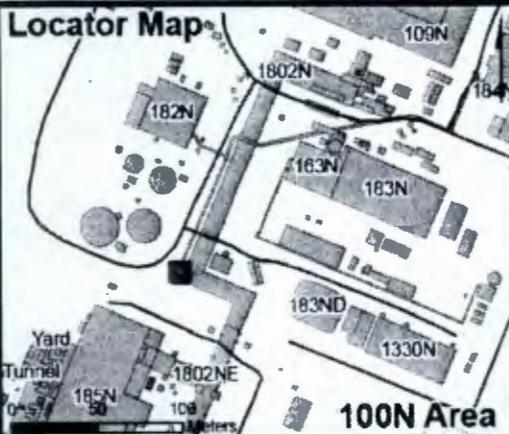
GPS Pre Demo Survey Report For 105ND Building

Name	Feat_Code	Northing	Easting	Elevation
6	corner	149285.689	571072.438	139.166
7	corner	149287.924	571073.344	139.075
8	corner	149286.657	571076.347	139.165
9	corner	149284.44	571075.416	139.129

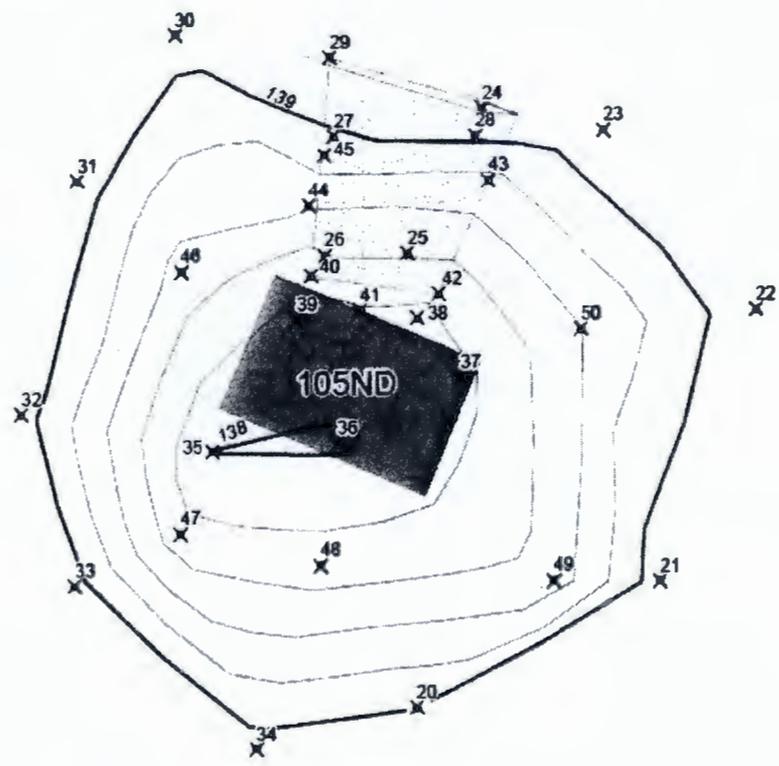
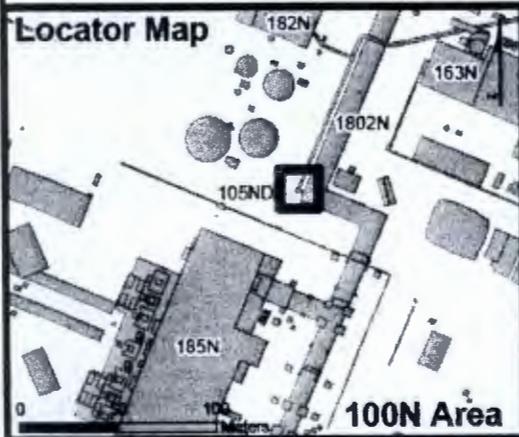
GPS Post Demo Survey Report For 105ND

Notes: This excavation had a large concrete footing with in it.
