FACILITY STATUS CHANGE FORM

Date Submitted: February 20, 2014 Originator: Chris Strand Phone: 554-2720	Area: 300 Area Facility ID: 340 Action Memorandum: Action Memorandum #3	Control #: D4-300-096
--	---	---------------------------------

340 Waste Neutralization Facility

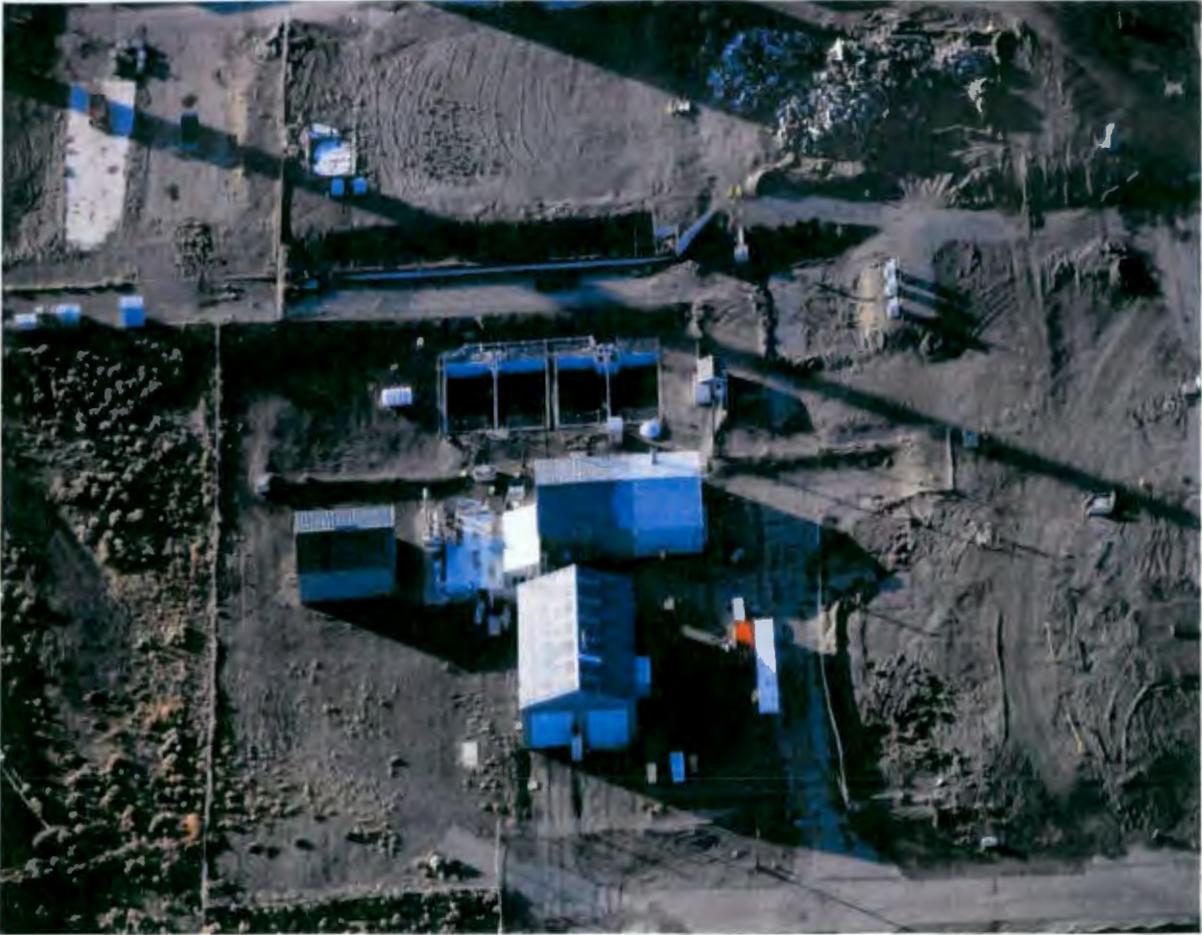
Photograph 1: Aerial photograph of the 340 Complex, looking south on October 22, 2009.

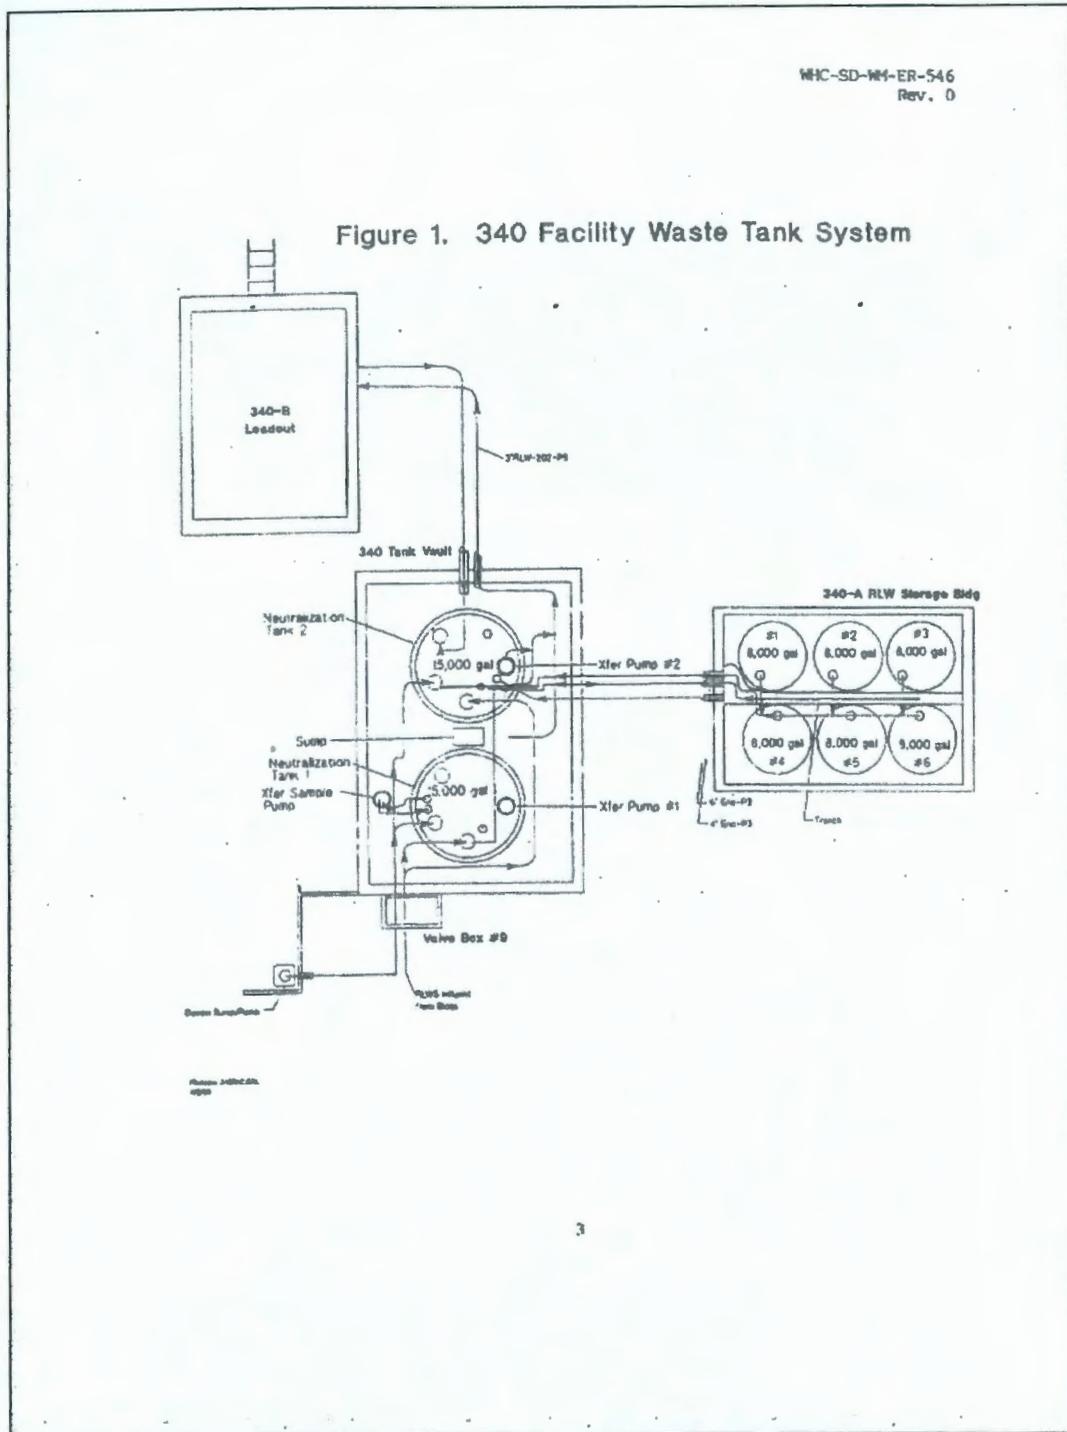
Figure 1: 340 Complex tank system layout showing relation of the 340 vault to other complex facilities.

The concrete vault that enclosed the two tanks was 38 by 25 by 25 ft with removable shielding cover blocks and access holes. The two tanks within the vault were of a nominal 15,000 gallon capacity each and were serviced by a network of piping that connected the 340 facility with upstream generating laboratories and the 307 retention basins. Above-grade penthouses allowed controlled entry to the tank vault and the associated valve pit. The vault and vault tanks had a common exhaust system that discharged through two-stage HEPA filters and two exhaust fans. Charcoal filters were later added to control the potential Iodine-131 releases.

The 340 facility was supported by process operations at 340A, 340B, and 307 retention basins. 340A, 340B, and 307 were demolished and loaded out as part of the overall 340 Complex removal action (reference Facility Status Change Forms D4-300-054, D4-300-051, and D4-300-058, respectively).

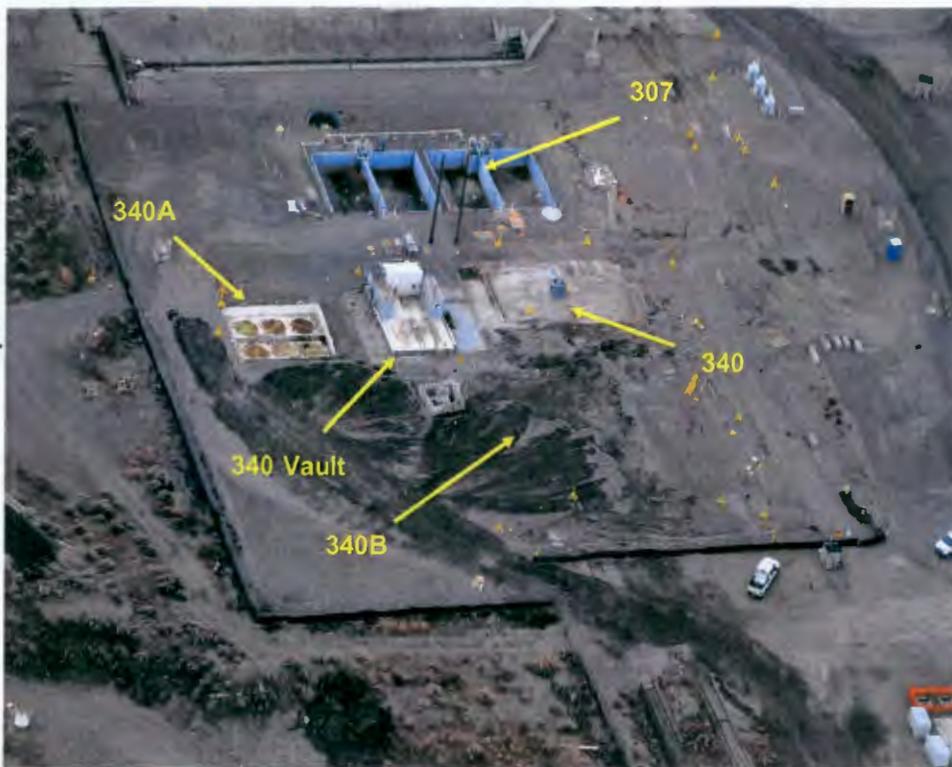
Photograph 2: Aerial photograph of the 340 Complex following above-grade demolition, looking southeast in October 2012.

Demolition of the 340 above-grade structure was completed in November 2011. Demolition of the below-grade structures was completed with removal of the 340 vault in February of 2014. The debris was removed and disposed of at ERDF.

Above-grade demolition of the 340 Waste Handling Facility was completed in November 2011. Below-grade demolition, including vault (with tanks) removal was completed in February of 2014. Specifically, the vault was transported out of the excavation on February 13, 2014.

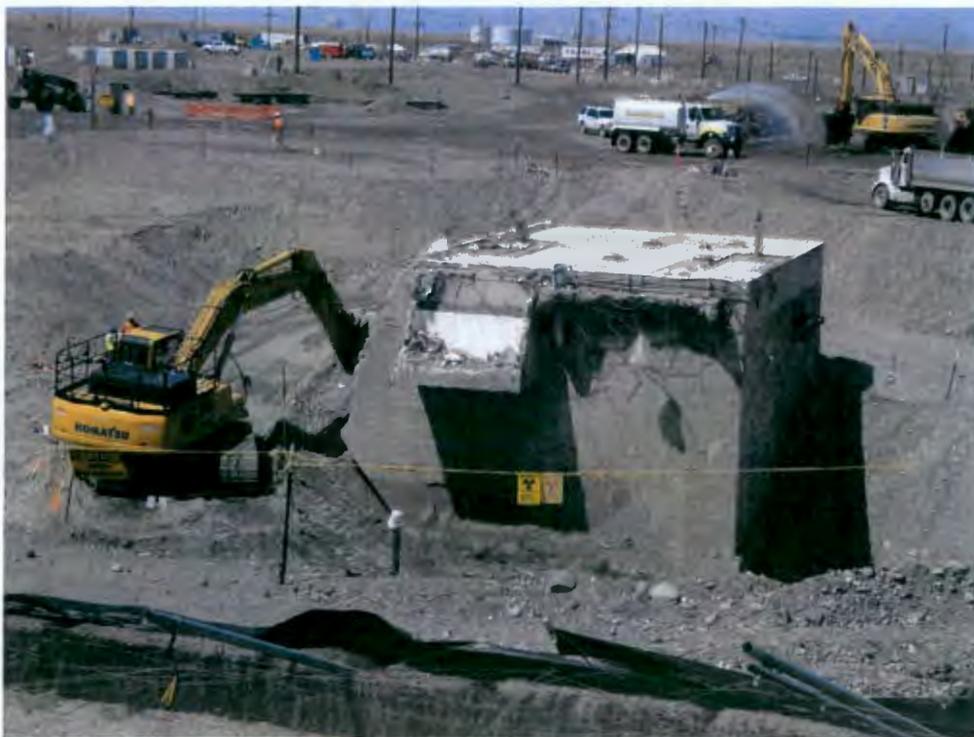
Photograph 3: 340 Vault during remediation excavation looking north on July 17, 2012

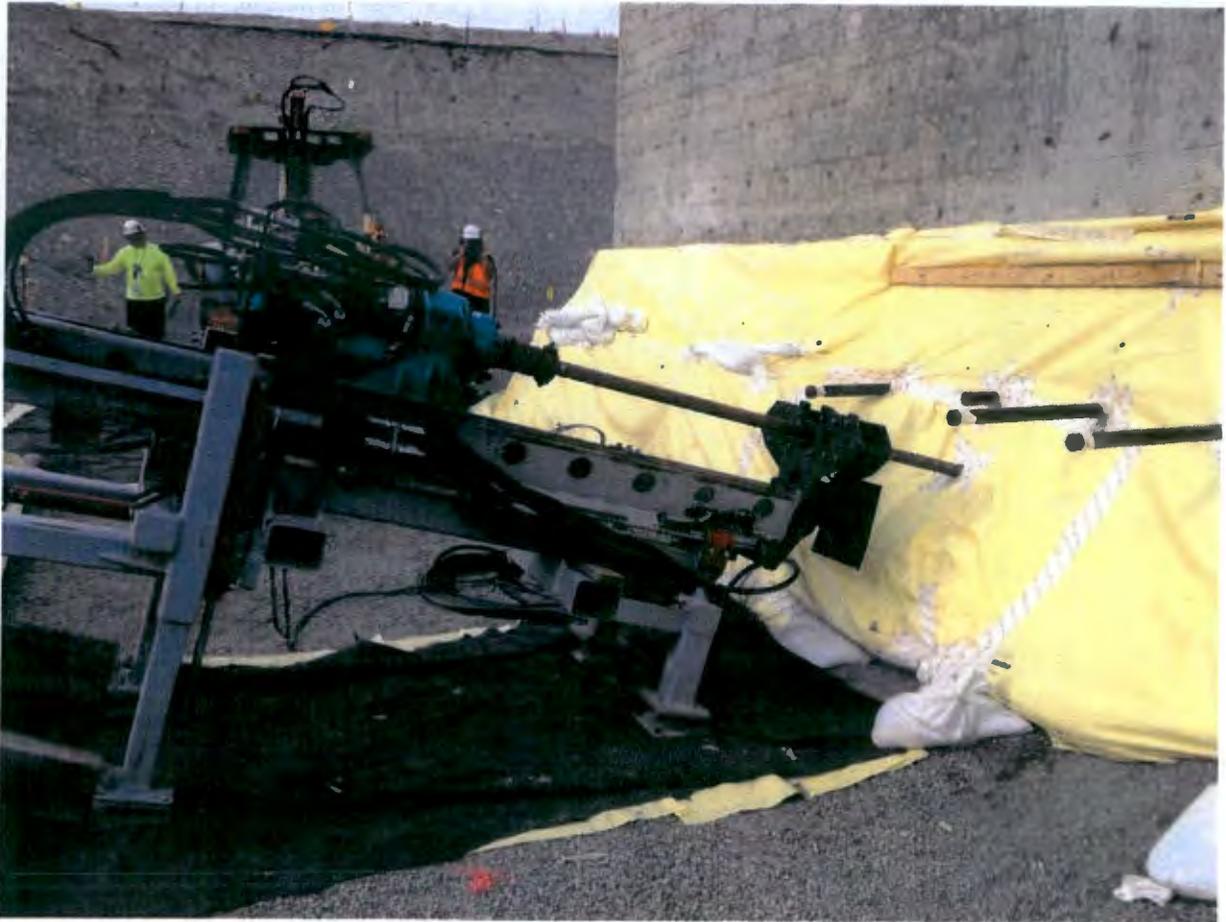
Photograph 4: Geo-Probe placement beneath vault, looking south on May 16, 2013.

Following discovery of highly contaminated soils beneath the 340 vault (reference Anomalies section below), an additional six (6) direct push environmental investigation wells were installed underneath the vault. Four were installed horizontally and two were installed at a 7.5 degree and 15 degree angle respectively. Radiological instruments were then inserted to measure dose and verify the spatial extent of the contaminated soil.

These six additional wells were assigned the following identification numbers:
C8831, C8832, C8833, C8834, C8835, C8836

All six investigation wells were entirely removed during the excavation of soils beneath the 340 vault that were associated with installation of shoring caissons and lift beams.

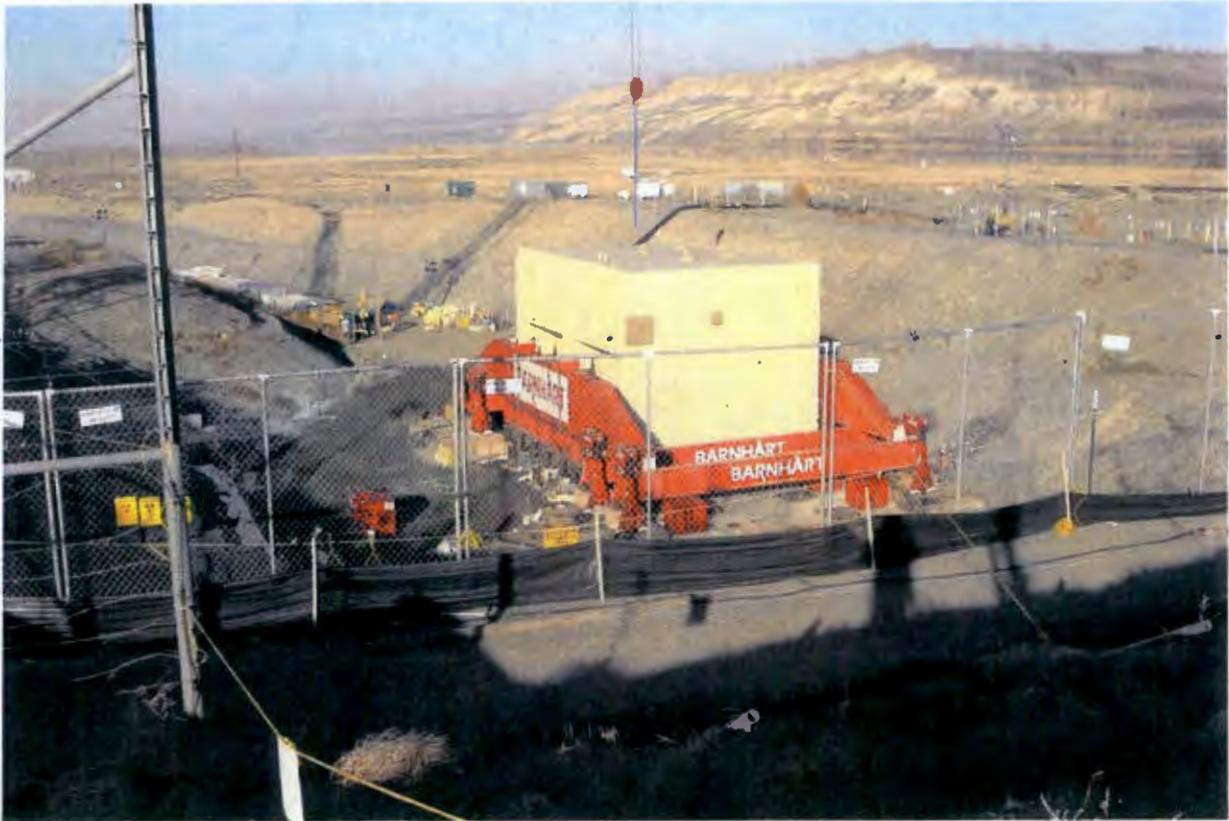
Photograph 5: 340 Vault on lift assembly, looking northeast on January 16, 2014.

During placement of shoring caissons underneath the 340 vault, highly contaminated soil was encountered approximately under the center of the structure. Additional controls were necessary to prevent the spread of contamination and protect workers. These controls included use of disodium phosphate amended dust suppression water to mitigate potential migration of Sr-90 to ground water. The majority of the contaminated soil was removed during placement of shoring caissons and lift beams. Residual contamination remaining in the soil beneath the vault location will be removed as part of ongoing 340 Complex waste site remediation. Therefore, no GPERS surveys were conducted at this time.

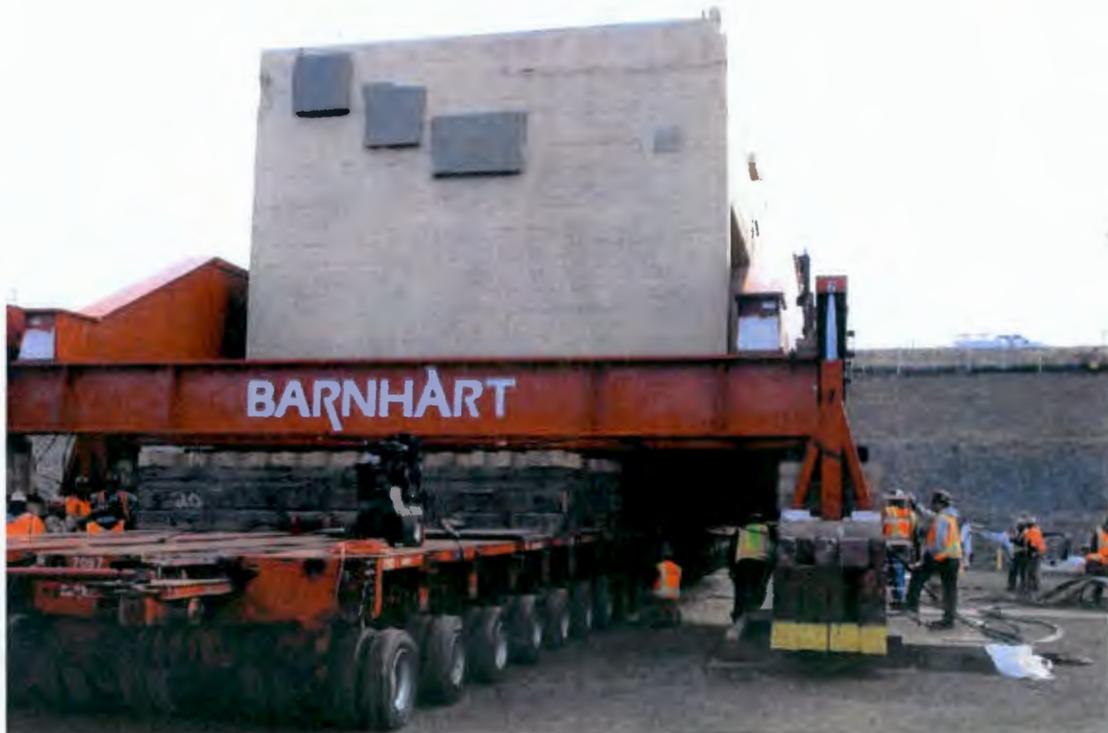
Photograph 6: 340 Vault during loading on the transport trailer, looking south on January 31, 2014

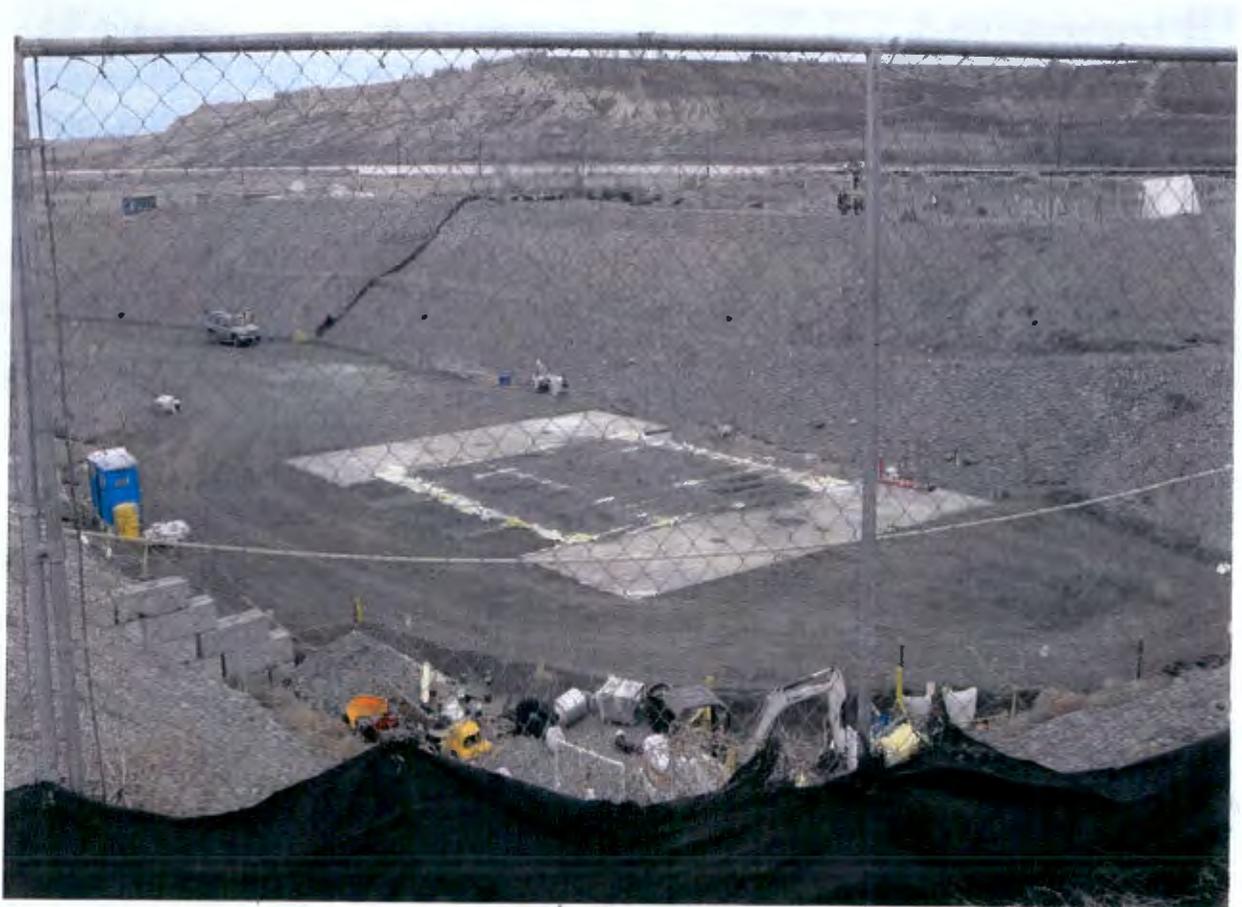
Photograph 7: 340 Vault excavation following vault transport to ERDF, looking northeast on February 18, 2014

The excavation remains open and radiologically posted as remediation of 340 Complex waste sites continue. No GPERs surveys were conducted as close-out surveys and verification sampling will be performed in accordance with the 300-FF-2 Final Action ROD.
