WCH-447

# **River Corridor Closure Contract**

## **300 Area D4 Project Fiscal Year 2010 Building Completion Report**

**Washington Closure Hanford**

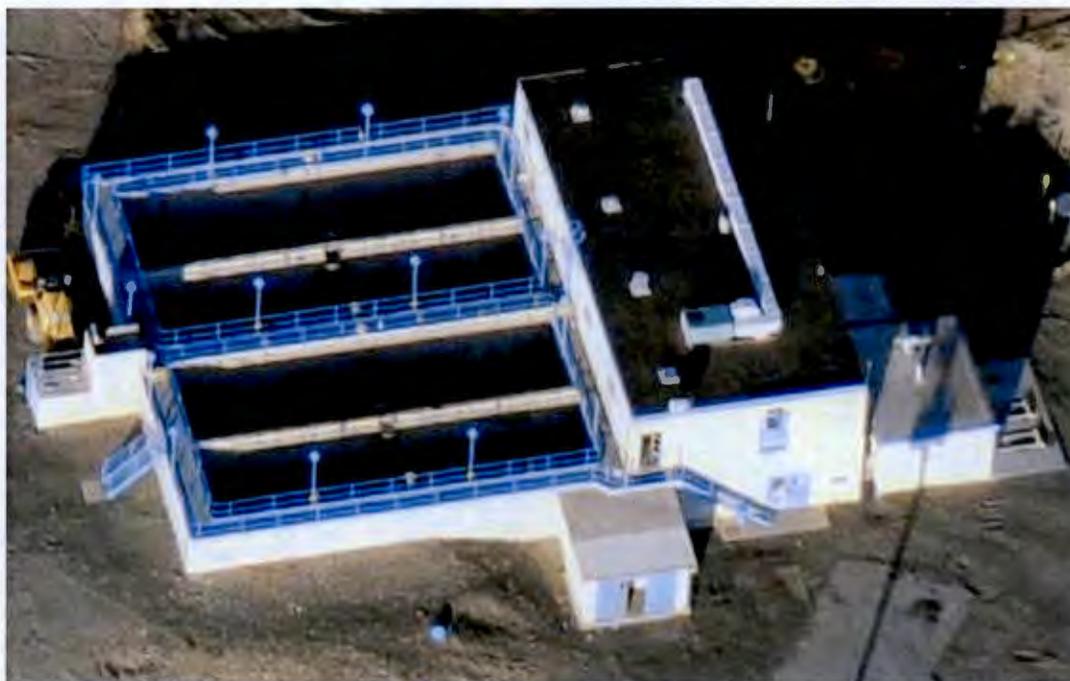
**Figure 1. 315 Water Filter Plant**

The 315 Water Filter Plant was a 65 ft by 94 ft structure constructed of reinforced concrete and concrete block. The facility included the main 315 Building and two annexed concrete/concrete block structures: the 315A Transformer House located on the eastside of the 315 Building, and the 315B Chlorine Storage Facility located on the northeast corner of the 315 Building. The 315 Building had four clearwell sedimentation basins, four troughs, filter bank, alum storage tank (5600 gallons, estimated), small tanks, several pumps, motors and an extensive piping system. The 315B Building stored two, one-ton chlorine supply cylinders.

The 315 Water Filter Plant (315, 315A and 315B) was located on the north side of Locust Street in the southeast 300 Area about 370 feet west of the Columbia River. The facility originally supplied filtered cooling water to the 309 Plutonium Recycle Test Reactor, but was later modified to supply sanitary water for the entire 300 Area. Operation was discontinued in the mid 1990's when the 300 Area began receiving sanitary water from the City of Richland. The facility was transitioned to the WCH contract in August 2005.

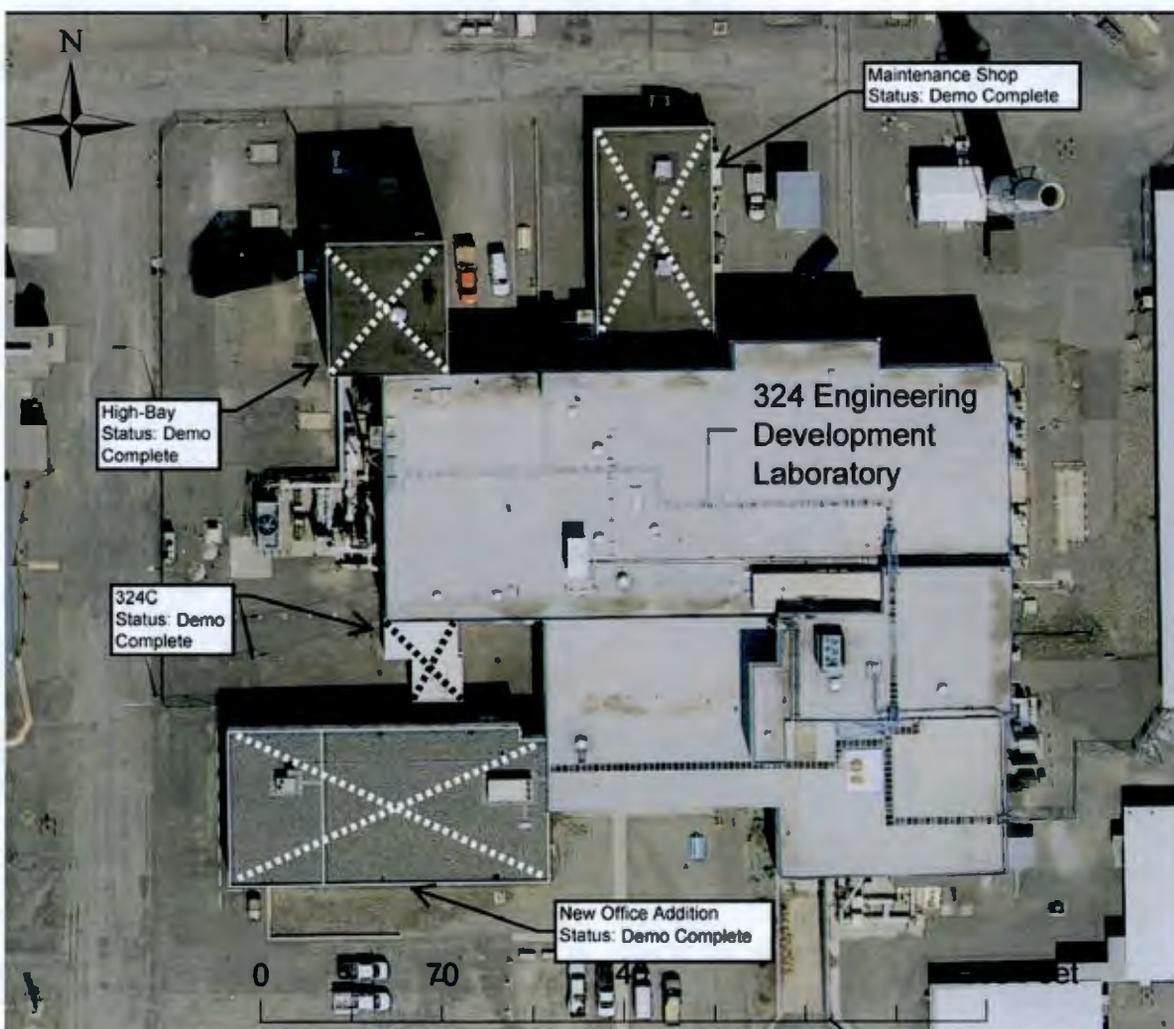
Figure 2. 324 Building Support Areas

The new office building (60 ft by 86 ft) was a two-story tilt-up concrete panel structure on a slab with built-up tar and gravel roof. The High-Bay Engineering Laboratory (45 ft by 50 ft), the maintenance shop (44 ft by 100 ft), and the 324C Experimental Lithium Enclosure (18 ft by 34 ft) were steel frame on slab with fluted steel panel siding and built-up tar and gravel roofing.

The 324 Building, known as the Engineering Development Laboratory, was completed in 1965. Four significant support areas were added to the building since its original construction: a new office addition, a High-Bay Engineering Laboratory, a maintenance/machining shop, and the 324C Experimental Lithium Enclosure. The 324 Complex was operated by Pacific Northwest National Laboratory (PNNL) until 1996, when the facility was transferred to B&W Hanford Company (BWHC) for interim operation and eventual stabilization and deactivation in preparation for building decommissioning. PNNL continued limited operations in the 324 Complex until October 1998. Responsibility for the building stabilization and deactivation was assumed by Fluor Hanford (FH) in September 1999 and then by Washington Closure Hanford (WCH) in August 2005. In FY2010, WCH demolished only the four support areas to the 324 Building. These areas did not contain any radiological contamination or chemical inventory.

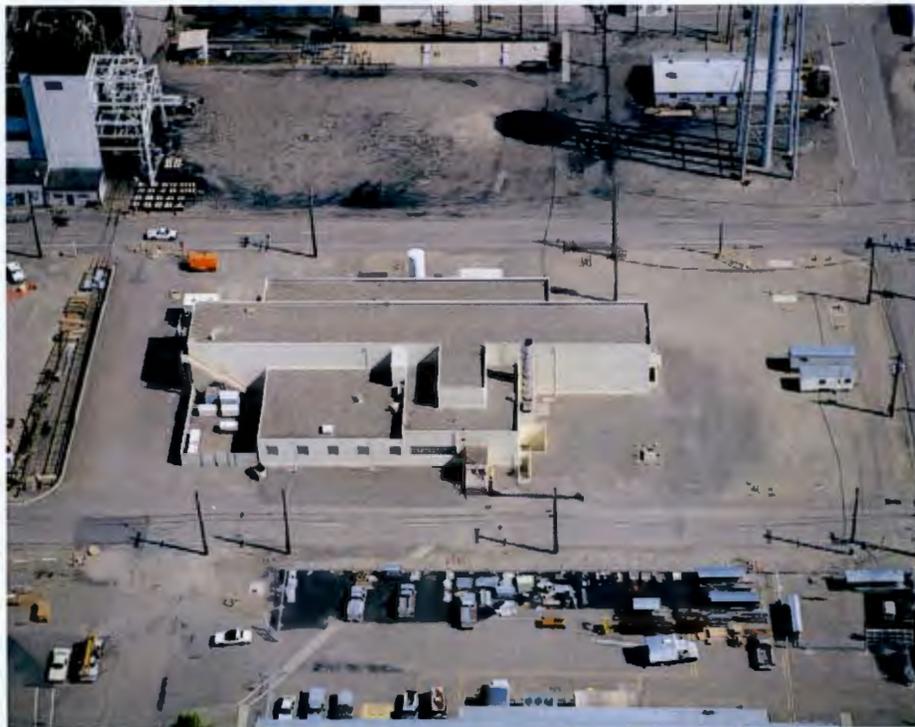
**Figure 3. 327 Post-Irradiation Test Facility**

The 327 Building was a single-story structure with a welded steel framework with a partial basement. Maximum dimensions were 215 ft by 140 ft and 32 ft in height. The total work area of the building was approximately 25,200 ft<sup>2</sup>. The slightly sloped roof was a steel deck with a 20-year built-up of tar and gravel. Exterior walls were insulated fluted-steel panels. The first floor was reinforced concrete or steel decking covered with concrete.

The 327 Facility performed its designed mission from 1953 to 1996. Services historically performed in the 327 Building included physical and mechanical properties measurement and testing, metrology, metallography, ceramography, auto radiography, fission product gas extraction and sampling, microdrill sampling, sampling for burnup and chemical analysis, encapsulation and disassembly of irradiated test modules, and encapsulation of irradiated structural materials for further irradiation testing. Irradiated fuels examined consisted primarily of fuel pins containing plutonium oxides and uranium oxides. Other fuel forms such as metals, carbides, and nitrides were handled occasionally. Examination, testing, and processing operations were carried out in the shielded cells equipped with viewing windows, manipulators, and special equipment.

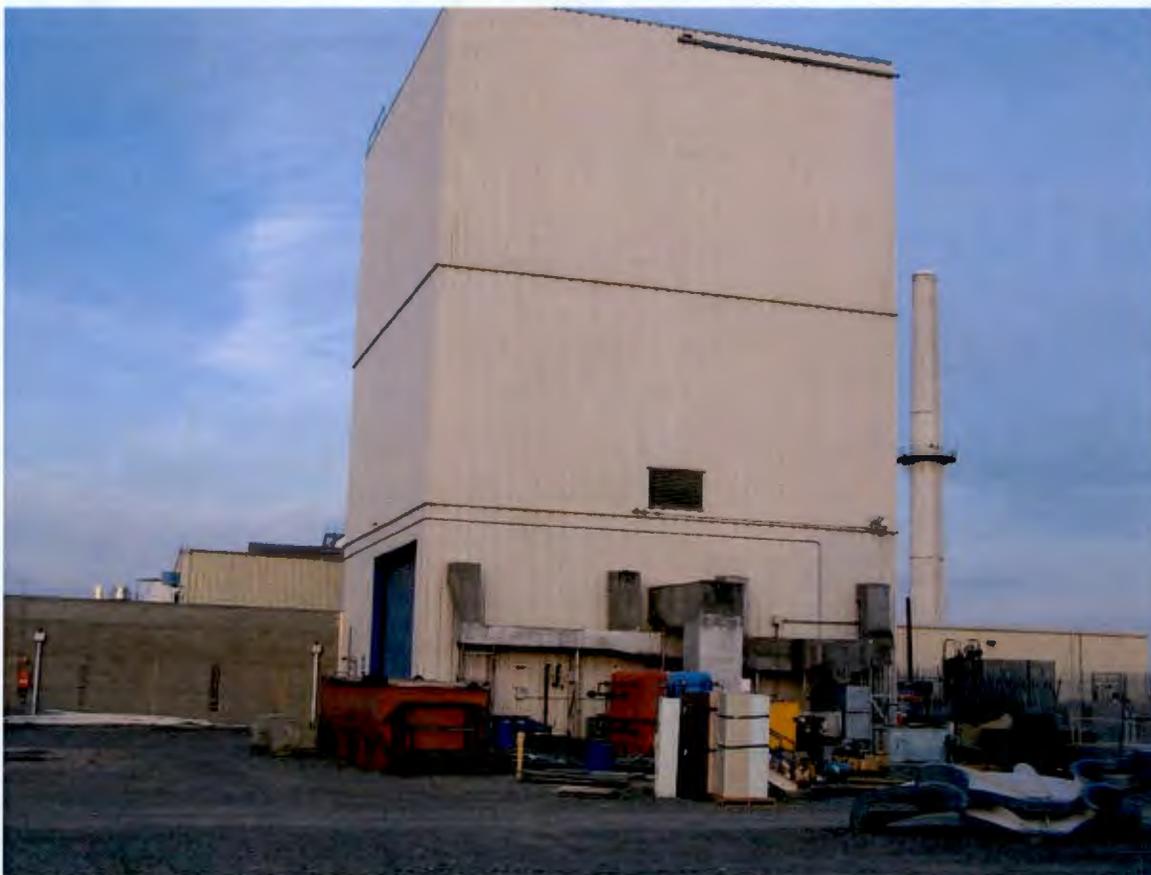
**Figure 4. 336 Core Segment Development Facility**

The 336 Building was constructed in 1969 on a concrete foundation with the dimensions of 50 ft by 50 ft by 65 ft in height. It was a steel-framed structure with insulated steel corrugated siding and a corrugated steel roof topped with gravel. The building also contained a 50 ft deep concrete lined pit which was located at the center of the high bay portion of the building with a truss-supported, steel-plate/grate floor cover. The pit had an approximately one-foot sump below the lowest level floor grates. The original structure contained a five-ton bridge crane, sodium storage vessel, argon supply tank, a computer room and various pieces of electronic

control equipment. A wet chemistry laboratory addition was constructed (two wet laboratories, common area and restrooms) to the building, consisting of concrete masonry units containing steel-studded, gypsum board-covered interior walls and vinyl ceiling tiles.

The 336 Building was located on Locust Street in the east side of the 300 Area. The building was originally constructed to house experimental equipment for the study of the properties of sodium. It was known as the Core Segment Development Facility and supported Fast Flux Test Facility (FFTF) developmental studies. WCH took possession of the facility in September 2008.

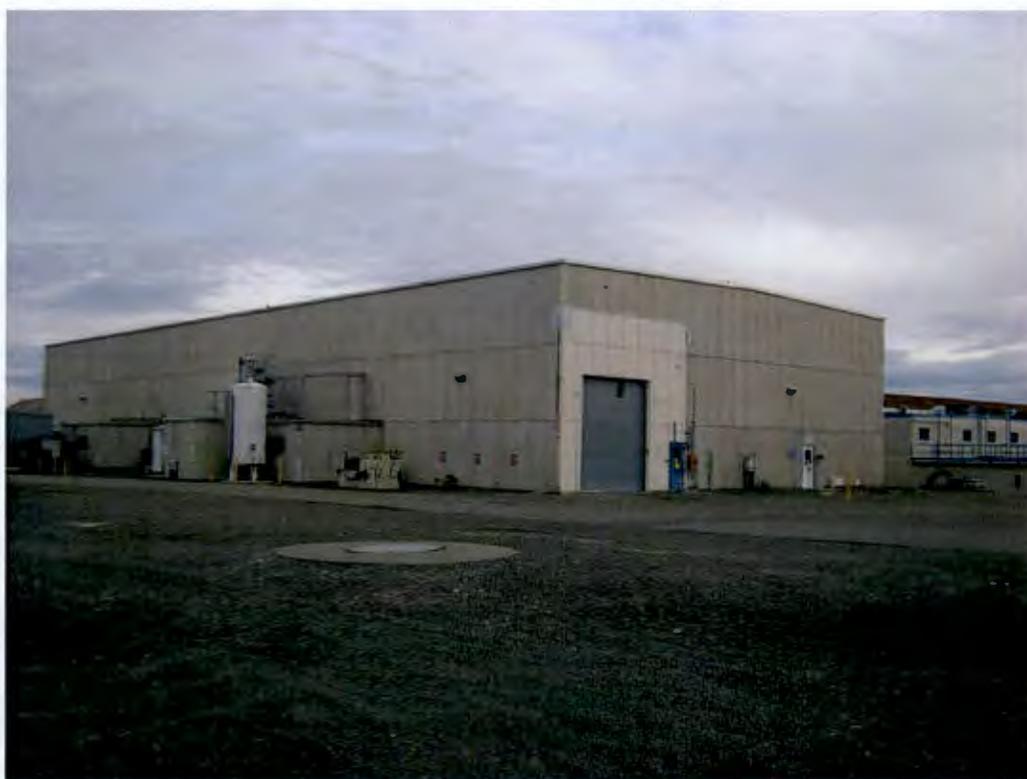
**Figure 5. 338 Maintenance Building**

The 338 Building was a single-story bolted steel frame structure originally used in the 300 Area to provide space to receive, mock up, test and store components and certified materials for use in the High Temperature Sodium Facility. The structure, 80 ft by 196 ft by 30 ft, was constructed of corrugated transite (steel and asbestos) siding. The slightly sloped roof had a built-up asphalt and gravel finish, and the main floor was painted concrete. Interior walls were constructed of metal studs covered with gypsum board siding. The structure included a pit (50 ft by 65 ft by 33 ft) in the north end, covered by a truss-supported steel plate. A sump (20 ft by 12 ft by 4 ft) was located in the south end of the pit. A 20-ton bridge crane served the building's entire interior floor space. Four attached cubicles were added on the east and west outer walls to provide space for heat pumps. An additional cubicle housing change rooms and sanitary restrooms were added on the east side, and an entry air lock to provide a barrier against

blowing dirt and dust was placed on the south end. These additions brought the building's total area to 20,869 sq ft.

The 338 Building was originally located in 100-F Area, but was relocated in the eastern portion of the 300 area in 1971. The building was last known as the Maintenance Building and served as a less-than-90-day storage facility for hazardous materials. The building was turned over to WCH for demolition in October 2008.

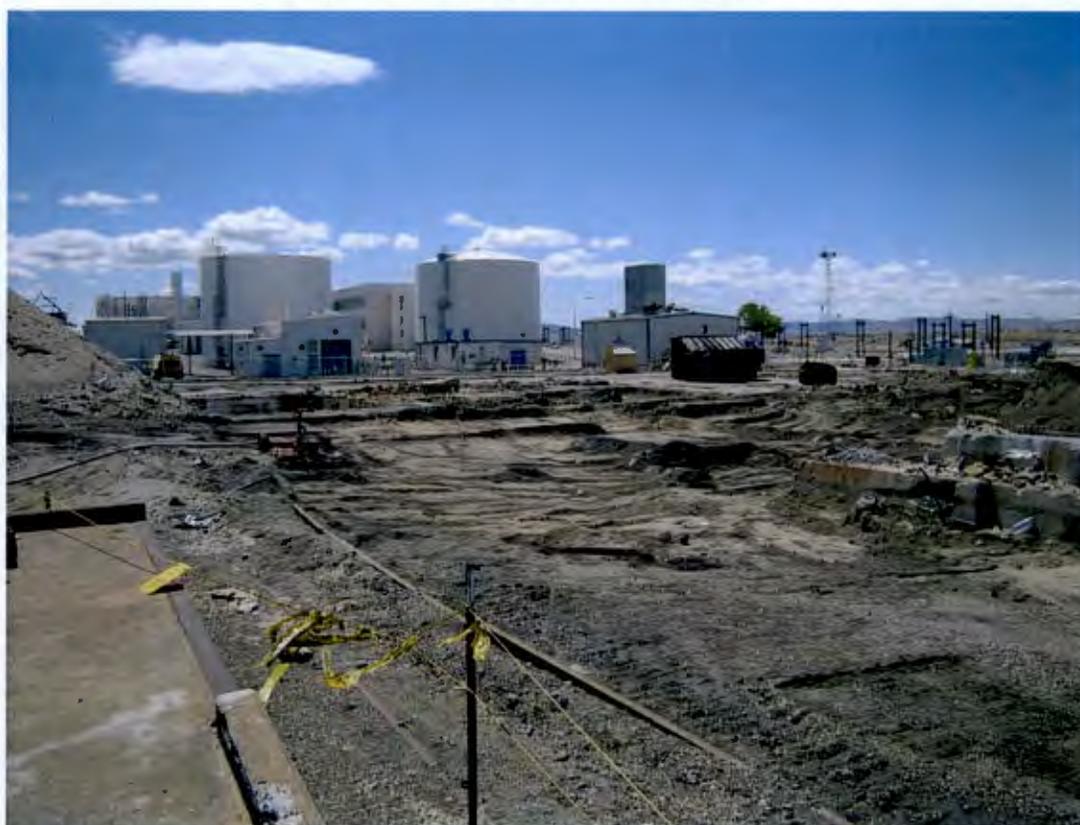
**Figure 6. 384 Power House Basement**

The dimensions of the 384 Building footprint during its last working configuration were 89 ft by 208 ft. The basement contained coal transport equipment, ash removal equipment/structures, and condensate equipment. The foundation was reinforced concrete extending 4- to 5-foot below ground level and supported a 6-inch reinforced concrete floor.

The 384 Building was known as the Power House and the Heating Plant. The building was constructed in 1943 to provide process and heating steam and compressed air to the 300 area. WCH took over responsibility for the building in 2005. Demolition of the above-grade structure was completed in May of 2008 (documented in Building Completion Report WCH-310).

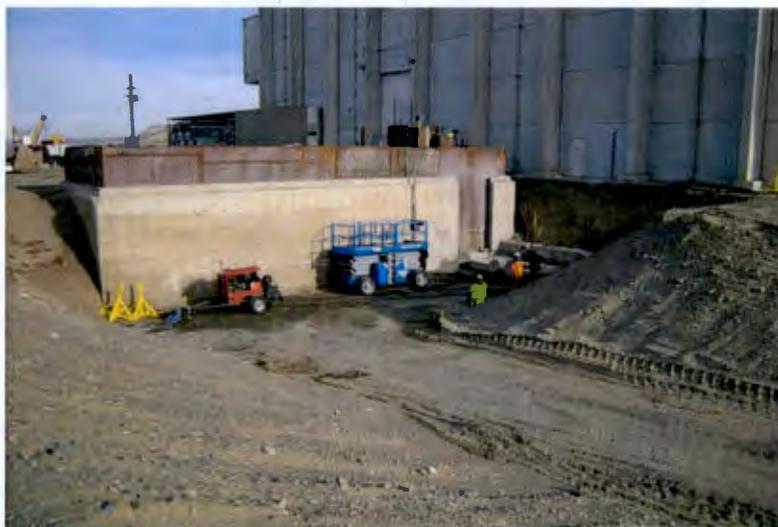
**Figure 7. 3718M Sodium Storage Tank Building**

The 3718M Building was approximately 90 ft by 23 ft by 27 ft. Of the 27 ft, 14.5 ft was below-grade. The building was set on a foundation that had 1.25 ft thick walls and 1.5 ft floor, all composed of reinforced concrete. The walls of the building, above grade, were composed of 8-inch concrete block. Inside the building was a 60 ft liquid sodium storage tank on a reinforced concrete pedestal. The roof was composed of metal decking and 1-inch rigid insulation.

The 3718M Building (primarily below-grade) was known as the Sodium Storage Tank Building and was constructed in the early 1970's in support of the High Temperature Sodium Facility. WCH gained possession of the facility in September 2005.

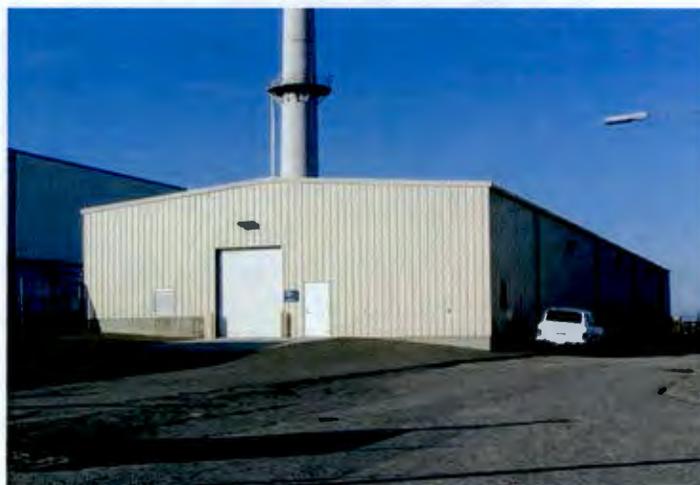
**Figure 8. 3718P General Storage Building**

Constructed in 1996, the 3718-P Building was a single-story, rectangular facility constructed of a bolted steel framework structure on a concrete foundation with a gable type metal roof. The structure was 60 ft by 196 ft and had a total area of 11,760ft<sup>2</sup>. The building had a small room in the northwest corner which was used as an office area.

The 3718-P Building was known as the General Storage Building, which supported D4 activities in the 300 Area. The 3718-P Building was located on Locust Street in the east side of the 300 Area. WCH took possession of the building in September 2007.

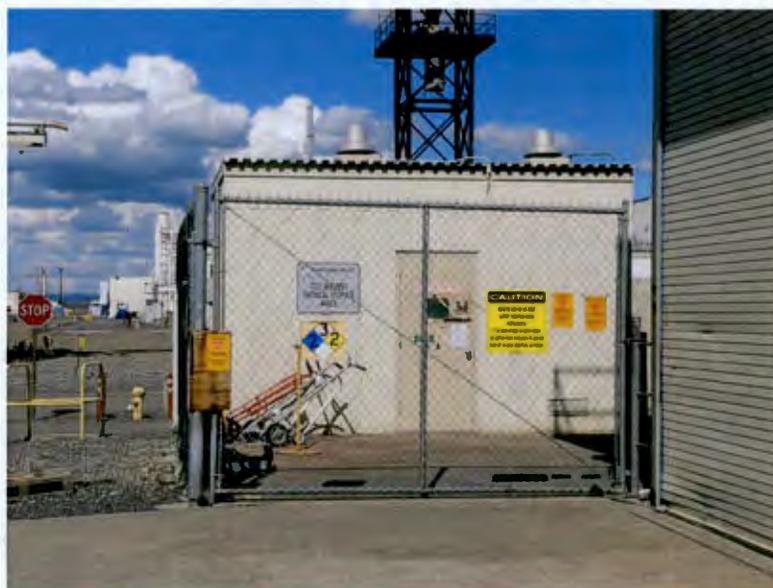
Figure 9. 3723 Sodium and Acid Storage Building

The 3723 Building was constructed of concrete block walls with a steel deck roof and a slab concrete floor. The size of the building was 144 ft<sup>2</sup>. WCH took possession of the building in August 2005.

The 3723 Building was located adjacent to the 327 Post-Irradiation Test Facility and was used to store acids and solvents. The building was also used as a storage location by waste management and recycling operations (i.e., storage location for spent batteries, etc.).

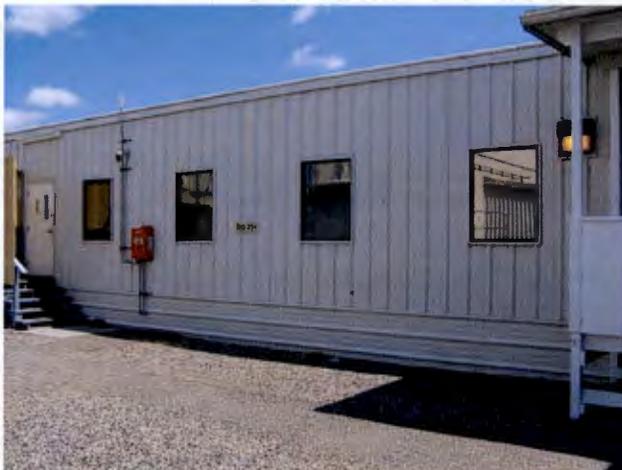
**Figure 10. MO-274 Mobile Office**

The mobile office trailer was a double-wide, 28 ft by 66 ft, transportable metal clad building on a steel frame. The exterior under portion of the trailer was covered with metal under-skirting material.

The MO-274 mobile office trailer was brought onto the Hanford site in 1993 and was located in the south central region of the 300 Area. The trailer was used by the Industrial Hygiene group as a temporary office space, meeting room, and lunch area. One room (Room 9) in the trailer was used as a Fiber Counting Room for counting and storing asbestos air samples (some samples were radiological). This room was posted as a Radiologically Controlled Area (RCA).

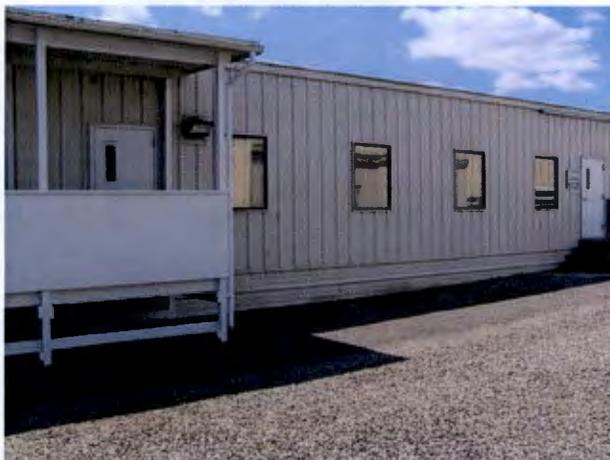
**Figure 11. MO-275 Mobile Office**

The mobile office trailer was a double-wide, 28 ft by 66 ft, transportable metal clad building on a steel frame. The exterior under portion of the trailer was covered with metal under-skirting material.

The MO-275 mobile office trailer was brought onto the Hanford site in 1993 and was located in the south central region of the 300 Area. The trailer was used by senior management and project controls personnel as a temporary office space, meeting room, and lunch area.
