FACILITY STATUS CHANGE FORM

Date Submitted: Aug 13, 2012	Area: 300 Area	Control #: D4-300-069
Originator: John Harrie	Facility ID: 305A & 3232	
Phone: 509.308.9935	Action Memorandum: Action Memorandum #1.

300-FF-2

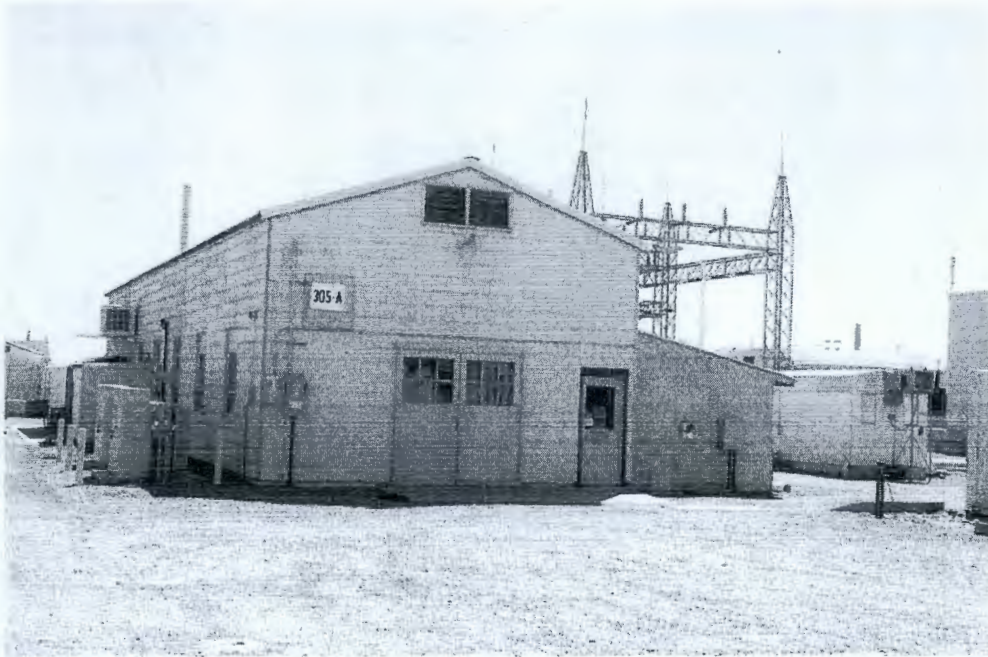
Figure 1: Looking north at 305A in June of 2003.

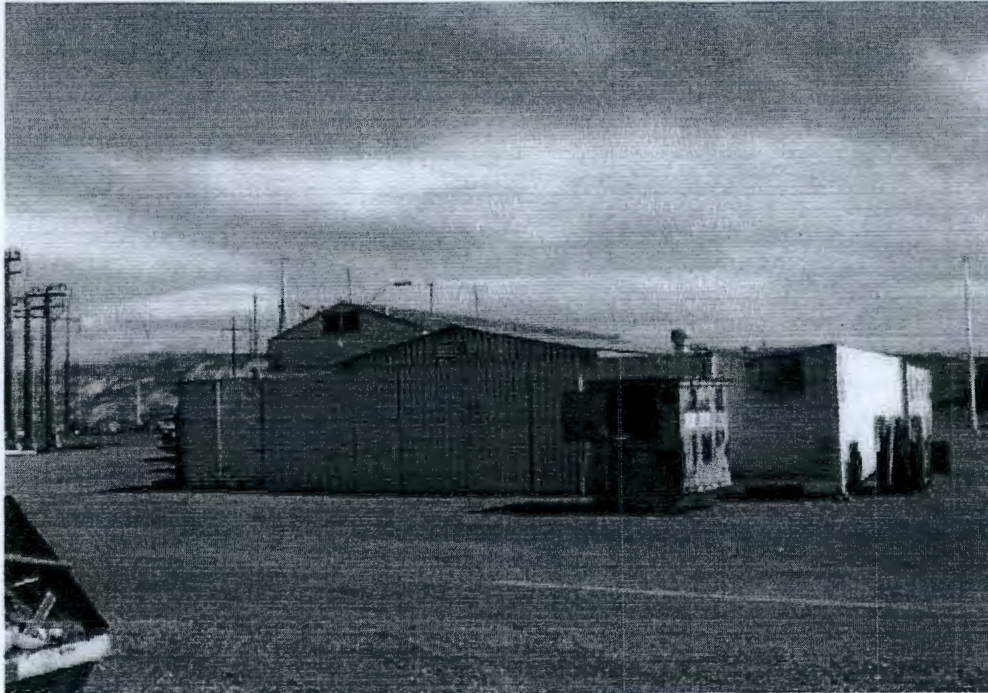
Figure 2. Looking east at 3232 in January of 2002.

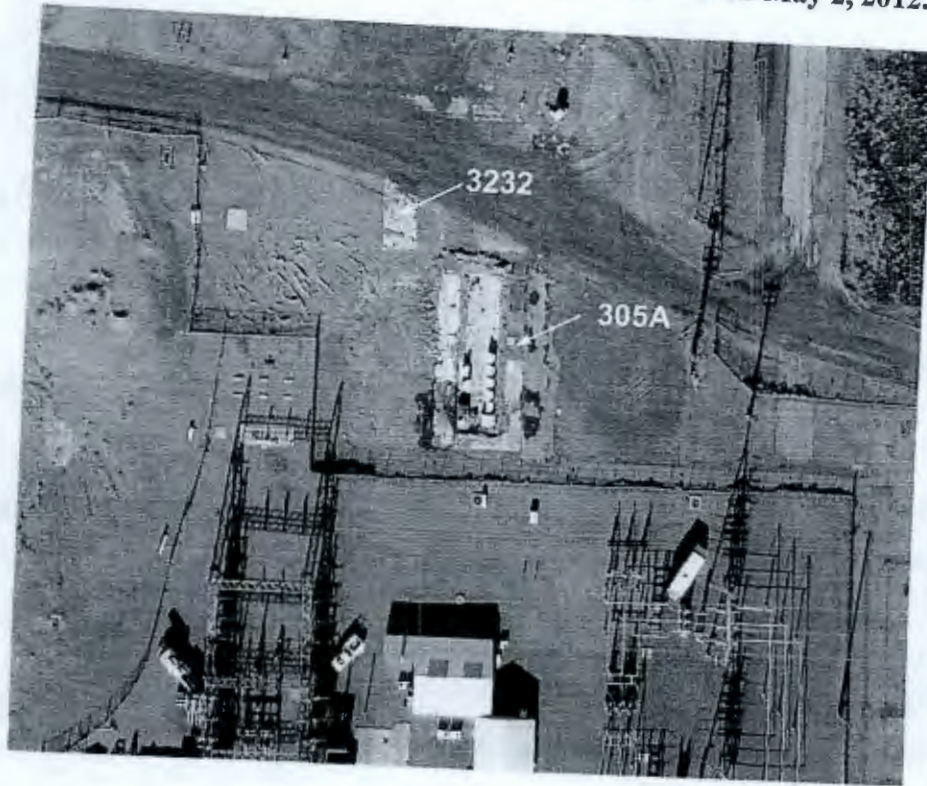
Figure 3. 305A and 3232 Slabs prior to demolition on May 2, 2012.

Prior to removal, the 305A and 3232 slabs were surveyed and no radiological contamination was observed. Because the buildings were non-radiological, the final GPERS surveys were performed at 20% coverage.

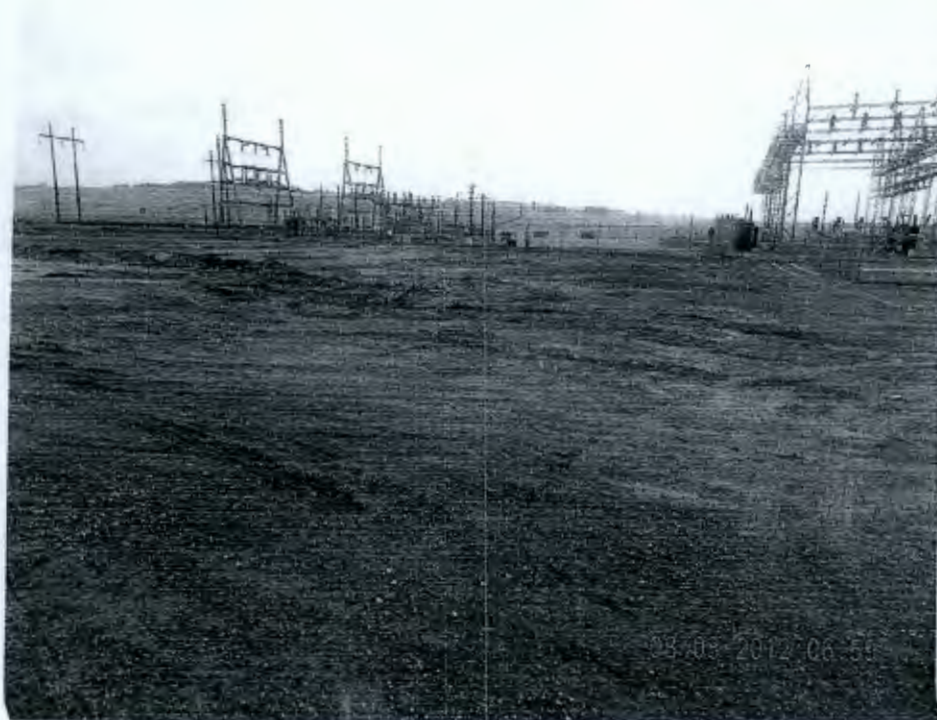
Figure 4. Looking east at 305A and 3232 following slab removal on August 8, 2012.

The 305A and 3232 Building slabs were demolished in August of 2012. The foundation debris were loaded out to EDRF. Approximately 2 to 3-feet a soil was removed during slab removal and the excavation was backfilled to grade with clean imported fill. A GPERS survey is included as Attachment 3.

No anomalies were reported during the removal of 305A and 3232 slabs. Soils were inspected prior to backfill, no staining or discoloration was observed.

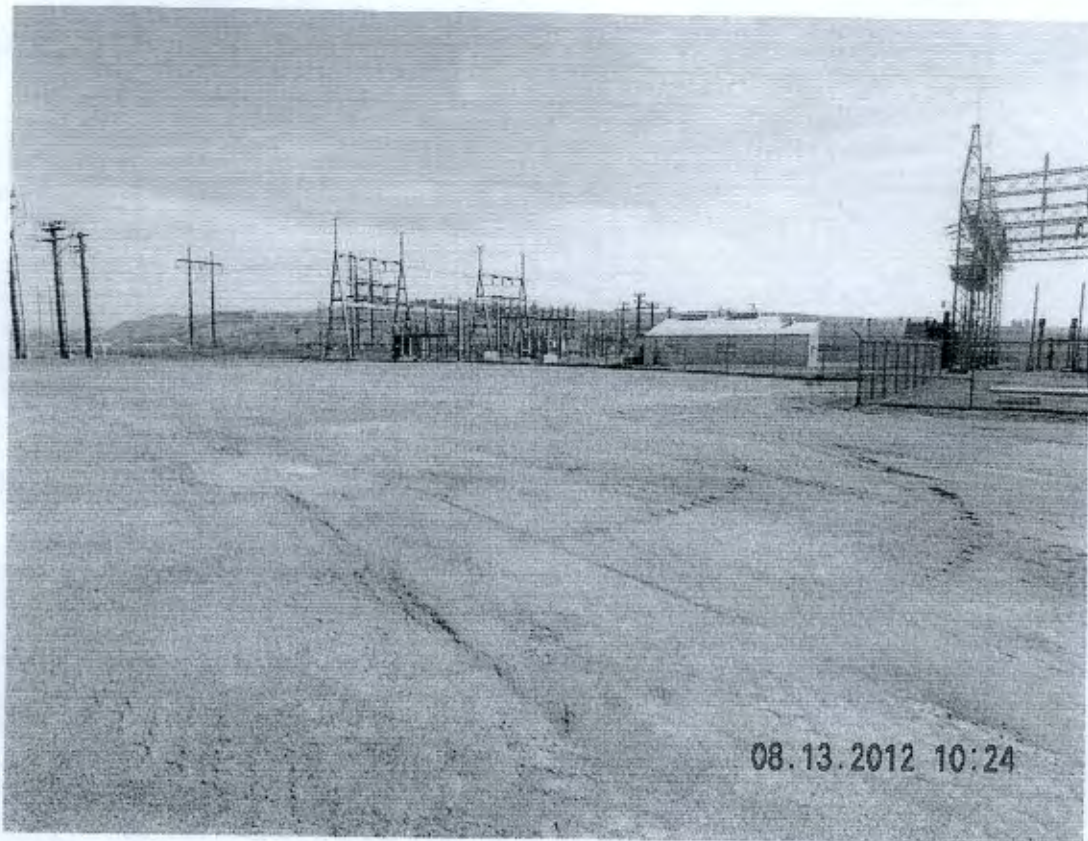
Figure 5. Looking northeast at 305A and 3232 following backfill on August 13, 2012.
