Asbestos NESHAP Thorough Inspection Report at
2503Z

PFP Closure Project

Document Number: CWR-PFP-00033

The purpose of this report is to disclose the results of an asbestos thorough inspection of 2503Z 13.8kV Switch Yard - N of 234-5Z

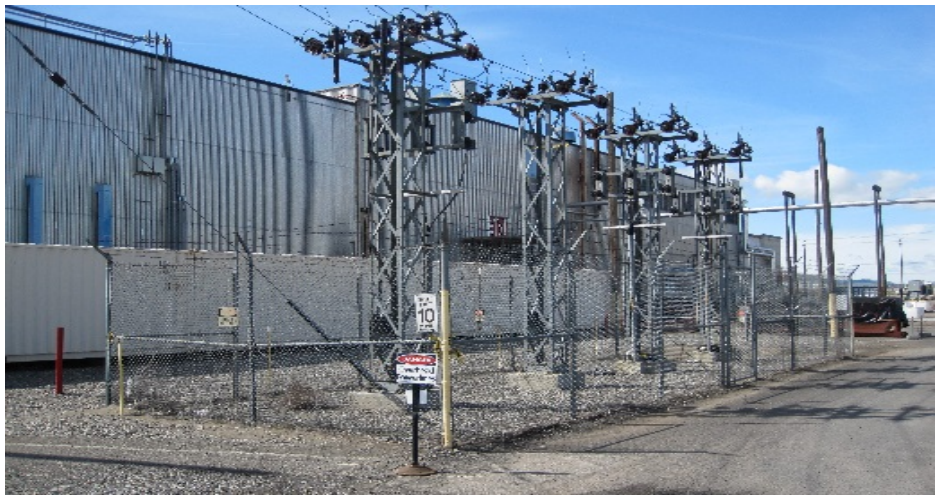
Figure 2. 2503Z East Side

- 5.5 by 22.9 m (18 by 75 ft) fenced gravel pad
- Four 0.9 m (3 ft) square concrete bases
- Four high voltage power poles
- High voltage power lines
