### CLOSURE CHECKLIST, SITE ASSESSMENT CHECKLIST AND REVISED REPORT FOR UNDERGROUND STORAGE TANK 130-B-1 REMOVAL

SITE ASSESSMENT CHECKLIST &  
REPORT FOR UNDERGROUND STORAGE TANK 130-B-1 REMOVAL

**SITE ASSESSMENT REPORT  
UST 130-B-1**

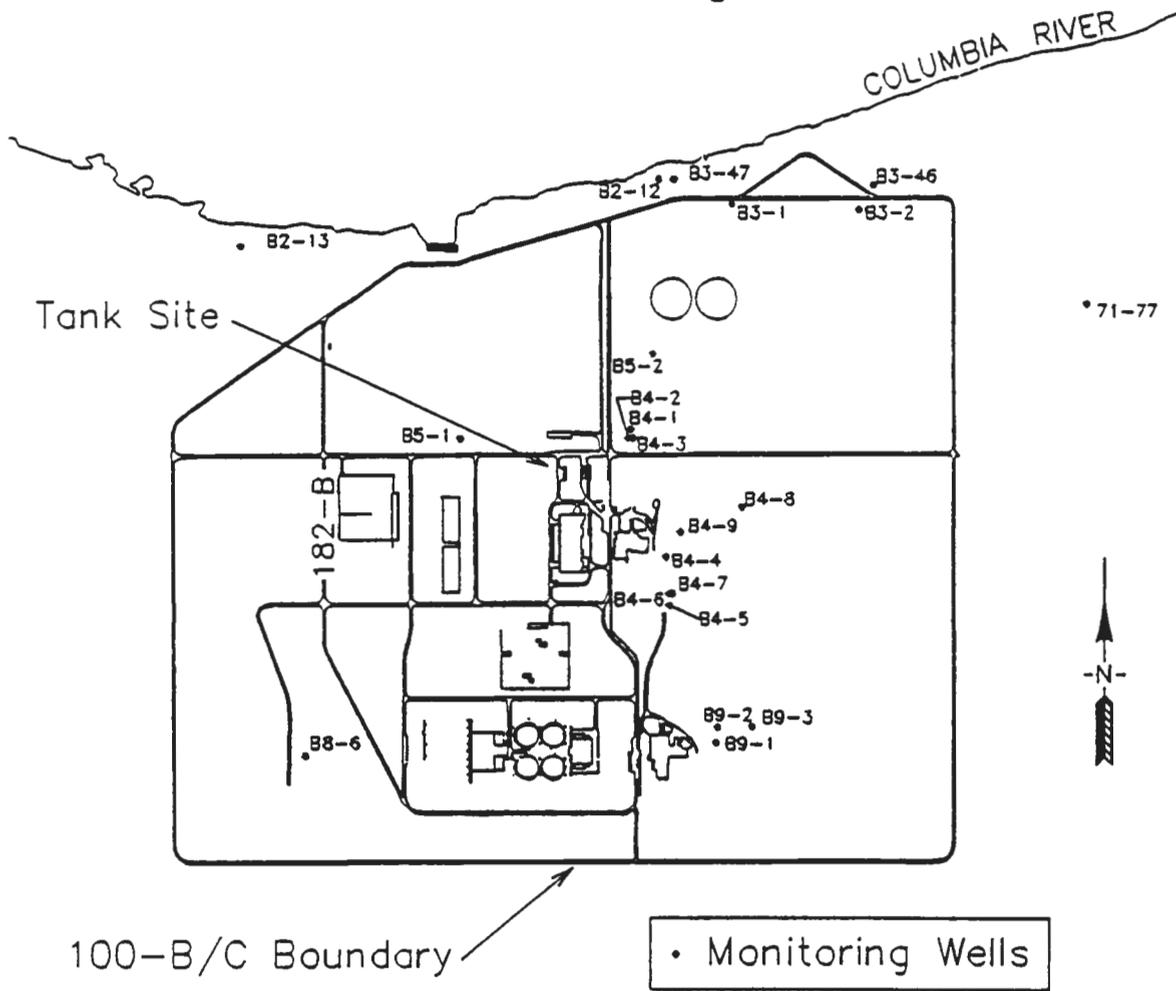
Figure 2: 100-B/C Area and Monitoring Wells

No leak detection system or secondary containment was associated with the 130-B-1 underground storage tank system. Monitoring wells of interest are 199-B4-1, 2, and 3 (see Figure 2 and Figure 5, page SA6 and SA11).

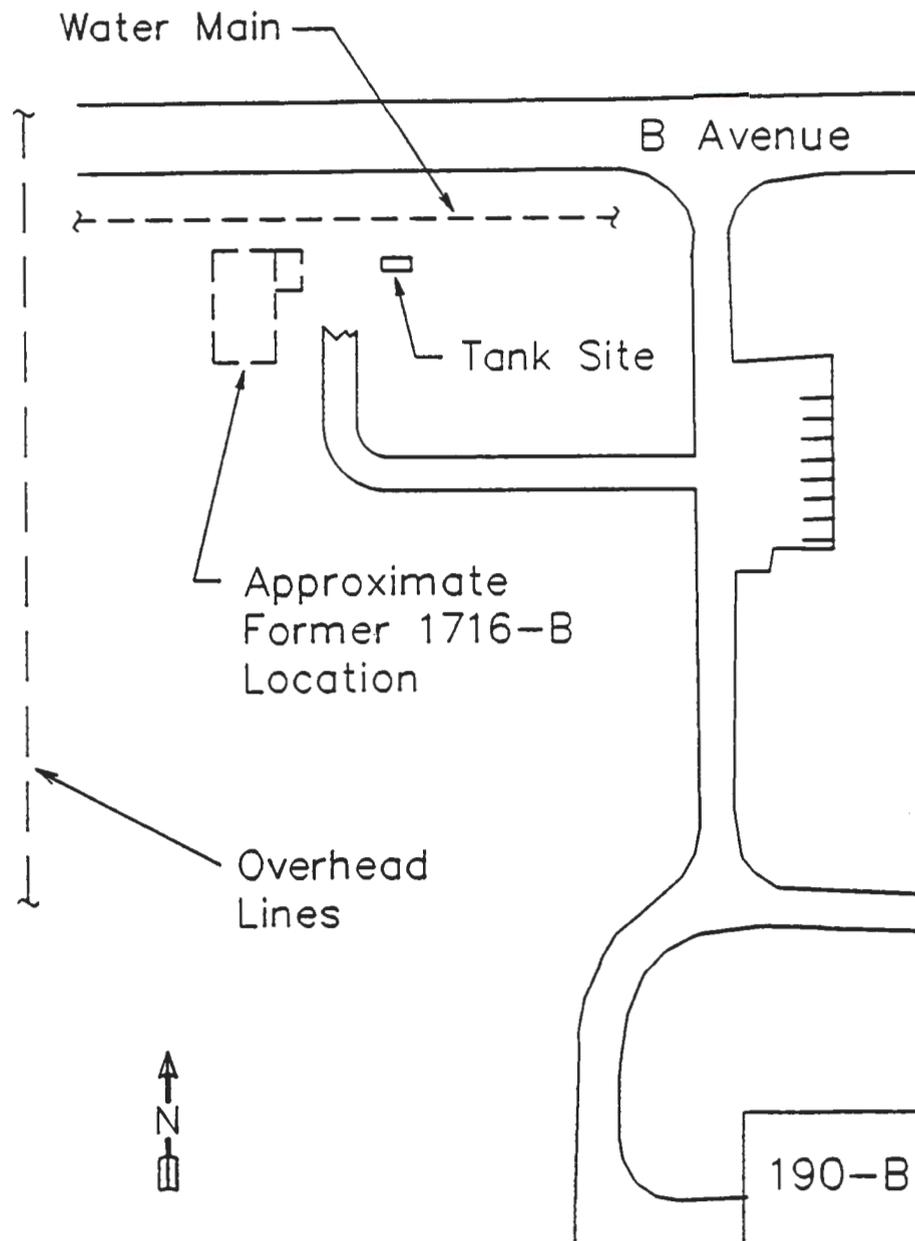
Figure 3: 130-B-1 UST Location

A ground penetrating radar survey indicated a water main 20 feet to the north of the tank. Overhead power lines run north/south approximately 180 feet to the west of the tank.

A water main runs east/west approximately 20 feet to the north of the 130-B-1 UST (see Figure 3, page SA7).

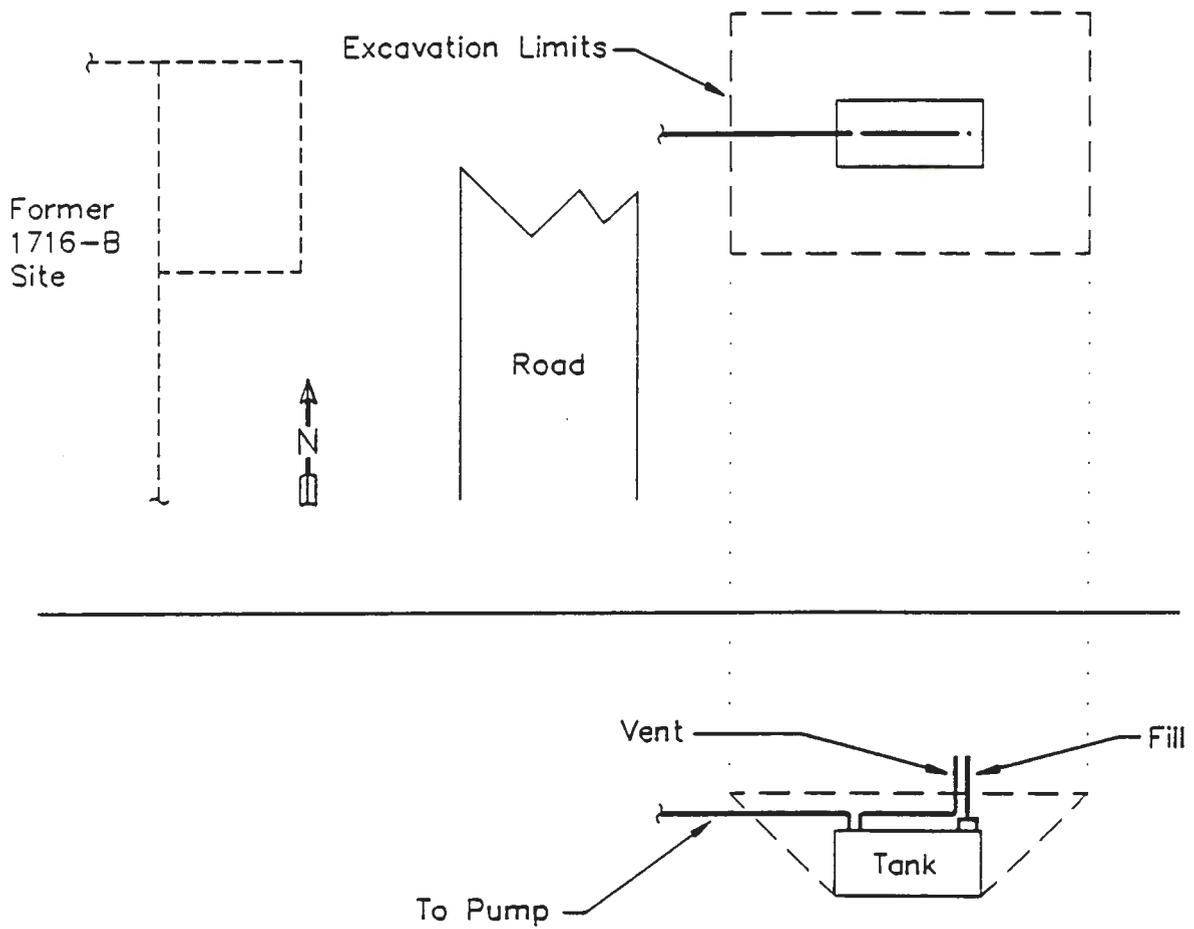
Figure 4: 130-B-1 Excavation

The tank site ground surface was native soils with no pavement or aboveground systems present. Upon removal, the tank and risers were visually inspected. Although some rust was discovered, the system was still in good condition. Minimal corrosion was found, no indication of leakage was detected, and overall tank integrity was acceptable. Spoils and the tank excavation appeared to be free of any petroleum contamination.

No drawings were found detailing the tank system or installation. Exploratory excavation was used to determine actual piping configuration, including the manifolded fill line that caused initial sticking measurements to be inaccurate (see Figure 4, Page SA8).

Upon removal, the tank was found to be 4 feet 9 inches in diameter and 7 feet 8 inches long, with a 1000 gallon capacity.

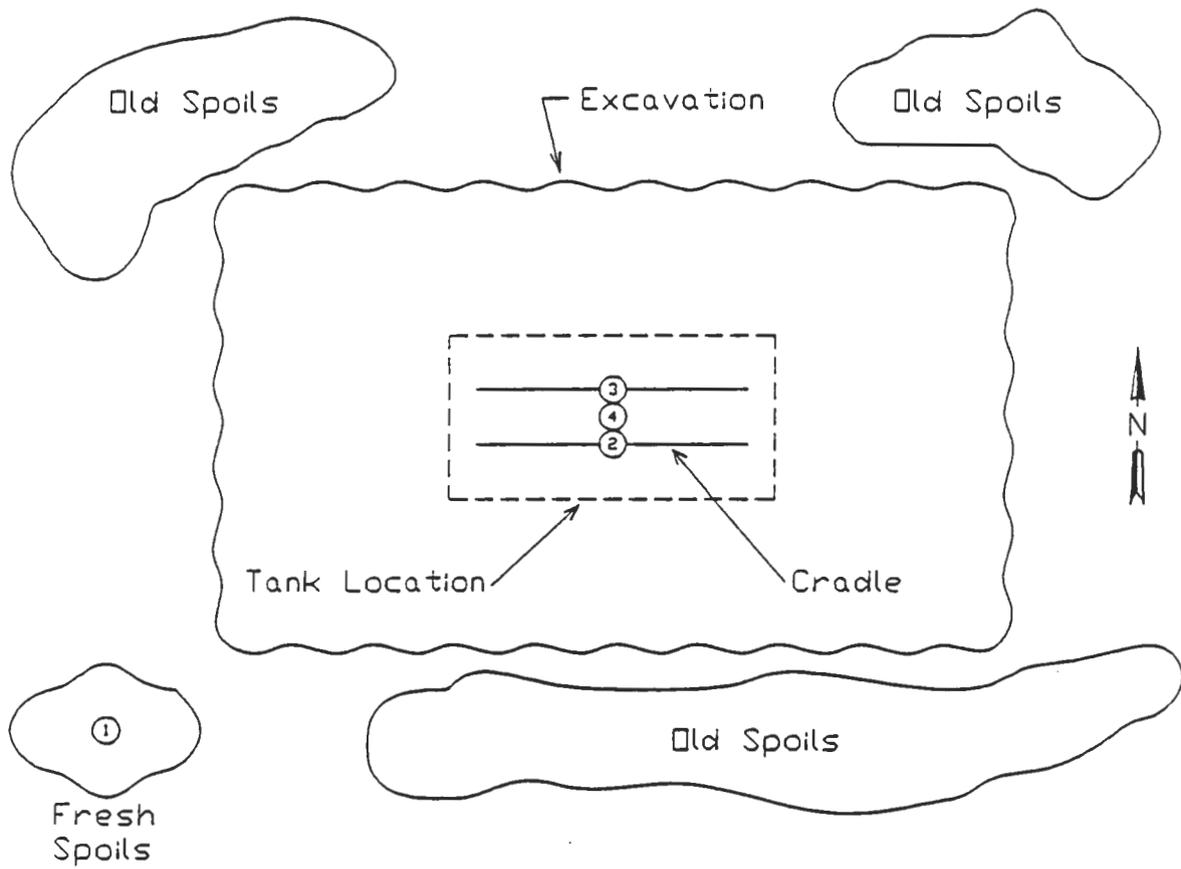
Figure 6: 130-B-1 Sample Locations

Sample ID	Sample Location
B07TD4	Spoils pile
B07TD5	South center of cradle
B07TD6	North center of cradle
B07TD7	Duplicate of B07TD6
B07TD8	Trip blank
B07TD9	Center of cradle (low point beneath tank)

#	Sample
1	B07TD4
2	B07TD5
3	B07TD6,7
4	B07TD9
