## FACILITY STATUS CHANGE FORM

<b>Date Submitted:</b> Apr 30, 2012	<b>Area:</b> 300 Area	<b>Control #:</b> D4-300-059
<b>Originator:</b> John Harrie	<b>Facility ID:</b> 320 & 320BA	
<b>Phone:</b> 509.308.9935	<b>Action Memorandum:</b> Action Memorandum #3

## Attachment 1: Facility Information

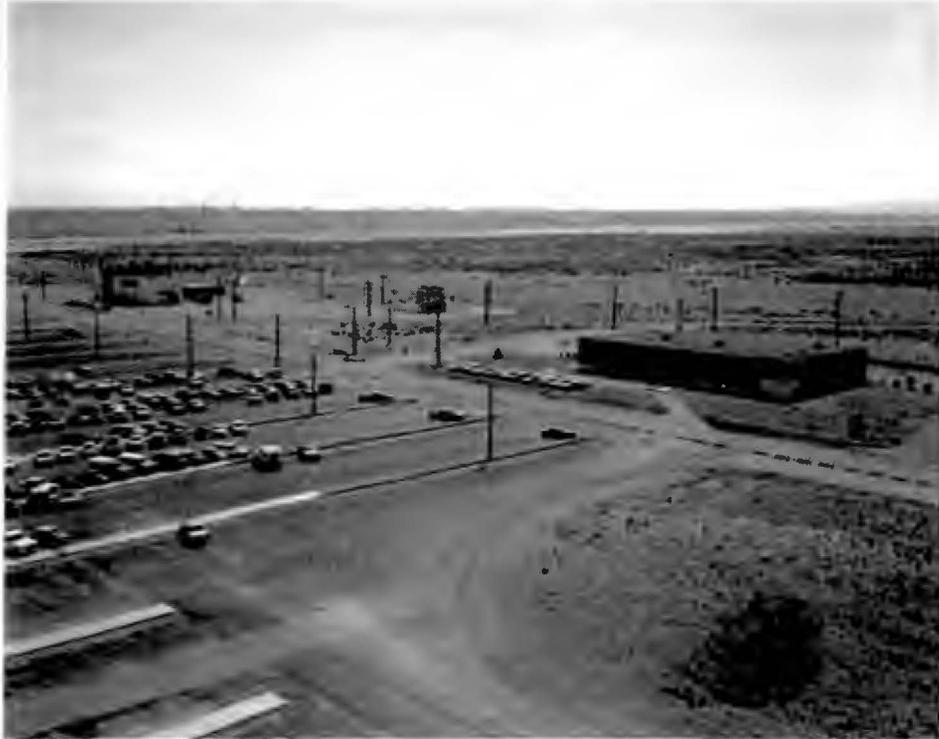
**Photo 1: Looking southeast at the 320 Building on August 22, 1968.**

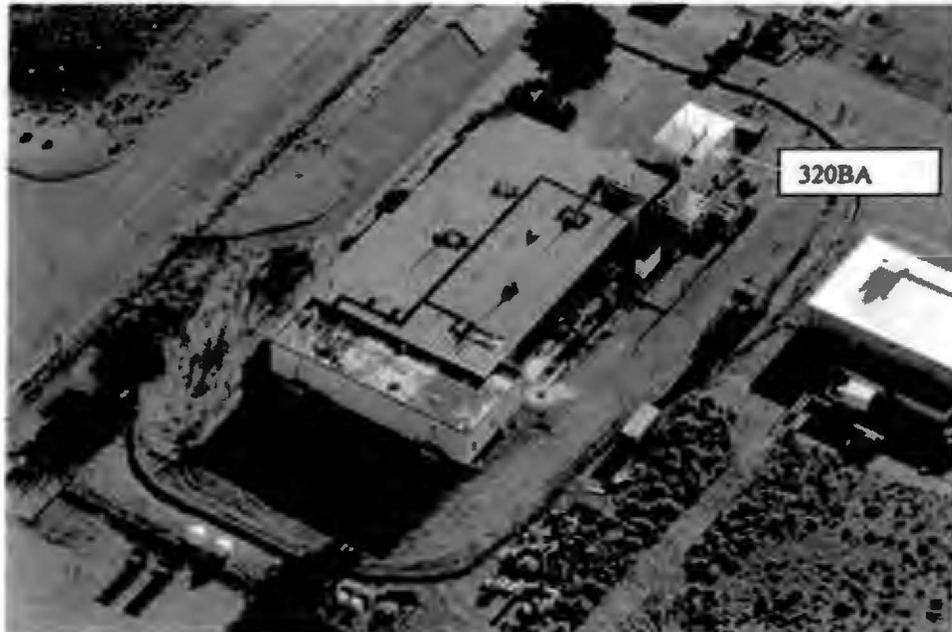
**Photo 2. Looking northeast at the 320 Building & 320BA on August 16, 2011.**

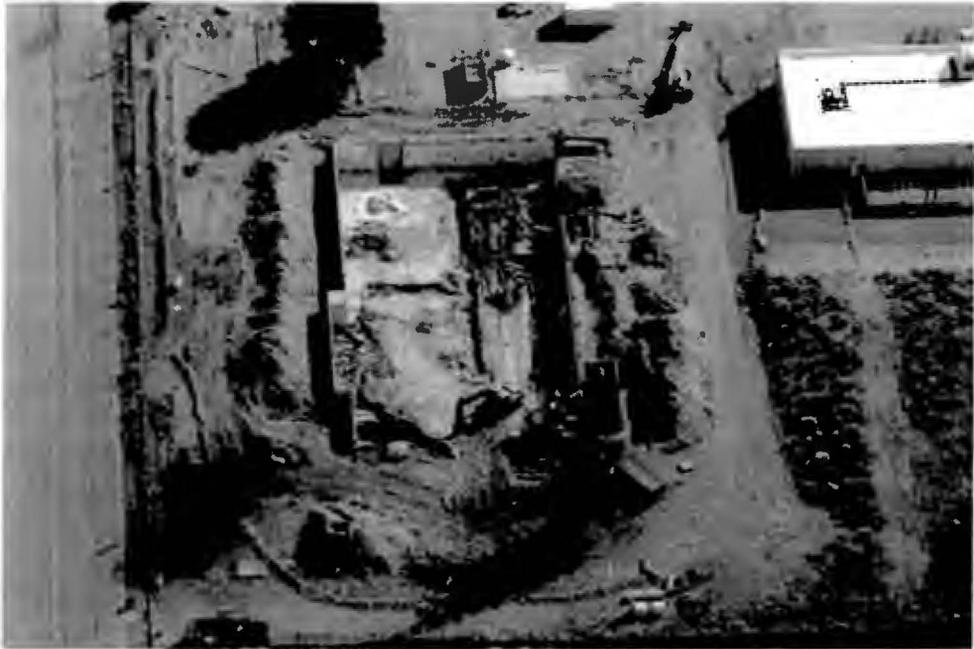
**Photo 3. Looking east at the 320 Building basement and 320BA Slab on March 8, 2012.**

The 320BA slab and the southeast corner of the 320 building foundation remain due to utility interference. The basement walls were demolished to minus 3-feet below grade. Portions of the 320 concrete basement floor were removed to access process sewer piping. A Civil survey and GPERS survey are included as attachments 3 and 4, respectively. Soils were evaluated before backfill, no anomalies noted.

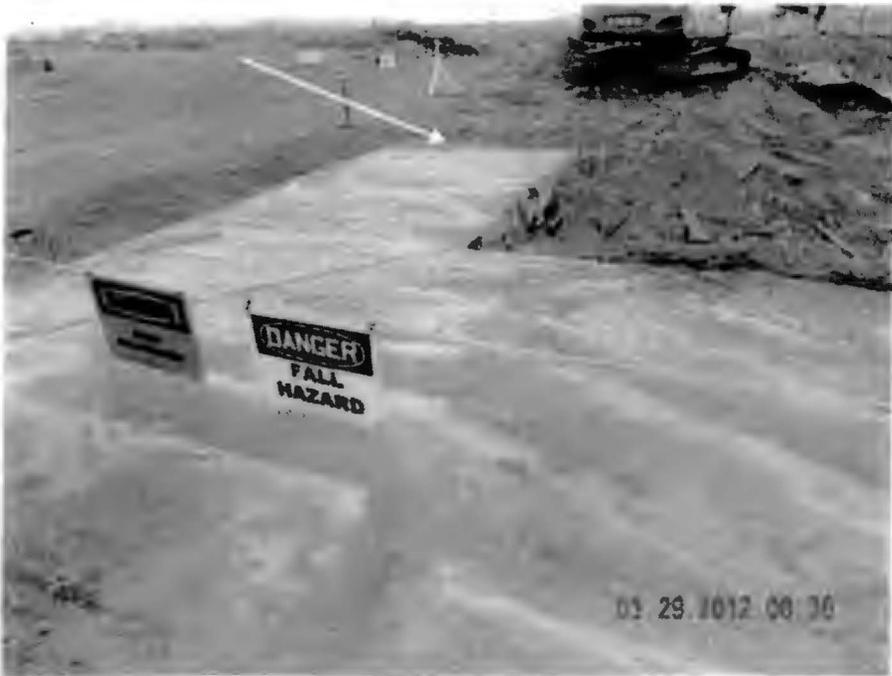
**Photo 4. Photo of the southwest corner of the 320 Building slab left due to utility interference.**

The 320BA slab was deferred due to utility interference. Also a portion of the southeast corner of the 320 building foundation is deferred due to interference with by a live 13.8 kv line that runs diagonal right under the concrete

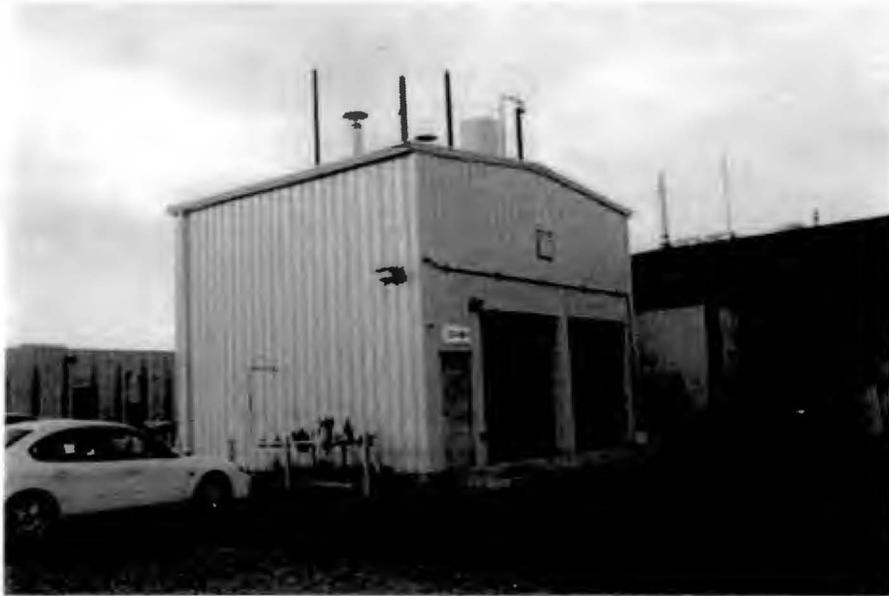
**Photo 5. Looking southwest at 320BA on February 7, 2011.**

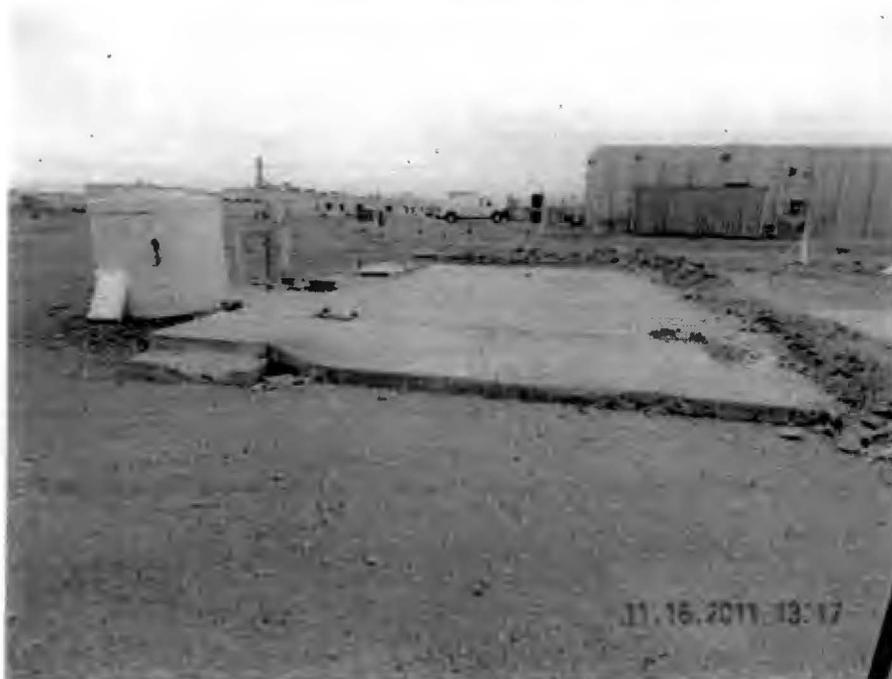
**Photo 6. 320BA Slab on November 16, 2011.**

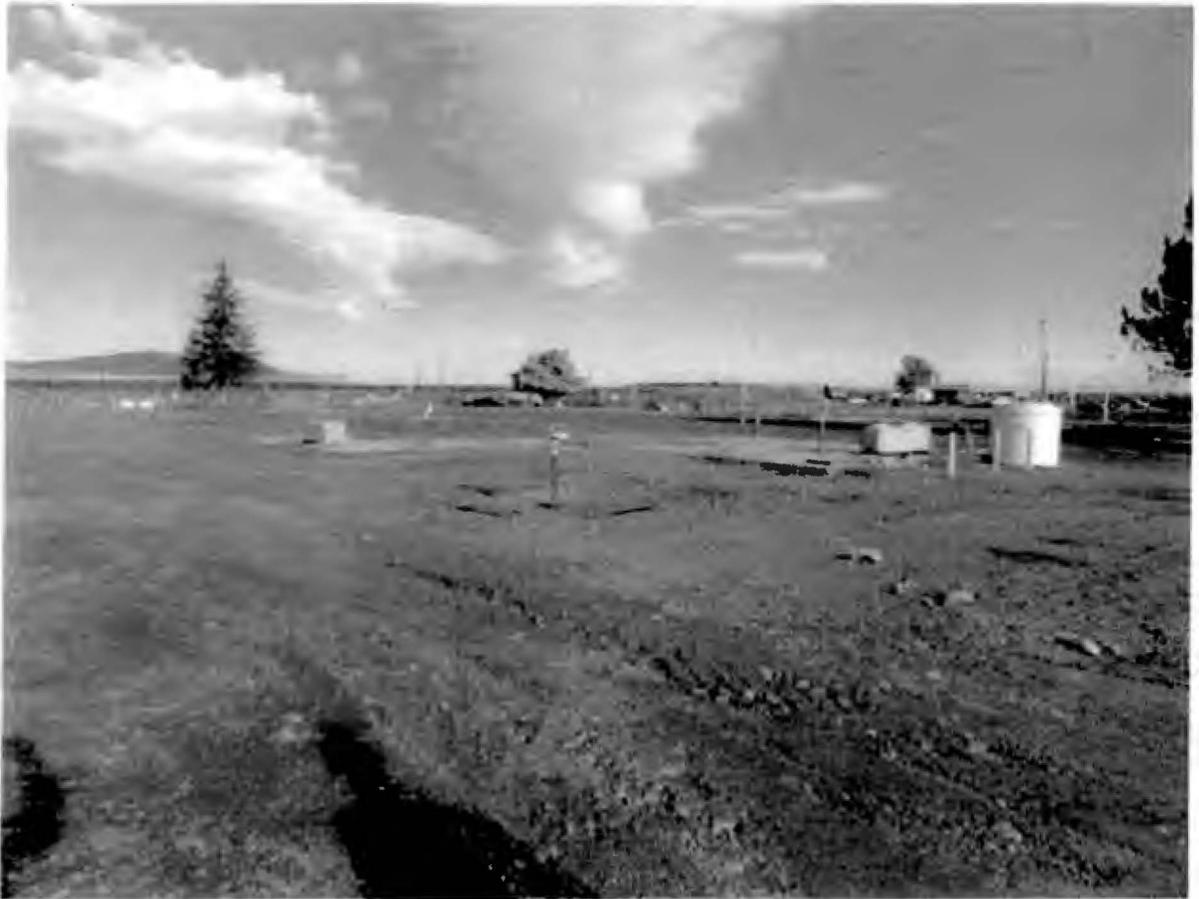
**Photo 7. 320 & 320BA after backfill. Looking northwest on April 29, 2012.**
