158342

FROM: M. L. Proctor *mlp*  
Sample Design & Cleanup Verification  
Manager  
H4-22/372-9227SUBJECT: **300-290, RADIOLOGICAL DEBRIS AREA EAST OF HORN RAPIDS DISPOSAL  
LANDFILL FOR REMEDIAL ACTION**

**300-290 RADIOLOGICAL DEBRIS AREA EAST OF  
HORN RAPIDS DISPOSAL LANDFILL  
REMOVE, TREAT, AND DISPOSE REPORT**

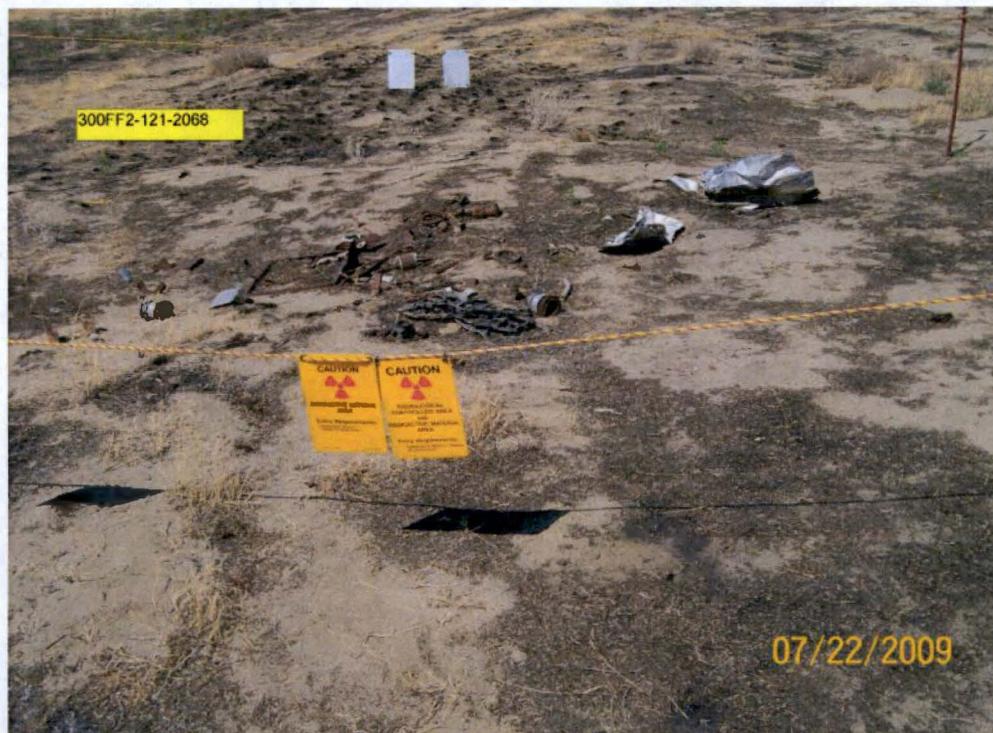
**Figure 2. The 300-229 Waste Site at Time of July 22, 2009 Walkdown.**

On July 22, 2009 a field walkdown for orphan sites was conducted (WCH 2009). During this walkdown, the posted RMA was located (Figure 2). The material in the RMA consisted mostly of rusted metal automotive parts, scraps of crumpled sheet metal, electrical wire debris, and engine gaskets. A phone number provided on the RMA posting sign was called, and the orphan walkdown team spoke with the Radiation Control supervisor for the Fluor Daniels Hanford Landlord Radiation Protection Group. The supervisor stated that one of his radiological technicians had surveyed the debris and found contamination. The site was posted as an RMA on October 27, 2008.

The 300-290 waste site was recommended for RTD based on previous investigations that determined the site contained electrical ballasts that are a potential source of PCBs and the posting of the site as an RMA. In designing the 300-290 remediation, the following items should be considered.

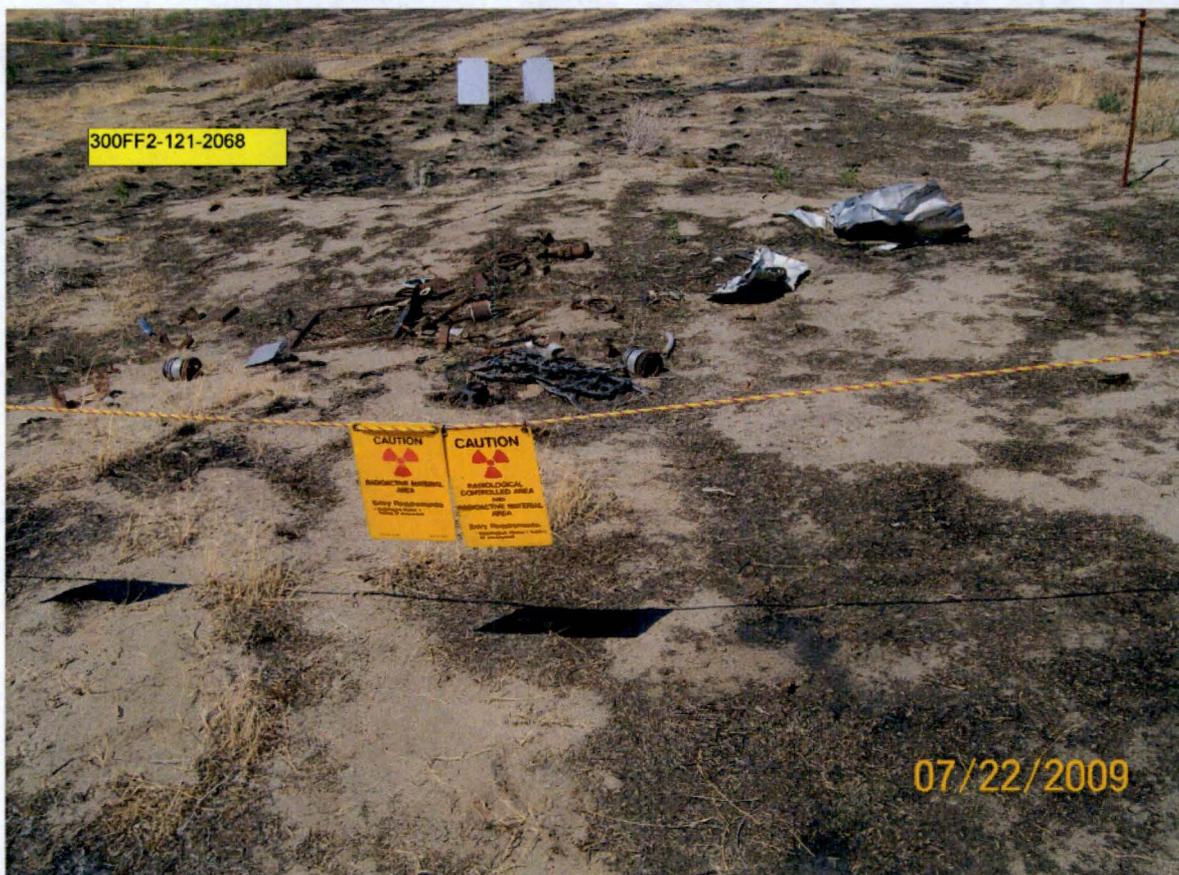
Historical Photo Number: 300FF2-121-2068

Description: RMA site showing debris and posting.
