242BBL Facility Status Change Form

FACILITY STATUS CHANGE FORM

Date Submitted:	Area: 200 East	Control Number: D4-242BBL-01
Originator: D. Turlington/ S. Guillen	Facility ID: 242BBL	Phone: 509-373-0176

Action Memorandum/Removal Action Work Plan:
DOE/RL-2010-102, Rev. 0

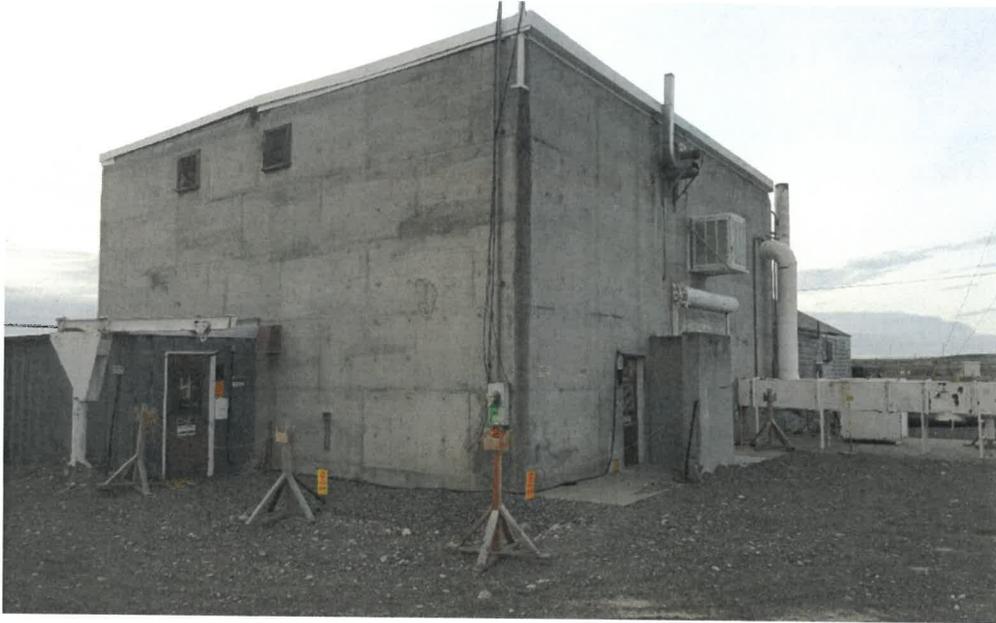
242BBL Before Demolition (South view)

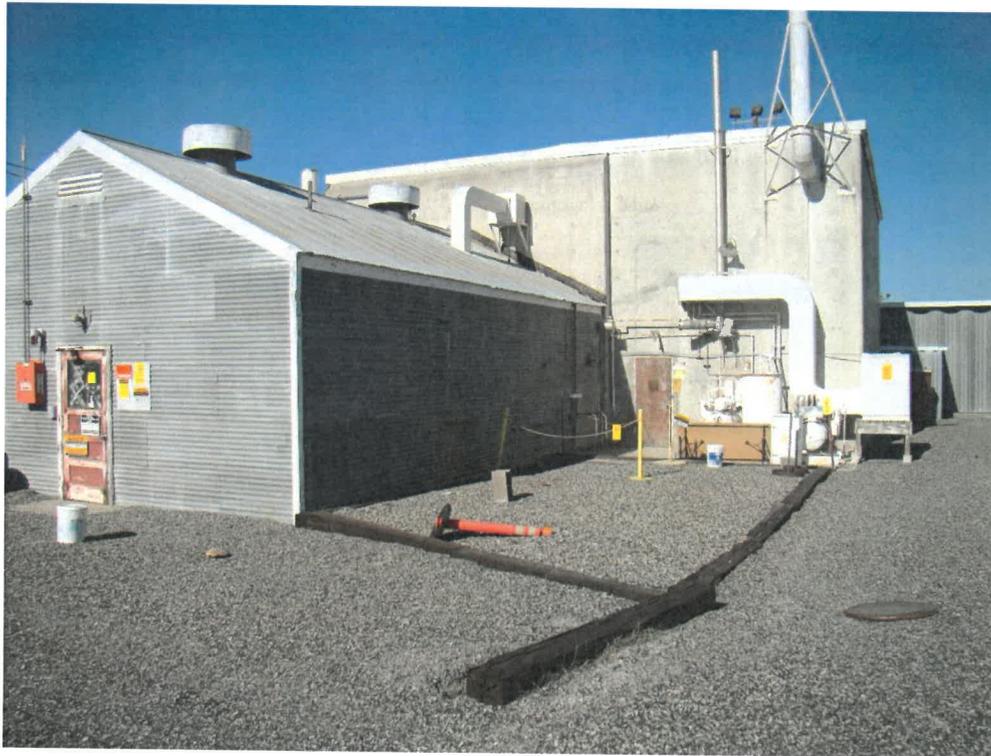
242BBL Before Demolition (Northeast view)

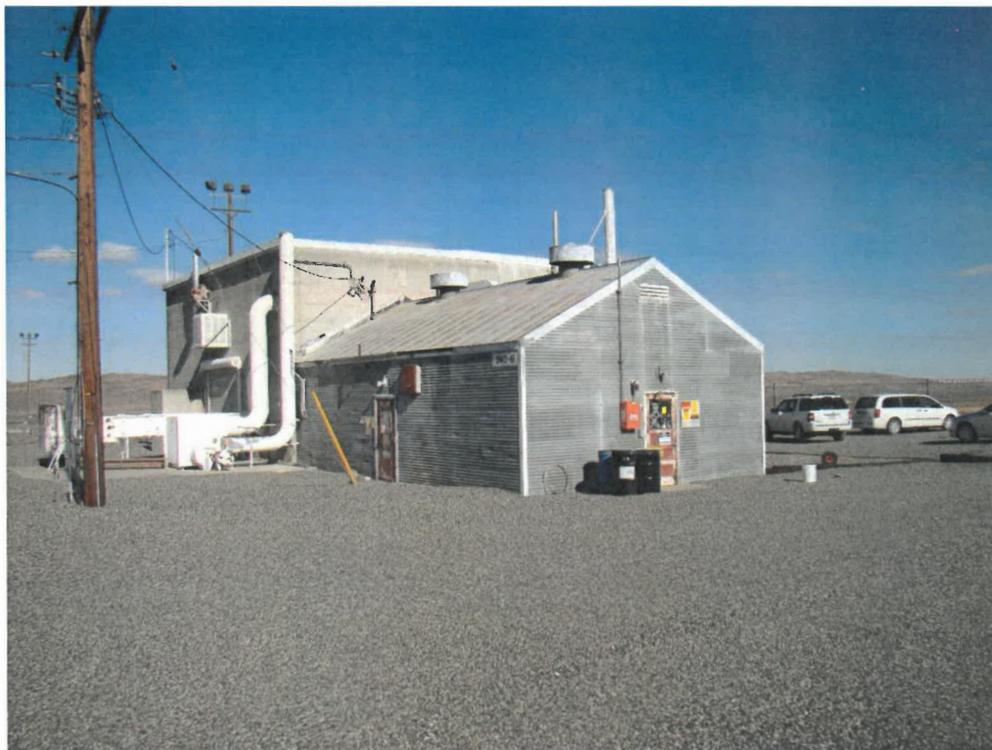
242BBL Before Demolition (Northwest view)

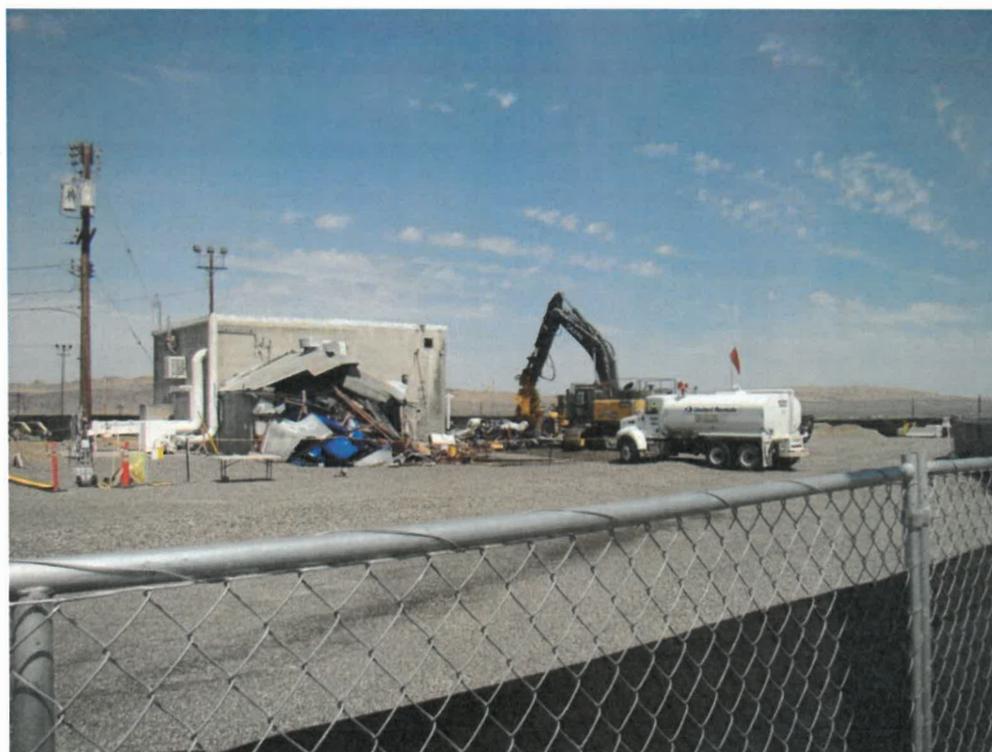
242BBL During Demolition (North view)

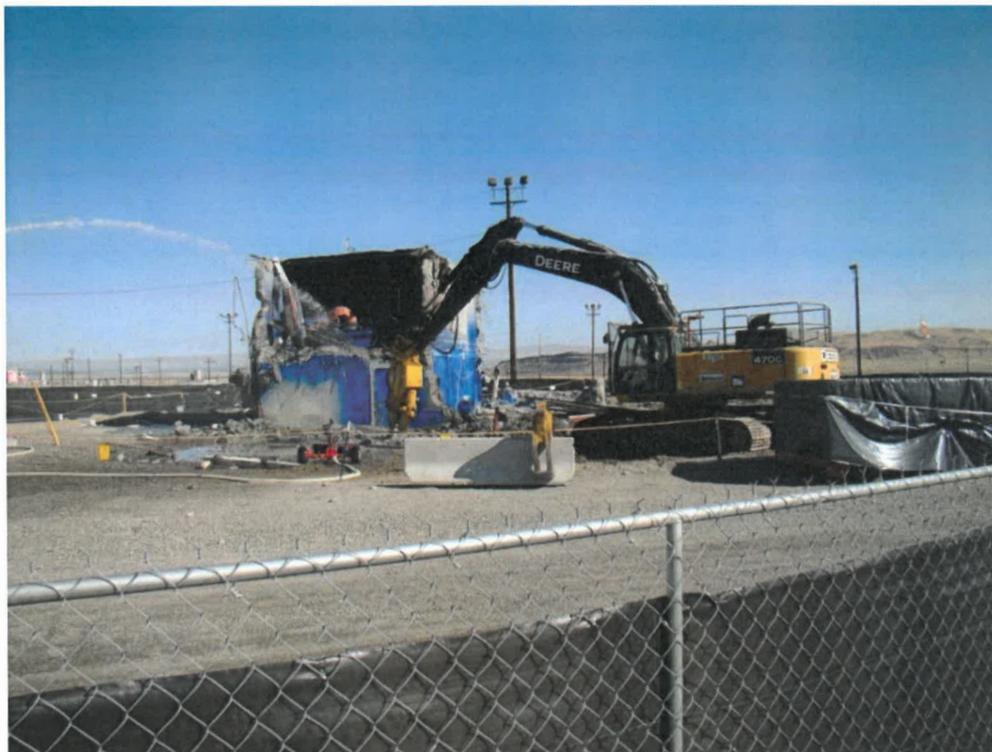
242BBL During Demolition (North view)

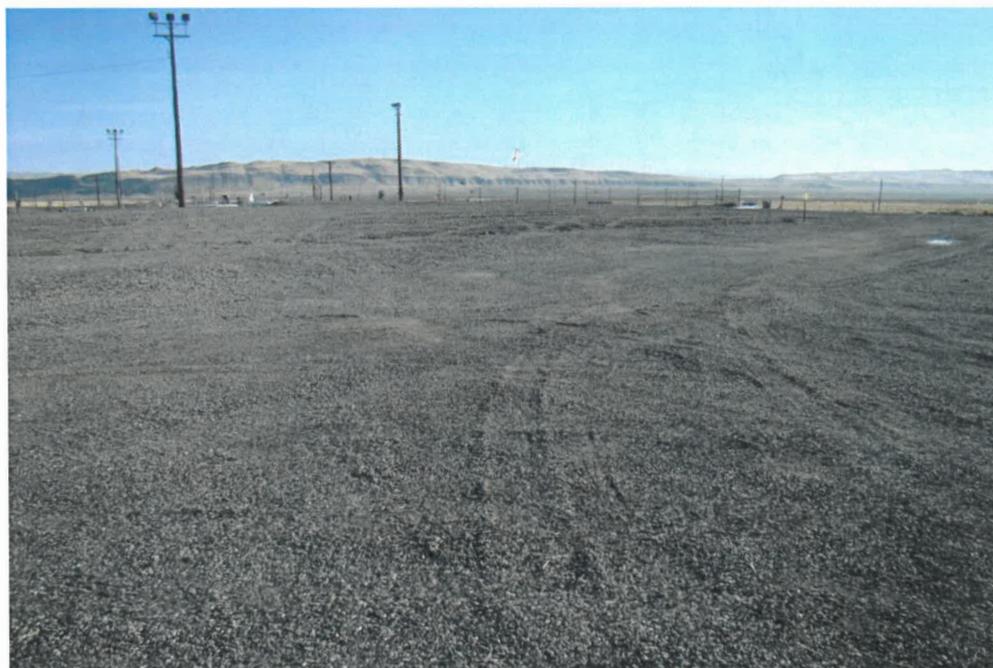
Above Grade structure completely removed down to grade, the slab was left in place, all penetrations were grouted and plugged and a minimum 6" gravel (5/8 minus) cap was placed over and contoured.

242 BBL After Demolition (North view)
