FACILITY STATUS CHANGE FORM

Date Submitted: Jan 30, 2013	Area: 100-N	Control #: D4-100N-0049
Originator: David Warren	Facility ID: 1303-N Spacer Silos	
Phone: 539-6040	Action Memorandum: 100-N Ancillary Facilities

1303-N Spacer Silos Completion

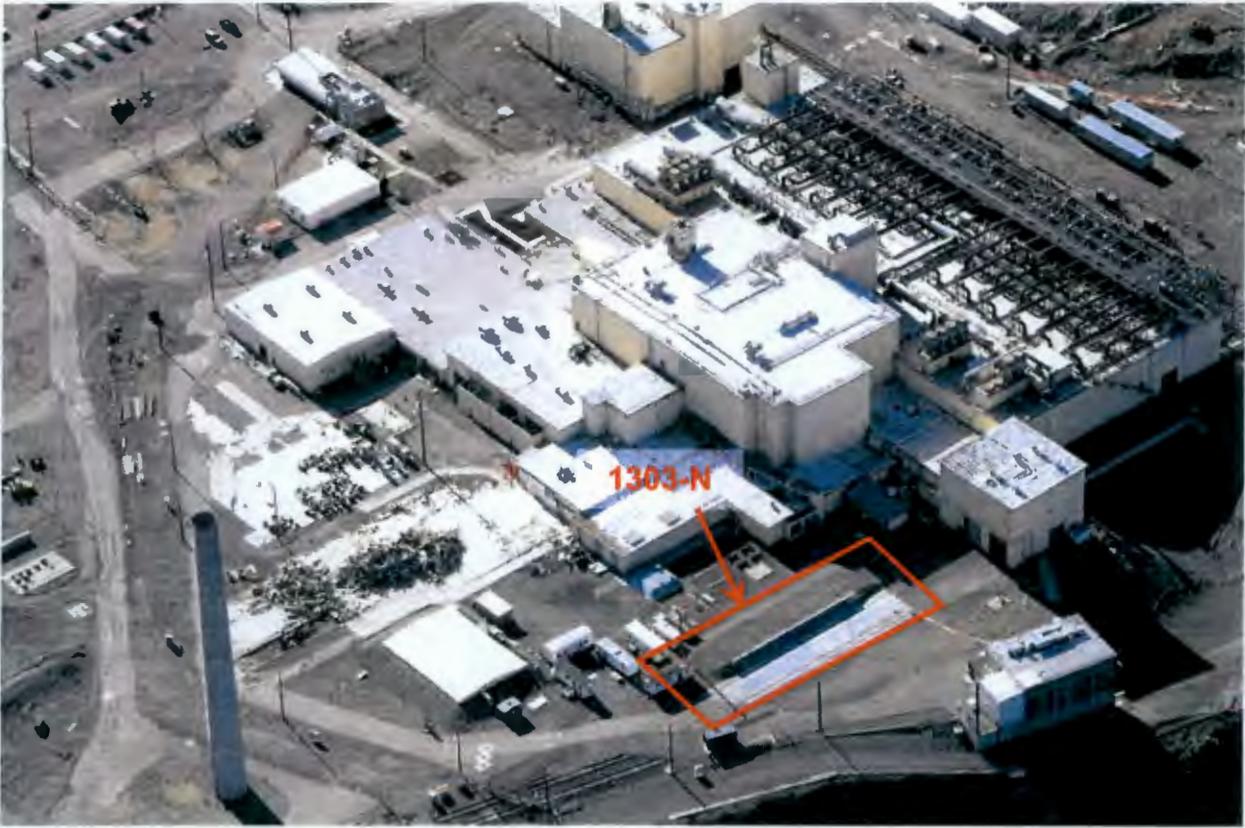
1303-N Pre-Demolition

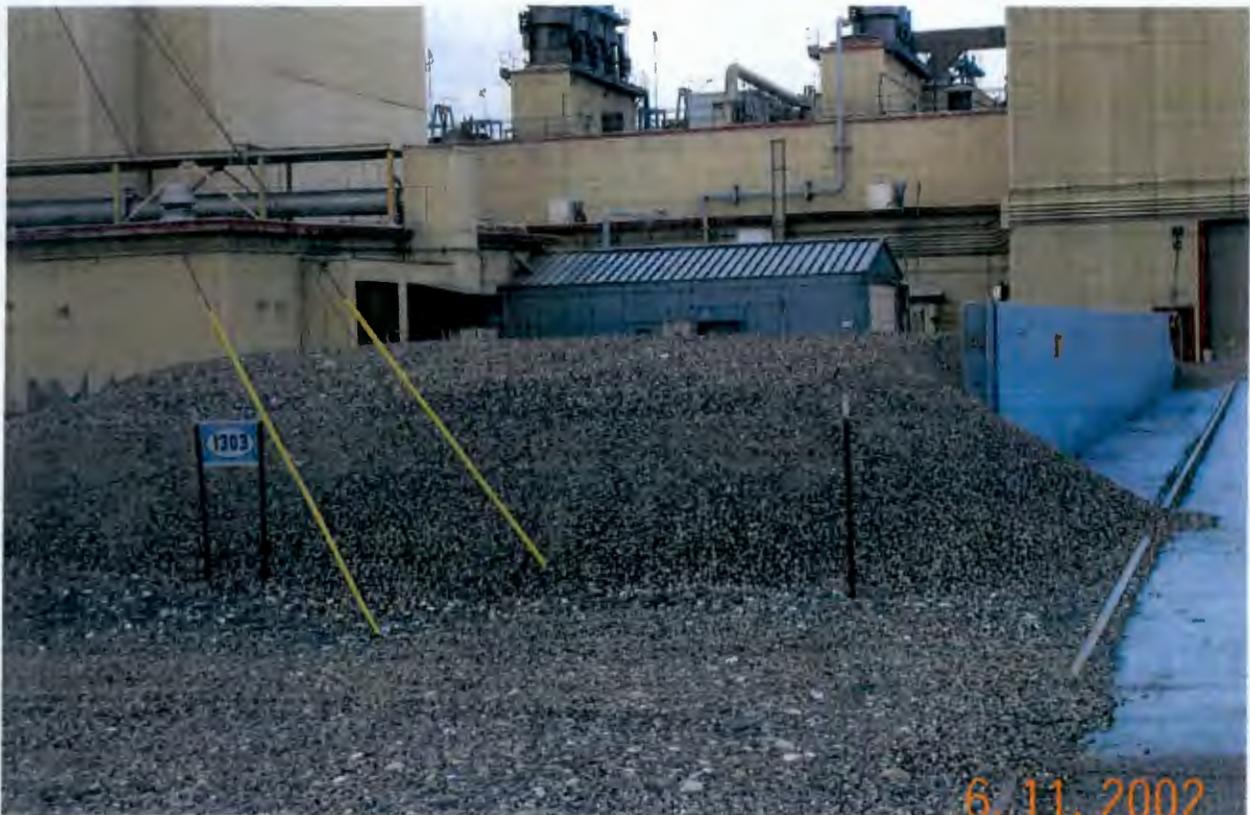
1303-N Pre-Demolition

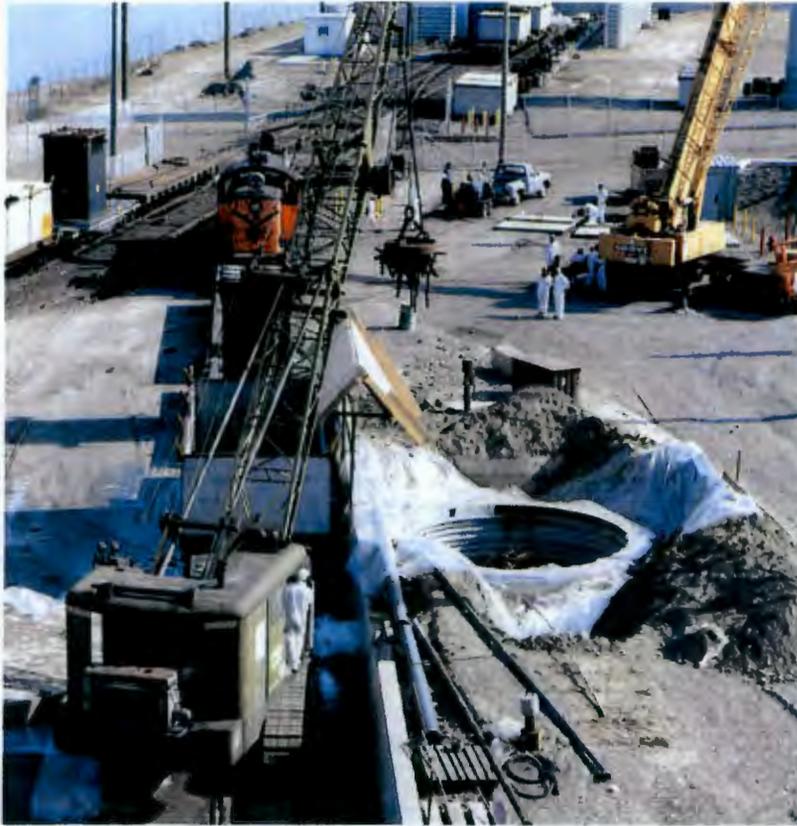
Removal of Irradiated Fuel Rod Spacers (April 1983)

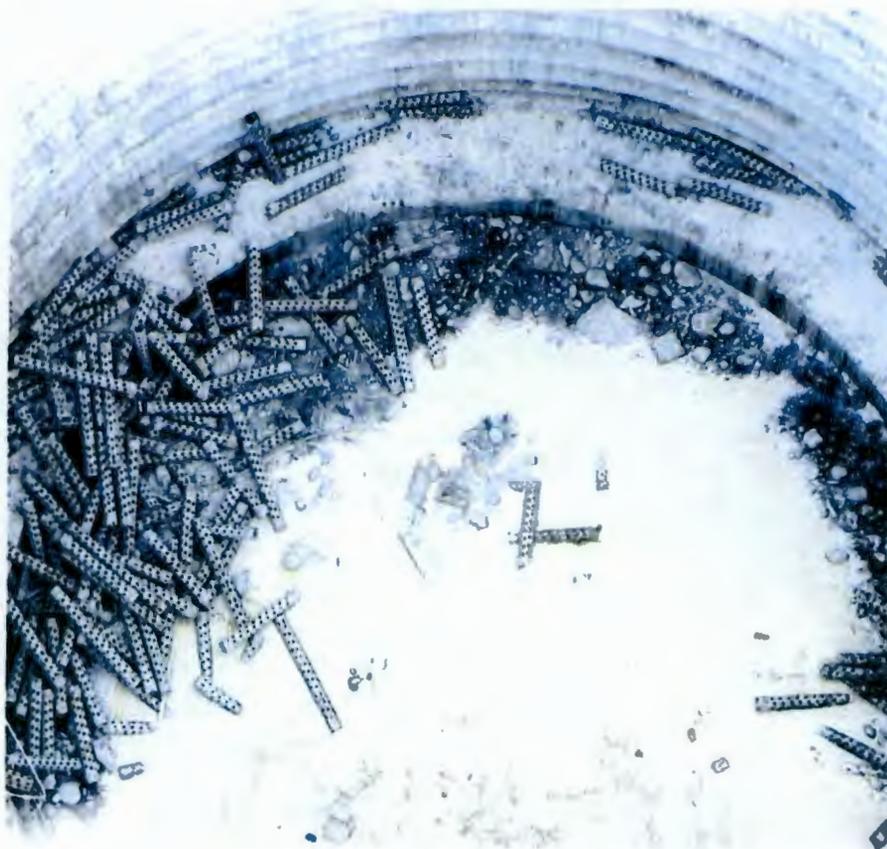
Irradiated Fuel Rod Spacers within Silo 3 (August 1985)

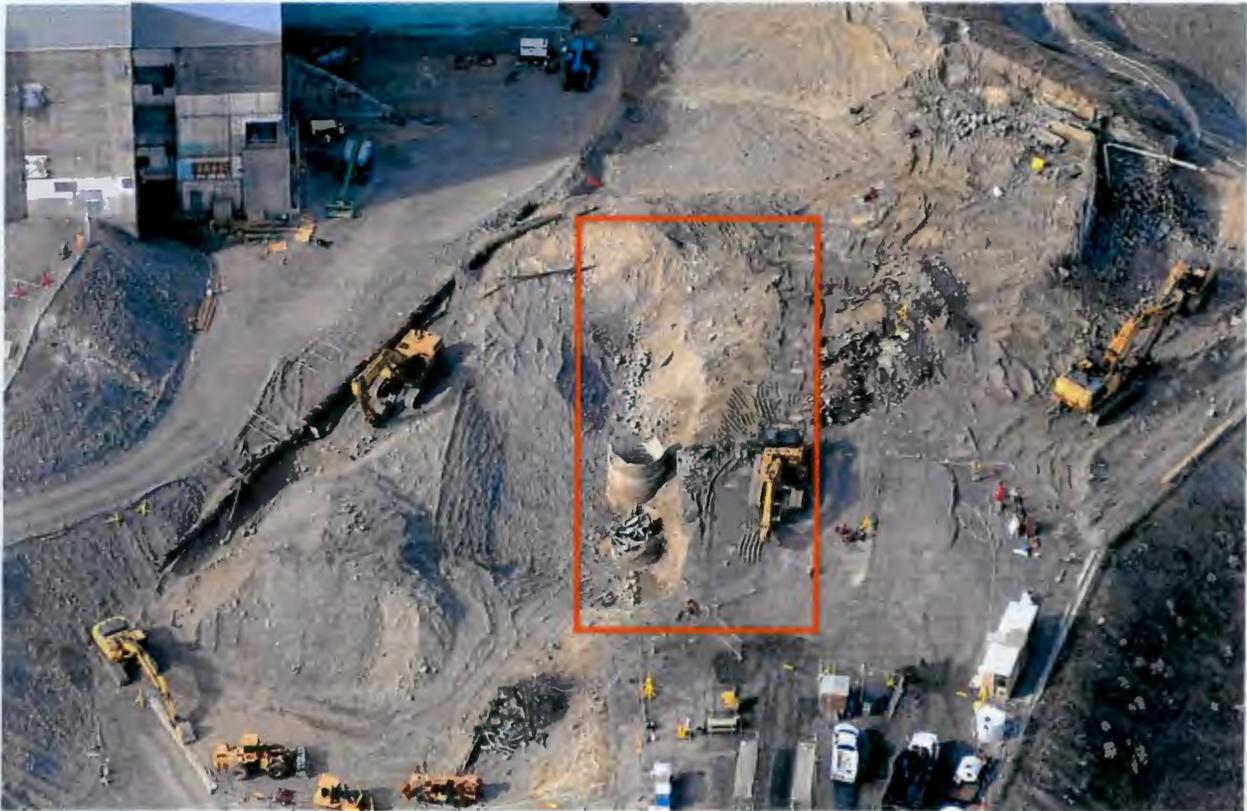
1303-N During Demolition (May 2012)

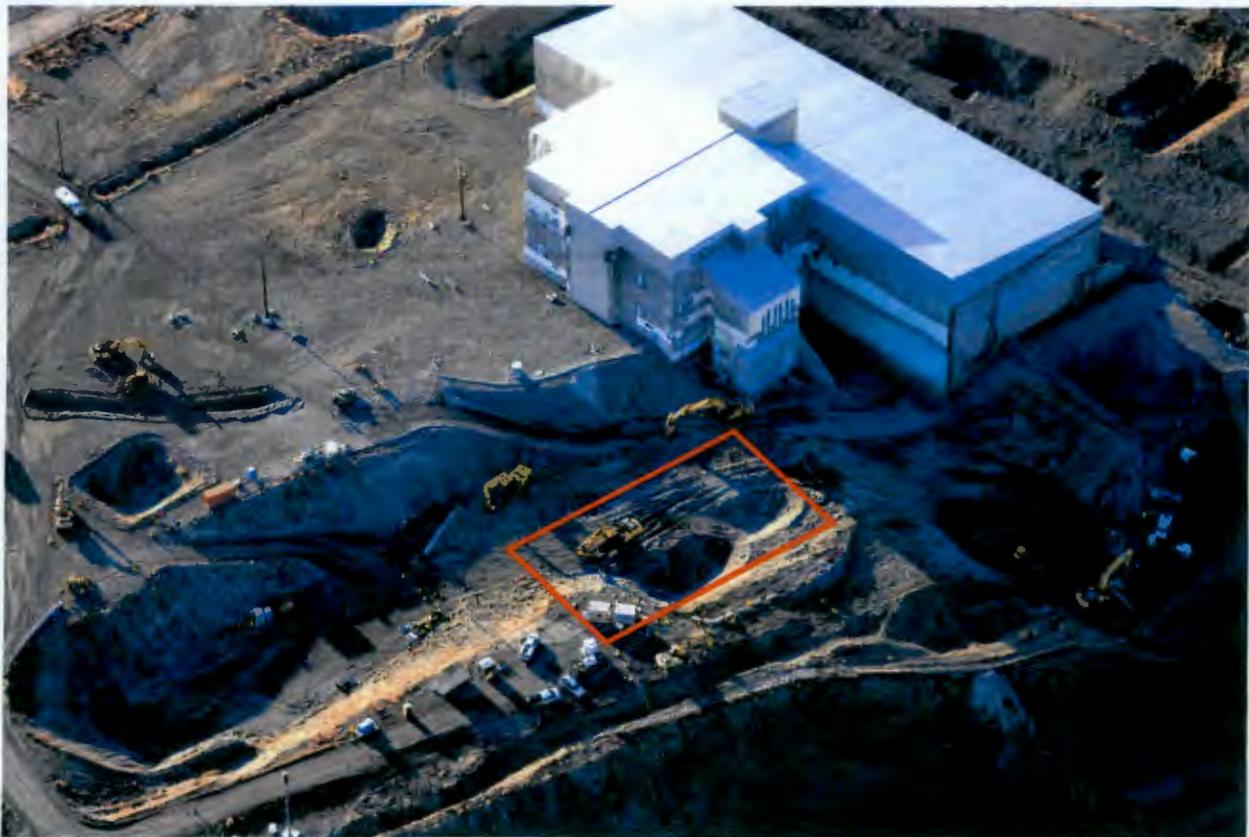
The entire footprint of the 1303-N facility has been incorporated into WIDS site 118-N-1. This WIDS site is comprised of the three silos of the 1303-N facility as well as the underlying and adjacent soil. The three silos were removed, along with some of the underlying and adjacent soil, from the 1303-N facility footprint by July of 2012 and sent to the ERDF for disposal. Post-demolition GPERS surveys performed at the soil remaining within the 1303-N facility footprint identified residual radiological contamination. This residual contamination will be addressed by the Field Remediation organization as part of WIDS site 118-N-1. No other WIDS site remains within the 1303-N excavation boundary. The excavation has not been backfilled.

1303-N Post-Demolition (October 2012)

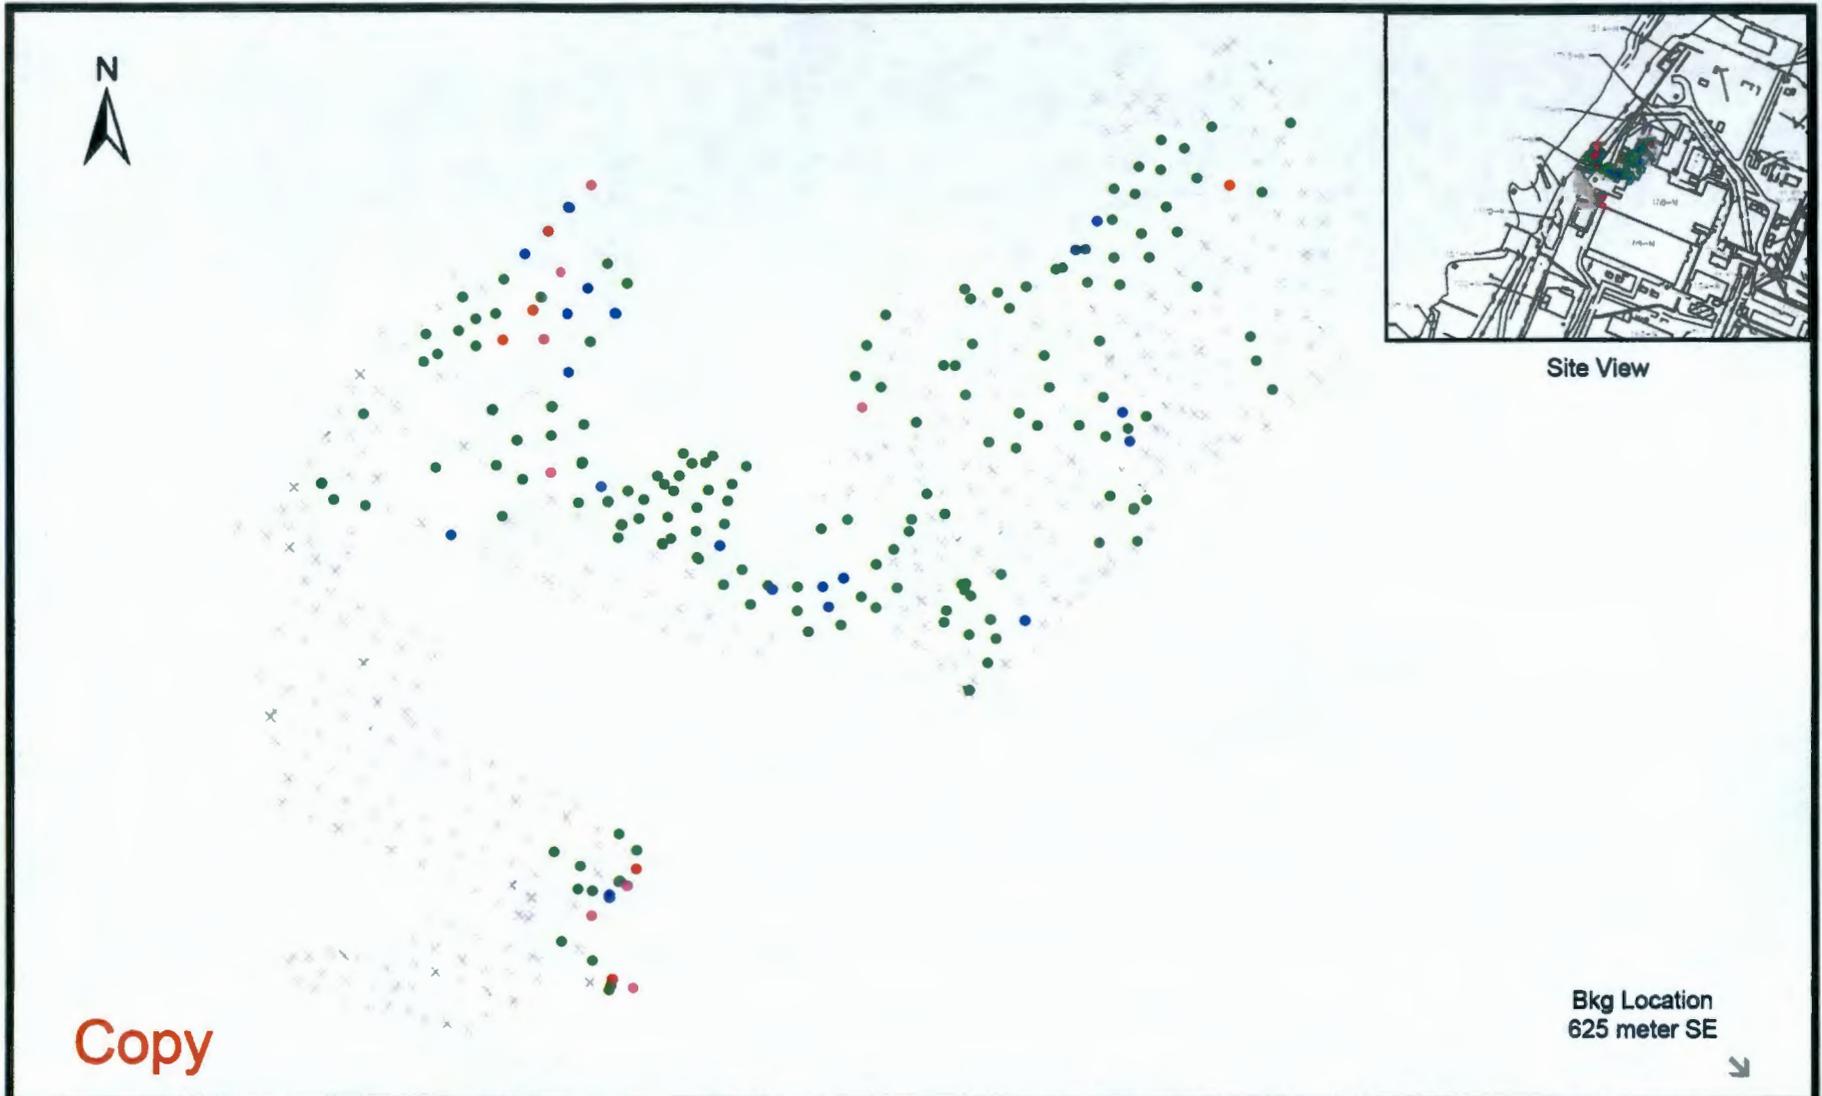
100N D4
1303-N Work Zones
GPERS Radiological Survey
Beta Track Map

Post-demolition Global Positioning Environmental Radiological Surveyor (GPERS) surveys were performed at the 1303-N Spacer Silos in December of 2012. Residual radiological contamination was detected during these surveys. The GPERS survey maps are included in Attachment 3 and are summarized in Table 1 below.

Legend	Summary Statistics
NET CPM	Coverage File: N, NN349, A, B, C
	Number of Data Pnts: 652
	Type of Survey: beta
	Max GCPM: 139,217
	Avg Bkg CPM: 401
	Survey Date: 12/14/2012
	Area Surveyed: 2250 m ²
	Project File: ESRFRM120150B
	Pdf File: ESRFRM120150BC

The post-demolition GPERS surveys performed within the historical footprint of the 1303-N Spacer Silos identified radiological contamination within the remaining soil. The entire footprint of the 1303-N Spacer Silos has been incorporated into WIDS site 118-N-1, and accordingly, the contamination remaining within the historical facility footprint will be addressed during activities performed for closeout of this WIDS site. These activities will be performed by the Field Remediation organization.

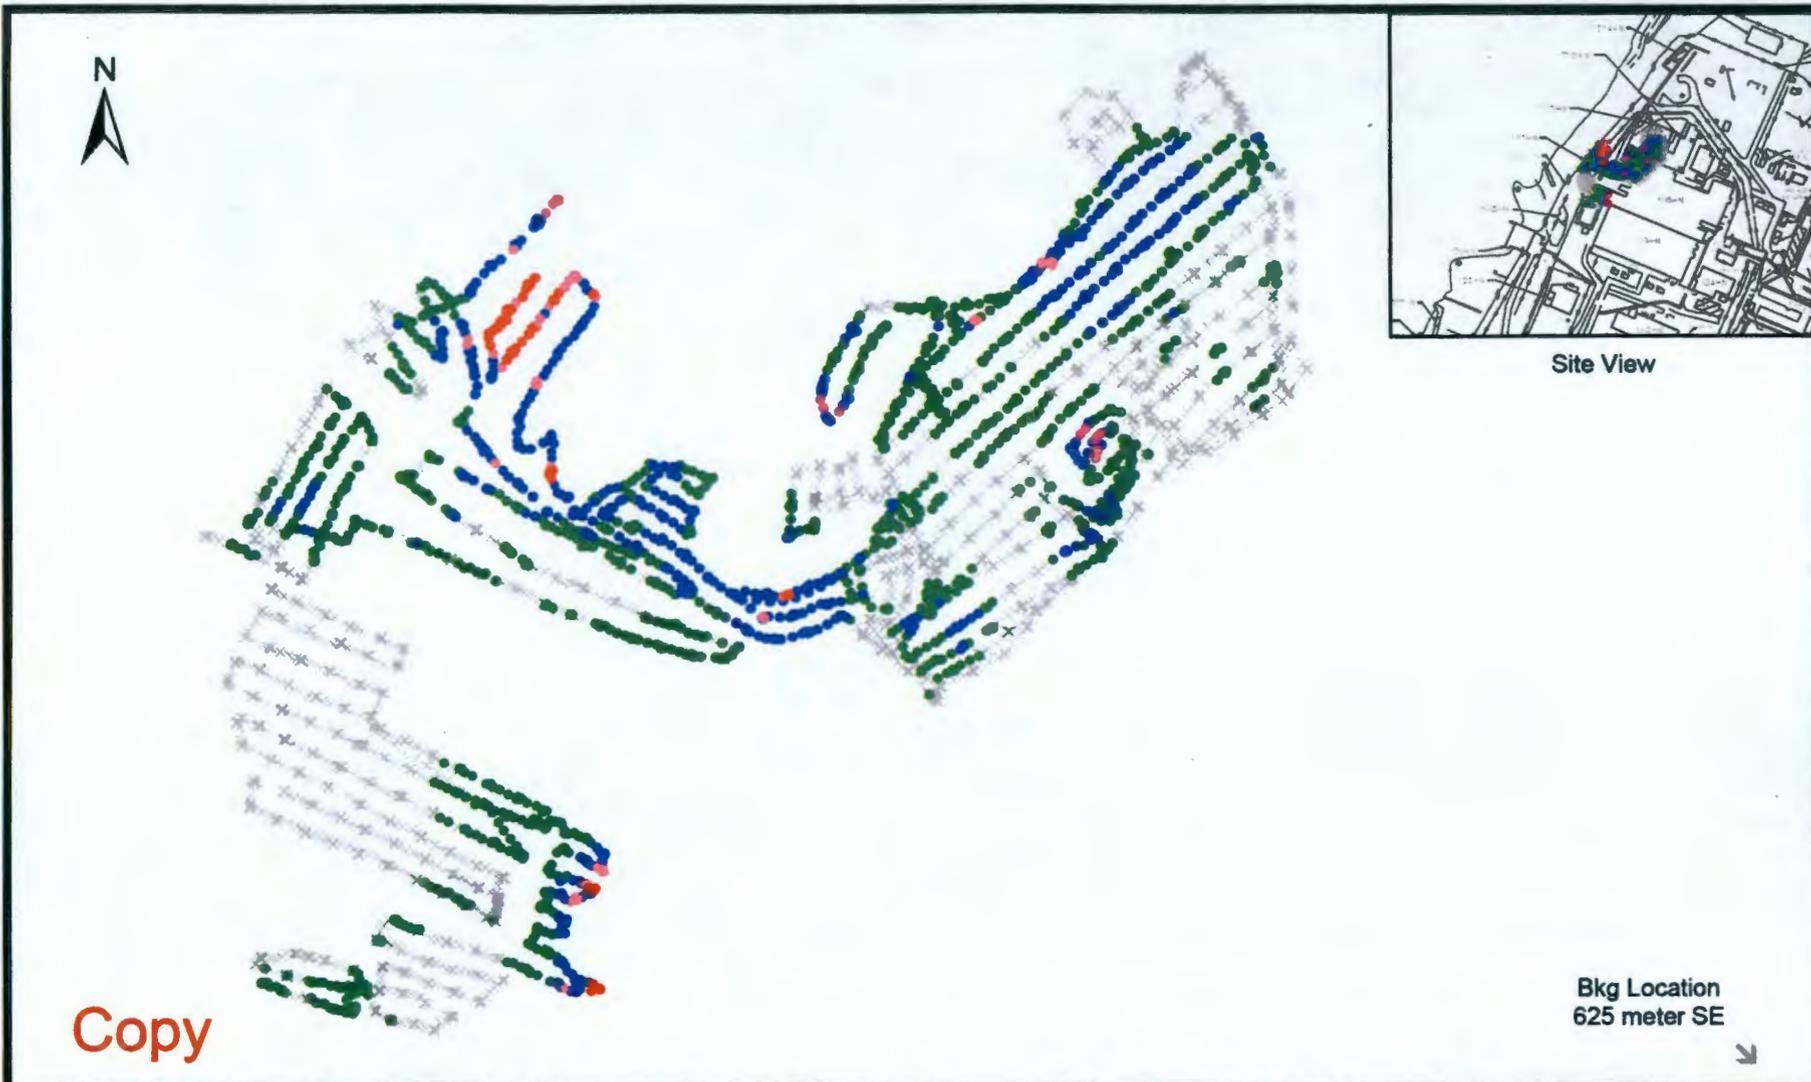
100N D4
1303-N Work Zones
GPERS Radiological Survey
Gamma Track Map

Legend	Summary Statistics
NET CPM	Coverage File: N,NN349, A,B,C
	Number of Data Pnts: 8717
X $1.5\times$ Bkg	Type of Survey: Gamma
● 1.5x Bkg - 10000	Max GCPM: 680,272
● 10000 - 50000	Avg Bkg CPM: 1327
● 50000 - 100000	Survey Date: 12/14/2012
● >100000	Area Surveyed: 2250 m ²
	Project File: ESRFRM120150G
	Pdf File: ESRFRM120150GC

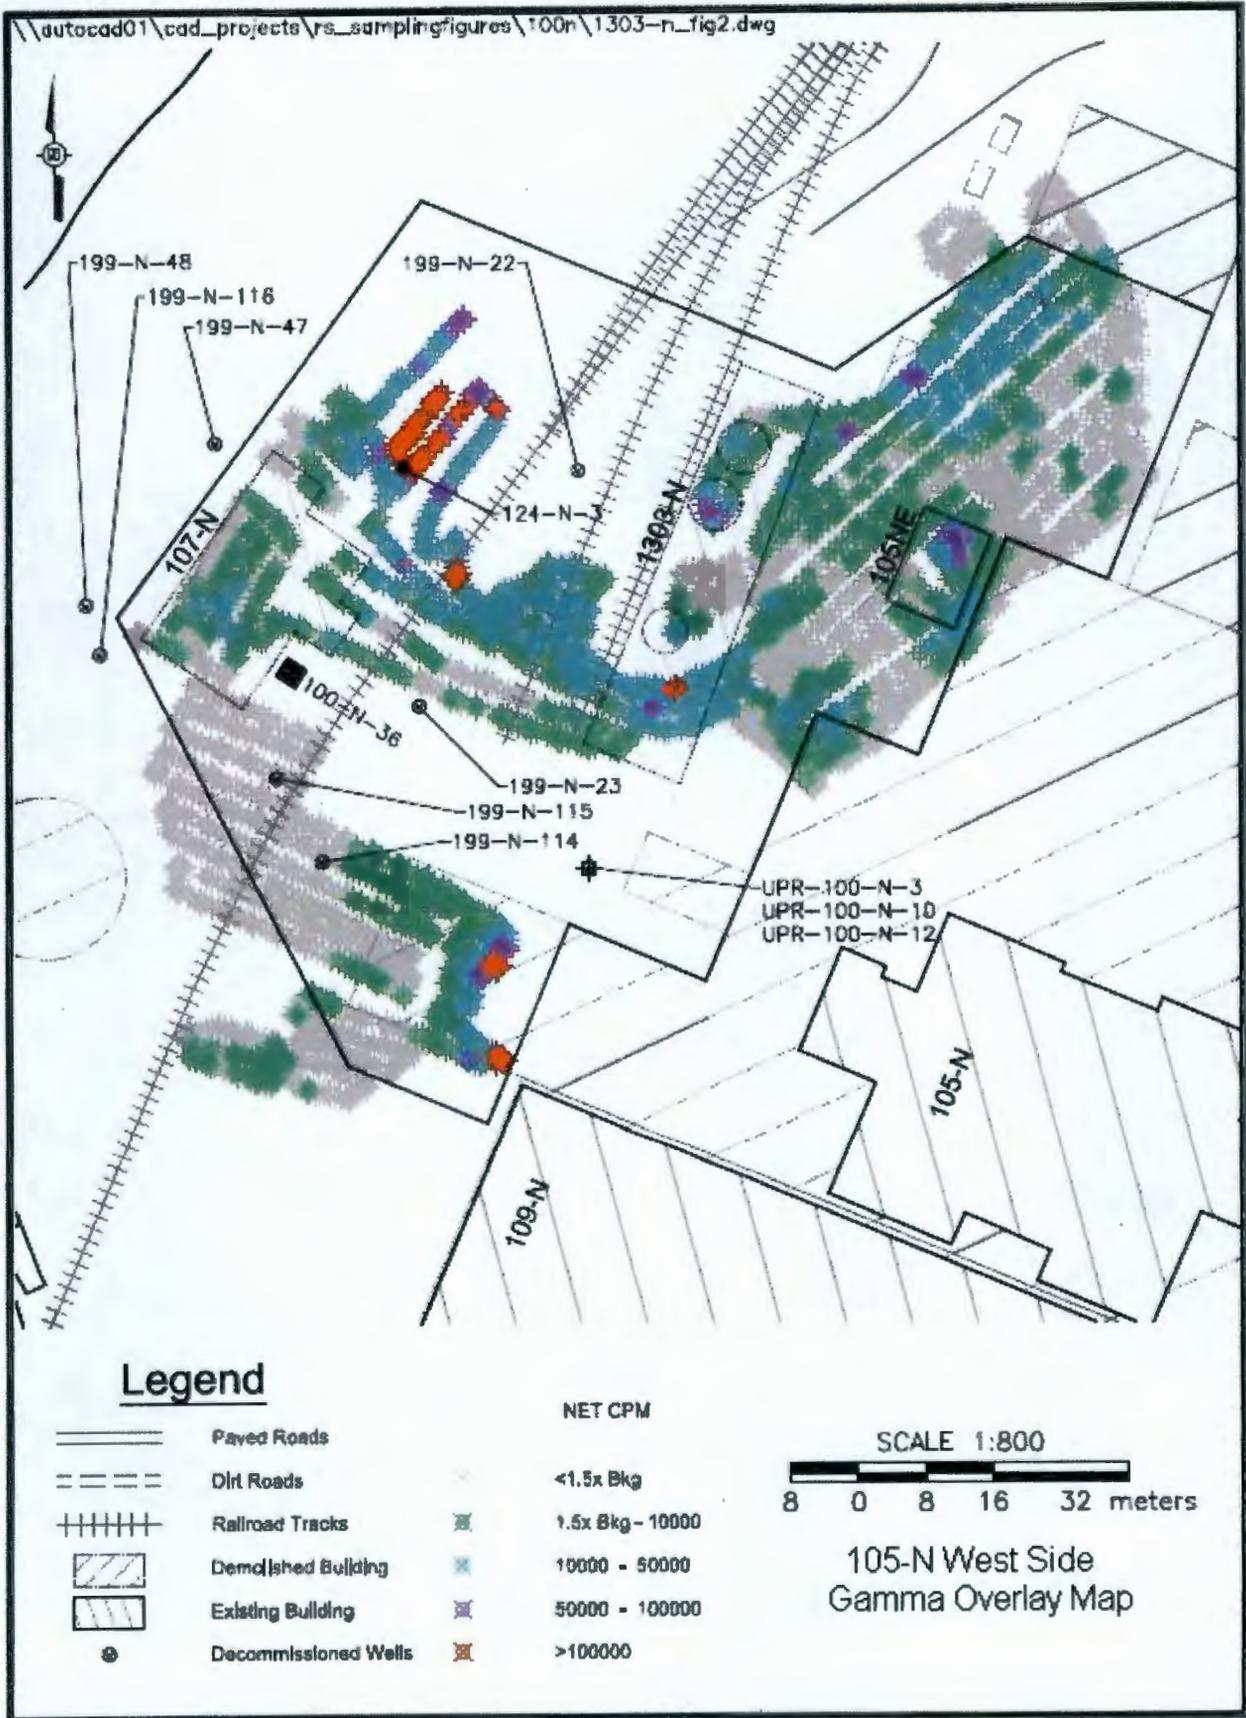
GPERS Gamma Map Location Overlay (for reference purposes only)

Post-demolition GPERS surveys identified elevated levels of radiological contamination within, and adjacent to, the 1303-N facility footprint (ESR-FRM-12-0150BC, ESR-FRM-12-0150GC, GPERS Beta Map Location Overlay [attached to this form], and GPERS Gamma Map Location Overlay [attached to this form]).

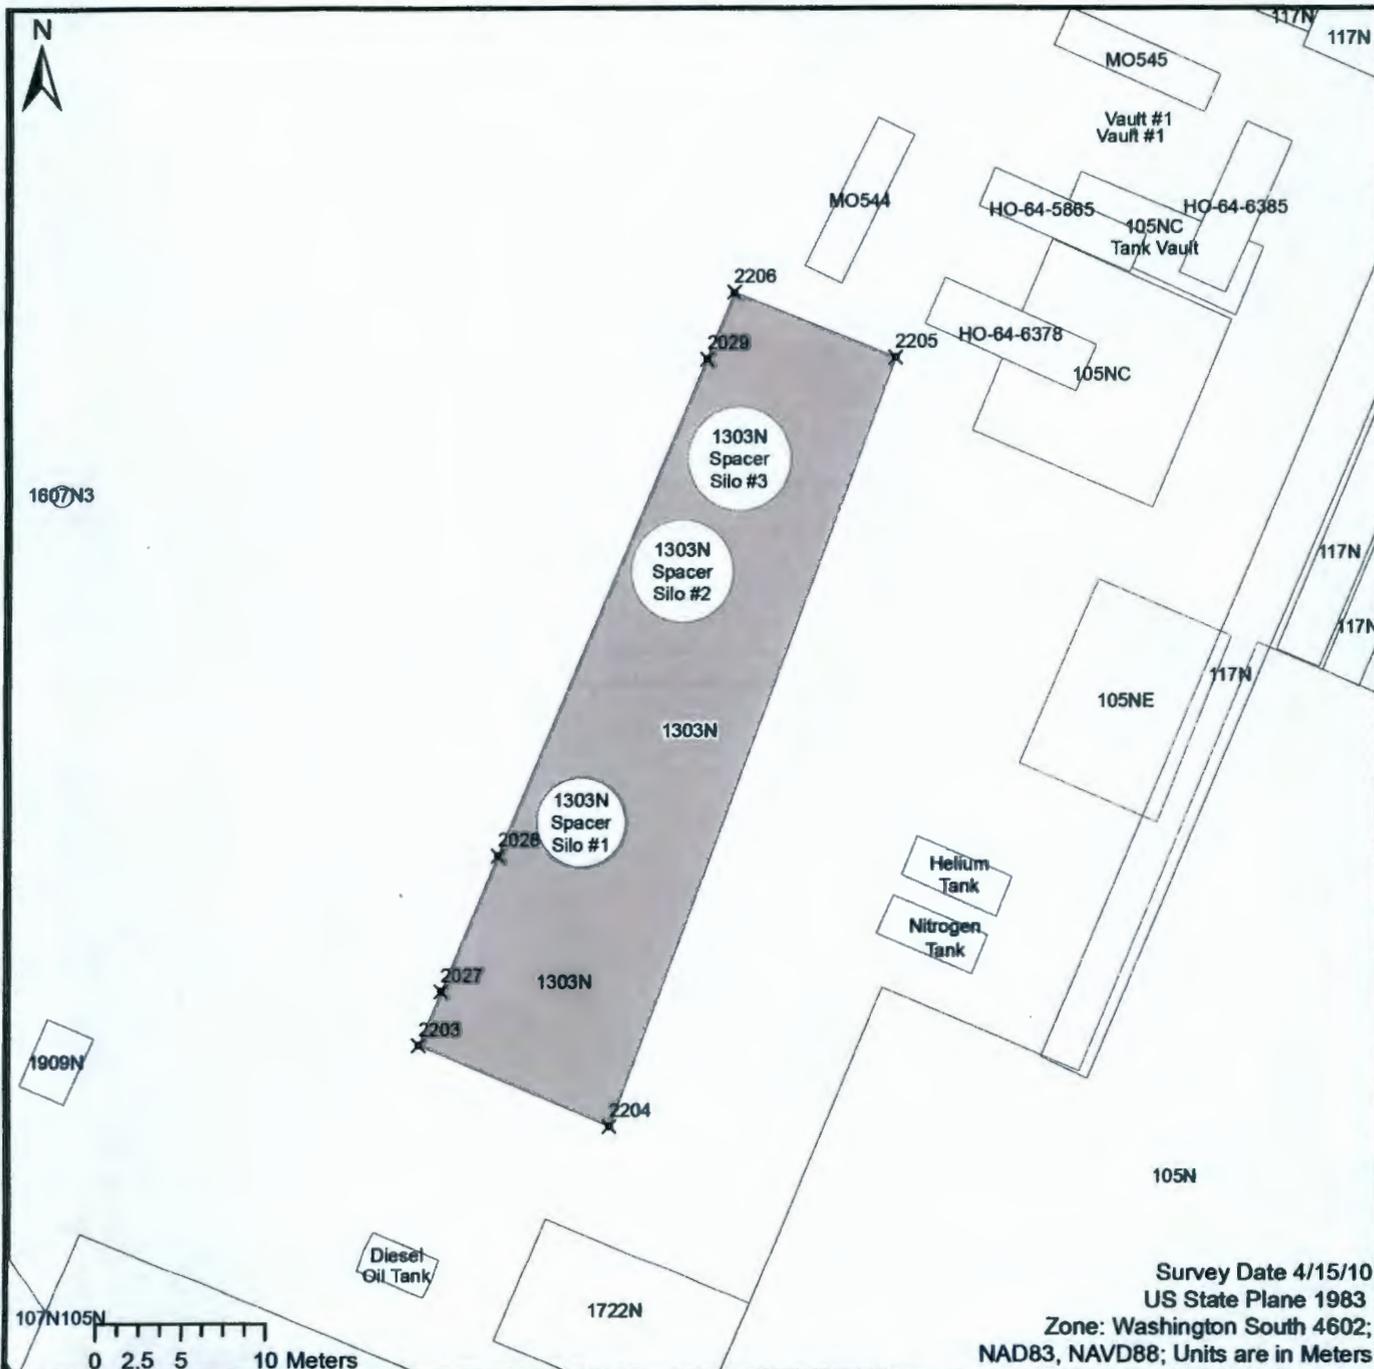
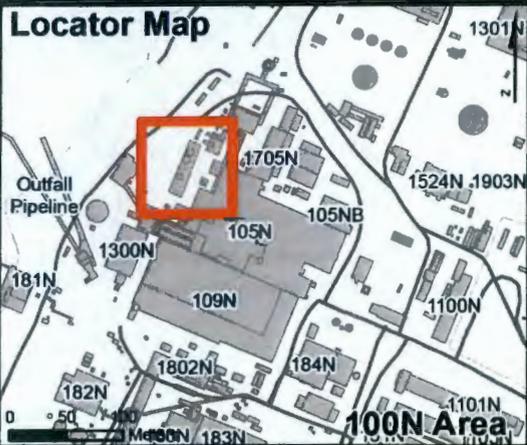
GPS Pre Demo Survey Report For 1303N Building

A pre-demolition Global Positioning System (GPS) survey was performed at the 1303-N Spacer Silos in April of 2010. A post-demolition GPS survey was performed at the 1303-N Spacer Silos excavation footprint in December of 2012. Copies of these GPS surveys are provided in Attachment 4.

- × GPS/GIS Point Locations
- 1303N Building
- Historic Building Locations

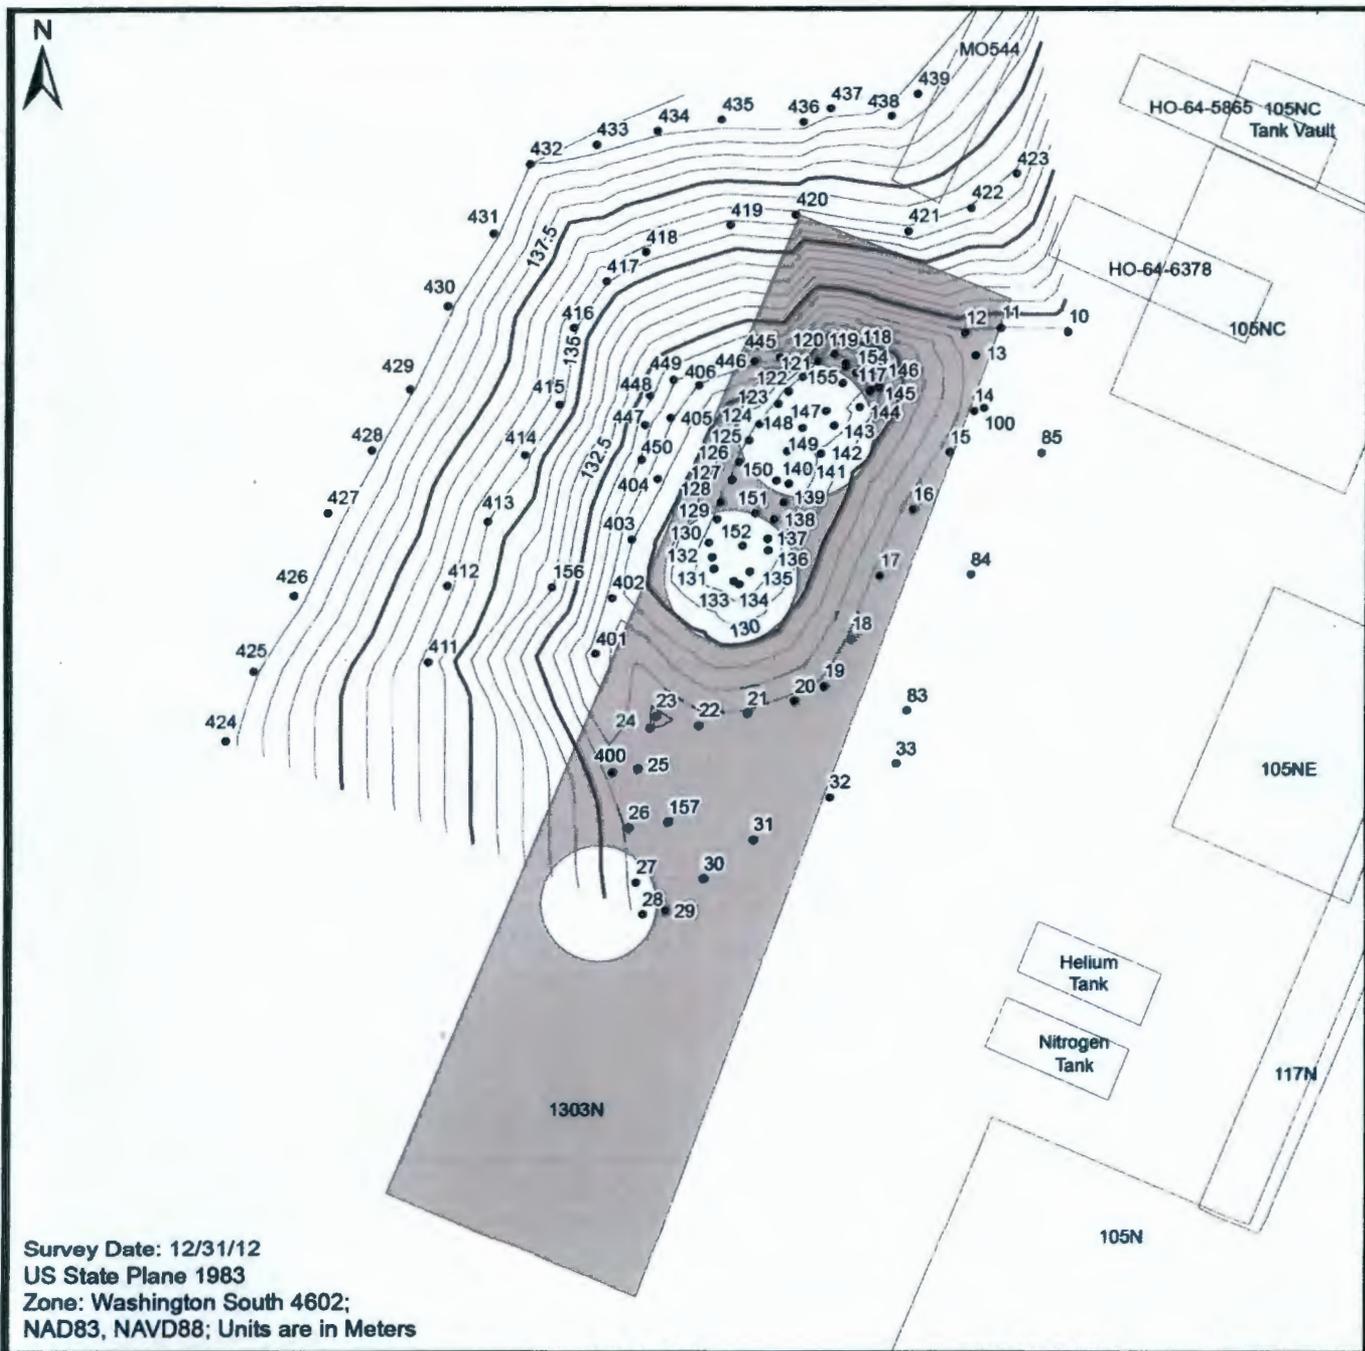
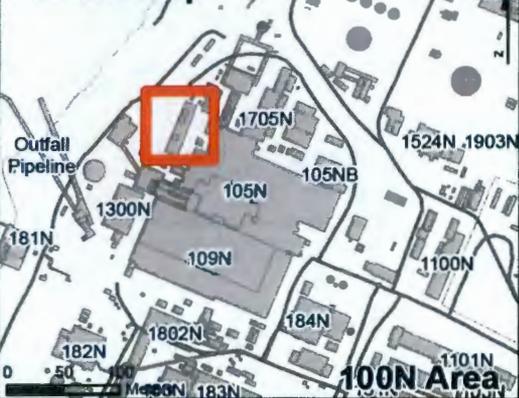
GPS Pre Demo Survey Report For 1303N Building

GPS surveys were performed to document the location of the 1303-N facility prior to its demolition as well as the extent of the excavation required to demolish and remove the facility. Table 5 below summarizes the contaminants of concern for removal of the 1303-N facility. Photographs are included in Attachment 2. All pertinent GPERS surveys are included in Attachment 3 and all pertinent GPS surveys are included in Attachment 4.

Survey Date: 12/31/12
 US State Plane 1983
 Zone: Washington South 4602;
 NAD83, NAVD88; Units are in Meters
