FACILITY STATUS CHANGE FORM

Date Submitted: 02/14/2019	Area: 200W	Control Number: D4-PFP-068 D4-PFP-069
Originator: James Leary	Facility ID: 291Z and 291Z001	Phone: 509-942-6675
Action Memorandum/Removal Action Work Plan: DOE/RL-2005-13 / DOE/RL-2011-03		
This form documents the status of facility decontamination, deactivation, decommissioning, and demolition operations or debris removal in accordance with the applicable regulatory decision documents.		
Section 1: Facility Status		
<input checked="" type="checkbox"/> All D4 operations required by action memo complete.

The 291Z001 Main Exhaust Air Stack was deactivated and demolished to slab-on-grade in July 2017.

The 291Z Exhaust Air Filter Stack Building was deactivated, the above-grade portion was demolished, and the below-grade portion backfilled with work finishing in October 2017.

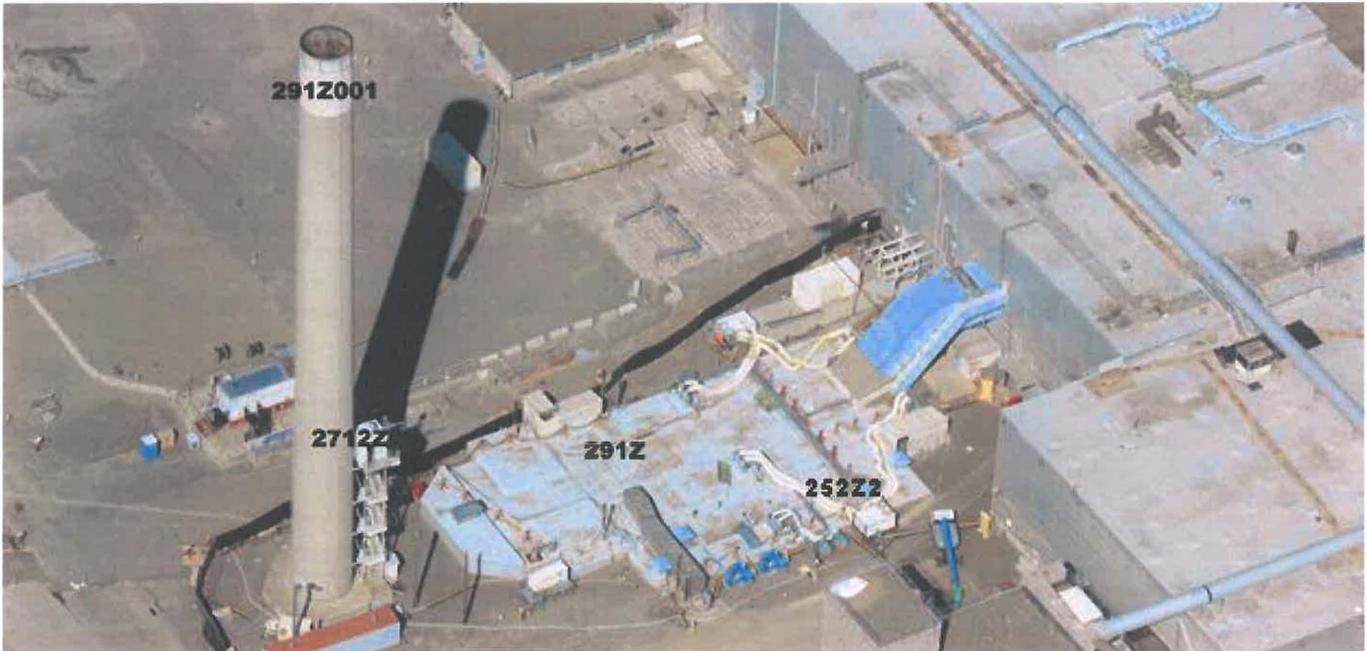
Figure 1. 291Z001 Exhaust Stack and 291Z Exhaust Air Filter Stack Building: Pre-Demolition

A 200-ft reinforced concrete stack, the 291Z001 Exhaust Stack expels through a large plenum from 291Z. The stack's inside diameter is approximately 15 ft. The stack foundation is a massive concrete footing block that is roughly octagonal in shape and 32 ft across its flat sides. The foundation block is approximately 27 ft thick, and its top is approximately 3 ft above the finished grade. A 90-degree elbow opening in the footing connects the bottom of the stack to the main exhaust duct from 291Z. The 2712Z monitoring building was attached to the stack at the 50-ft level with stairs leading up to the building.

The 291Z Exhaust Air Filter Stack Building is a reinforced concrete structure south of the central part of the 234-5Z Building. Of irregular shape, its approximate dimensions are 74 by 143 ft. Its overall height is approximately 23 ft, with only 4 ft above-grade. This structure houses the exhaust fans, mechanical service equipment, and electrical substation 252Z2, which is located in the northwest corner in room 500 of the 291Z Building.

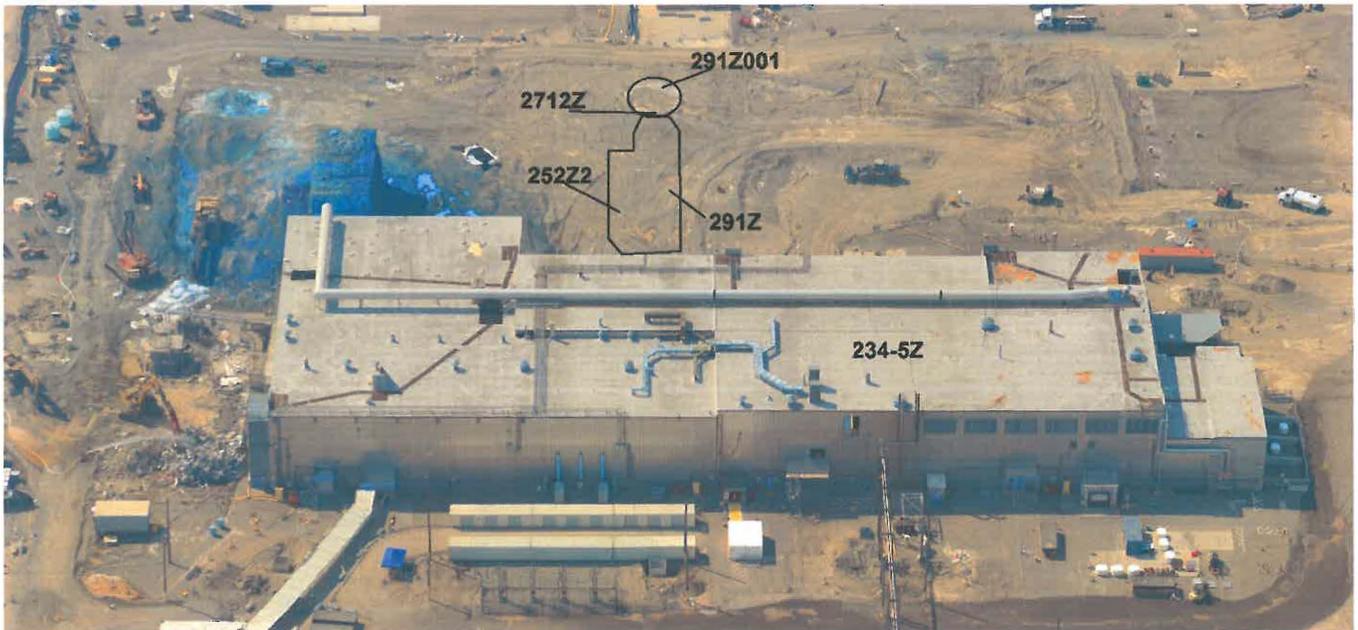
Figure 2. 291Z Facility Post-Demolition

291Z001 Exhaust Stack: The 291Z001 Exhaust Stack was removed to the grade-level stack base pedestal. The demolition filled the below-grade portion of the stack.

291Z Exhaust Air Filter Stack Building: The roof and above-grade portions of walls of the 291Z Building were removed. Asbestos and hazardous materials were removed during pre-demolition preparation activities. TRU items were also removed prior to demolition except for two objects that were removed as specially handled items during demolition. Items remaining in below-grade space include demolition debris, the stabilized duct from 232Z, and fixed equipment such as piping, motor control centers, transformers, switch gear, substation, fans, motors, and compressors. The below-grade space was backfilled to grade See CWR-PFP-00014, 2017, 291Z Demolition Report, Rev. 0.
