## FACILITY STATUS CHANGE FORM

<b>Date Submitted:</b> July 8, 2013	<b>Area:</b> 300 Area	<b>Control #:</b> D4-300-086
<b>Originator:</b> Chris Strand	<b>Facility ID:</b> 331C	
<b>Phone:</b> 554-2720	<b>Action Memorandum:</b> DOE/RL-2010-22, Rev 0.

300 D4  
331C

GPERS Radiological Survey  
Beta Track Map

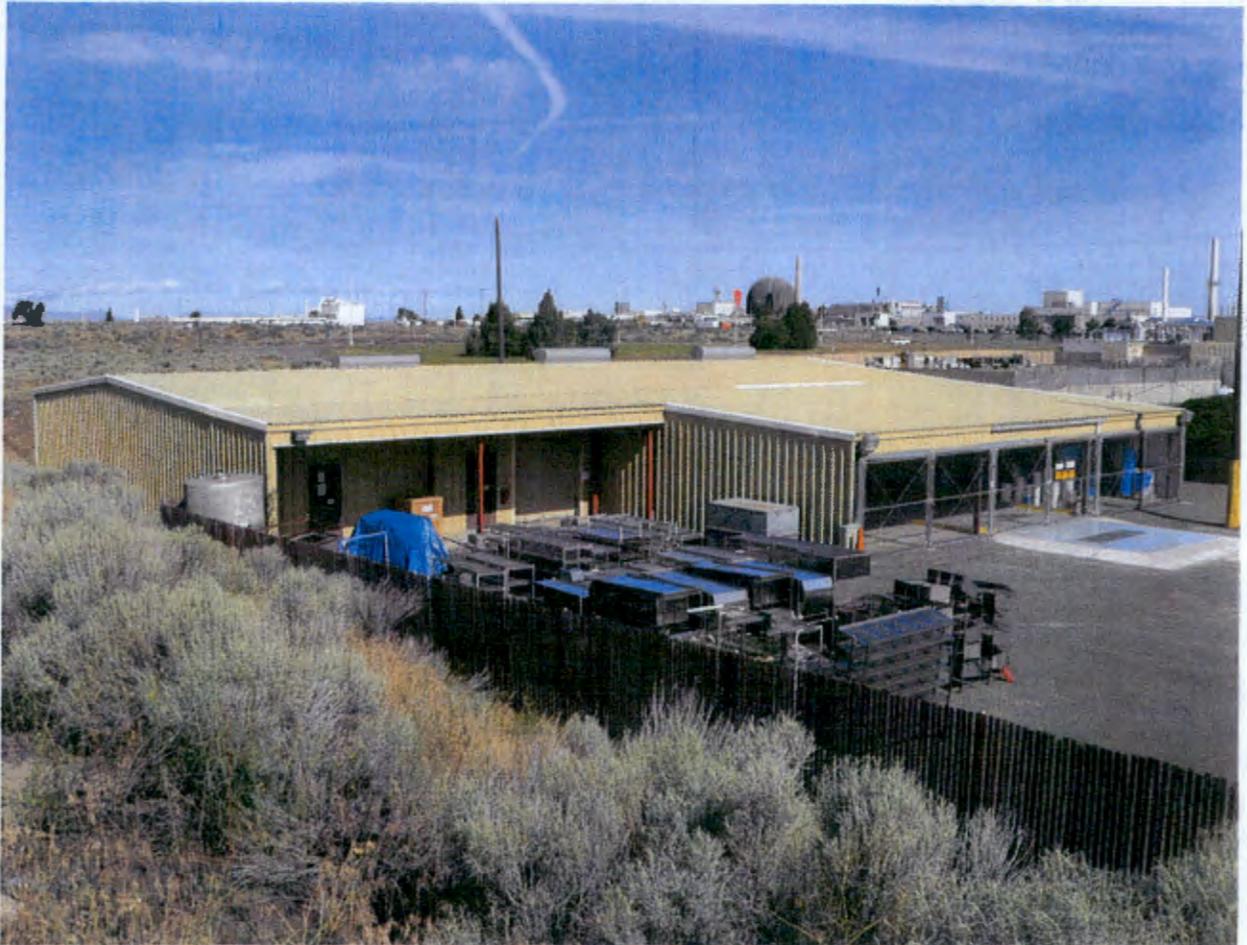
**Photograph 1: 331C, looking northwest on June 5, 2006.**

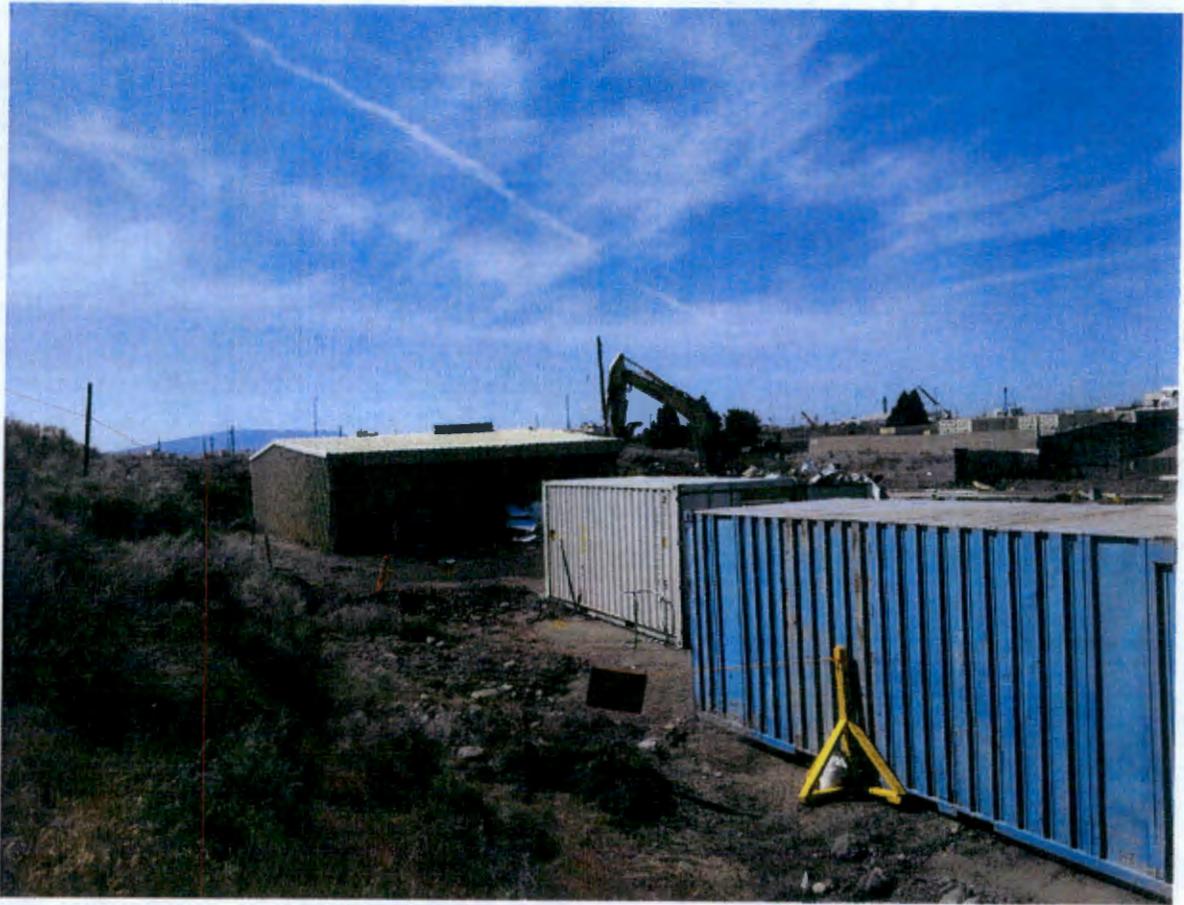
**Photograph 2: 331 during demolition looking west on May 1, 2013.**

Demolition: The 331C building was demolished in May of 2013. Demolition included both above-grade and below-grade structures. All debris was loaded out and disposed of at ERDF.

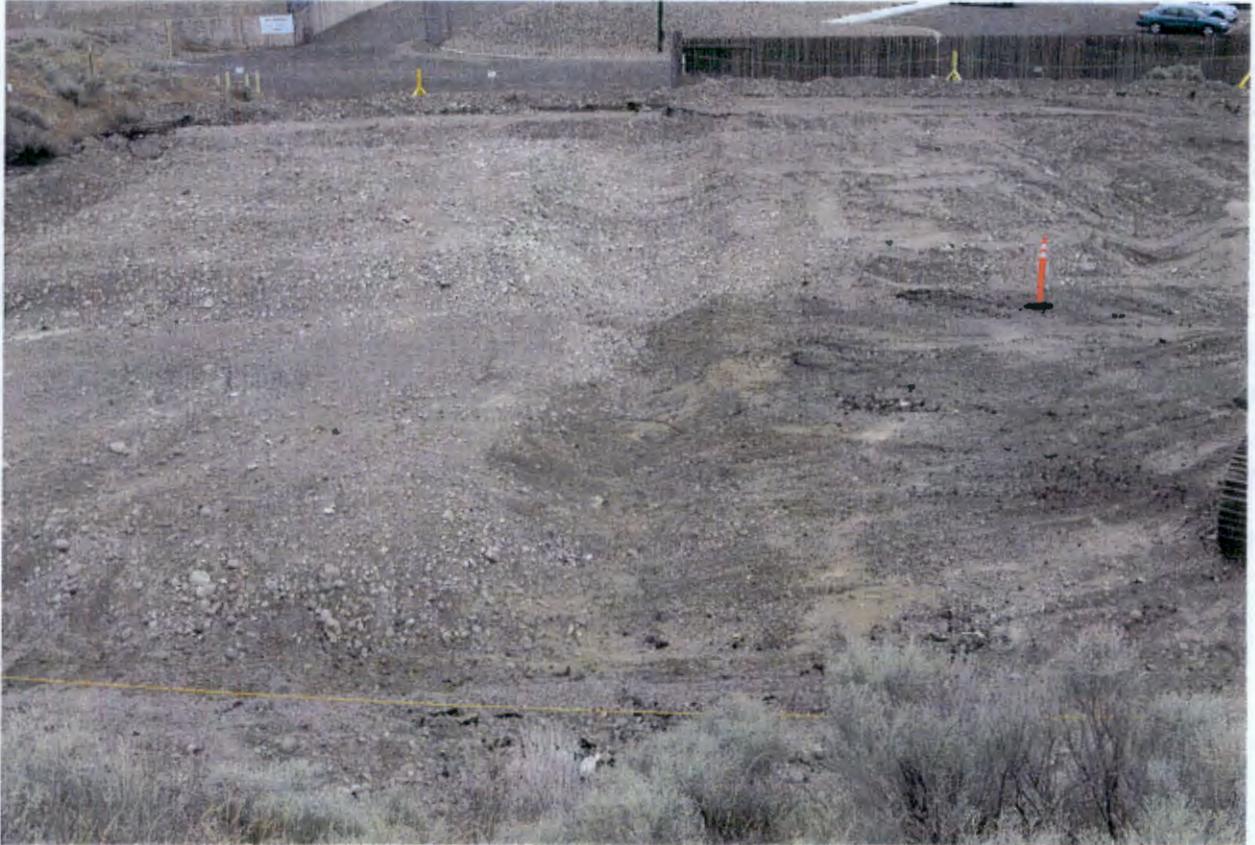
**Photograph 3: 331C Excavation following slab demolition,  
looking north on May 21, 2013.**

No anomalies were discovered during the below-grade removal of 331C. No soil staining within the excavation was observed and GPERS surveys identified no radiological contamination. The excavation was backfilled with clean fill material.

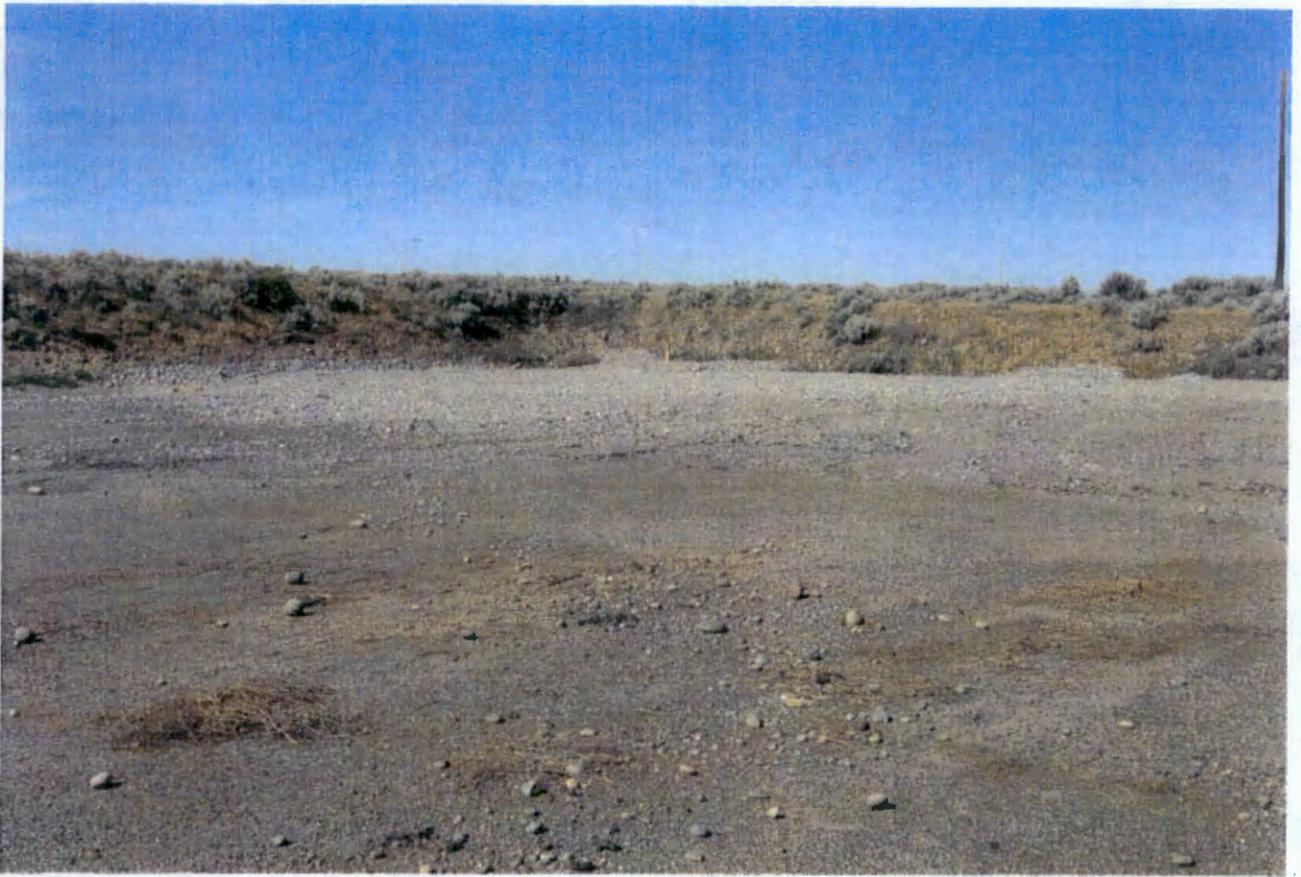
**Photograph 4: 331C following backfill looking southwest on July 3, 2013.**

The excavation was backfilled with clean material following GPERS Surveys. No radiological or IH postings remain.

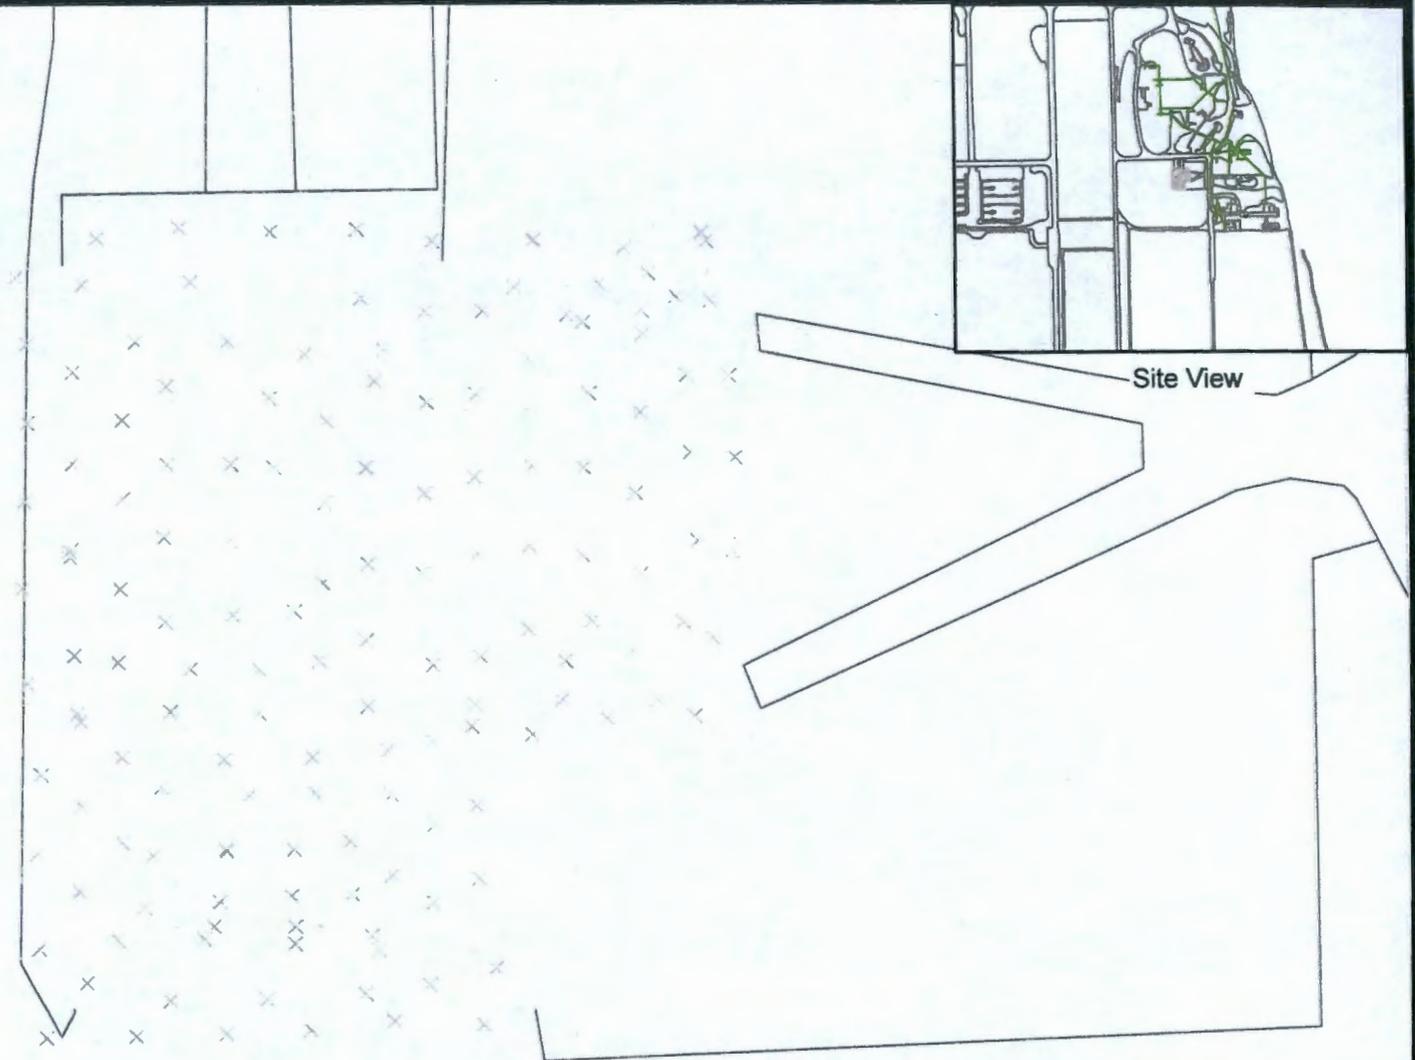
Bkg Location  
1,185m NW  
295 cpm

Coverage File: D4\_0150  
Number of Data Pnts: 160  
Type of Survey: beta  
Max GCPM: 508  
Avg Bkg CPM: 295  
Survey Date: 5/30/2013  
Area Surveyed: 885 m<sup>2</sup>  
Project File: ESRFRM130043B  
Pdf File: ESRFRM130043BC

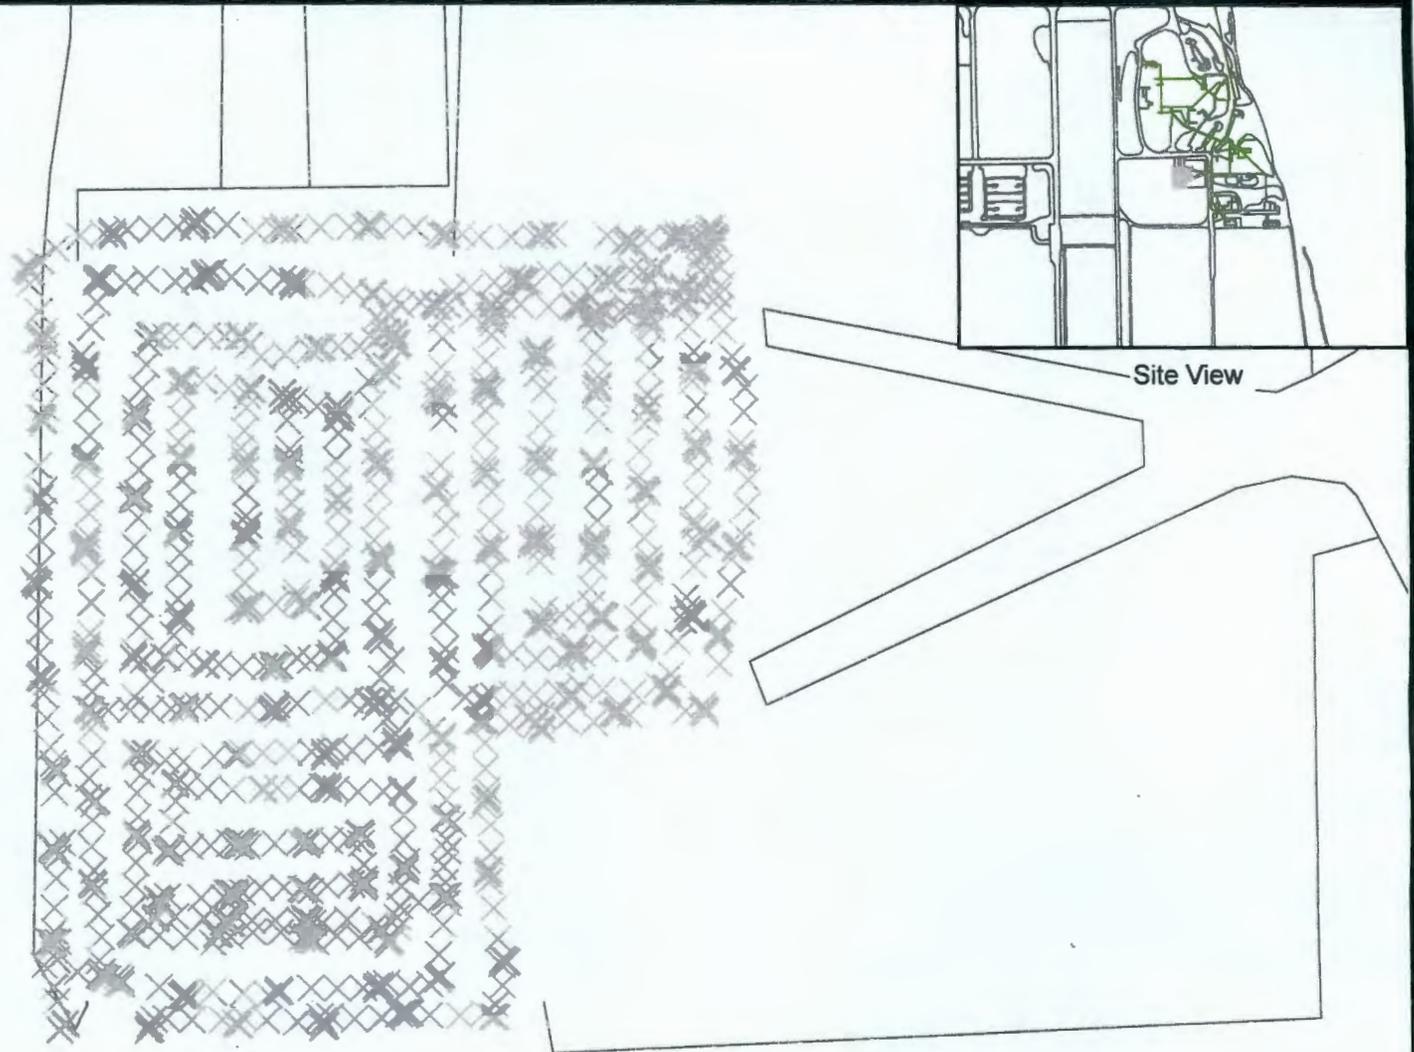
**GPERS Radiological Survey**  
**Gamma Track Map**

Bkg Location  
1,185m NW  
1028 cpm

Coverage File: D4\_0150  
Number of Data Pnts: 2007  
Type of Survey: gamma  
Max GCPM: 2221  
Avg Bkg CPM: 1028  
Survey Date: 5/30/2013  
Area Surveyed: 865 m<sup>2</sup>  
Project File: ESRFRM130043G  
Pdf File: ESRFRM130043GC
