FACILITY STATUS CHANGE FORM

Date Submitted: 1/24/2017	Area: 200W	Control Number: D4-PFP-046
Originator: James Leary	Facility ID: 2729Z	Phone: 509 942-6675

2729Z Storage Building

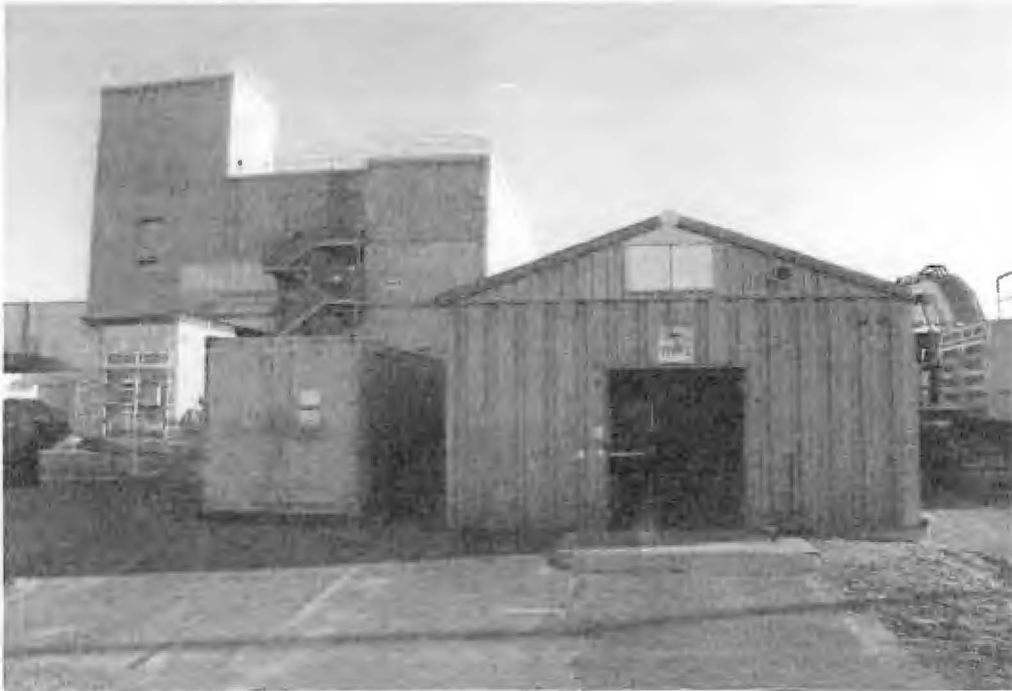
Figure 1. 2729Z Pre-demolition

The 2729Z building was constructed in 1966. The building was a 1600 ft² prefabricated structure placed on a concrete slab. The building had one general open space with a single room used for bottle cart storage. In 2010, the building was converted to a machine shop.

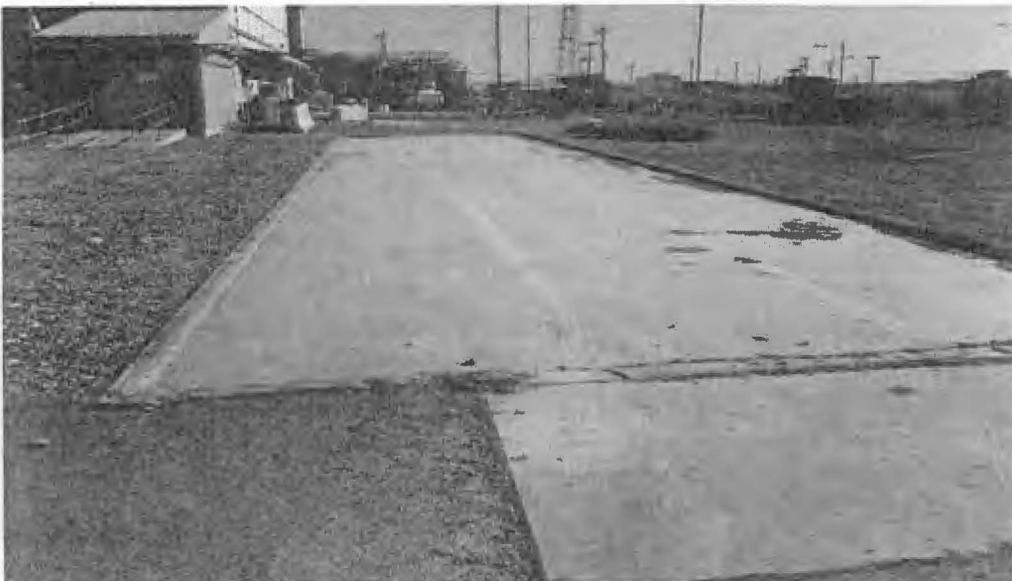
Figure 2. 2729Z Post-demolition

Building 2729Z was deactivated and demolished to slab-on-grade July and August 2016. Deactivation and demolition actions completed included, but were not limited to, the following:

No anomalies were discovered during demolition. Soils around the slab displayed no visual evidence of staining or discoloration.
