241ZRB Retention Basin (207Z) Demolition Report

As Left Characterization

Document Type: RPT Program/Project: PFP Closure

Date Published
February 2017

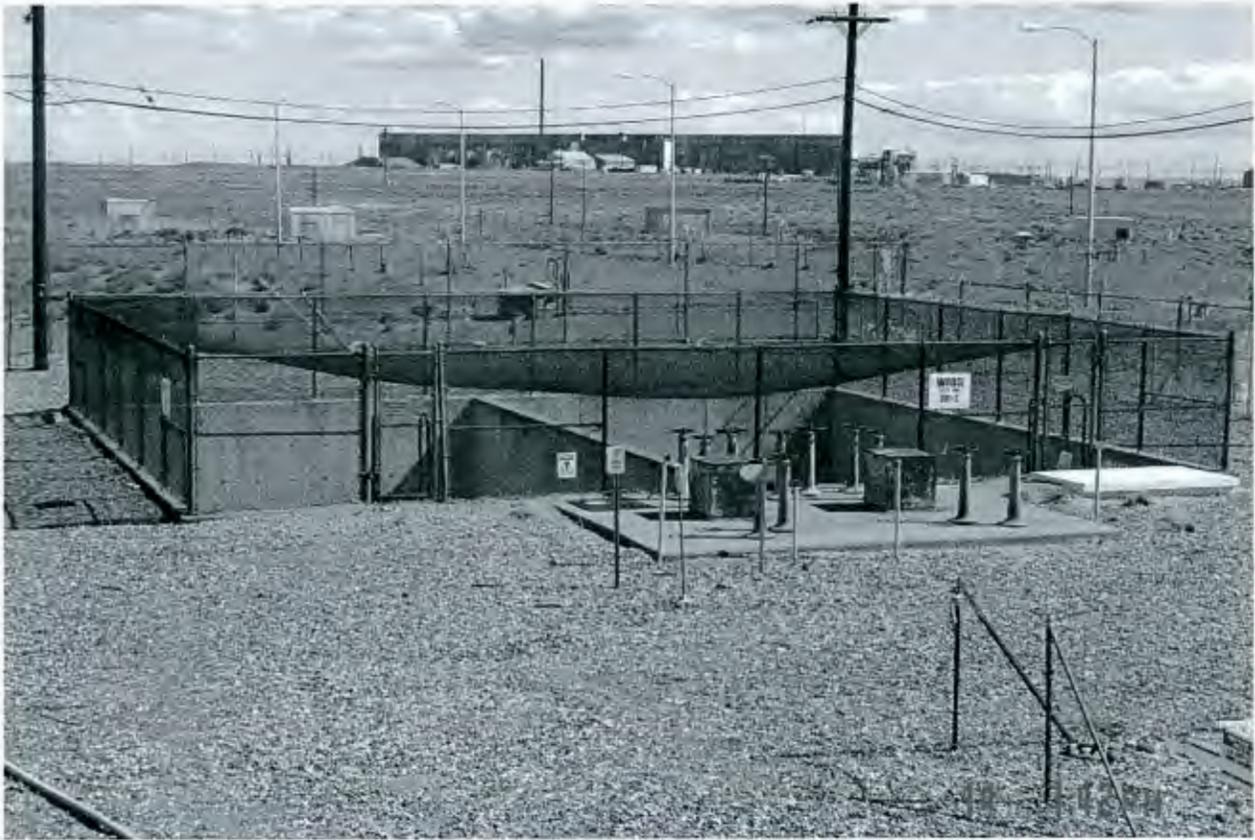
Figure 1. PFP Retention Basin and Valves Before Demolition

The basins were located in the southeast corner of the PFP Complex and provided a holding and sampling area of waste water associated with the PFP Complex. The retention basins themselves were two side by side concrete structures, approximately 40 ft long by 22.5 ft wide by 10 ft deep. The operating volume for each basin is roughly 8,550 ft³, for a total of about 17,100 ft³. A valve pit is also located at the west side of the basins, below-grade, in a covered vault.

The 241ZRB (Figure 1) volume was approximately 17,100 ft³, and it was constructed in 1948 using reinforced concrete. The building was located inside the PFP fenced area at longitude/latitude 119.63183/46.54931.

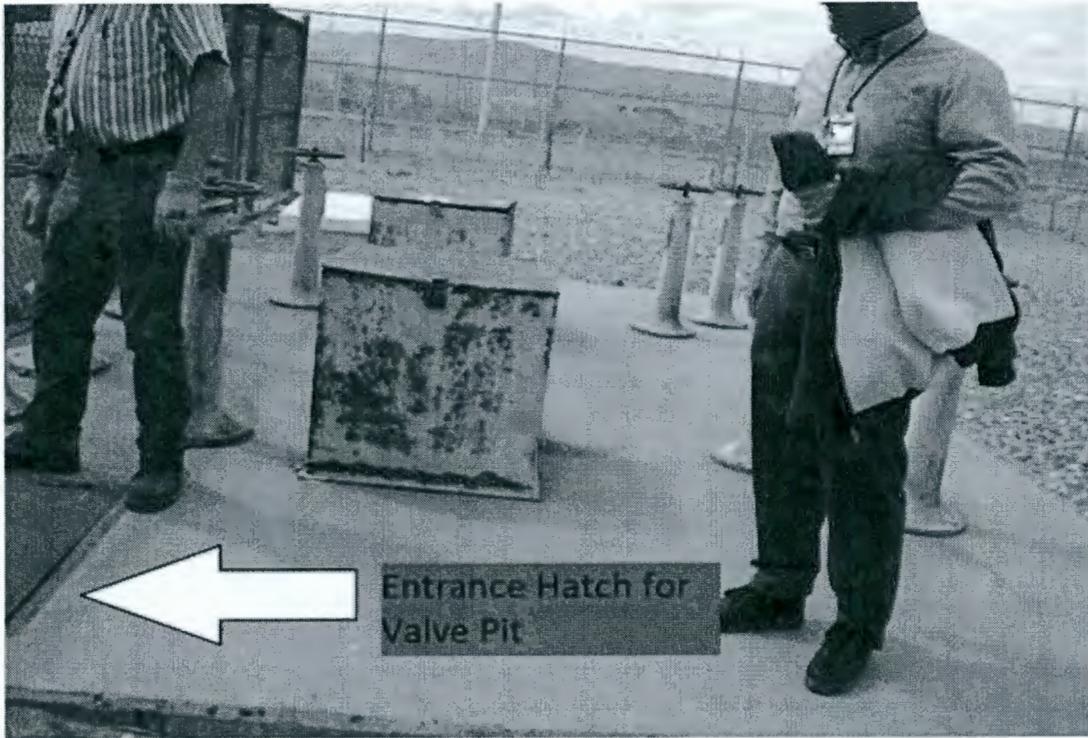
Figure 2. PFP Retention Basin Valve Pit Surface Level Before Demolition

The retention basin valve pit has an internal volume of approximately 2,200 ft³ and was constructed at the same time and adjacent to the retention basin (1948). The valve pit housed all of the required pumps and piping to direct the flow of waste water through the retention basins. The valve pit was constructed using reinforced concrete and measures 11 ft deep. Figures 2 through 4 provide different views of the valve pit.

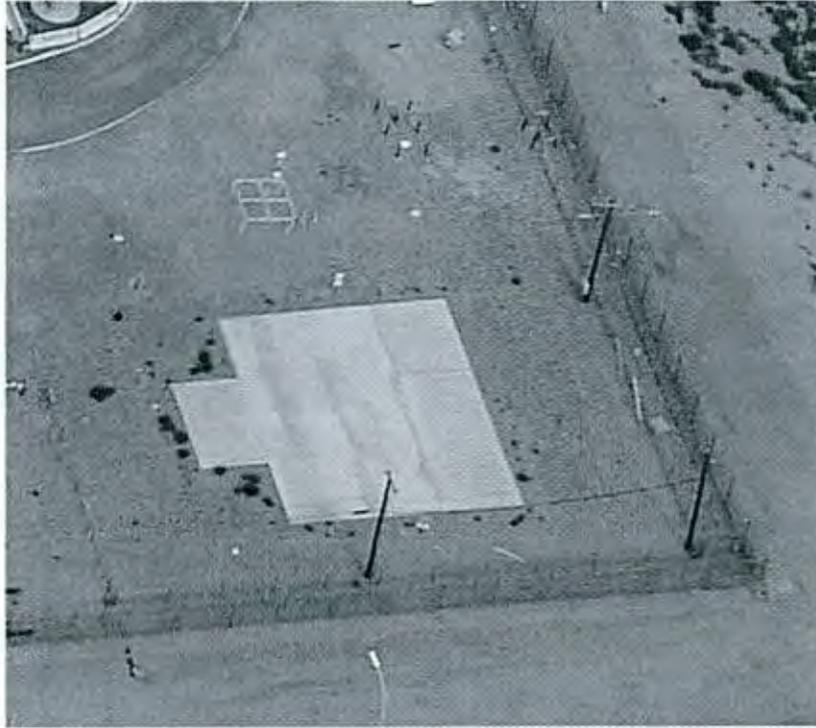
Figure 5. 241ZRB Facility after Stabilization

The facility was left in a clean slab-on-grade condition (Figure 5), with all penetrations sealed, and the waste site was entered into the Waste Information Data System as 207Z.

There is no known unique radiological or chemical hazard associated with the slabs. There is no significant holdup identified in either the valve pit or the basins themselves.

The fence and loose debris were removed from the north and south basins. The basins and valve pit were filled with control density fill (CDF) by work packages 2Z-05-05336 (basin) and 2Z-06-00204 (valve pit). Composition of the CDF can be found in Appendix B of CWR-PFP-00005-ADD1. Waste from the valve pit stabilization and above-grade equipment was sent to the Environmental Restoration Disposal Facility. A contamination control cap was installed by work package 2Z-06-00380, *Install 241-ZRB Contamination Control Cap*.
