FACILITY STATUS CHANGE FORM

Date Submitted:	Area: 200W	Control Number: D4-PFP-029
Originator: James Leary	Facility ID: 243ZB	Phone: 509 942-6675

Attachment 1: Facility Information**243ZB, Cooling Towers and Concrete Pad**

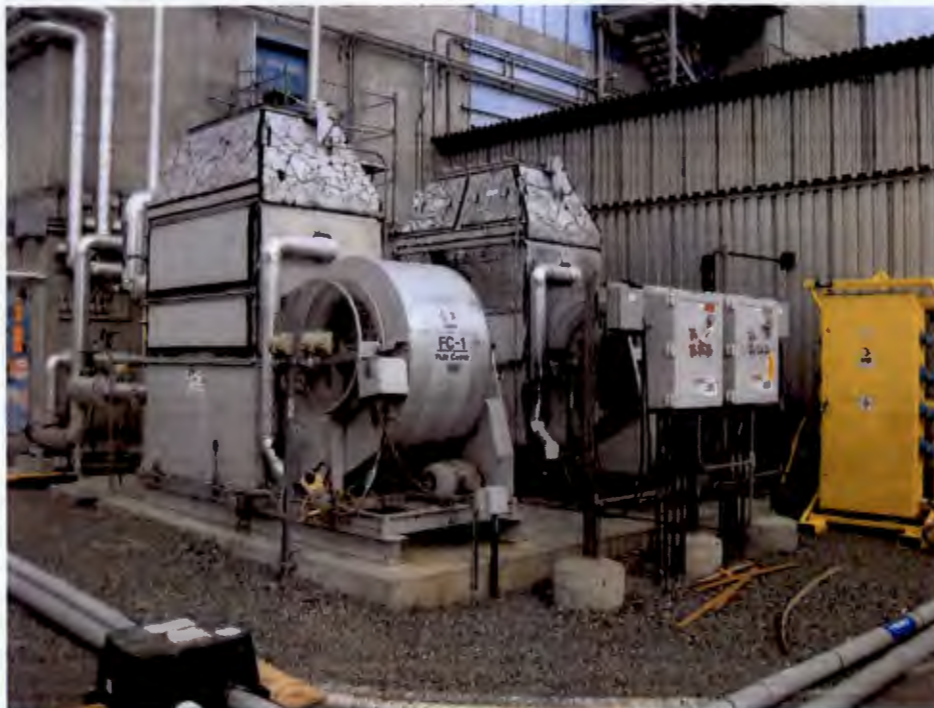
Figure 1. 243ZB Pre-demolition

The 243ZB Cooling Towers and Concrete Pad facility was affiliated with the 243Z Low Level Waste Treatment Facility. It was constructed in 1993 and was located north of the 243ZA Low-Level Waste Storage Facility. The two cooling towers were mounted on a concrete slab that is approximately 7.3 m (24 feet) by 4.6 m (15 feet). The 243ZB housed the closed-loop cooling water system and two fluid cooling units that supported 243Z Building operations.

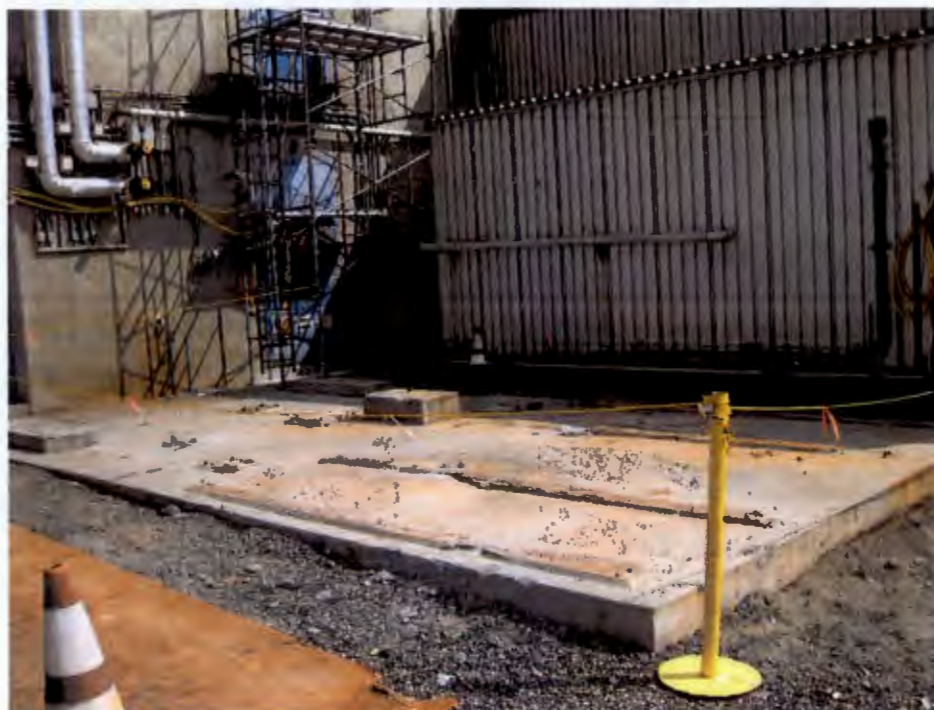
Figure 2. 243ZB Post-demolition

The 243ZB Cooling Towers are part of the PFP closed-loop cooling water system. The 243ZB slab has been left in place with all penetrations sealed and is in a suitable condition for D4 activities to proceed in adjacent areas. A walkdown of the area where the structure previously stood has been conducted to confirm that demolition is complete, waste has been removed and the area is properly posted in accordance with radiological and occupational safety requirements. (See Endpoint Criteria Checklist DOE/RL-2015-34, Rev 1, Appendix A, Section 1).

No anomalies were discovered during demolition. The slab remains in place, and all pipe penetrations (drains, sanitary water, etc.) have been isolated, cut flush to the slab, and sealed. Soils around the slab displayed no visual evidence of staining or discoloration.
