FINAL REPORT

CONSTRUCTION QUALITY ASSURANCE (CQA)

CQA PHOTOGRAPH LOG WEEK 29
(8/23/10 TO 8/27/10)

ERDF CONSTRUCTION CELLS 9-10

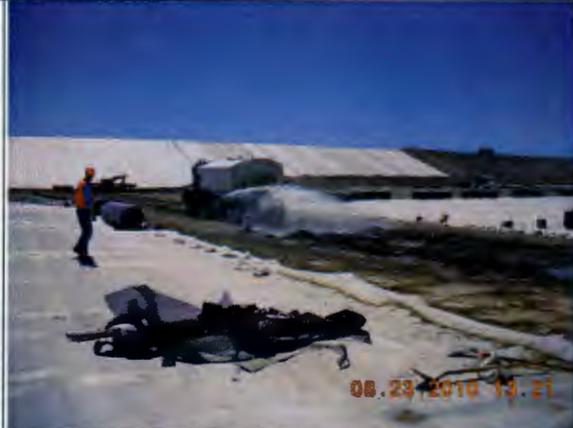
08.23.2010 13.21

Facing SW – TWS moisture conditioning the admix surface prior to recompacting the admix.

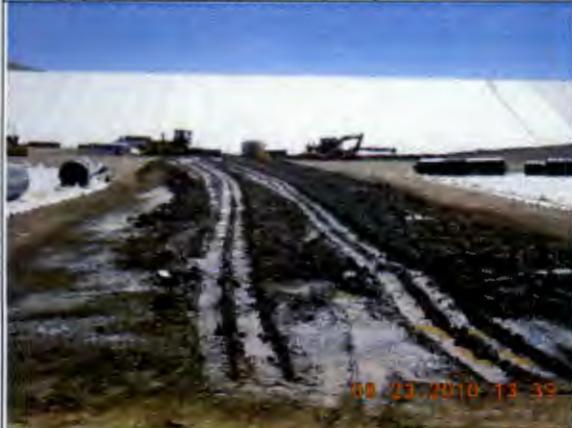
08.23.2010 13.39

Facing S – ESI preparing to use the CAT 825 to compact the admix on the Cell 10 secondary sump haul road.

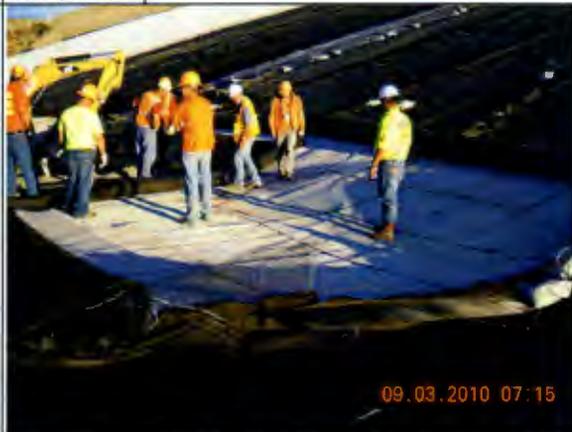
<p>09 02 2010 15:06</p>

<p>09.03.2010 07:15</p>
<p>Facing SW – ESI and TWS removing the drainage gravel in the Cell 9 sump to investigate the storm water infiltration.</p>	<p>Facing NW – ESI, TWS, and CQA continuing the investigation the following day.</p>

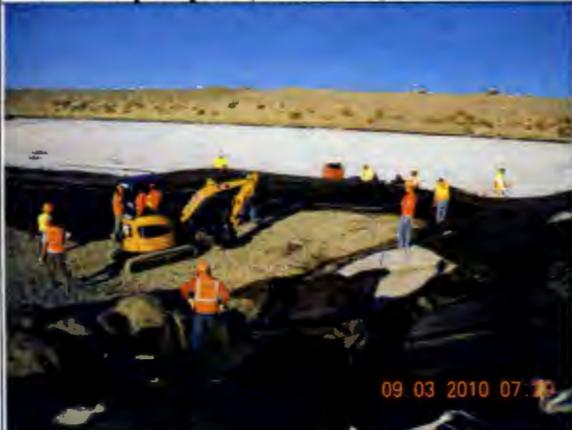
<p>09 03 2010 07:23</p>

<p>09 03 2010 07:46</p>
<p>Facing SW – ESI, TWS, and CQA tracing the source of the stormwater to the northwest corner of the sump.</p>	<p>Facing SW – The source of the stormwater infiltration.</p>

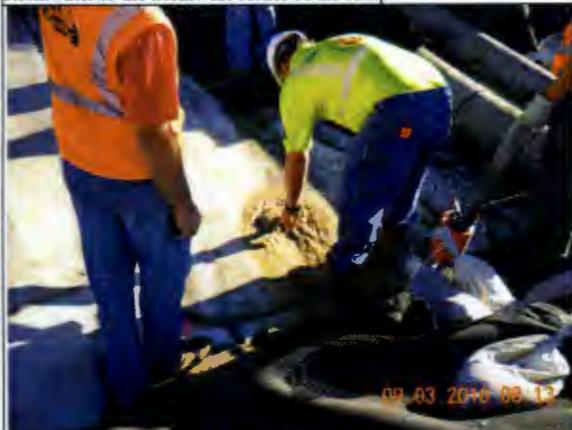
<p>09 03 2010 08:13</p>

<p>09 03 2010 08:28</p>
<p>Facing SW – ESI cutting a release hole in the secondary geomembrane in the Cell 9 sump.</p>	<p>Facing W – TWS and ESI "walking" the stormwater out from below the secondary geomembrane.</p>

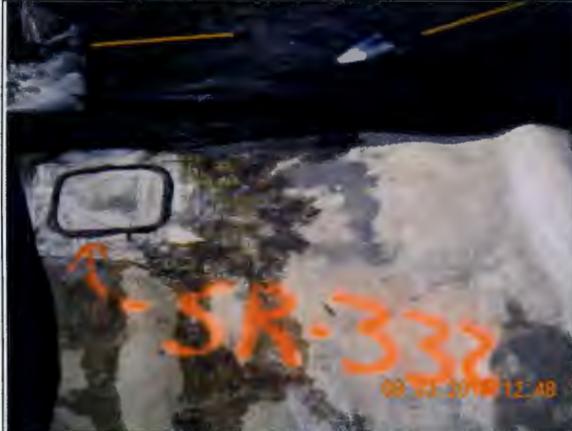
Facing S – After CQA investigated and verified that the admix surface met stability requirements, ESI patched the release hole.

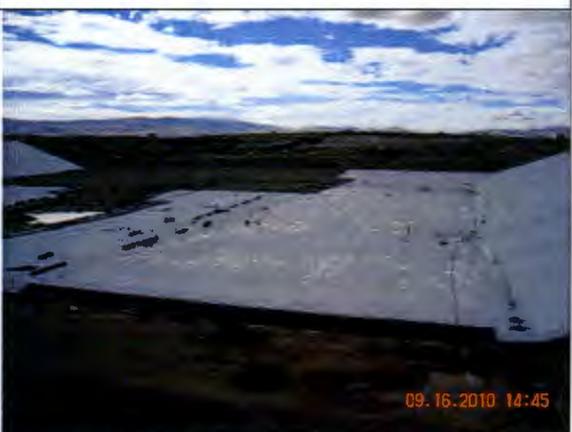
<p>09/16/2010 01:09 PM</p>

<p>09.16.2010 14:45</p>
<p>Facing N – ESI determining the extents of the failed Cell 10 primary seam P-11/P-12 (DP-03).</p>	<p>Facing SE – Extent of geosynthetic deployment on September 16, 2010.</p>

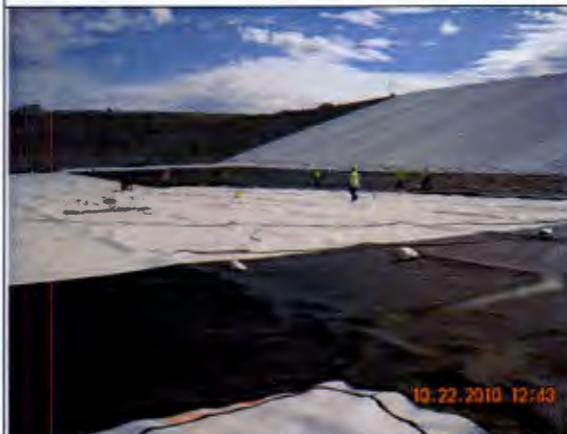
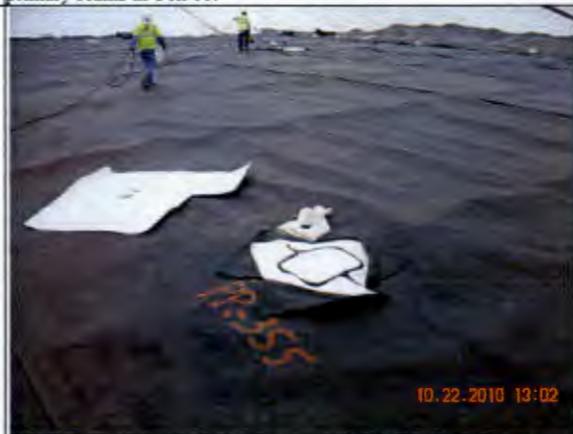
Facing Down – Due to failing destructive testing ESI located and repaired extrusion welds that had been covered by 16-oz fabric.

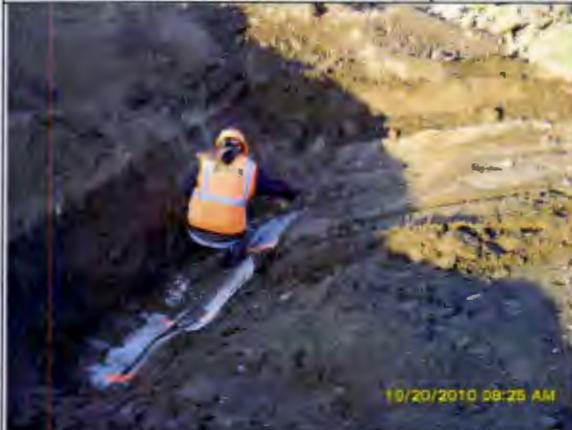
Facing W – TWS excavating the un-welded air release holes left open in liner in the north anchor trench so ESI could complete the welds.

Facing W – ESI completing the welding of the air-release holes in the north anchor trench.

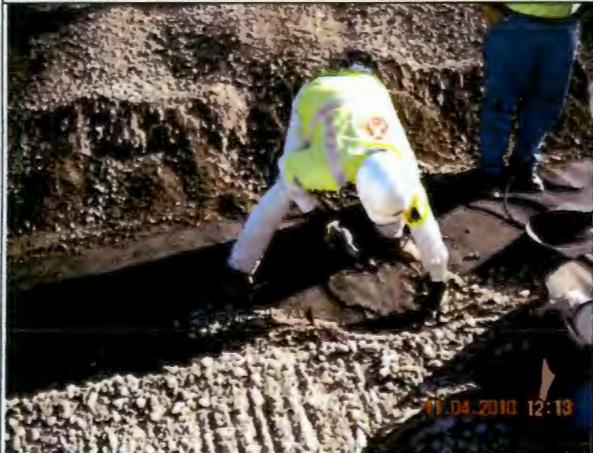
Facing Down – ESI is repairing the 16-oz fabric on the floor of Cell 10. TWS snagged the fabric while excavating for the collector pipe.

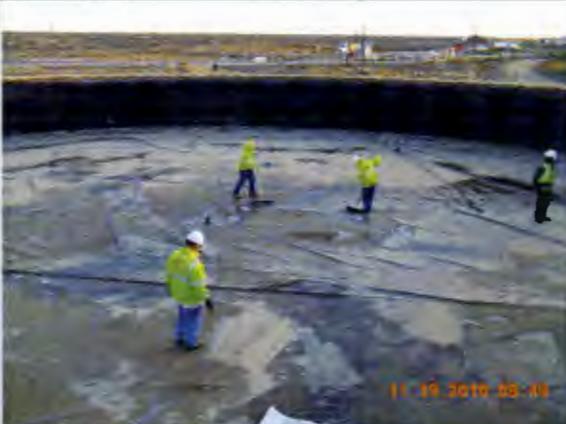
<p>11-18-2010 17:10</p>

<p>11-19-2010 09:49</p>
<p>Tank 4 – ESI making secondary repairs to leaks found during the electronic leak survey.</p>	<p>Tank 3 – ESI cleaning the floor of Tank 3 in preparation for placing secondary geocomposite.</p>

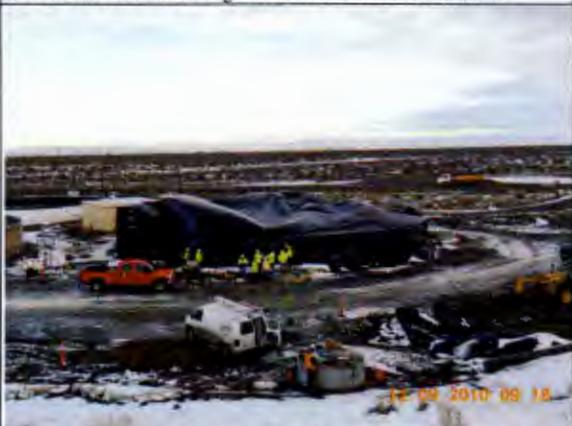
<p>12-08-2010 13:31</p>

<p>12-09-2010 09:18</p>
<p>Facing N – The tarp has been installed over Tank #3.</p>	<p>Facing N – High winds began to cause damage to the tent over Tank #3. The tarp was subsequently removed.</p>
